**Sandbank Street, Maryhill,
Glasgow,**

Archaeological Watching Brief

Report No. 2131

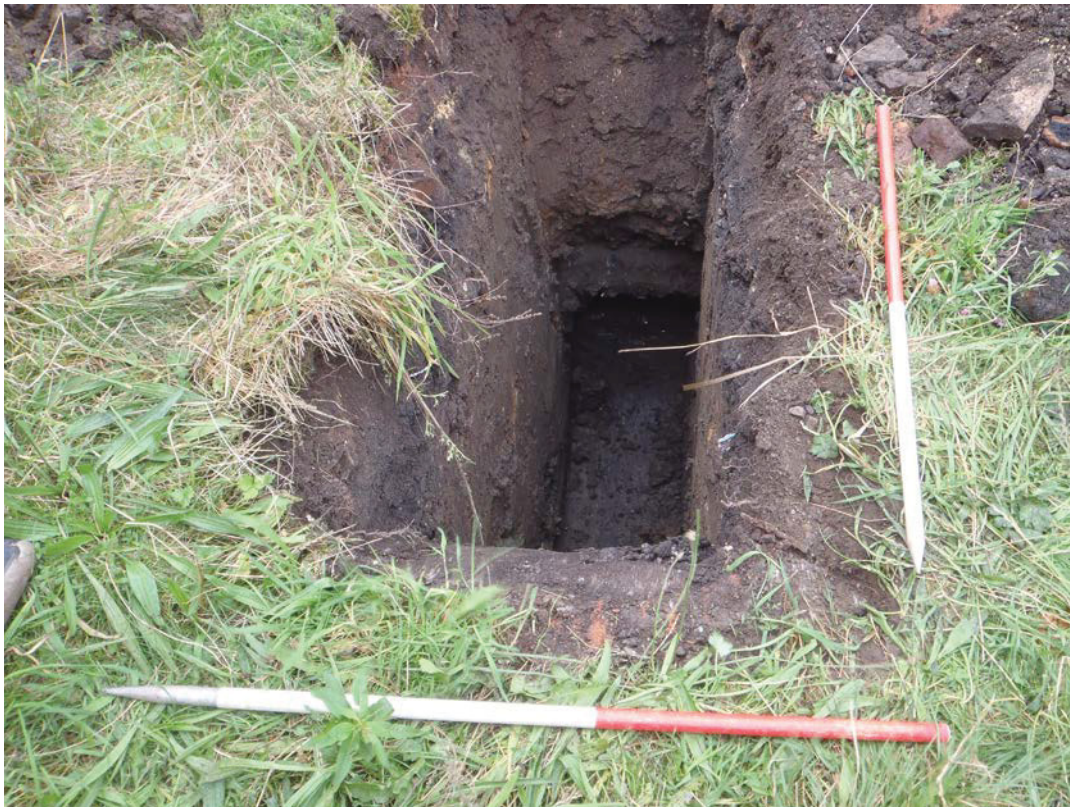
Fig. 2 Photograph of Test Pit 1

Test-pit 1 (NGR NS 256721 668919) was aligned north-south and located on the proposed line of the former canal. It measured 2m long by 0.6m wide by 2.6m deep. The stratigraphy consisted of 0.1m of topsoil, over 0.4m of industrial ash and broken brick. This overlay unconsolidated grey brown clay which was excavated to a depth of 2.6m. The nature of the clay suggested it was re-deposited, however, it was not bottomed before excavation ceased at the depth required for the ground investigation.

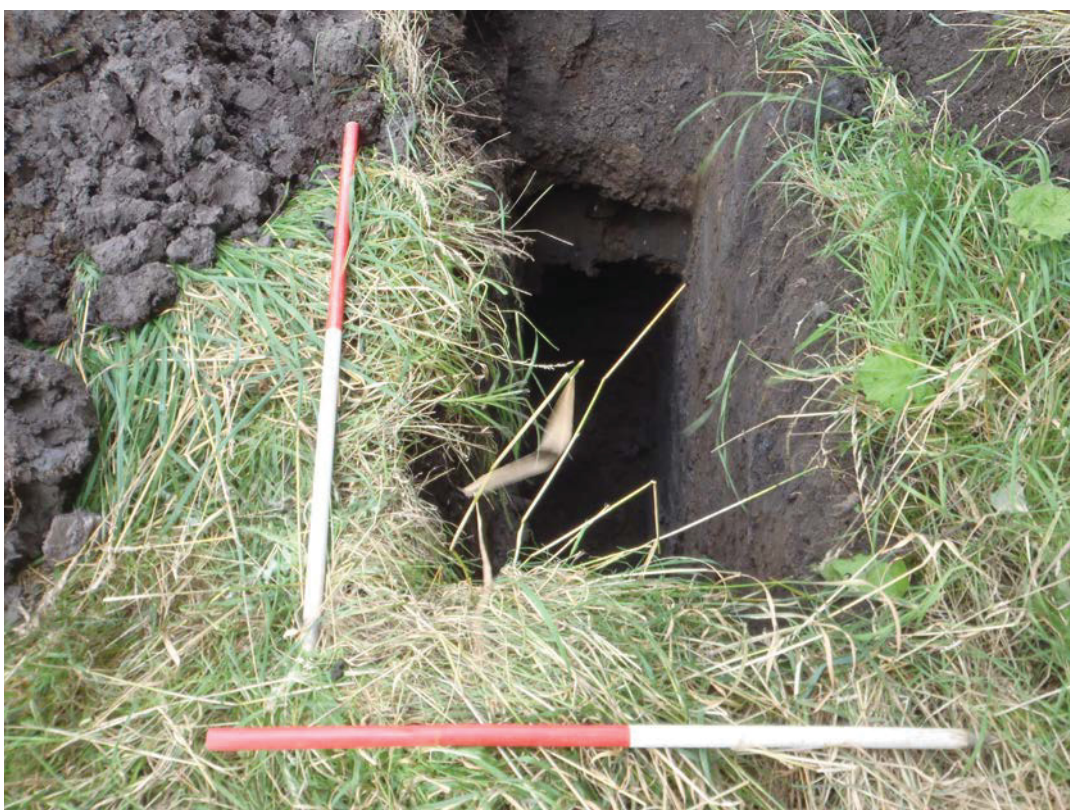
Fig. 3 Photograph of Test Pit 2

Test-pit 2 (NGR NS 256737 668928) was aligned northeast-southwest and located on the proposed line of the former canal. It measured 2m long by 0.6m wide by 2.6m deep. The stratigraphy consisted of 0.4m of brown silt, over 2.2m of unconsolidated grey brown clay. The clay included pieces of brick and rubble debris indicating that it was re-deposited, however, it was not bottomed before excavation ceased at the depth required for the ground investigation.

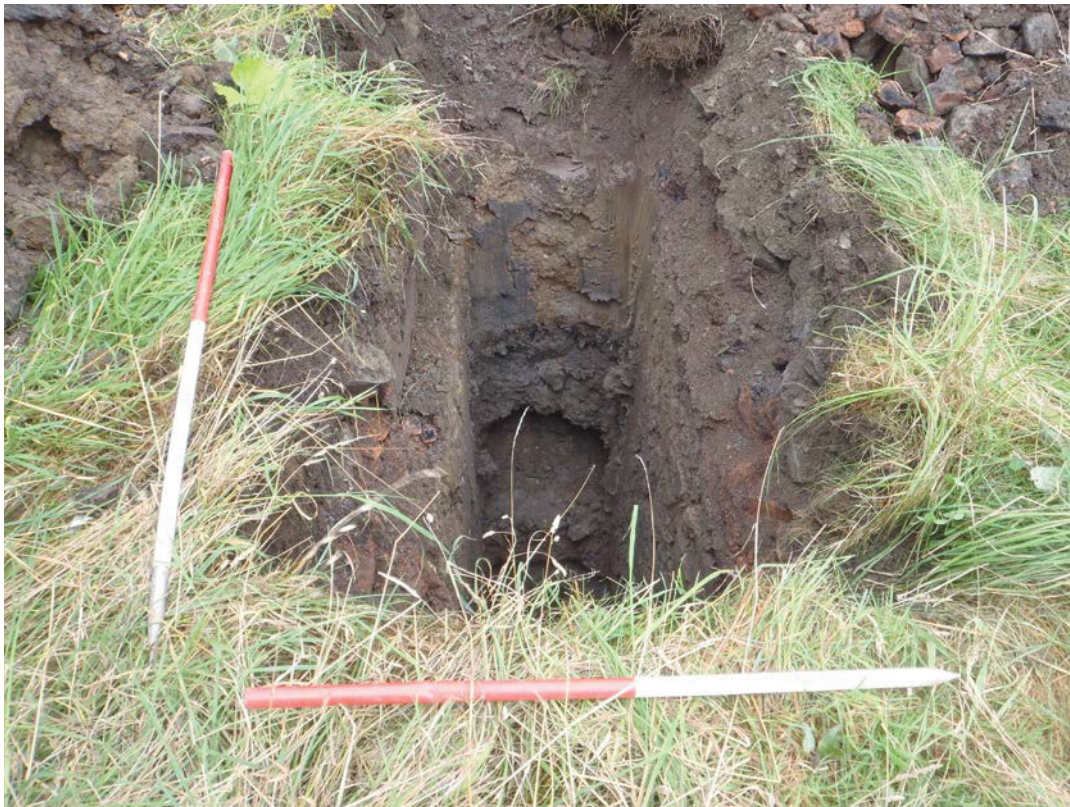
Fig. 4 Photograph of Test Pit 4

Test-pit 4 (NGR NS 256734 668917) was aligned north-south and located on the proposed line of the former canal. It measured 2m long by 0.6m wide by 2.9m deep. The stratigraphy consisted of 0.1m of topsoil over 0.5m of shattered brick and stone. This overlay 2.3m of unconsolidated dark grey brown clay. The nature of the clay suggested it was re-deposited, however, it was not bottomed before excavation ceased at the depth required for the ground investigation.

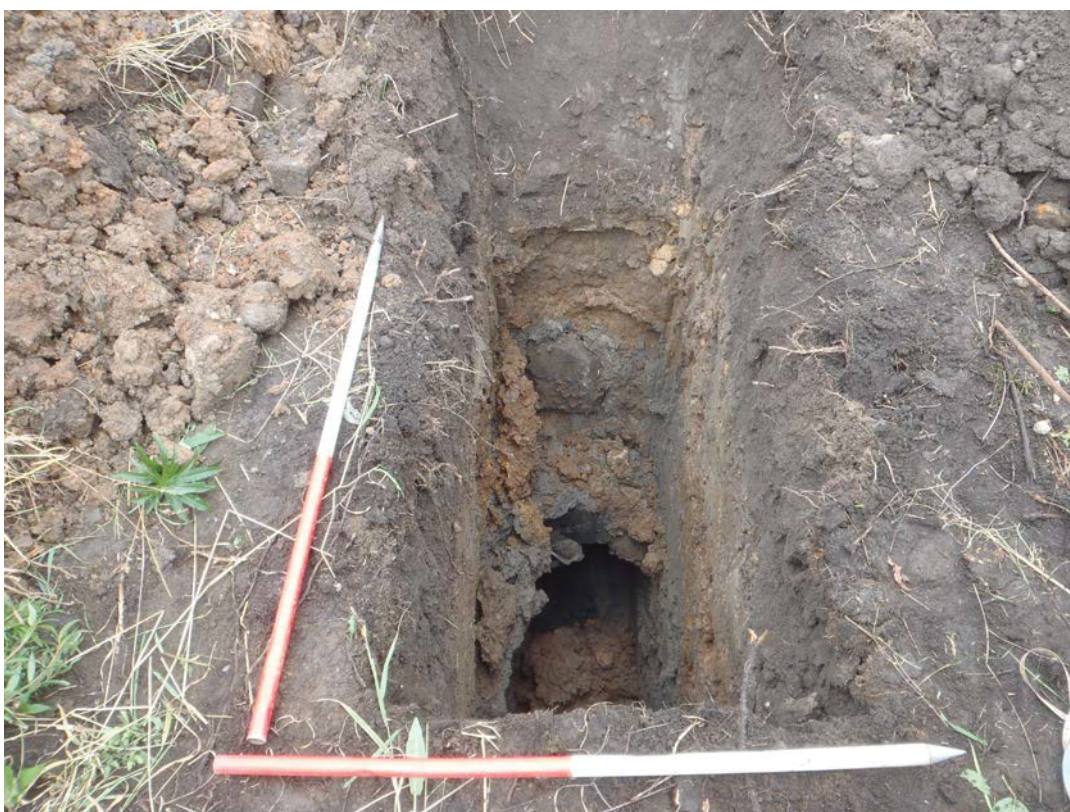
Fig. 5 Photograph of Test Pit 7

Test-pit 7 (NGR NS 256706 668905) was aligned northeast -southwest and located to the west of the proposed line of the former canal. It measured 2m long by 0.6m wide by 2.9m deep. The stratigraphy consisted of 0.7m of brown silt overlying 0.8m of redeposited mottled orange brown clay. Below this was grey clay which was at least 1.5m thick a wooden sleeper was identified in the clay at a depth of c 2m below the current site surface suggesting that the entire clay deposit was re-deposited, however, it was not bottomed before excavation ceased at the depth required for the ground investigation.

The results from TP7 suggest that there are greater depths of made ground than would normally be expected if this area of the site was simply a canal side area where natural could be expected quite close to the surface. So there is the potential that the former route of the canal was wider at this point than expected or that this part of the site was built up in the past during the creation of the cutting for Maryhill Road.
