Princes Street Gardens City of Edinburgh

Archaeological Test Pitting

Report No. 2138

Author	Magnus Kirby MA FSA Scot AIfA
Illustrator	Leeanne Whitelaw BSc MIFA
Editor	Bruce Glendinning BSc PgDip MifA
Commissioned by	City of Edinburgh Council
Date issued	October 2012
Version	0
Planning Application No	N/A
Grid Ref	NT 2530 7360

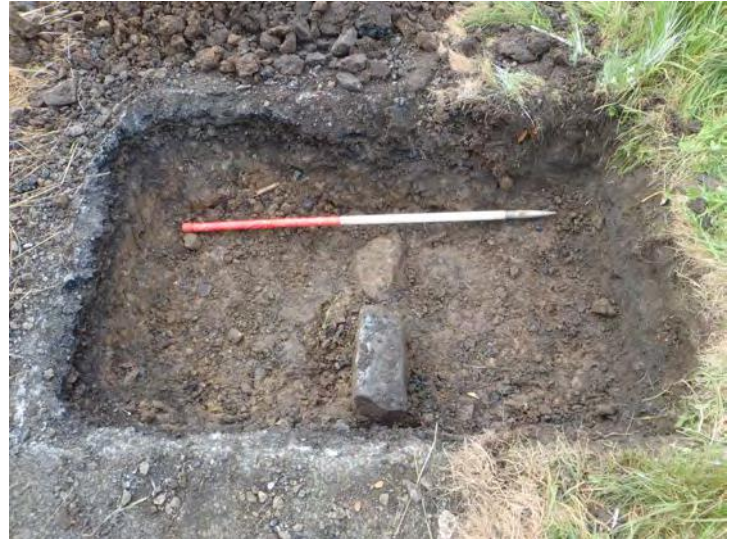
Fig. 4: Edge set stones 036 within BH5

Test-pit BH5 (Fig. 8) was located at c.63m OD on a terrace created for the path. It was mainly cut through the tarmac surface of the path, but extended into the grass verge. The top layer within this test-pit consisted of the path which was formed from 0.16m of tarmac and hardcore (**028**) this cut mid grey-brown silt topsoil (**029**) which was 0.16m deep. The topsoil directly overlay orange-brown sandy-clay natural (**030**). There were no finds from this test-pit. Two aligned edge set stones (**036**) (Fig.4) set into the natural may have been the edging for an earlier path (Fig. 4).

No significant archaeological features or deposits were identified, however, a cut for a terrace or other landscaping feature was identified within test-pit BH4 and two aligned stones within test-pit BH5 might represent the edge of an earlier path. Neither of these features were thought to be of any antiquity and probably related to the use of the area as a park.

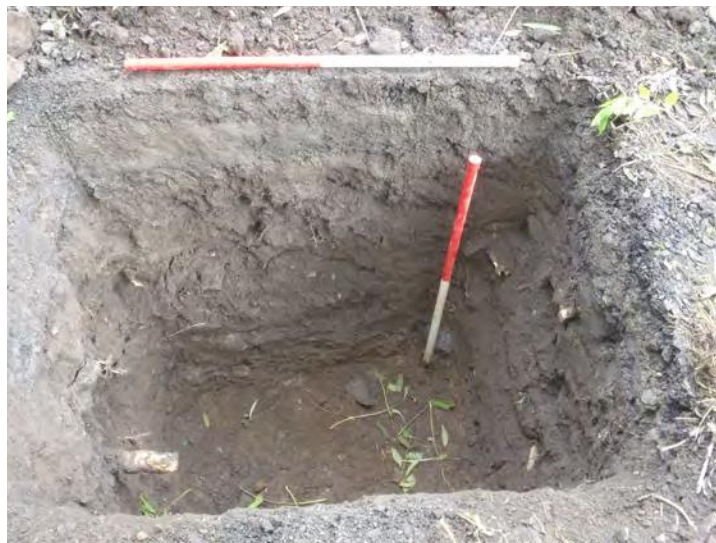
Fig. 5: BH1, south-facing section

Test-pit BH1 (Fig. 5) was located within the tarmac path towards the top of the slope (c.97m OD) and immediately down from the castle esplanade. The deposits within this test-pit from the top down consisted of the path which was constructed from 0.04m of tarmac (**031**) and 0.18m of grey-brown ash (**032**). The path overlay 0.92m of grey-brown sandy-silt (**033**) containing numerous small angular stones. Deposit **033** overlay orange-brown sandy-clay natural which was located at 1.14m below the current site surface. A number of finds were recovered from deposit **033**.

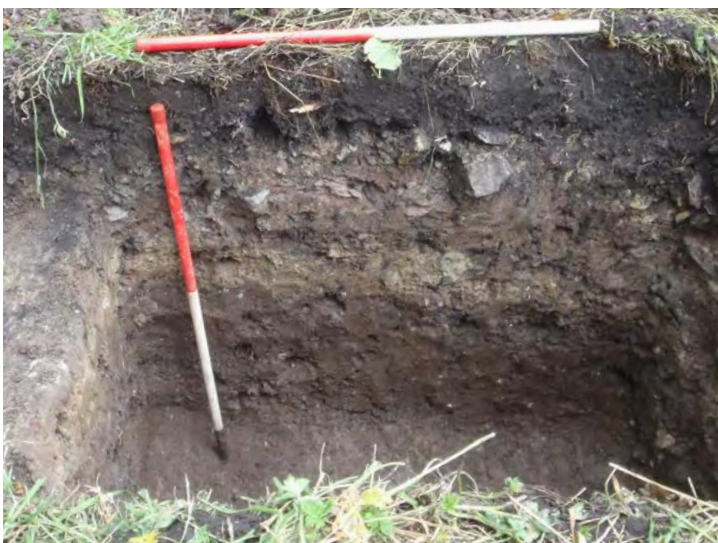
Fig. 6: BH2, east-facing section

Test-pit BH2 (Fig. 6) was also located towards the top of the slope (c.95m OD) lying immediately to the north of the tarmac path to the west of BH1. An electrical cable was uncovered during the initial excavation of this test-pit so it was relocated c.0.9m to the north of its original location. The deposits within this test-pit from the top down consisted of c. 0.2m of mid-brown silt topsoil (**020**), 0.4 – 0.6m of sandy clay deposits (**021**, **022** and **023**) and 0.3m – 0.65m grey-brown sandy-clay (**024**). Deposit **024** was not bottomed and natural subsoil was not reached in this pit. Finds were recovered from deposit **024**.

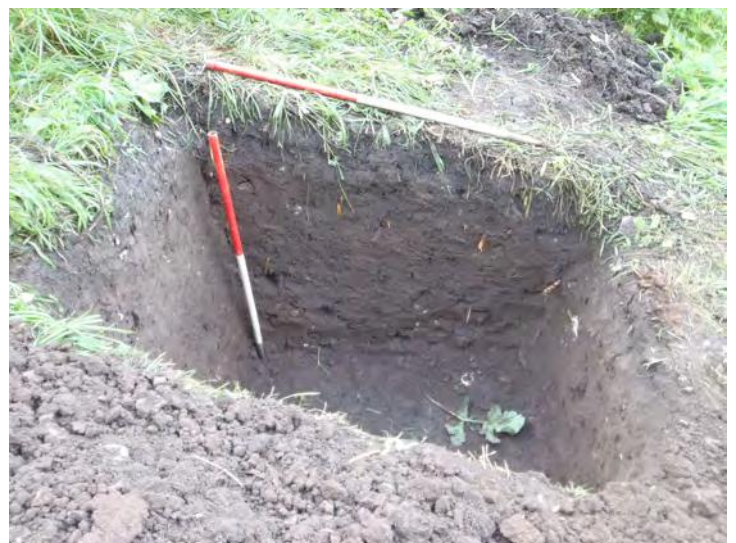
Fig. 7: BH3, east-facing section

Test-pit BH3 (Fig. 7) was located at c.85m OD on a steeply sloping grassy bank. This test-pit contained a single homogenous deposit of grey-brown silt (**001**). Deposit **001** was not bottomed and natural subsoil was not reached in this pit. A number of finds were recovered from deposit **001**.

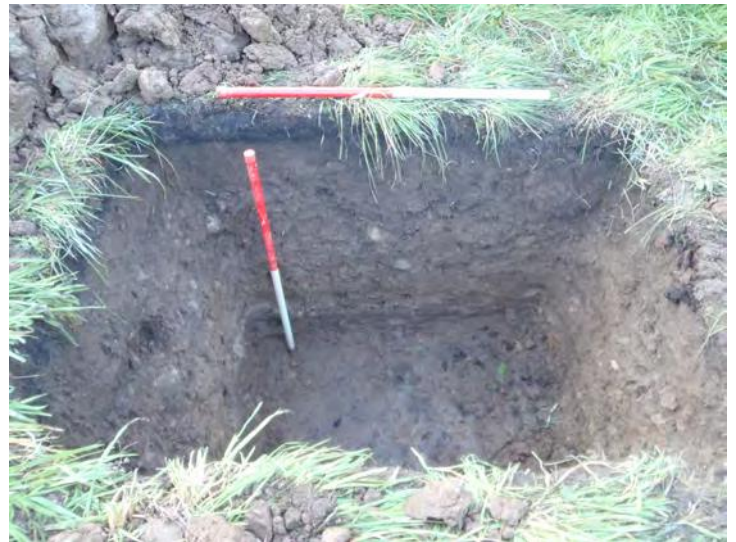
Fig. 9: BH6, east-facing section

Test-pit BH6 (Fig. 9) was located at c.58m OD on a steeply sloping grassy bank towards the base of the slope. The deposits within this test-pit from the top downwards consisted of 0.1m of black humic silt topsoil (**013**), 0.2m of slightly orangey-brown sandy silt slopewash (**014**), 0.7m of slightly yellowish-brown sandy clay (**015**) and 0.2m of soft slightly purplish clay (**016**). Deposit **016** was not bottomed. The two lower deposits (**015** and **016**) possibly represent two different bands of natural subsoil. There were no finds from this test-pit.

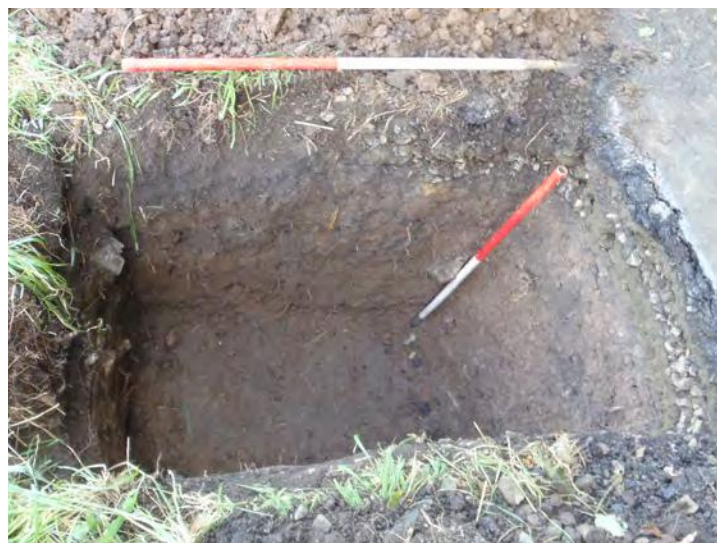
Fig. 10: BH7, west-facing section

Test-pit BH7 (Fig. 10) was located at c.74m OD on a terrace created for the path. It was partially cut through the tarmac surface of the path and partially cut into the grass verge. The uppermost layer (**005**) within this test-pit consisted of up to 0.2m of path material made up of tarmac and modern hardcore. This cut topsoil deposit **002**, which consisted of dark brown silt measuring up to 0.42m deep. This overlay a c.0.3m deep deposit of orangey-grey silty clay (**003**) and beneath **003** there was a c.0.65m deep deposit of orangey-brown silty (**004**). Deposit **004** was not bottomed and natural subsoil was not definitely reached. Finds were recovered from deposits **002** and **003**.

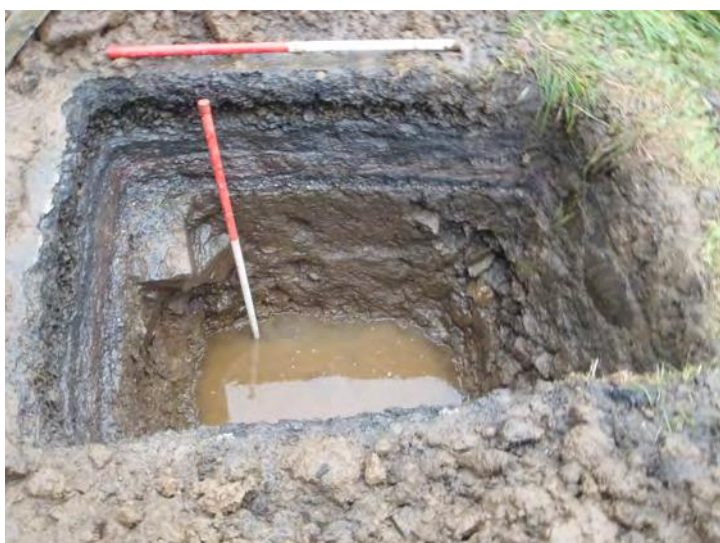
Fig. 11: BH8, east-facing section

Test-pit BH8 (Fig. 11) was located at c.63m OD on a terrace created for the path. It was mainly cut through the tarmac surface of the path, but extended into the grass verge. The Path (**025**) was constructed from 0.35m of tarmac and modern hardcore which cut a similar depth of brown silt topsoil. This overlay 0.44m of mid grey-brown sandy-clay (**026**) containing numerous large and small stones, which in turn overlay natural which was a brown sandy-clay (**027**).

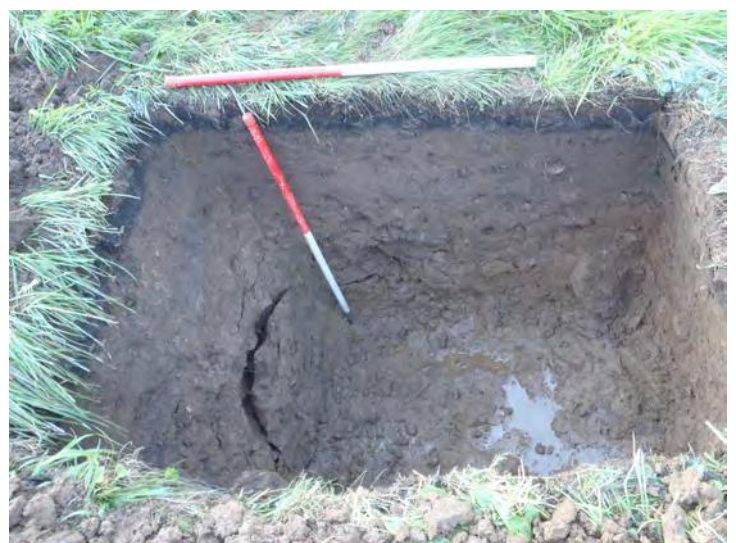
Fig. 12: BH9, east-facing section

Test-pit BH9 (Fig. 12) was located at c.58m OD on a steeply sloping grassy bank towards the base of the slope. The deposits within this test-pit from the top downwards consisted of 0.14m of black humic silt topsoil (**013**), 0.34m of mid grey-brown silty-clay (**018**) and 0.72m of wet unconsolidated mid orangey-brown sandy-clay (**019**). Deposit **019** was not bottomed and natural subsoil was not definitely identified. A sherd of post-medieval pottery was recovered from deposit **018**.
