**9 West Harbour Road, Granton,  
Edinburgh**

**Trial Trenching Evaluation**

**Data Structure Report  
No. 3036**

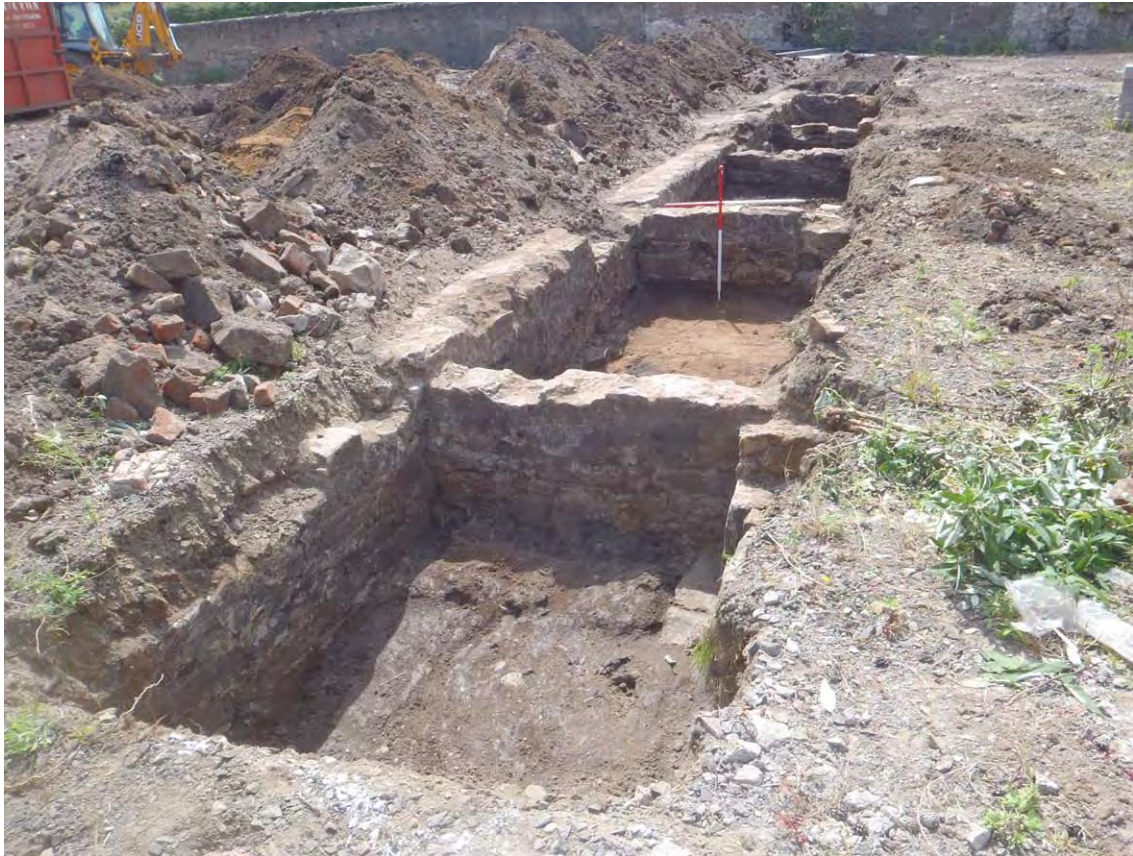
The remains of two parallel walls (**101 & 102**) set 1.6m apart ran the full length of the trench. The west wall (**102**) was not fully exposed in the trench but was visible in the section. It survived to a height of 0.9m and was founded onto the surface of the natural (**000**). It was built of large rough-hewn sandstone blocks and had poorly preserved mortar bonding near its top.

The east wall (**101**) was fully exposed in plan and was of identical character to **102**. It measured 0.45m thick and was founded in a shallow foundation cut (**107**) running along the base of the wall.

Fig. 7. - Trench1 wall footings from the north

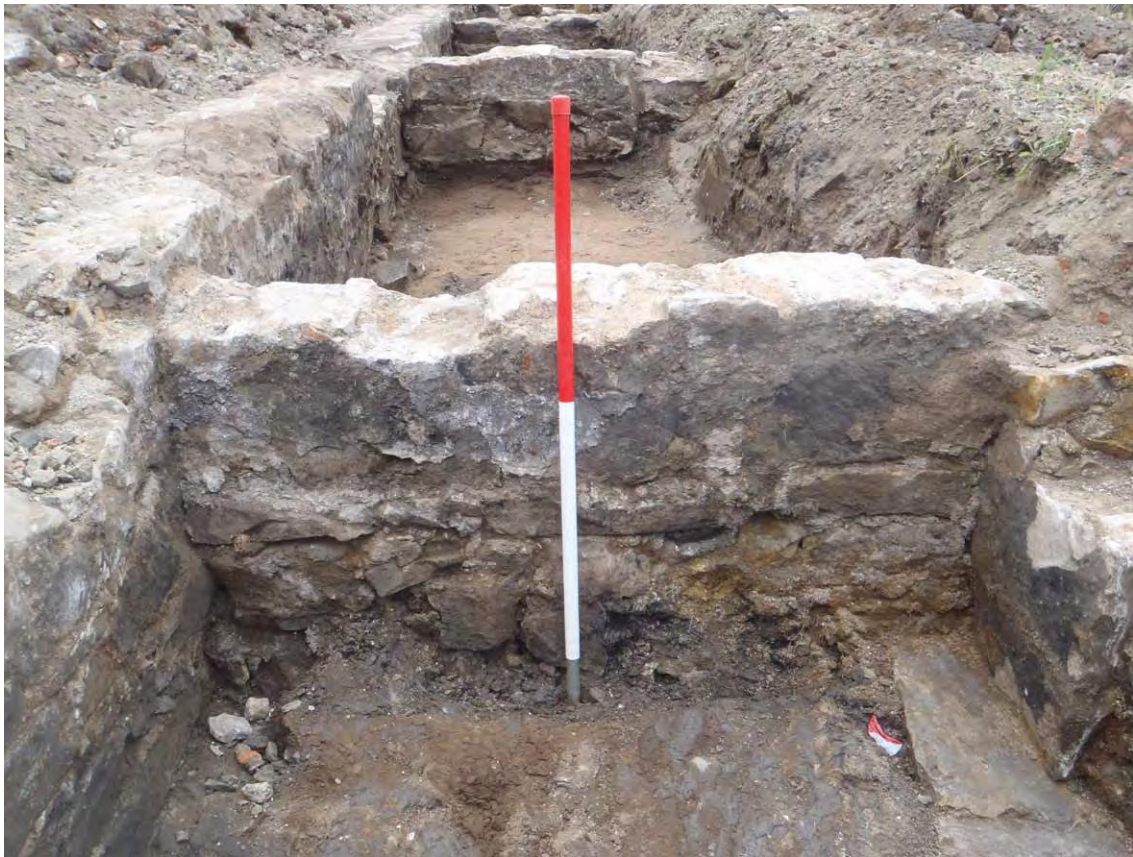
A series of five walls (**103, 104, 105, 106 & 110**) ran perpendicular between walls (**101 & 102**), subdividing the structure as exposed into 6 individual units. These walls survived to a height of 0.7m and were 0.3m thick. They abutted the two bounding walls and were set directly onto the surface of the natural (**000**). Wall **110** had a foundation trench (**108**) but the others all appear to have been built directly on the natural with no foundation trench.

Fig. 8 - Trench 1 interior dividing wall detail

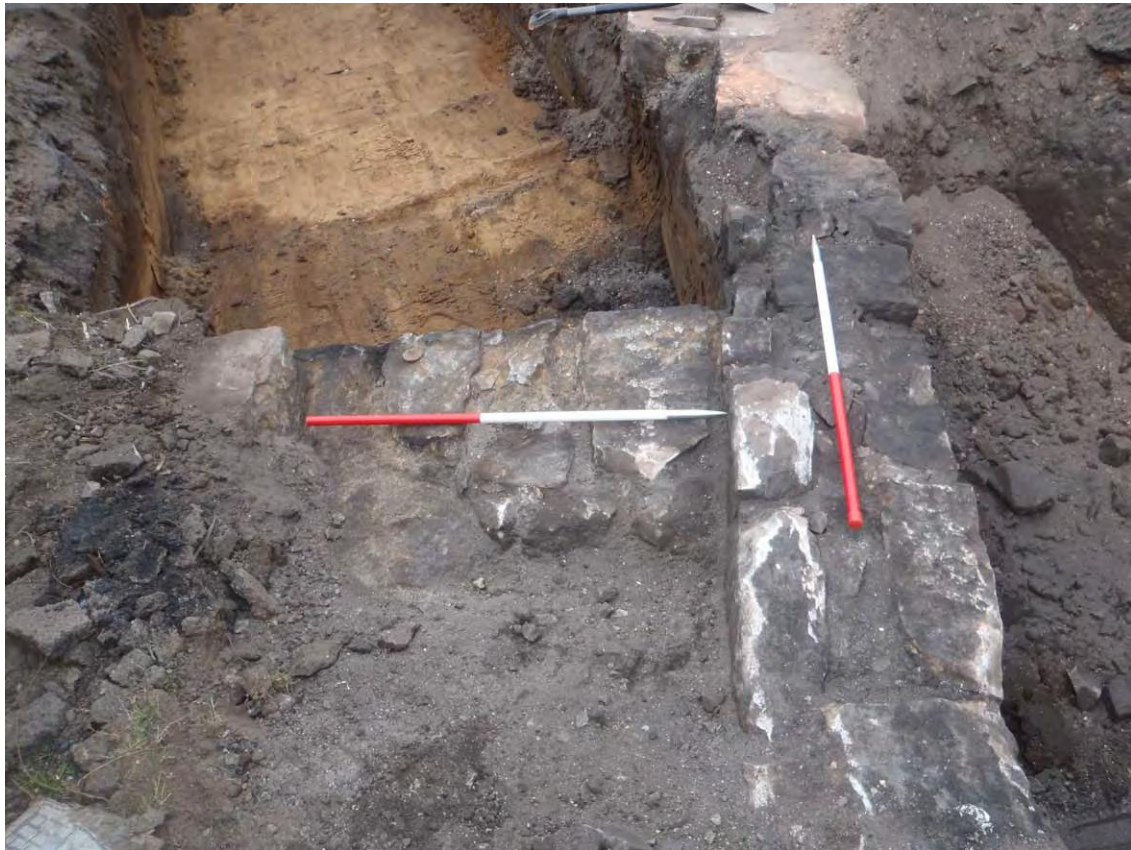
The remains of two wall footings were revealed. Wall (**402**) (Fig. 10) was aligned east to west and was exposed for an extent of 3.2m. It survived as a single course of large rough ashlar blocks forming the base of a double-skinned wall with a rubble core. It measured 0.5m wide. It was founded directly onto the surface of the silt deposit (**404**).

A shorter section of wall (403) (Fig. 10) was aligned north to south and abutted the south side of 402. It was 0.7m wide and was of the same build, and also founded on the silt deposit (404).

Fig. 10 - View of 402 & 403 from the north-west
