**9 West Harbour Road, Granton,
Edinburgh**

Archaeological Investigation

**Data Structure Report
No. 3047**

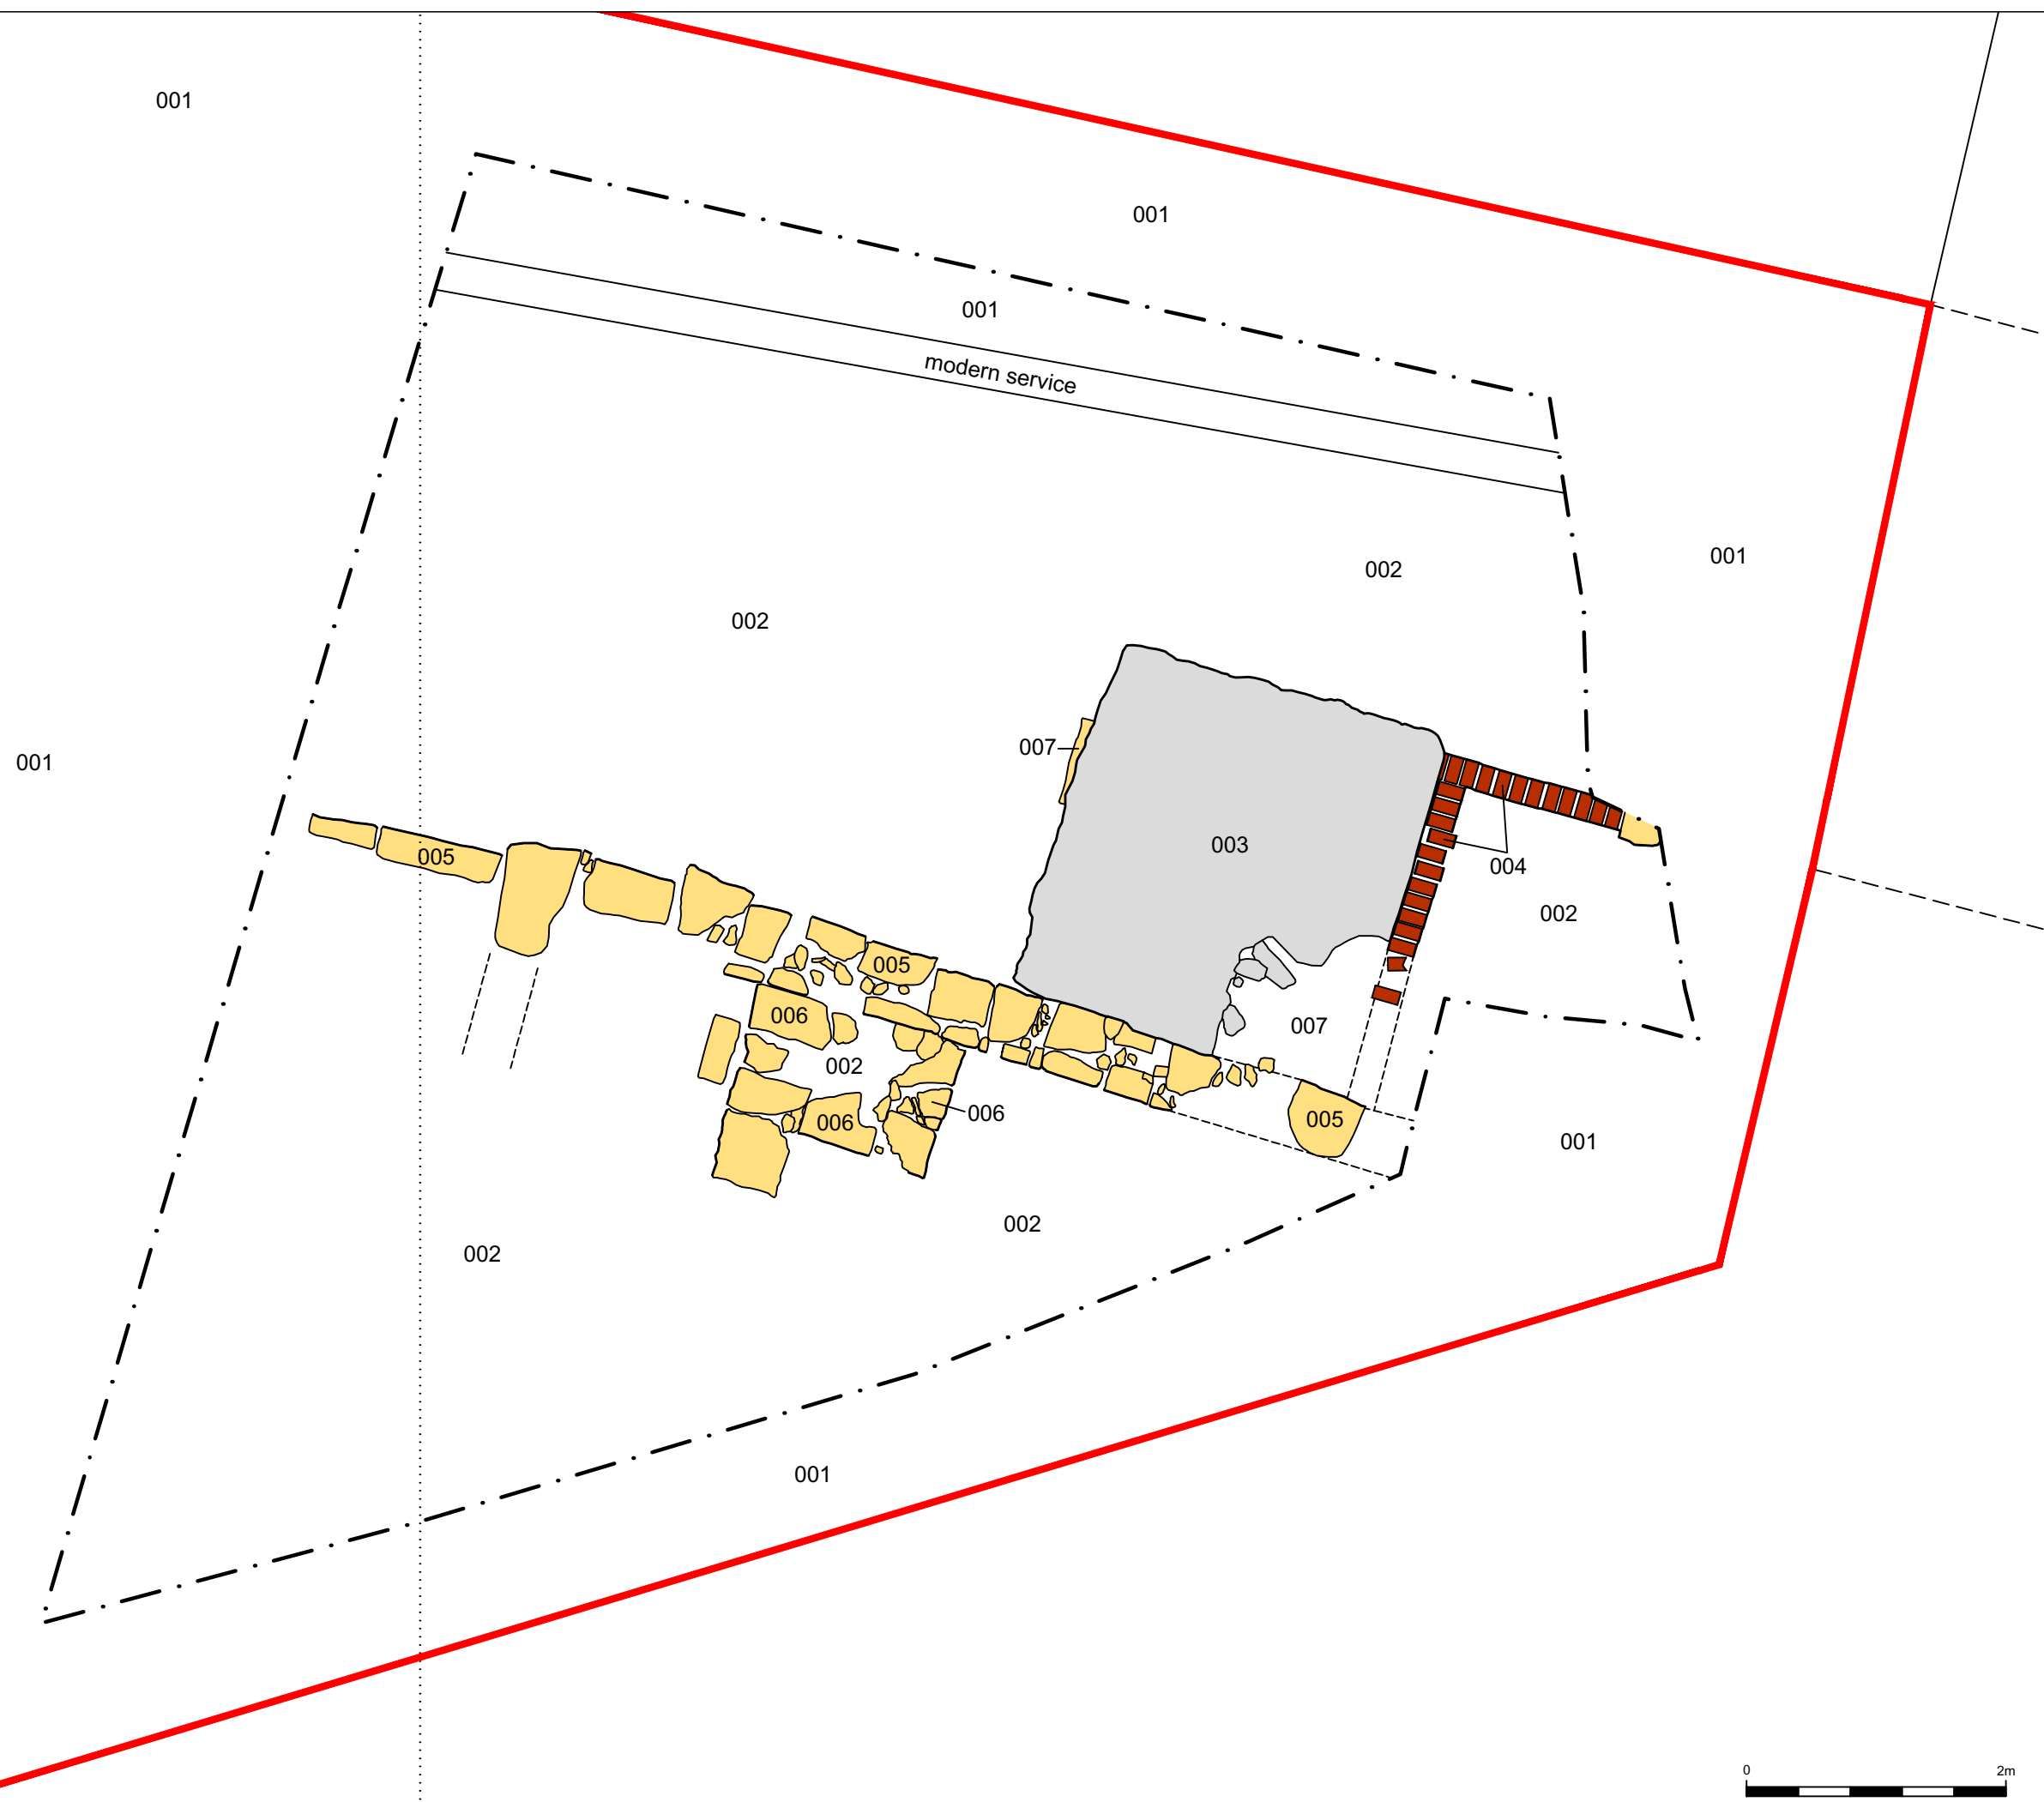
Fig. No: 2 Revision: A

Title:
Archaeological features

3.2 Smithy Building Remains (Figs. 2 & 5)

The fragmentary remains of the Smithy survived just below the modern tarmac site surface. The surviving remains extended slightly further than identified in the first phase of evaluation (Mitchell 2013) but not by much.

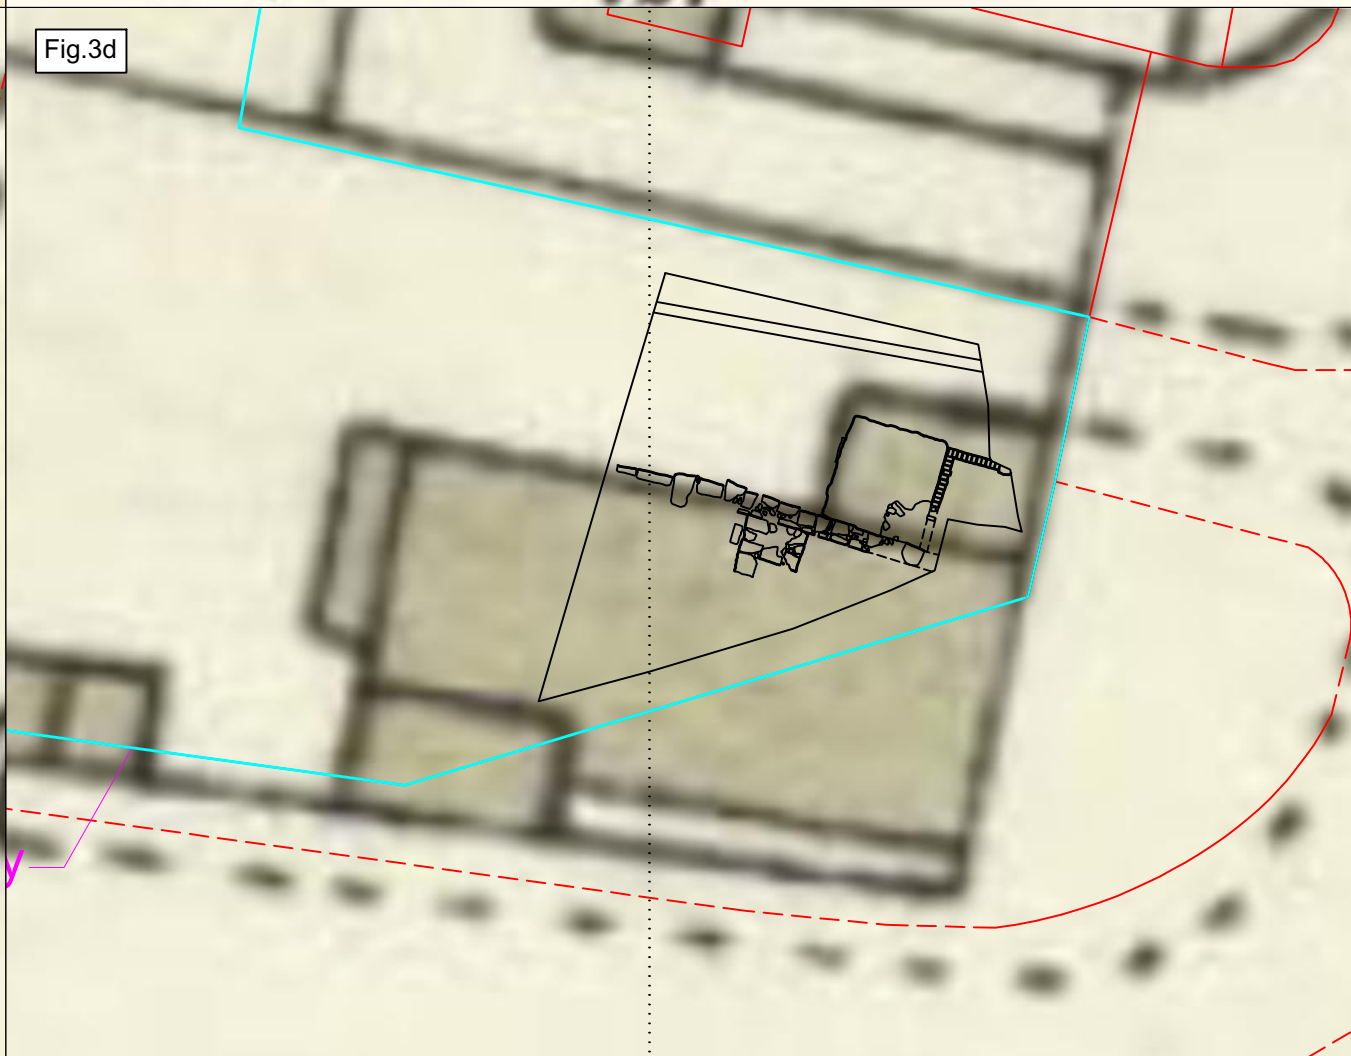
Fig. No: 3a-d Revision: A

Fig. 3a Ordnance Survey map, Town Plan, 1849

Fig. 3b Ordnance Survey map, Town Plan, 1876

Fig. 3c Ordnance Survey map, 3rd Edition, 1908

Fig. 3d Ordnance Survey map, 1933

Title:
Archaeological features over historic maps

Following this evaluation CECAS agreed that the buildings along the western edge of the site were of sufficiently limited significance for no further work to take place. However, the Smithy because of its industrial nature and its close proximity to the shore was deemed to have some potential significance in looking at small scale industrial processes that could have a tie in with the area's maritime past. A trench based on the layout of the building as it was mapped on the Town Plan of 1876-7 (Fig. 3b) was agreed with CECAS.

A single trench was excavated to a strategy agreed with CECAS (Fig. 1). The trench was designed to cover the mapped and ground truthed location of the Smithy buildings as they were mapped on the Town Plan of 1876-7 (Fig. 3b) whilst avoiding services and maintaining a minimum of 1m buffer between the trench and the surrounding boundary walls.

From an assessment of the map evidence (Figs. 3a-e) it is clear that Wall (005) is the original northern wall of the Smithy with the single stone set at a right angle to this being the remains of the western end the original building (Fig. 3a). The two stones to the west of the right angled stone are part of later extension work (Fig. 3c) dating to before 1908. The concrete surface (003) and brick wall (004) appear to be part of a northern extension to the structure dated to sometime between 1908 and 1933 (Figs. 3c & d).

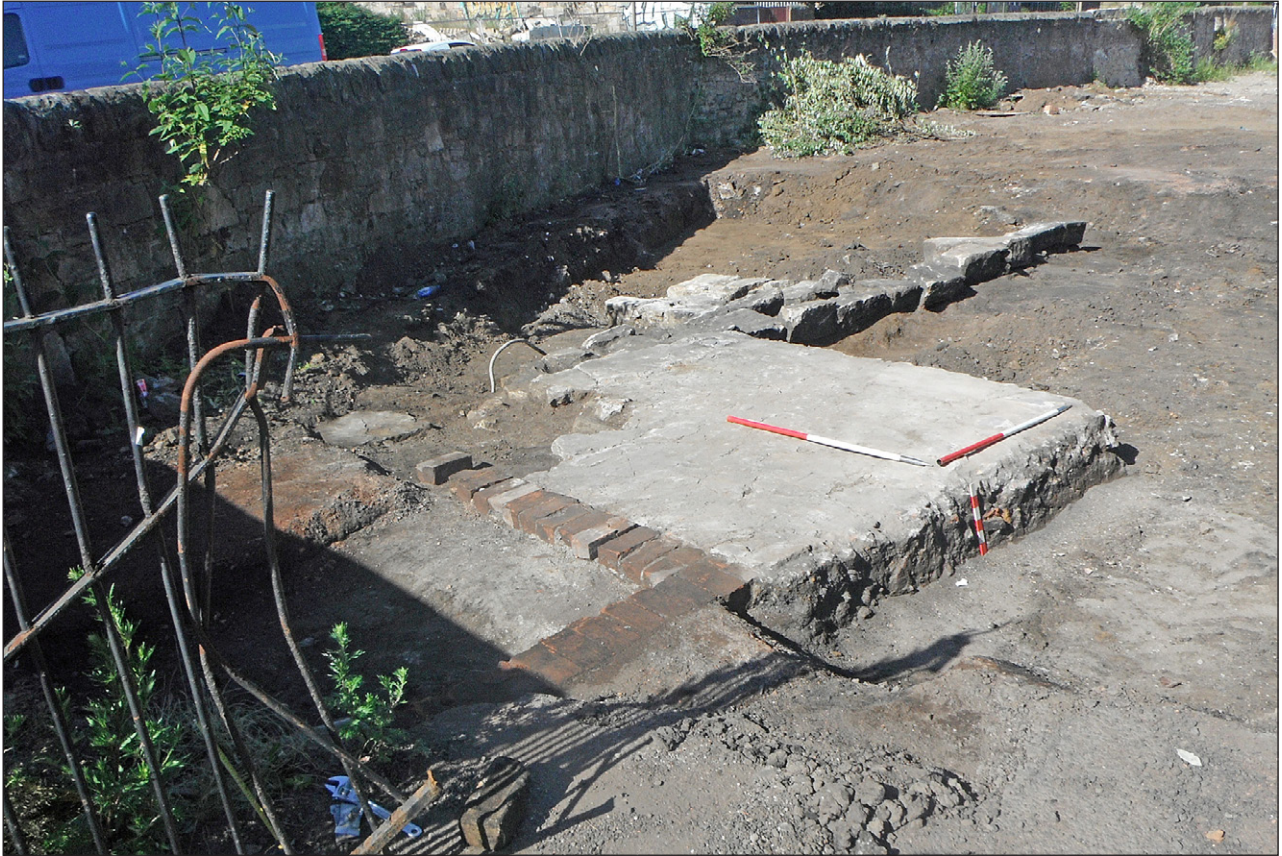
Fig. 5 - Remain of Smithy structures

The roughly east-west aligned wall (Figs. 5 & 6) previously identified as context **401** but here identified as **005** survived as a one course high sandstone wall which was 0.5 - 0.6m wide. In total 9.5m of this wall were uncovered. It ran out of the trench to the east but the proximity to the site boundary wall and the potential location of services meant that excavation could not continue any further in that direction. To the west a slight return formed by one stone was present and the east-west alignment continued

The eastern side of the concrete surface (003) (Figs 5 & 7) was bounded by a brick wall (004) (Figs 5 & 7). Almost parallel with the northern end of the surface the wall turned through 90° to run approximately to the east away from the surface. The wall ran for 1.7m before running out of the trench to the east and could not be followed due to the presence of the site boundary. The wall (004) was 1 brick wide and between 1 and 2 bricks high.

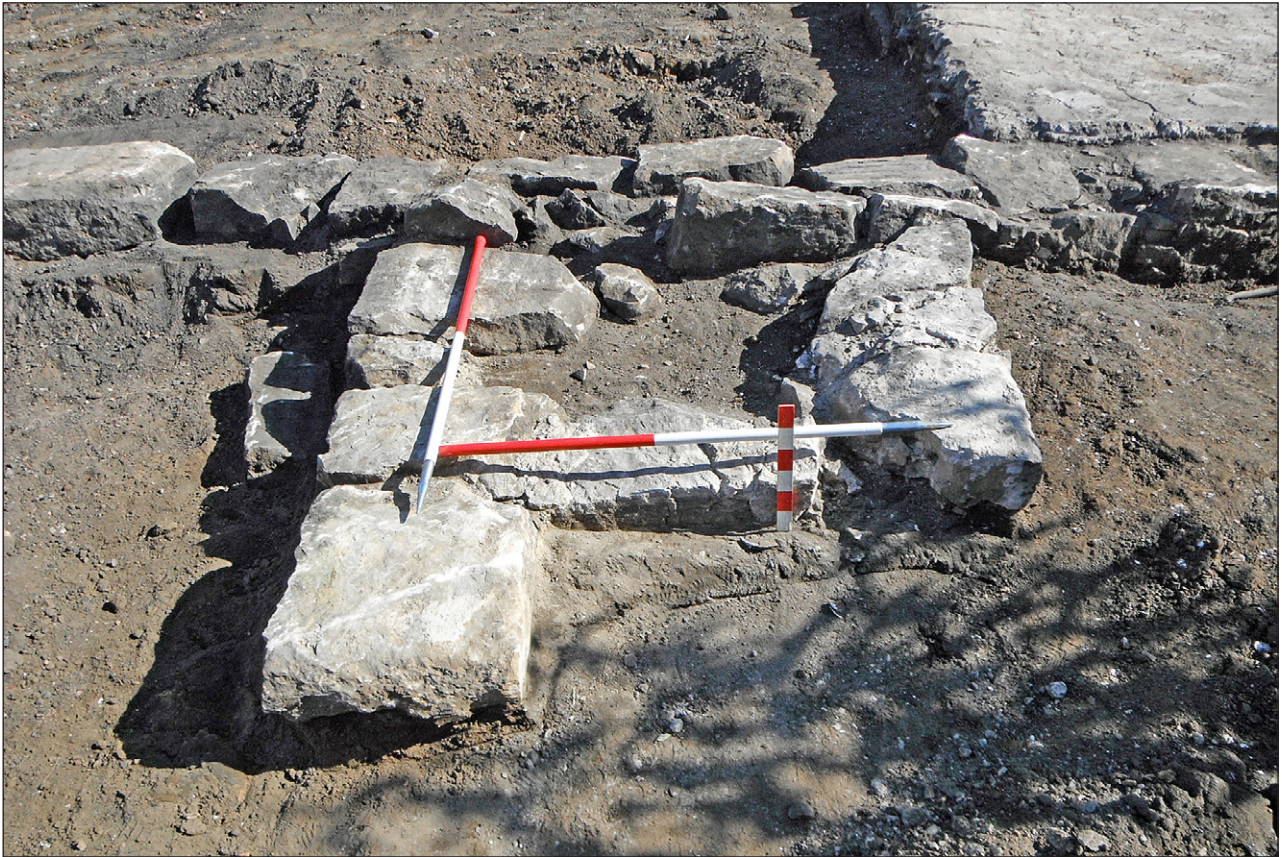
Fig. 6 - Wall 005 and Feature 006

Abutting the southern face of wall (005) was a possible wall (006) (Fig. 6) previously identified as context 403. This was only partially uncovered in the initial evaluation and had a full dimensions of 1.6m wide by 1.7m long. It was constructed from sandstone like wall 005 and again survived to and one course high. (006). Slight traces of mortar bonding were identified on the upper faces of the stones. It is also possible that this was a base for an internal feature as it does not align with any mapped walls (Figs. 3a-e) and it is quite wide in comparison to the Wall 005 which is a known structural wall.

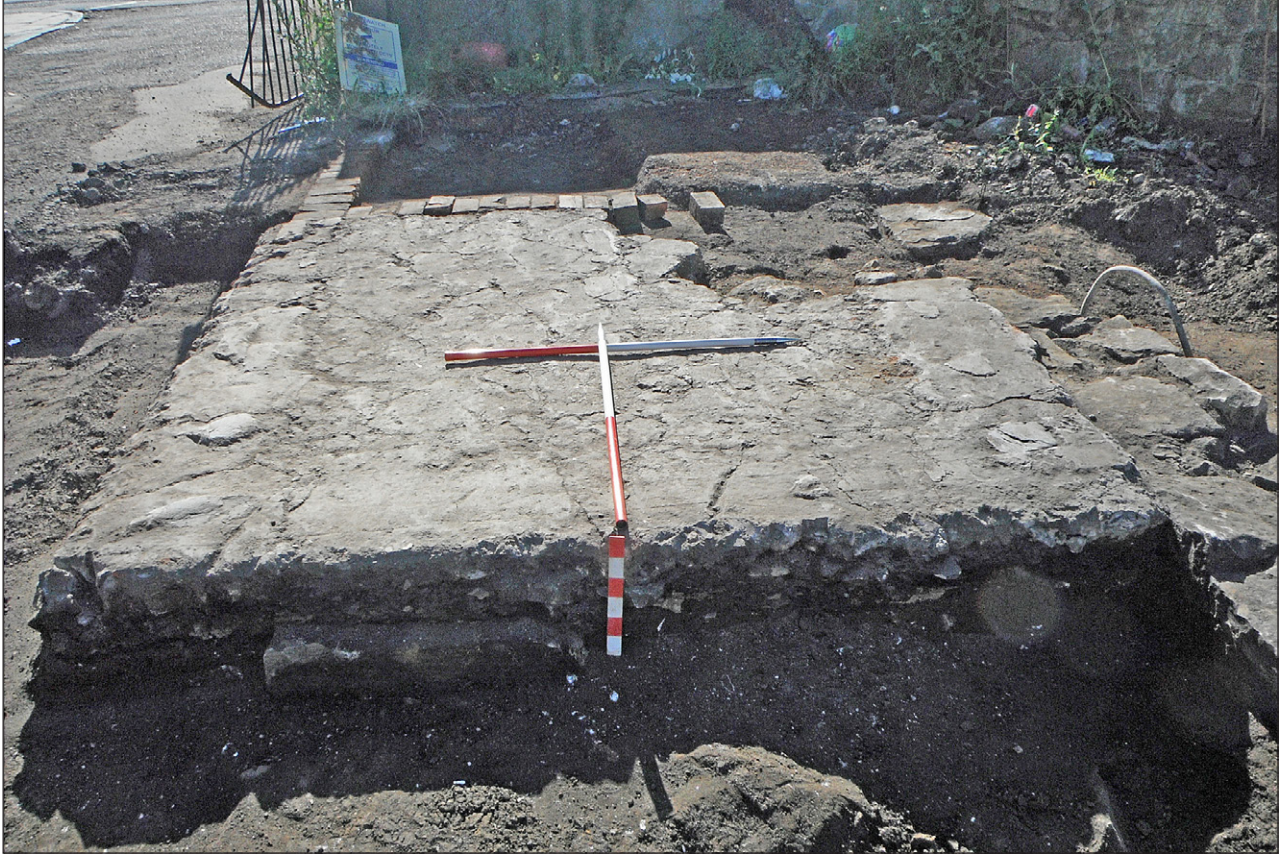
Fig No: 7		Revision: A	Project: 9 West Harbour Road, Granton, Edinburgh Archaeological Excavation

Fig. 7 - Concrete floor slab 003 and wall 004

On the north side of wall 005 a square concrete floor surface (003) was present. This measured 2.7m square and directly abutted the north face of (005). The concrete surface had been laid over a levelling / formation deposit of broken brick and rubble (007).
