**Crossaig Substation Service Road,
Cour, Kintyre**

Archaeological Watching Brief

Report No. 3249

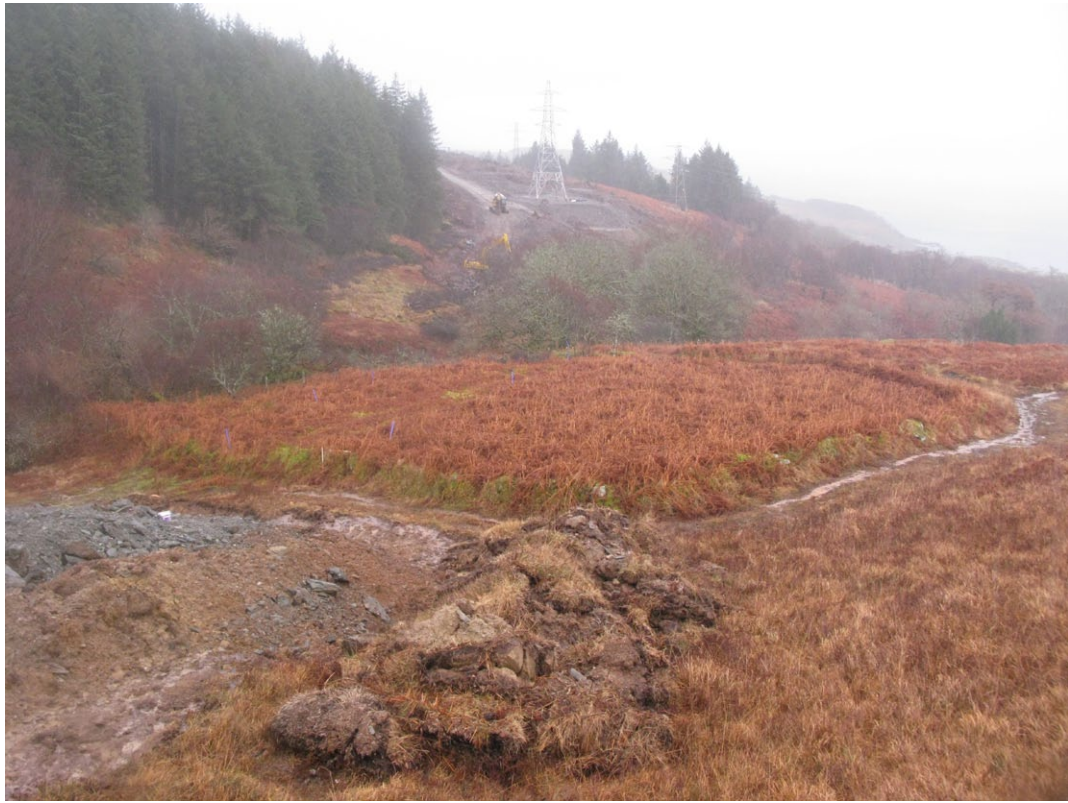
The enclosure (Fig. 2) measured 30m east-west by c.31m north-south. A 12m long portion of the western bank of the enclosure was demolished for the service road corridor. This revealed that the bank was 0.65m high, 2m wide at the base, and composed of a mixed grey/pink sandy clay deposit positioned above the subsoil and covered with topsoil (**003**) (Fig. 3). The bank appears have been constructed by mounding up natural deposits on de-turfed ground and placing the turfs on top of it. No archaeological deposits were exposed within the interior of the enclosure during topsoil stripping (Fig. 4).

Fig. 2 - Enclosure 30c prior to road stripping

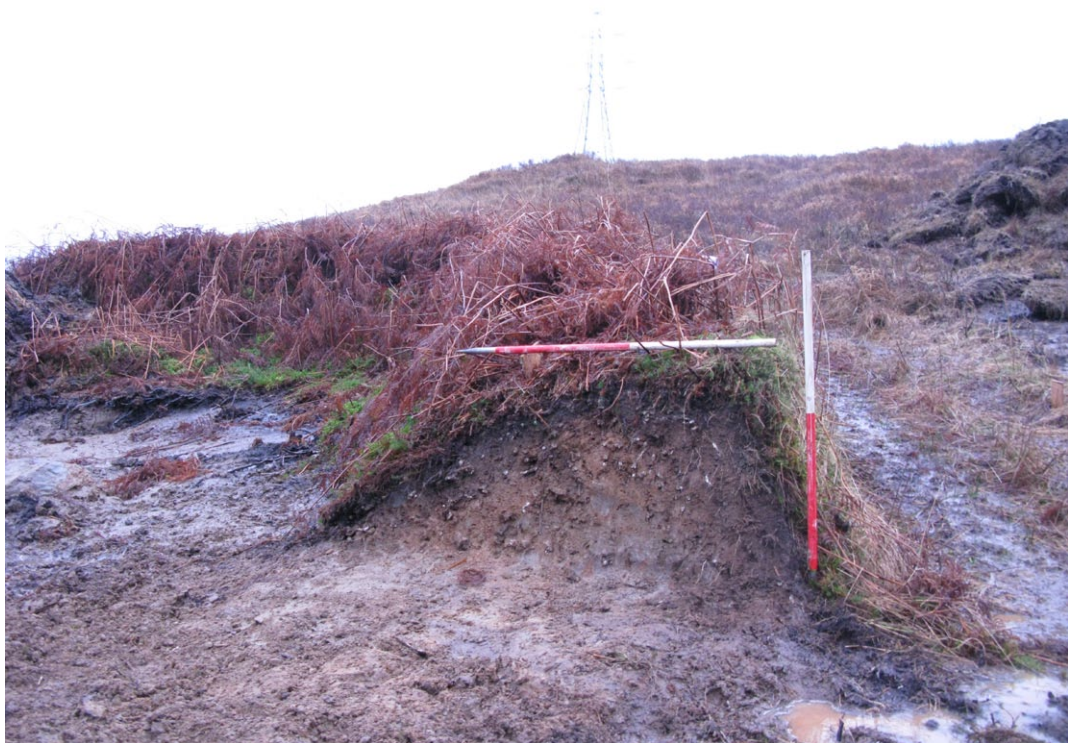
Fig. 3 - North-facing section through western bank of enclosure 30c

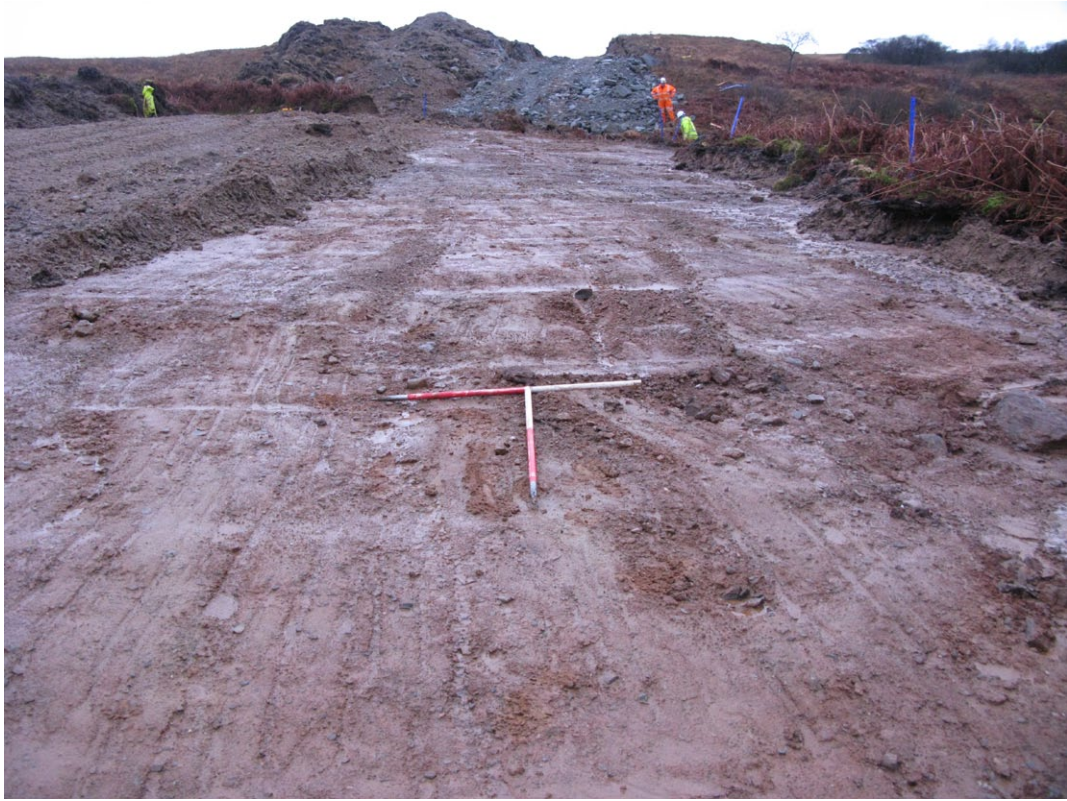
The excavated area for the service road, which ran through the north-west corner of the enclosure (30c), was aligned north-east by south-west and measured 16m by 40m. The service road itself measured 8m wide but an additional 8m wide strip was required for spoil storage to the south-east (Fig. 4). The monitored area terminated at the river crossing point.

Fig. 4 - Service road stripped to natural (000) and spoil storage area to the south-east

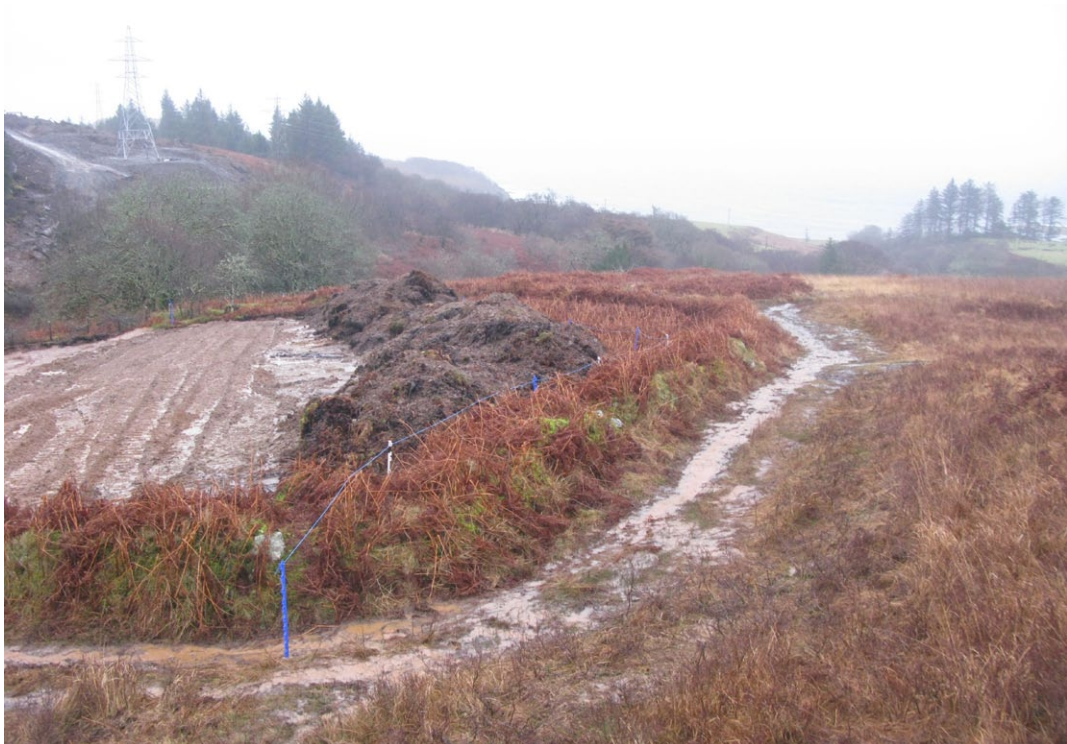
The upstanding elements of Site 30 in close proximity to construction activities were fenced off with blue rope and blue plastic posts. A working corridor of minimum possible width was set out where the service road crossed through Site 30c (Fig. 5).

Fig. 5 - Working corridor at Site 30c fenced off
