Site & Landscape Survey

**Proposed Crossaig Substation** Service Road, Kintyre **Appendix 2: Cultural Heritage**

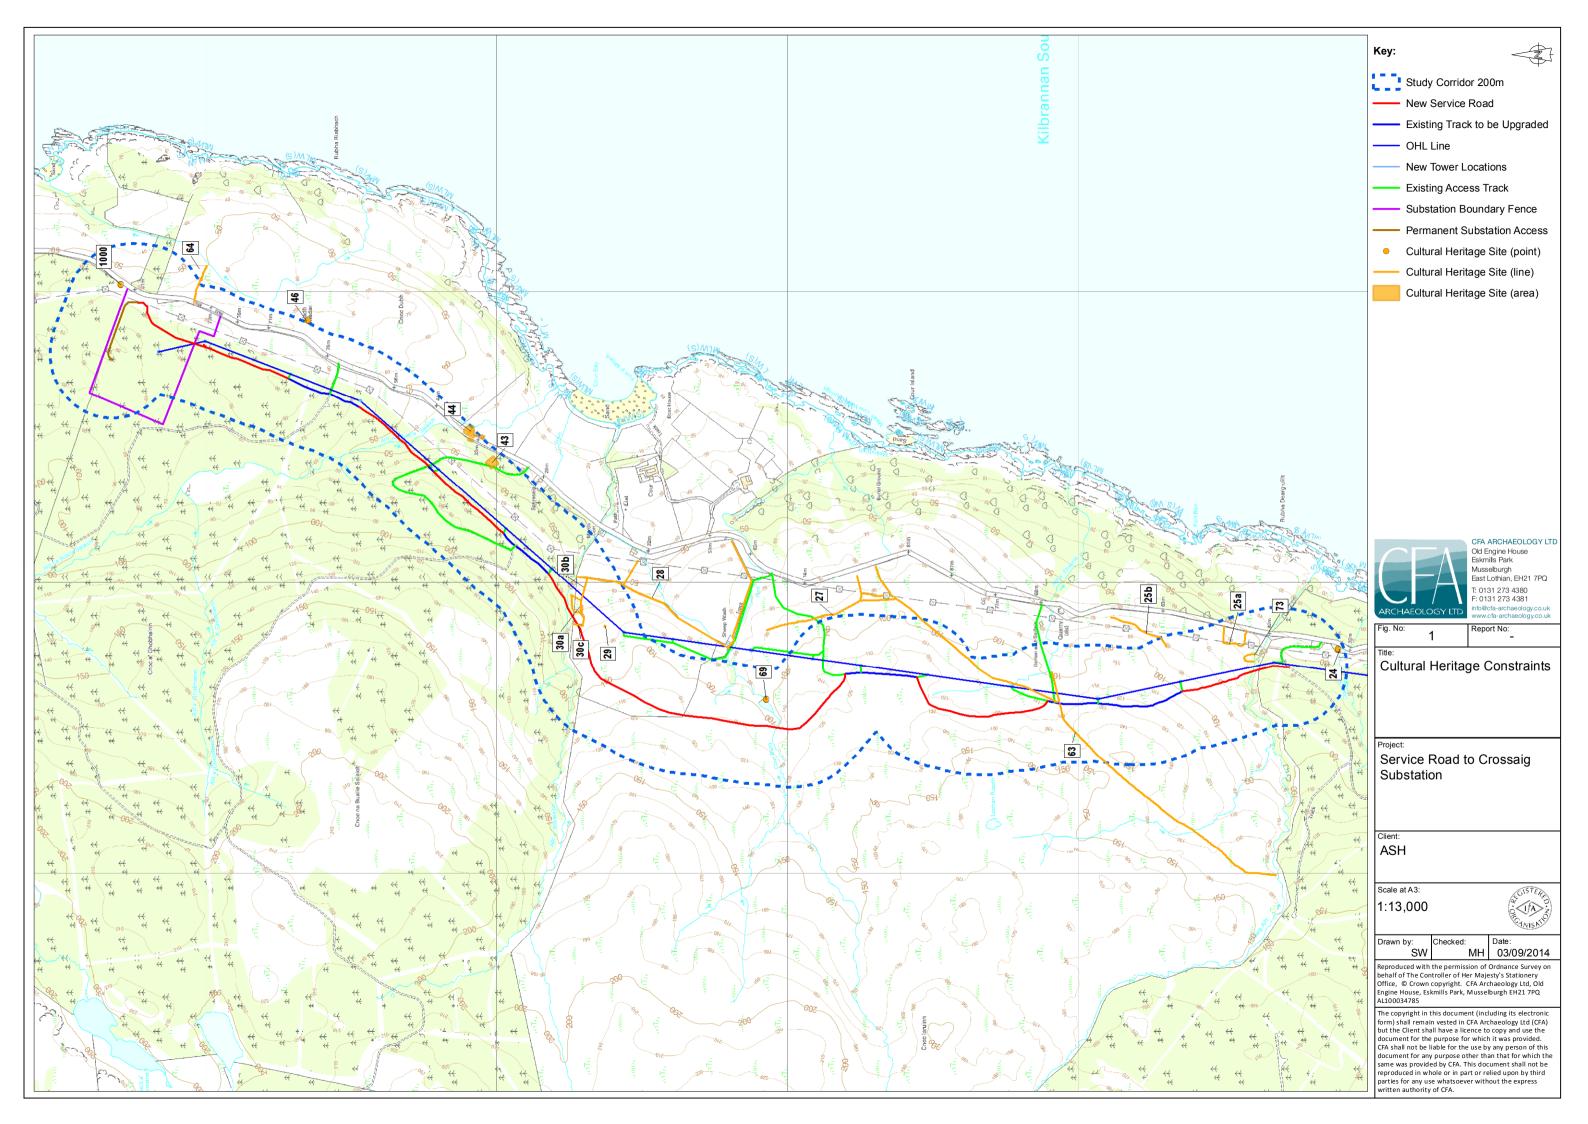
4.1 Fourteen cultural heritage assets have been identified within the study area and these are shown on Cultural Heritage Figure 1. For ease of cross-referencing the numbers from previous reporting (Jones 2010a-c) have been used; any new additional sites recorded during recent field survey carried out as part of the mitigation for the consented Carradale to Crossaig OHL are numbered from (1000) onwards. Annex 1 provides detailed gazetteer information on the character, history and baseline condition of each asset identified by the study, and provides an indication of their heritage importance.

4.2 Numbers in bold and brackets in the following sections refer to cultural heritage asset numbers identified on Cultural Heritage Figure 1 and in Annex 1.
