**National Performance Centre for Sports,  
Heriot-Watt University,  
Riccarton Mains Road, Edinburgh**

**Archaeological Evaluation**

**Report No. 3264**

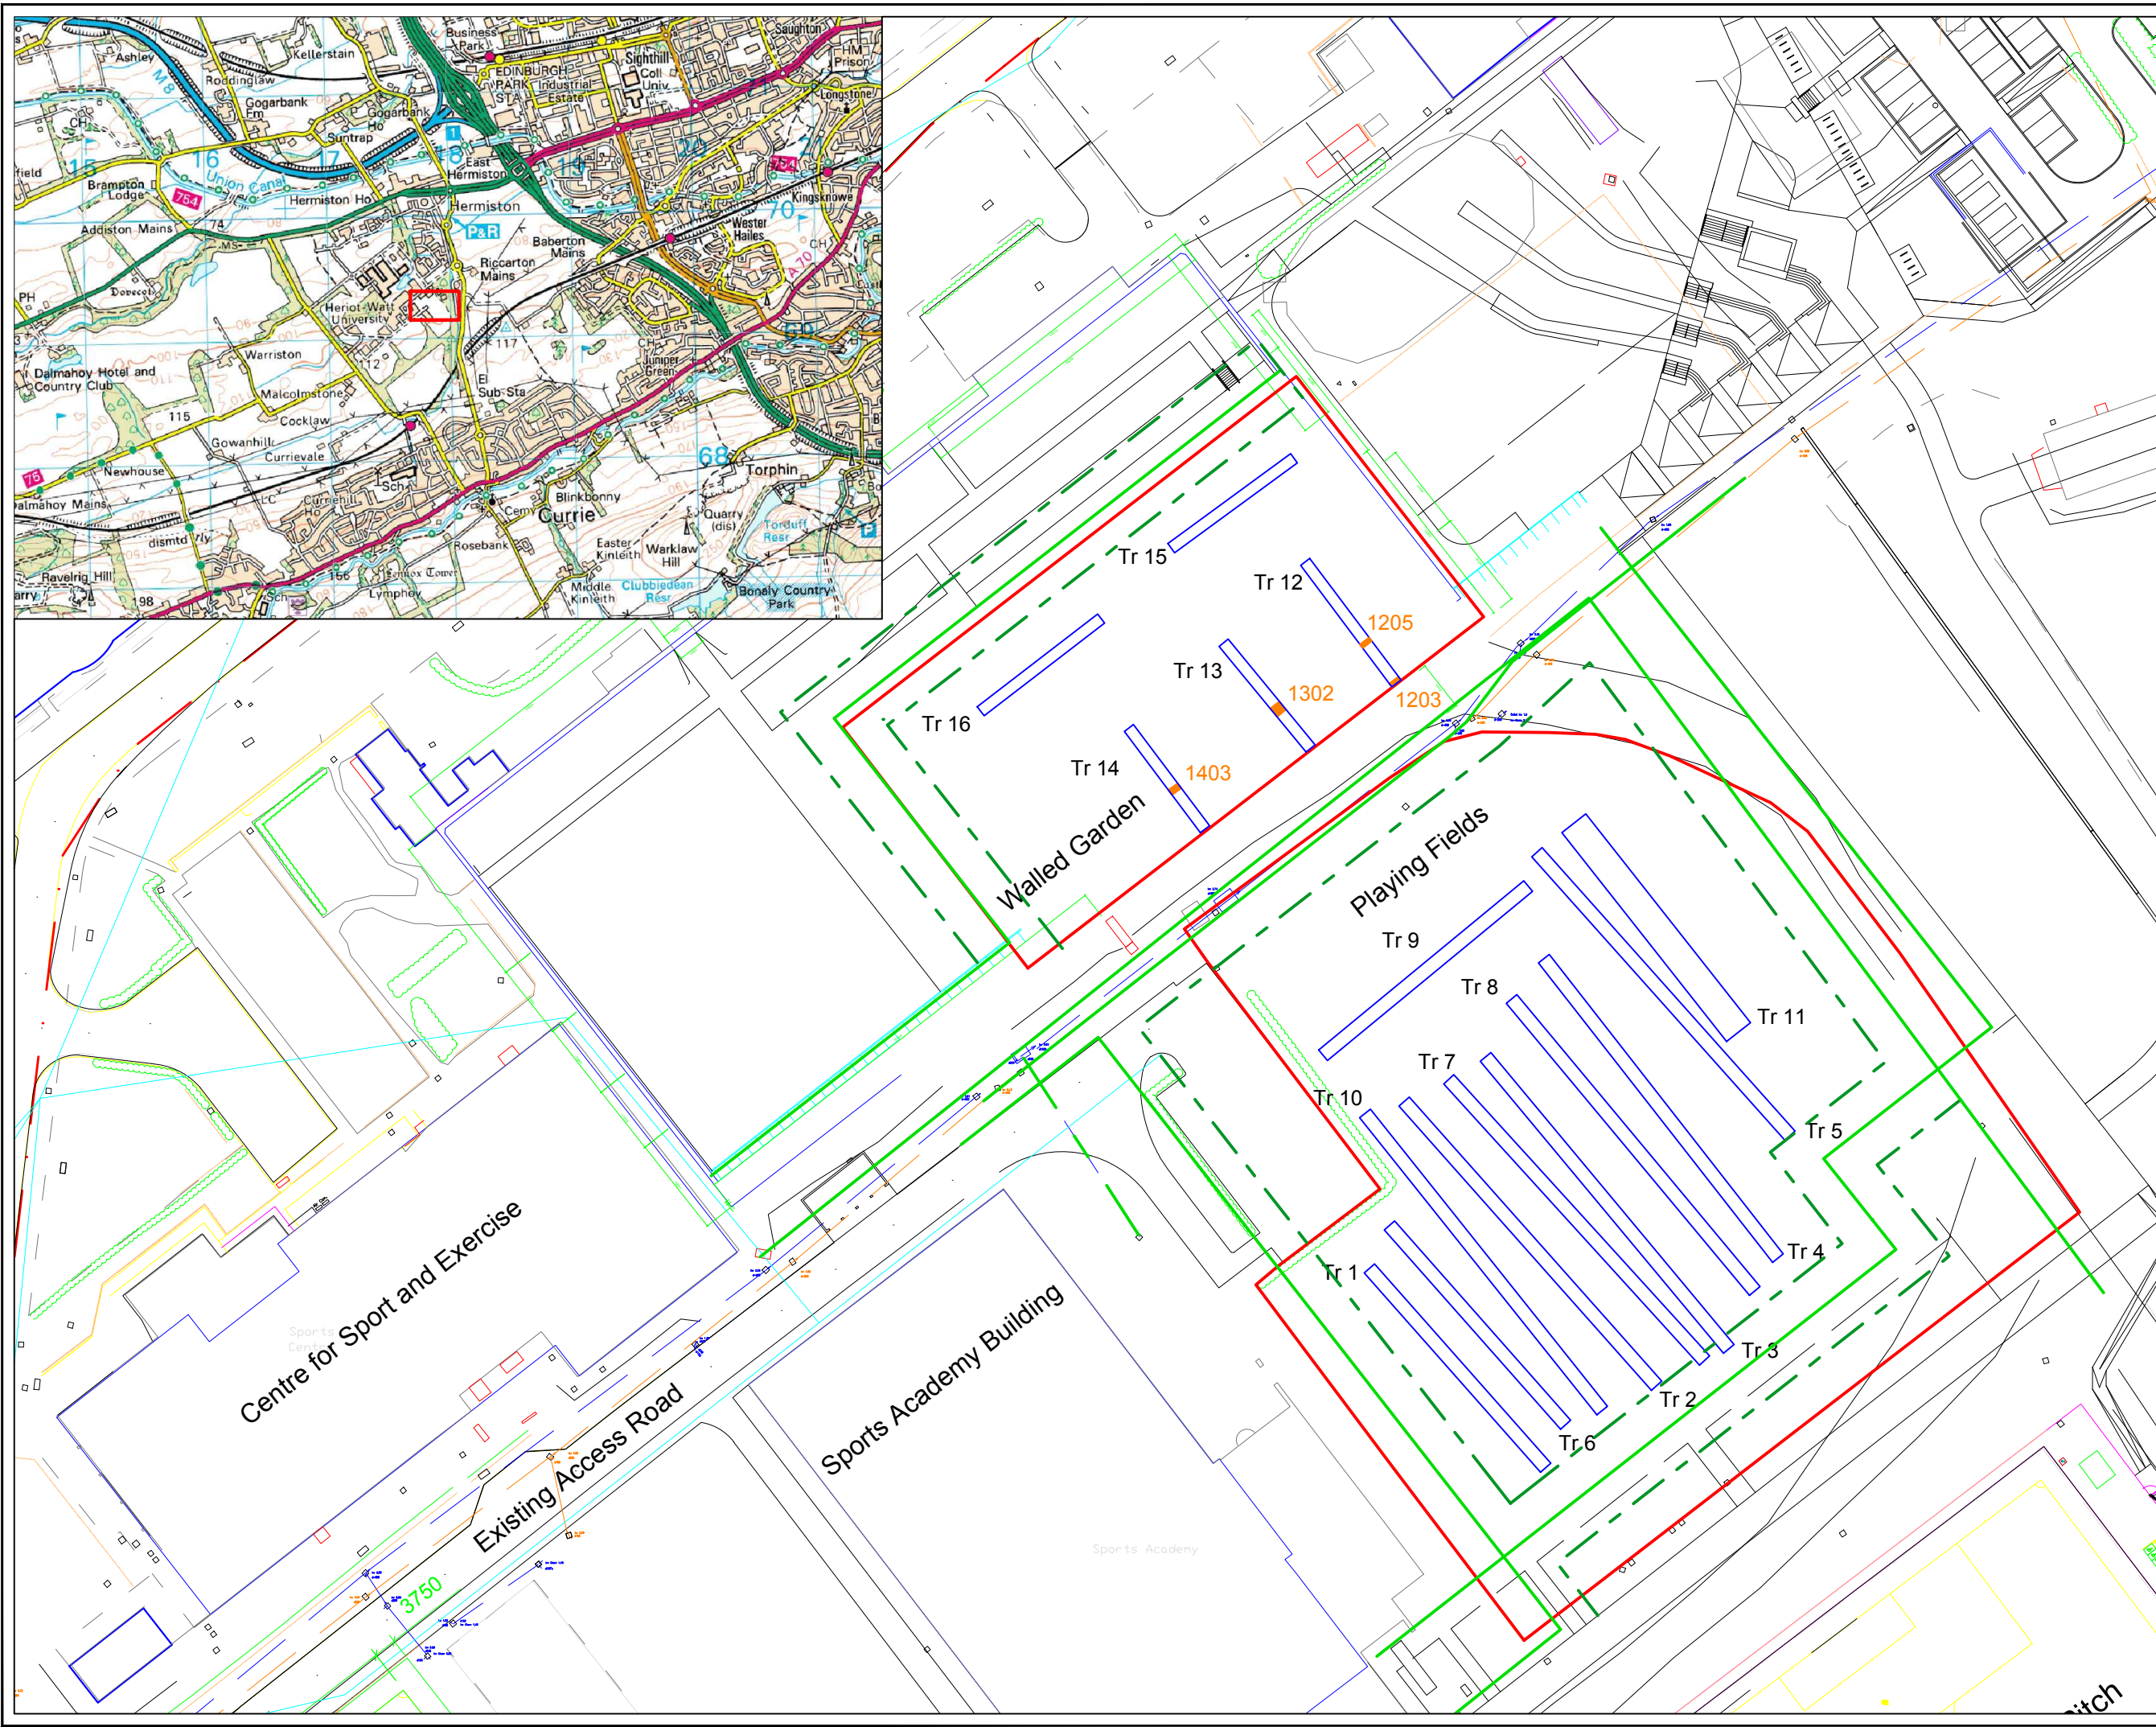
The area available in both locations was reduced by the presence of buried services. In the playing fields, water pipes, electricity cables and an IT cable greatly reduced the available area. Within the Walled Garden, an electricity cable ran through the northern part of the site. Fenced exclusion zones around these services were put in place for the duration of the fieldwork. All of these constraints are shown on Fig. 1.

Eleven trenches (Trenches 1-11), covering 938m<sup>2</sup> (9% of the area), were excavated in the playing fields and five trenches (Trenches 12-16) covering 140m<sup>2</sup> (5% of the area) were excavated in the Walled Garden (Fig. 1).

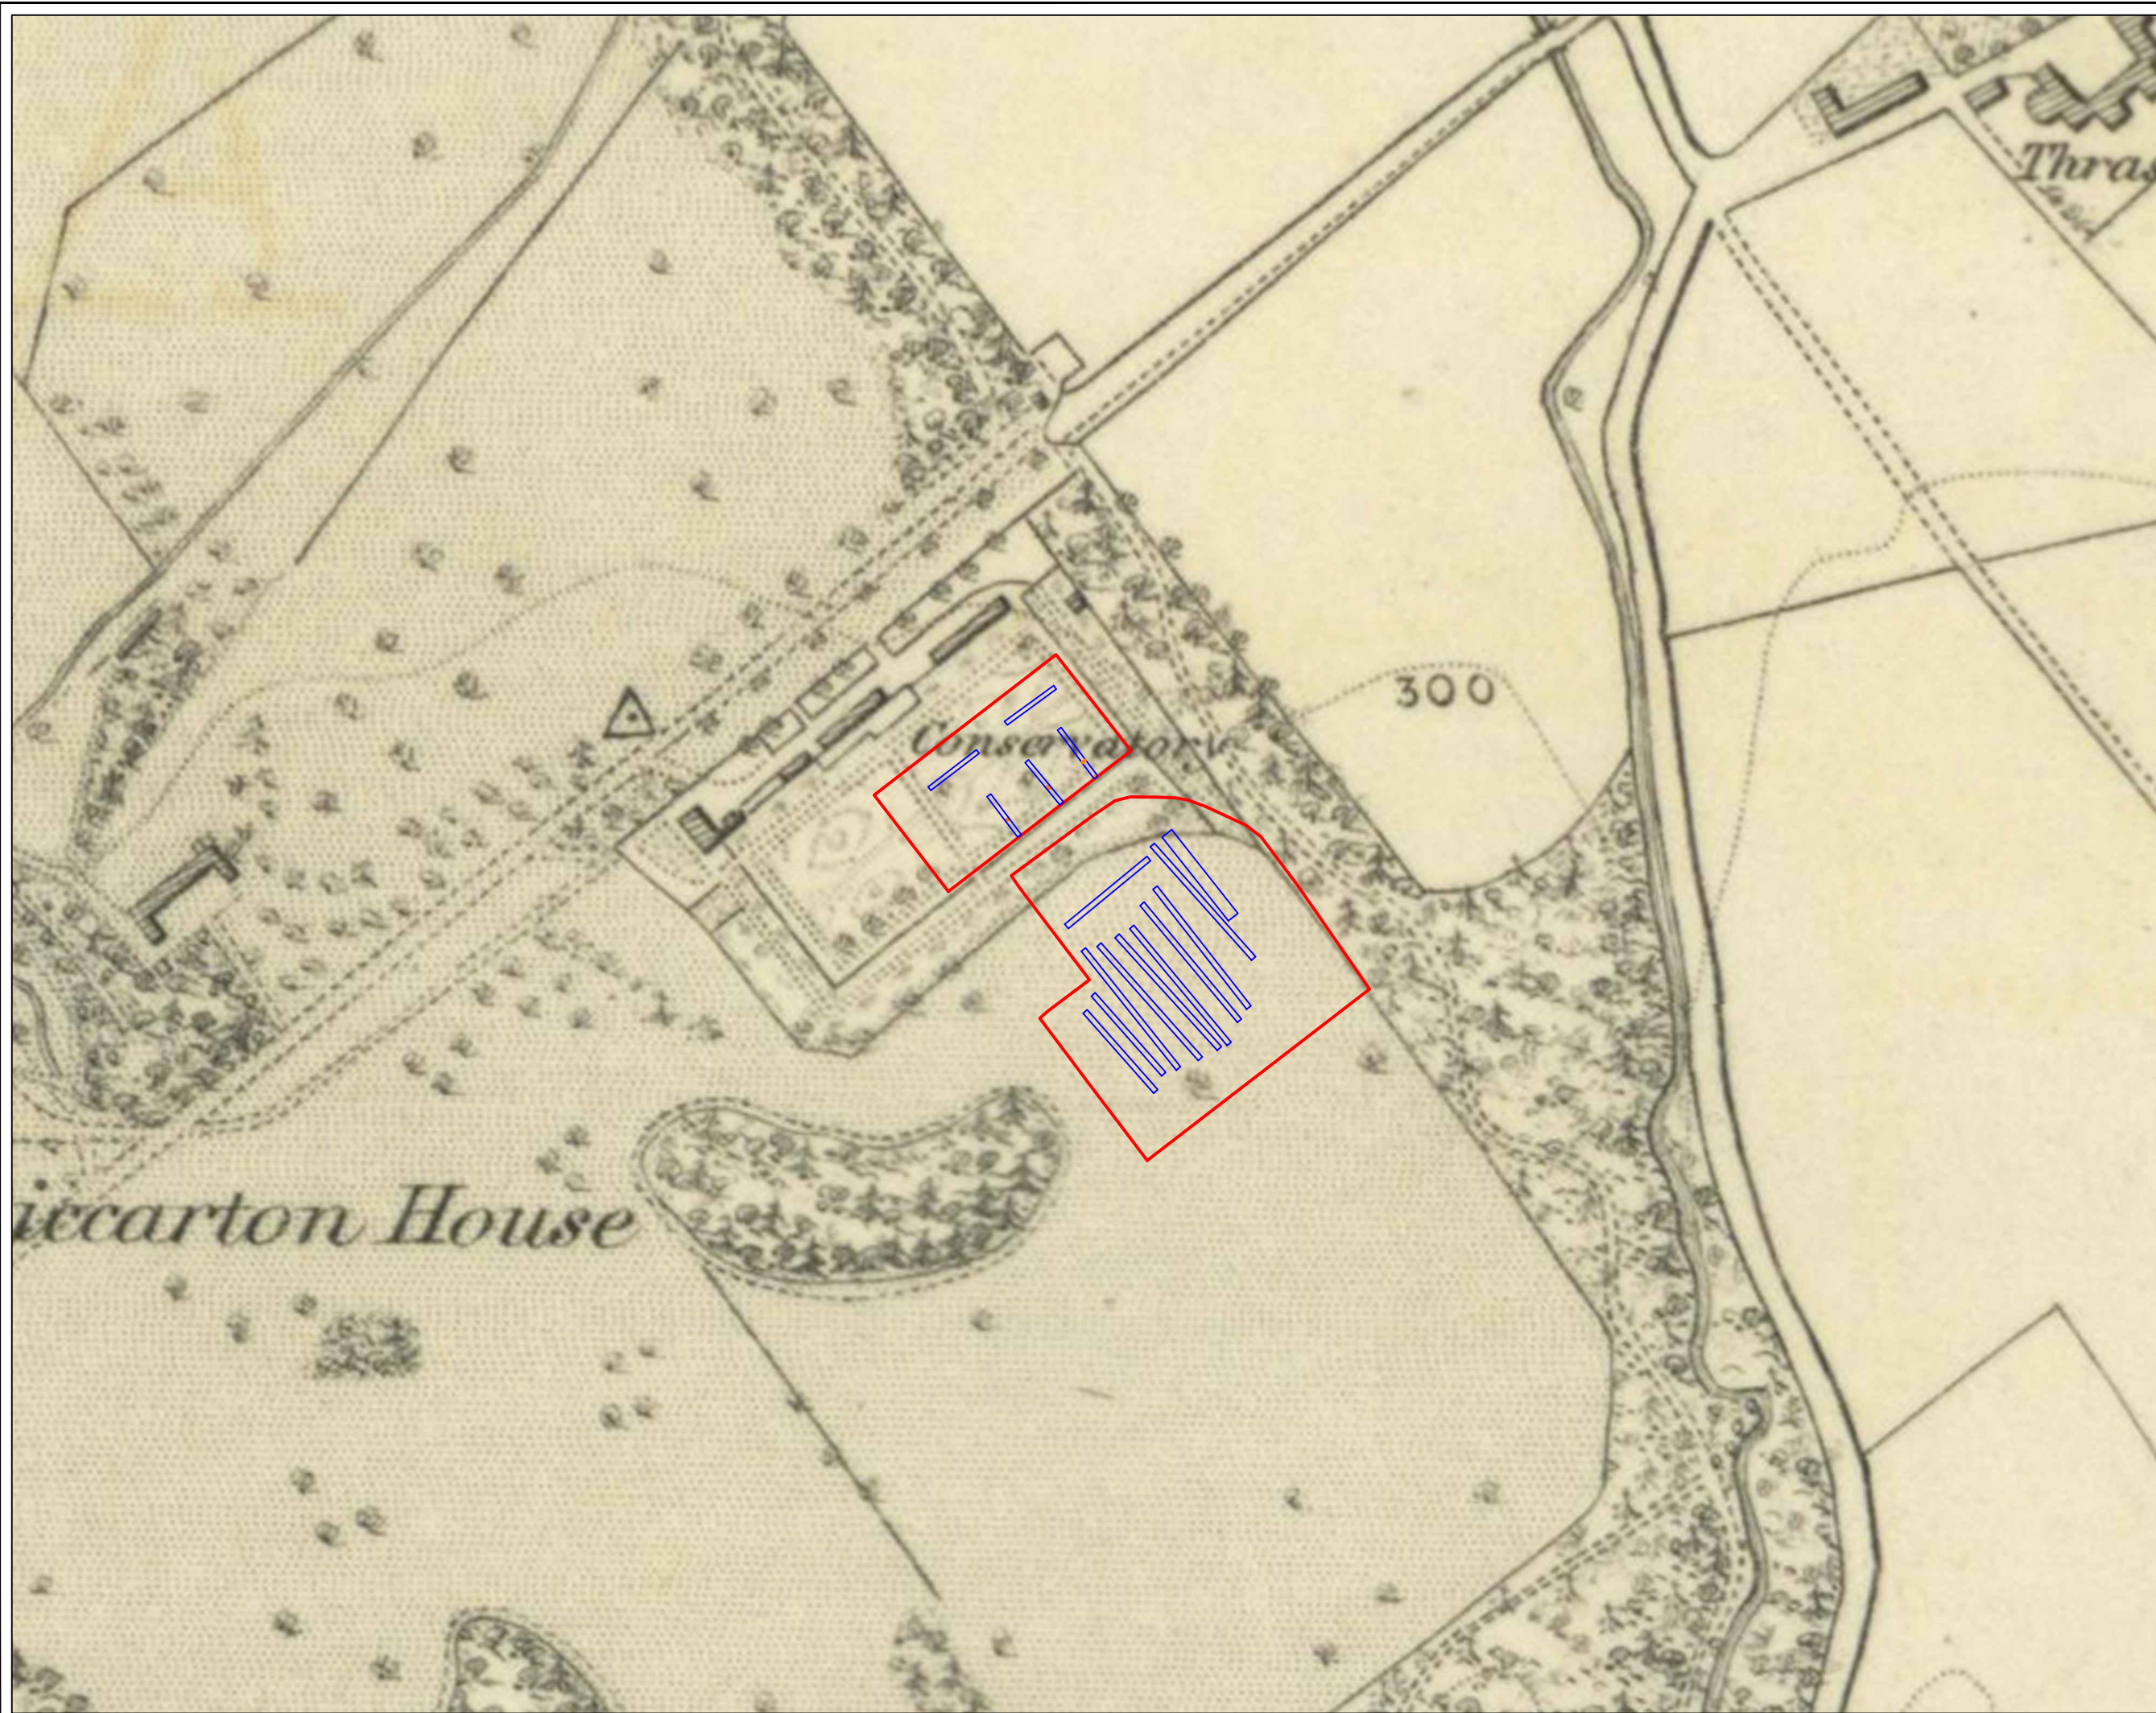
The building footprint straddles part of the wall forming the Walled Garden (NMRS NO. NT16NE 57) associated with the former Riccarton House (NMRS NO. NT16NE 10). The Walled Garden is shown on the Ordnance Survey First Edition map (Fig. 2) and on subsequent maps. Greenhouses and structures are shown along the north-western wall outside the building footprint and paths are shown bisecting the interior and around the perimeter, parallel to the wall. Trees and what may be flower beds are depicted. In recent years the area was used as sports pitches and is currently used for parking. To the south of the Walled Garden are playing fields, created in 1972, which are associated with the Heart of Midlothian Training Ground.

No features of archaeological significance were identified. It is likely that the path shown on historic maps as running around the edge of the Walled Garden concentric with the wall equates to the cobble foundations recorded in Trench 13. It is also likely that these foundations overlie the drain that was recorded in Trenches 12 and 14.

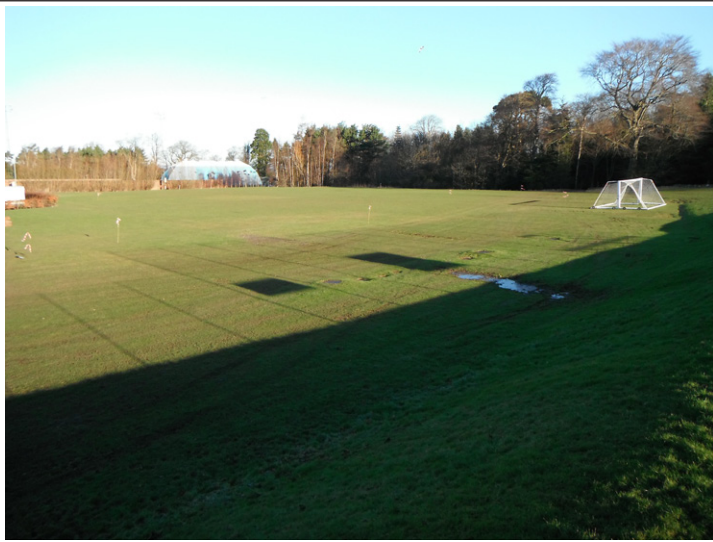
In the playing fields (Figs. 1, 3), a network of gravel and ceramic pipe drains date to 1972 when the playing fields were formed. Cut into made ground, these were removed to reveal the underlying layers.

Made ground varied in depth from 0.3m at the south-western corner of the area to 3.5m at the north-eastern corner. A patchy buried ploughsoil, still containing visible straw, was recorded under the made ground in the north-western half of the area. The made ground was waterlogged in places and the trench sides were often extremely unstable. No features other than field drains were recorded.

Fig 3 - General view of the playing fields from the south-east

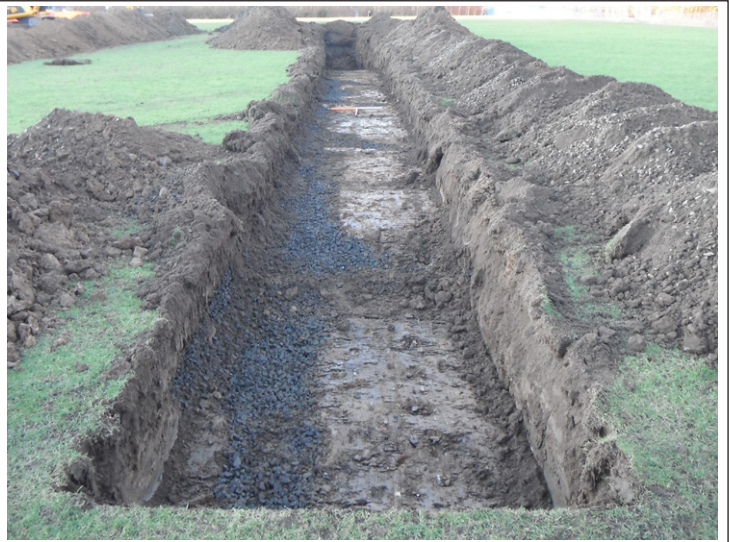
Examples of the trenches and the made ground within them are shown in Figs. 4-7.

Fig 4 - Trench 4, general view

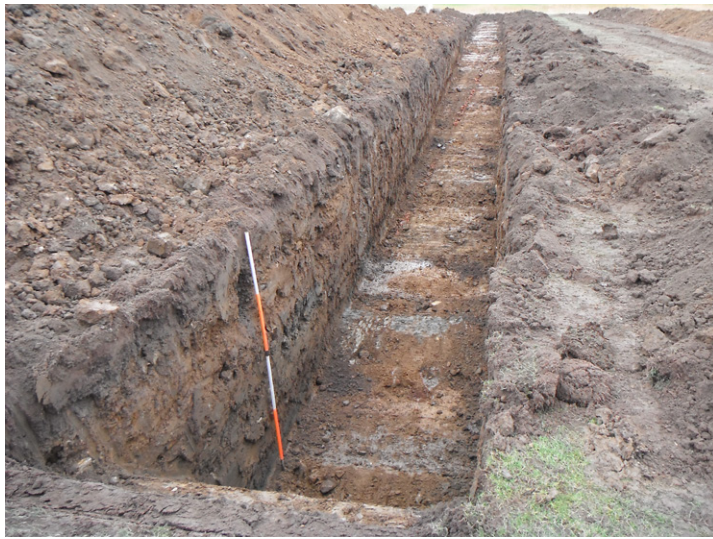
Fig 5 - Trench 7, general view

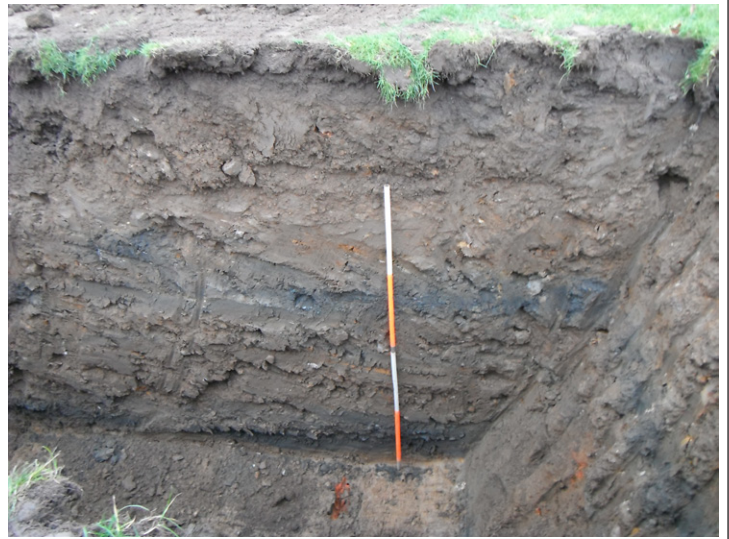
Fig 6 - Trench 8, soil profile at north-west end

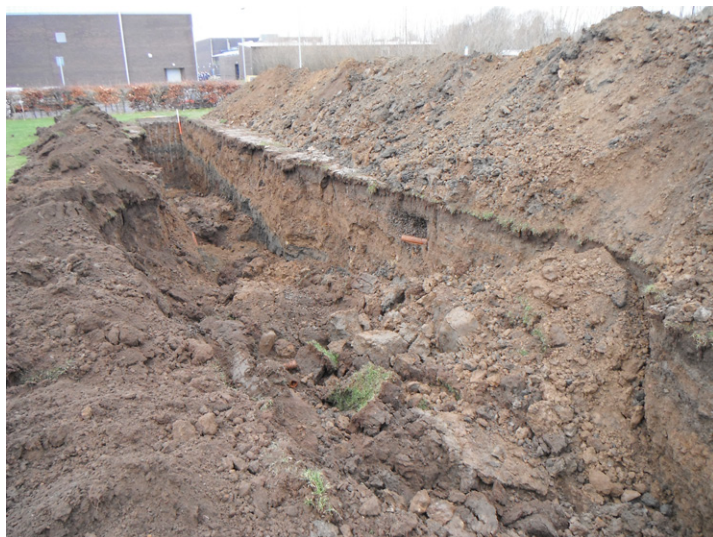
Fig 7 - Trench 9, collapsing sides

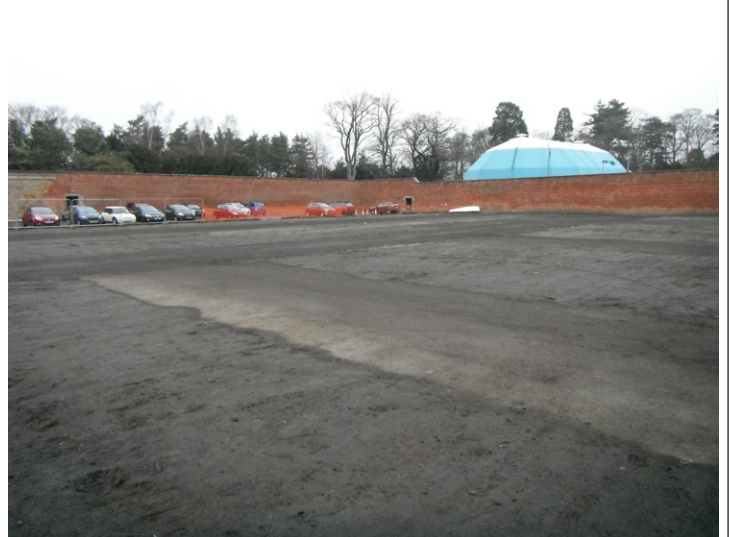
In the Walled Garden (Figs. 1, 8), a network of gravel and ceramic pipe drains underlay the parking area gravel surface. These cut the blaes which formed the surface of earlier sports pitches. These drains were not removed.

Fig 8 - General view of the Walled Garden

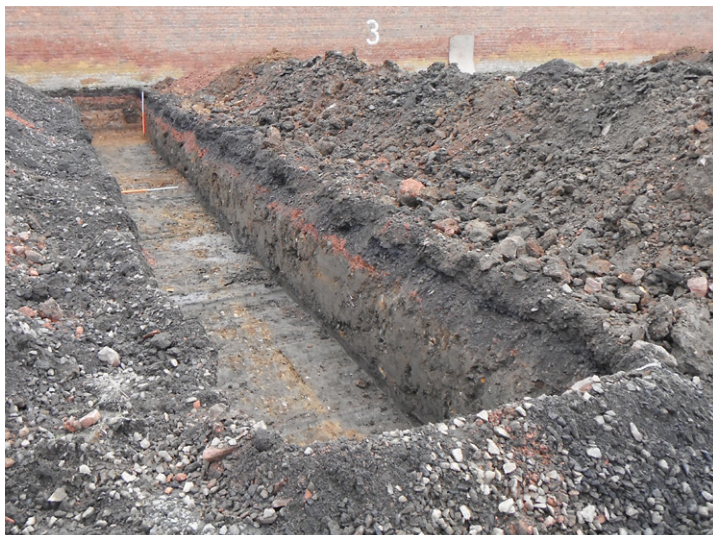
The blaes overlay around 0.6m of made ground which overlay a buried soil and, in Trench 13, a cobbled path foundation. Rubble-filled drains were recorded in Trenches 12 and 14. Figs. 9-10 show the above sequence of deposits in Trenches 12 and 15. The above sequence of deposits abutted the garden wall.

A quarried rubble filled drain (**1205**) was recorded at the same distance from the wall (Fig. 9 next to the ranging rod) as the identical drain (**1402**) in Trench 14 and the path foundation (**1302**) in Trench 13. A second drain, cut from a higher level (**1203**) was recorded against the garden wall. This was filled with smaller sandstone slabs and a cut wooden plank.

Fig 9 - Trench 12, general view

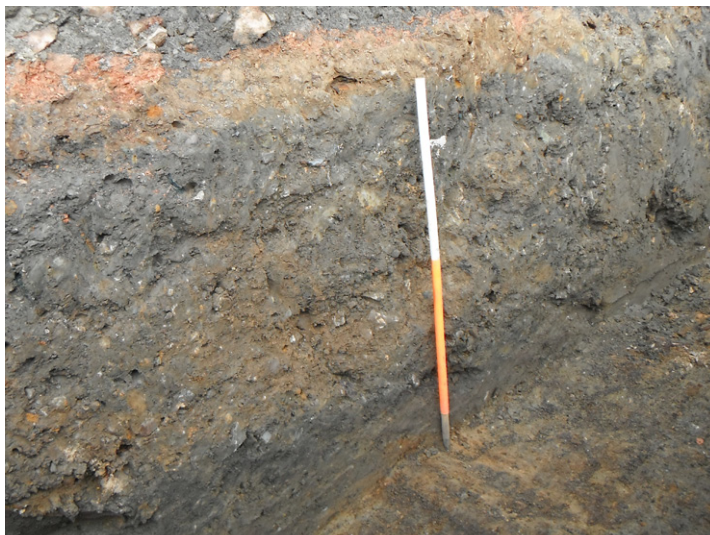
Fig 10 - Trench 15, trench section

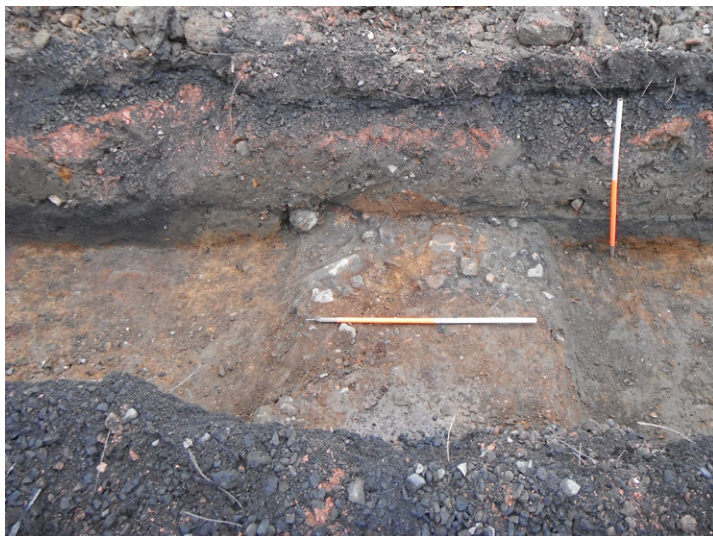
In Trench 13, made ground (010) overlay a linear cobble feature (1302). This had a width of 1.4m (Fig. 11) and the feature was 0.8m below the current surface. Dark soil (007), with a depth of 0.2m, was recorded on either side of the cobbles and this may be allotment or garden soils.

Fig 11 - Trench 13, path foundations 1302

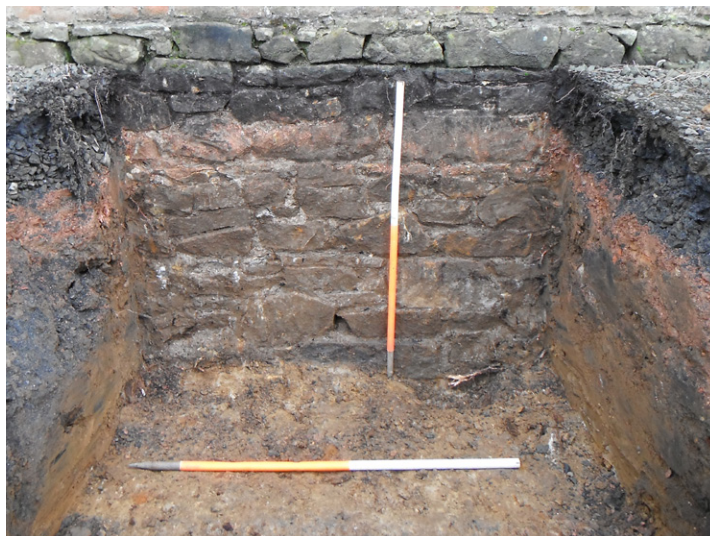
In Trench 14, the stonework of the garden wall (1401) measured 1.35m in height, with 1.2m of this being below current ground level (Fig. 12). Above this, the brickwork had a height of 4.3m.

Fig 12 - Trench 14, garden wall 1401 below current ground level
