**National Performance Centre for Sports,
Heriot-Watt University,
Riccarton Mains Road, Edinburgh**

Walled Garden: Standing Building Survey

Report No. 3272

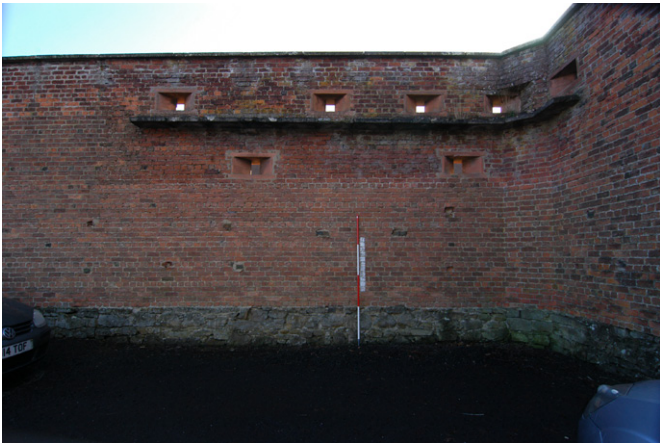
At the west end of the elevation, located at its corner are a series of seven square openings with sandstone surrounds (Plate 3). Each measures c.0.4m x 0.3m and are splayed inwards. The upper row of five openings run round the canted corner off the elevation and are located above a series of concrete slabs that project of the wall. Two of the openings are below the slabs. Lower down the wall there are a series of square voids that have been in-filled with brick.

Plate 3 - Interior NW-facing elevation, west corner with splayed openings

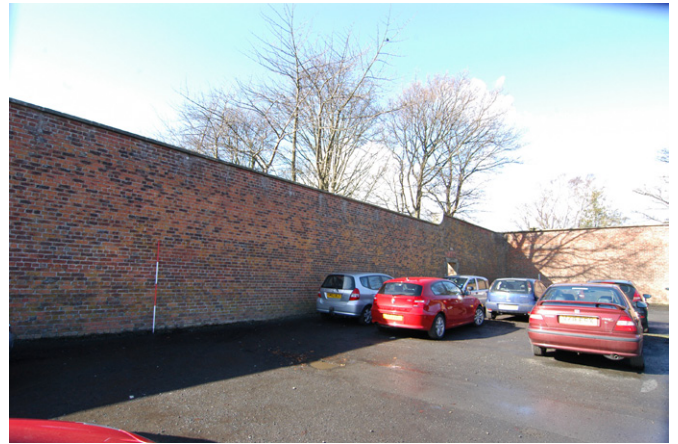
The interior north-east facing elevation measures approximately 50m long and 4.5m high and is brick-built (EGB 3:1, Plate 4) with ashlar coping stones. The wall has canted corners and falls in height to c.3.5m just above the doorway that is situated approximately 10m from the north-west corner. The doorway (Plate 5) shares the same dimensions and fabric as that described above

Plate 4 - Interior NE-facing elevation, general view

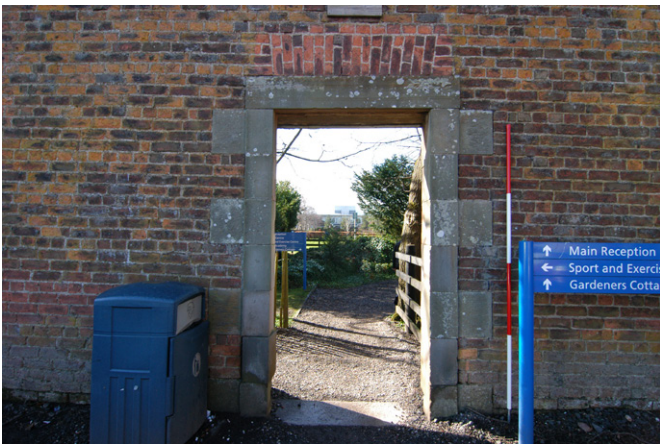
Plate 5 - Interior NE-facing elevation, doorway

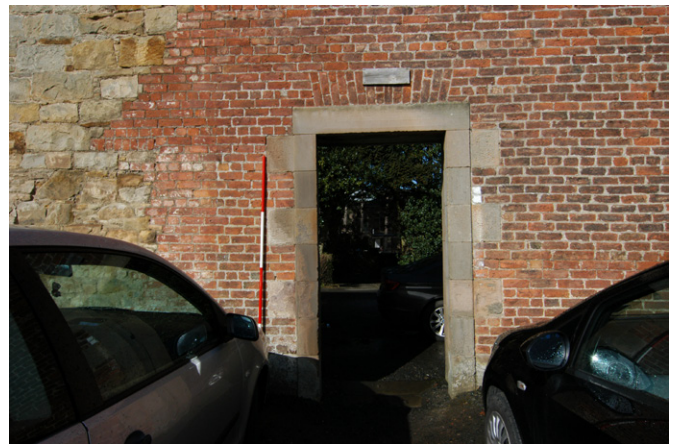
Approximately 1.5m from the west side of the doorway the wall is constructed of coursed blocks of sandstone almost to its full height (Plate 6). The sandstone section is topped by a series of stone slabs that project off the wall at a slight angle. Each slab has a set of holes drilled in it. The slabs (Plate 7) represent a roof line of a lean-to conservatory and the holes are possibly associated with sockets for cast-iron glazing bars. The slabs are surmounted by three courses of brickwork then capped with ashlar copings. Blocked vents were present along the base of the rubble wall (Plate 8). The presence of the vents indicate that when the wall was constructed a cavity was created between the outer and inner walls allowing the ventilation of the conservatory shown on the 1853 First Edition Ordnance Survey map (Fig 2).

Plate 6 - Interior SE-facing elevation, doorway and the junction between brick and stonework

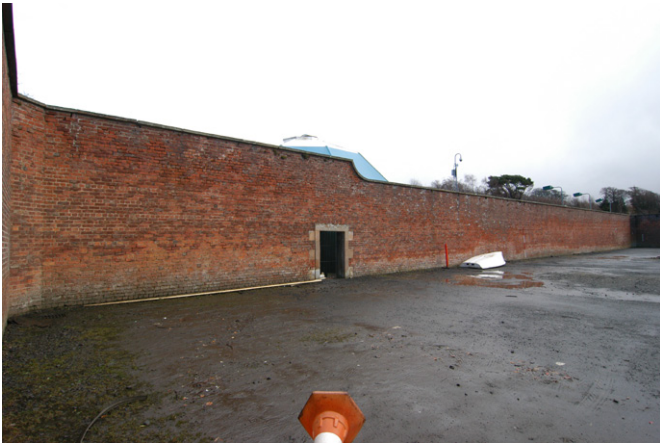
The interior south-west facing wall is the same build as described above. At the north end there is a barred doorway measuring 2.5m by 1.5m that has droved ashlar surrounds (Plate 9). Above the sandstone lintel is a brick-built flat relieving arch made up of sixteen segments.

Plate 9 - Interior SW-facing elevation, general view

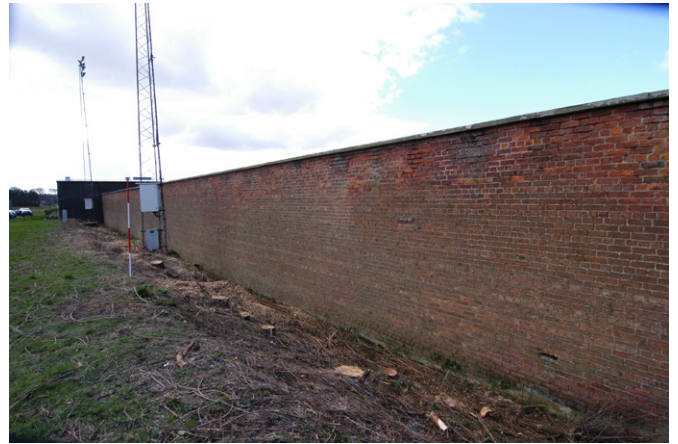
The exterior south-east elevation rests at the bottom of a steep bank and is built of red brick (EGB 3:1) throughout its length with ashlar copings (Plate 10). Ashlar quoins are present at each corner. Situated at the west end of the elevation are a set of rectangular splayed openings that are mirrored on the interior of the wall.

Plate 10 - Exterior SE-facing elevation, general view

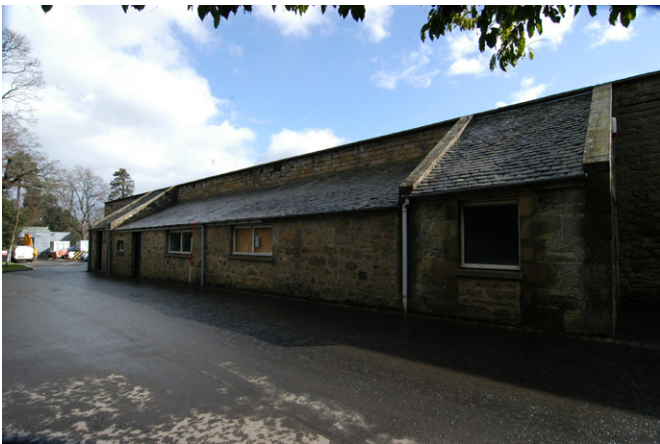
The north-west facing elevation includes three lean-to storage buildings (Buildings A-C) and the Gardner's Cottage (Building D) located at its west end. Building A (Plate 11) measures approximately 30m long and 4m wide. It is constructed of coursed

rubble with a slate roof that is 2m high at its eaves. The fenestration includes wooden casement windows and plank-built doors.

Plate 11 - Exterior NW-facing elevation, Building A

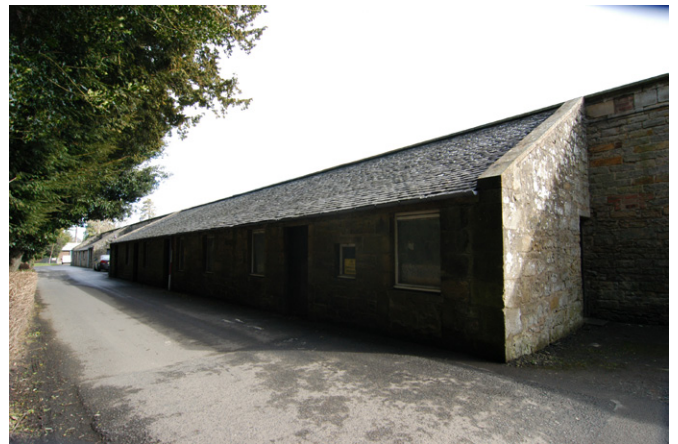
Building B (Plate 12) is approximately 40m long and 4m wide and is also rubble built with ashlar quoins. Its fenestration includes four plank-built doors and six casement windows. A door is present on its west-facing gable.

Plate 12 - Exterior NW-facing elevation, Building B

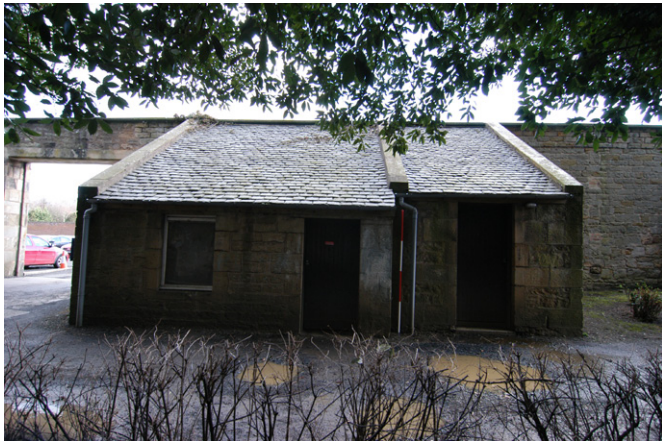
Building C (Plate 15) measures approximately 10m long and 4m wide with a slightly outshot main elevation. The building has a single casement window and two plank-built doors. The gables are featureless.

Plate 15 - Exterior NW-facing elevation, Building C

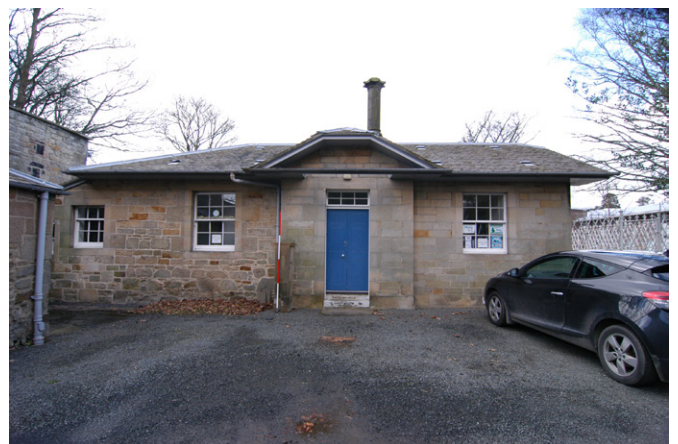
Building D (Plates 16-17) occupies an L-shaped footprint and is fully described in the Statutory List. The building is attributed to William Burn (c. 1823) and is a single storey building of Tudoresque style. The building has a main pitched roof and lower lean-to roofs where it has been built against the north-west facing elevation.

Plate 16 - NE-facing elevation of Building D (Gardener's Cottage) built against the walled garden

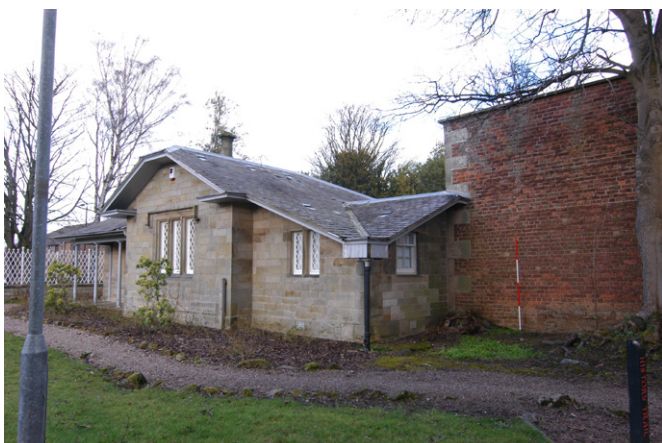
Plate 17 - SW-facing elevation of Building D adjoining the garden wall

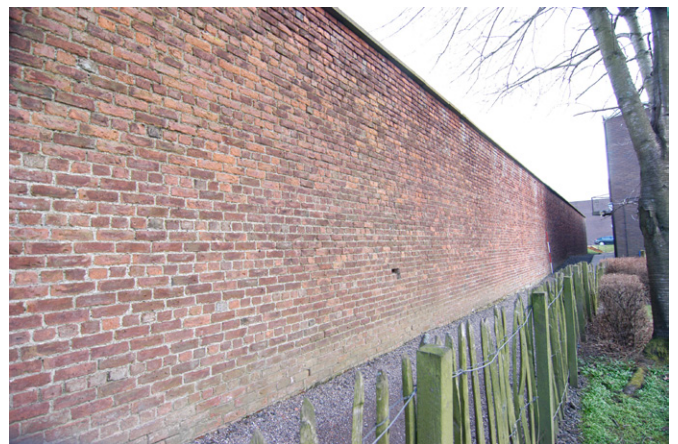
The exterior south-west facing elevation (Plate 18) includes the Gardener's Cottage (Plate 16-17) and is approximately 70m long. The wall is brick-built in EGB 3:1 throughout its length and has ashlar quoins at each corner. The wall is 4.5m high that drops to 3.5m above the pedestrian doorway close to the Gardeners Cottage. The doorway measures 2.5m by 1.5m and has droved ashlar surrounds.

Plate 18 - Exterior SW-facing elevation, general view
