**National Performance Centre for Sports,  
Heriot-Watt University,  
Riccarton Mains Road, Edinburgh**

**Walled Garden: Standing Building Survey**

**Report No. 3272**

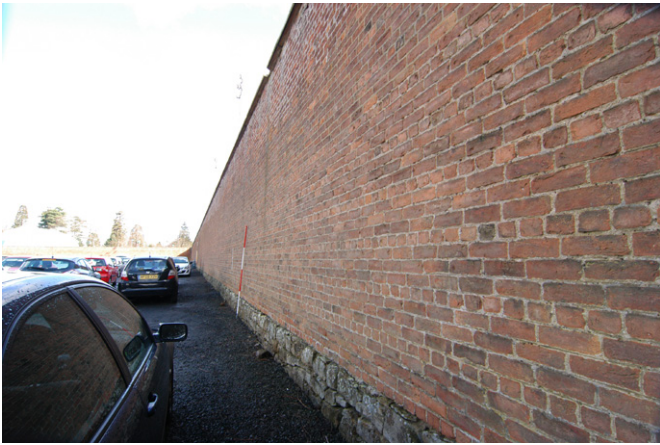
The interior north-west facing elevation measures approximately 100m long, 4.5m high and 0.65m thick and is brick-built (English Garden Bond (EGB 3:1, Plate 1) resting on a rubble foundation course. The top of the wall is capped by ashlar sandstone copings. At the centre of the elevation is a doorway (Plate 2) measuring 2.5m by 1.5m and has droved ashlar surrounds. Above the sandstone lintel is a brick-built flat relieving arch made up of sixteen segments.

Plate 1 - Interior NW-facing elevation, general oblique view

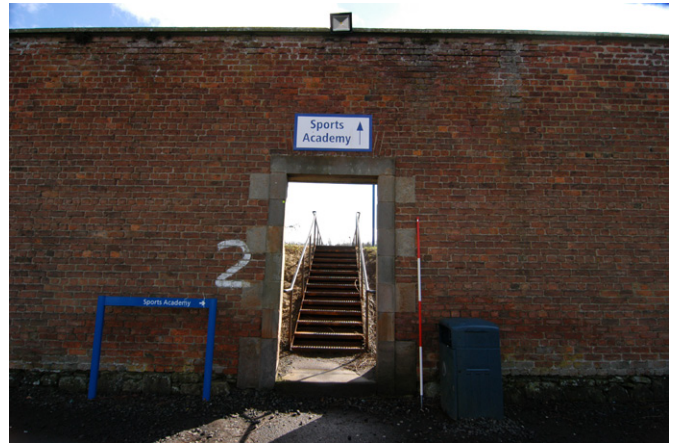
Plate 2 - Interior NW-facing elevation, central doorway

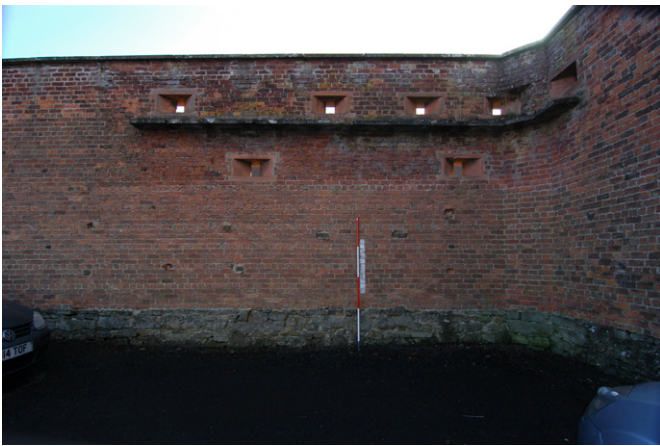
At the west end of the elevation, located at its corner are a series of seven square openings with sandstone surrounds (Plate 3). Each measures c.0.4m x 0.3m and are splayed inwards. The upper row of five openings run round the canted corner off the elevation and are located above a series of concrete slabs that project of the wall. Two of the openings are below the slabs. Lower down the wall there are a series of square voids that have been in-filled with brick.

Plate 3 - Interior NW-facing elevation, west corner with splayed openings

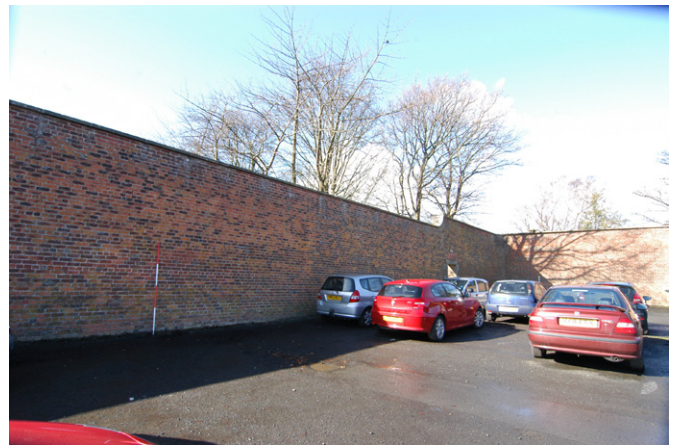
The interior north-east facing elevation measures approximately 50m long and 4.5m high and is brick-built (EGB 3:1, Plate 4) with ashlar coping stones. The wall has canted corners and falls in height to c.3.5m just above the doorway that is situated approximately 10m from the north-west corner. The doorway (Plate 5) shares the same dimensions and fabric as that described above

Plate 4 - Interior NE-facing elevation, general view

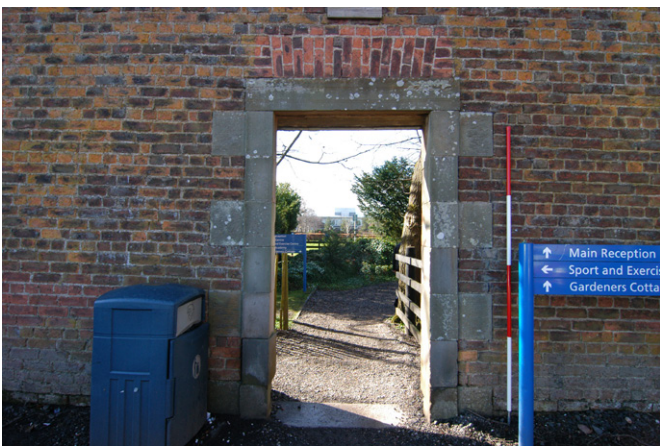
Plate 5 - Interior NE-facing elevation, doorway

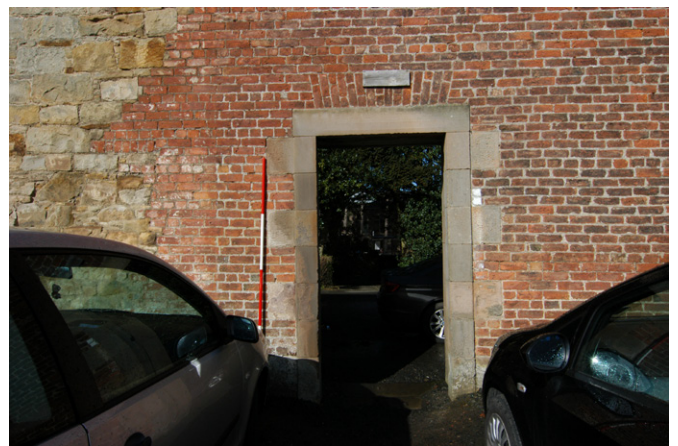
Approximately 1.5m from the west side of the doorway the wall is constructed of coursed blocks of sandstone almost to its full height (Plate 6). The sandstone section is topped by a series of stone slabs that project off the wall at a slight angle. Each slab has a set of holes drilled in it. The slabs (Plate 7) represent a roof line of a lean-to conservatory and the holes are possibly associated with sockets for cast-iron glazing bars. The slabs are surmounted by three courses of brickwork then capped with ashlar copings. Blocked vents were present along the base of the rubble wall (Plate 8). The presence of the vents indicate that when the wall was constructed a cavity was created between the outer and inner walls allowing the ventilation of the conservatory shown on the 1853 First Edition Ordnance Survey map (Fig 2).

Plate 6 - Interior SE-facing elevation, doorway and the junction between brick and stonework

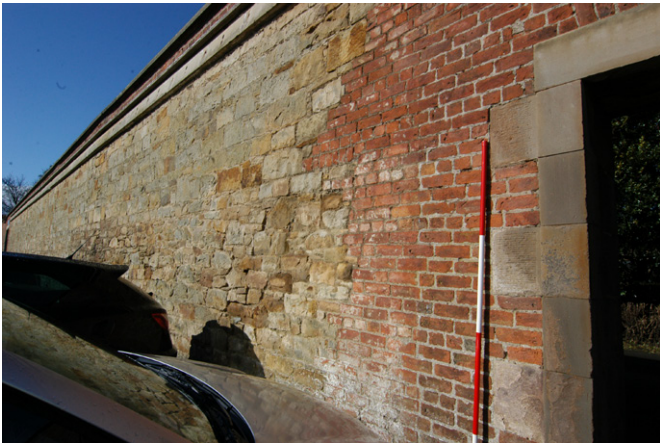
Plate 7 - Interior SE-facing elevation, stone built wall and the roofline of a former conservatory

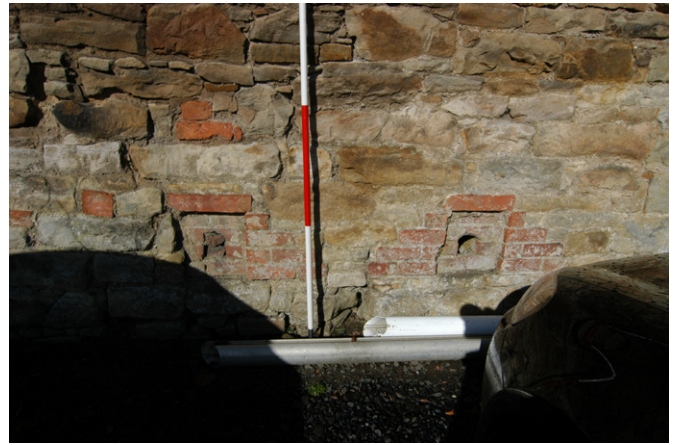
The rubble-faced wall that the conservatory was built against had a series of vents present on the external and internal wall faces. These represent the remains of a cavity wall heating and ventilation system. It is therefore probable that the conservatory was used for growing citrus fruits, as heating was critical for growing citrus fruits, especially through the Scottish winter months. Heating in glasshouses first occurred as early as the mid 17<sup>th</sup> century and was provided by furnaces placed within the structure, but fumes often damaged or killed the plants. By the 18<sup>th</sup> century hot-air flue systems were devised, which dissipated heat slowly through winding flues built into cavity walls. These 'fire

Plate 8 - Interior SE-facing elevation, blocked vents at the base of the wall

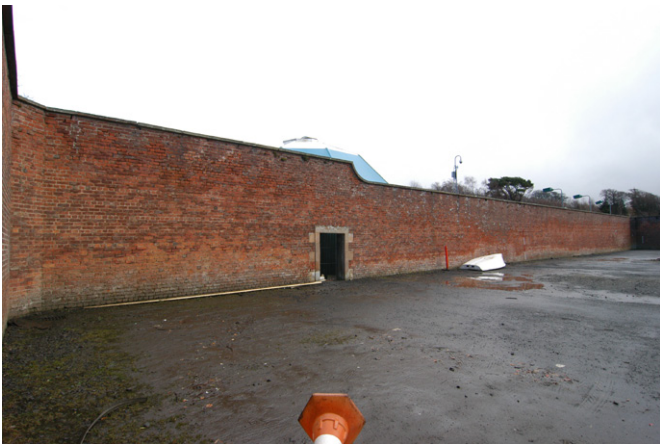
The interior south-west facing wall is the same build as described above. At the north end there is a barred doorway measuring 2.5m by 1.5m that has droved ashlar surrounds (Plate 9). Above the sandstone lintel is a brick-built flat relieving arch made up of sixteen segments.

Plate 9 - Interior SW-facing elevation, general view

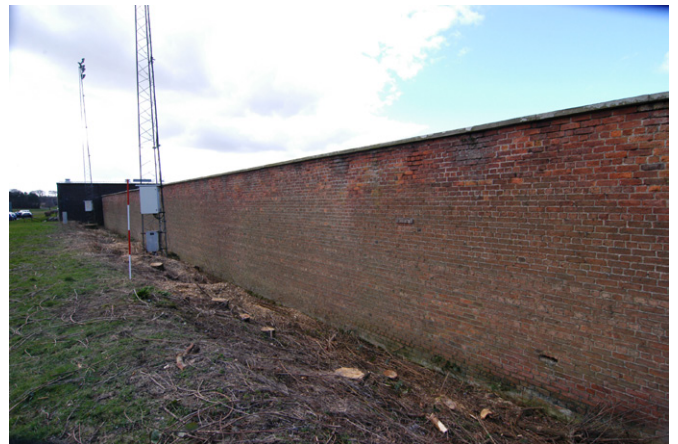
The exterior south-east elevation rests at the bottom of a steep bank and is built of red brick (EGB 3:1) throughout its length with ashlar copings (Plate 10). Ashlar quoins are present at each corner. Situated at the west end of the elevation are a set of rectangular splayed openings that are mirrored on the interior of the wall.

Plate 10 - Exterior SE-facing elevation, general view

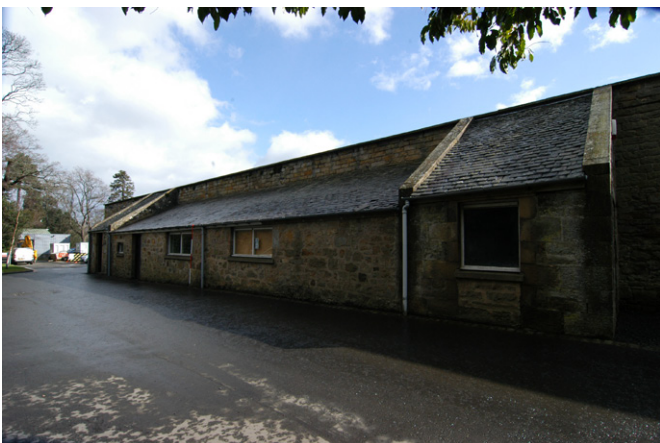
The north-west facing elevation includes three lean-to storage buildings (Buildings A-C) and the Gardner's Cottage (Building D) located at its west end. Building A (Plate 11) measures approximately 30m long and 4m wide. It is constructed of coursed

rubble with a slate roof that is 2m high at its eaves. The fenestration includes wooden casement windows and plank-built doors.

Plate 11 - Exterior NW-facing elevation, Building A

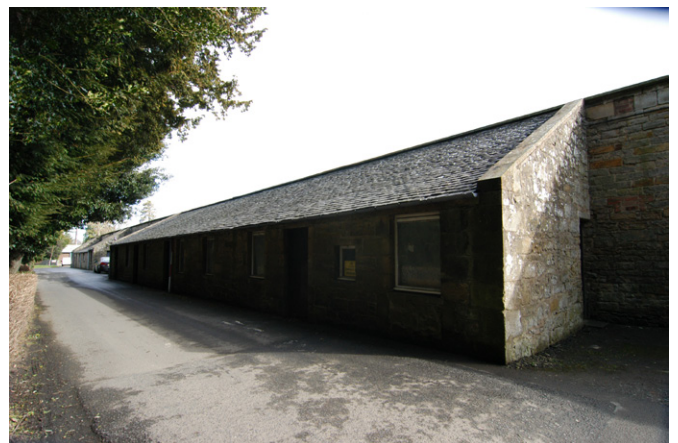
Building B (Plate 12) is approximately 40m long and 4m wide and is also rubble built with ashlar quoins. Its fenestration includes four plank-built doors and six casement windows. A door is present on its west-facing gable.

Plate 12 - Exterior NW-facing elevation, Building B

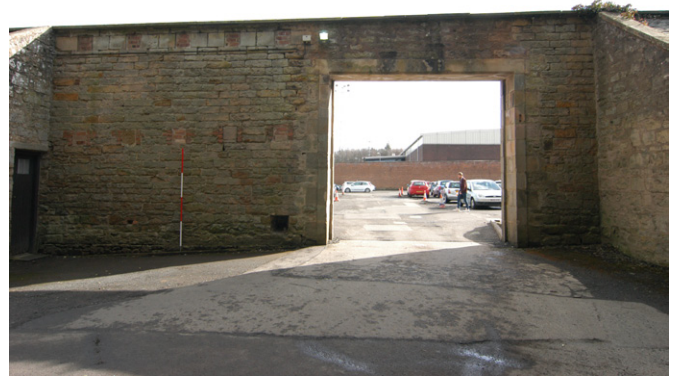
Plate 14 - Exterior NW-facing elevation, main vehicular access into the walled garden with blocked hatch vents on its left hand side

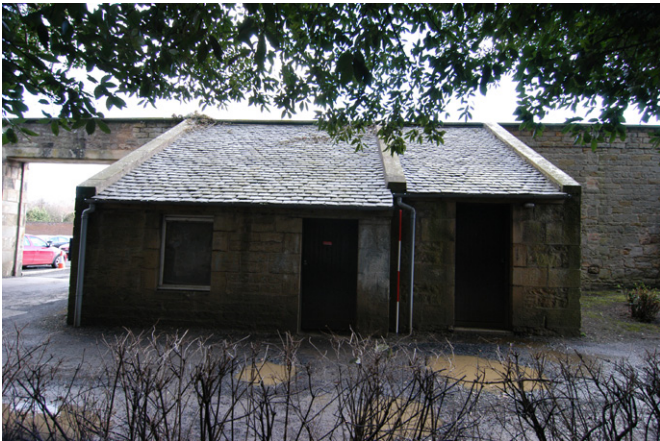
Building C (Plate 15) measures approximately 10m long and 4m wide with a slightly outshot main elevation. The building has a single casement window and two plank-built doors. The gables are featureless.

Plate 15 - Exterior NW-facing elevation, Building C

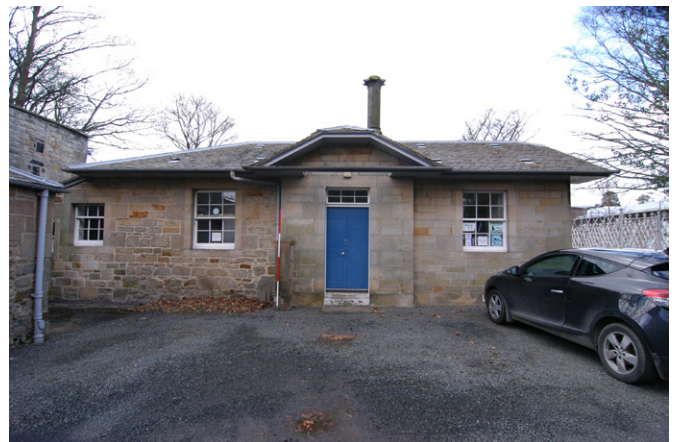
Building D (Plates 16-17) occupies an L-shaped footprint and is fully described in the Statutory List. The building is attributed to William Burn (c. 1823) and is a single storey building of Tudoresque style. The building has a main pitched roof and lower lean-to roofs where it has been built against the north-west facing elevation.

Plate 16 - NE-facing elevation of Building D (Gardener's Cottage) built against the walled garden

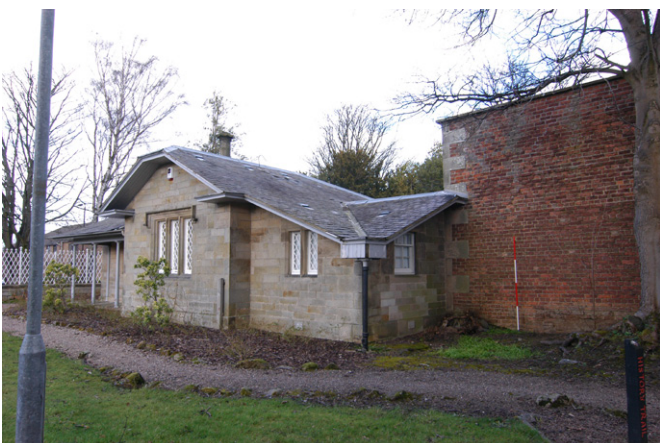
Plate 17 - SW-facing elevation of Building D adjoining the garden wall

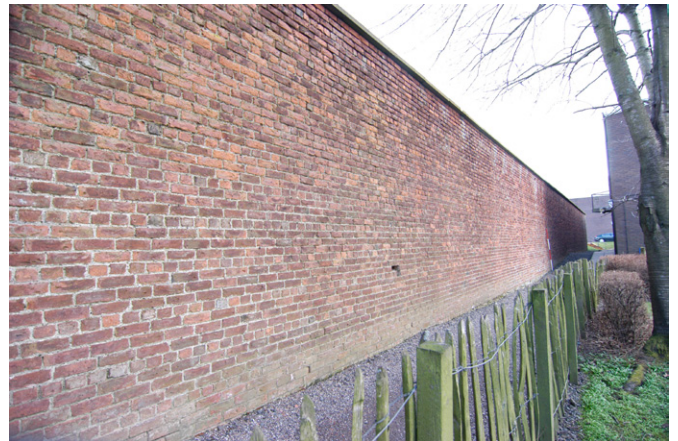
The exterior south-west facing elevation (Plate 18) includes the Gardener's Cottage (Plate 16-17) and is approximately 70m long. The wall is brick-built in EGB 3:1 throughout its length and has ashlar quoins at each corner. The wall is 4.5m high that drops to 3.5m above the pedestrian doorway close to the Gardeners Cottage. The doorway measures 2.5m by 1.5m and has droved ashlar surrounds.

Plate 18 - Exterior SW-facing elevation, general view
