Royal Botanic Gardens Nursery, Edinburgh. North-East Corner Development.

Archaeological Evaluation

Report No. 3274

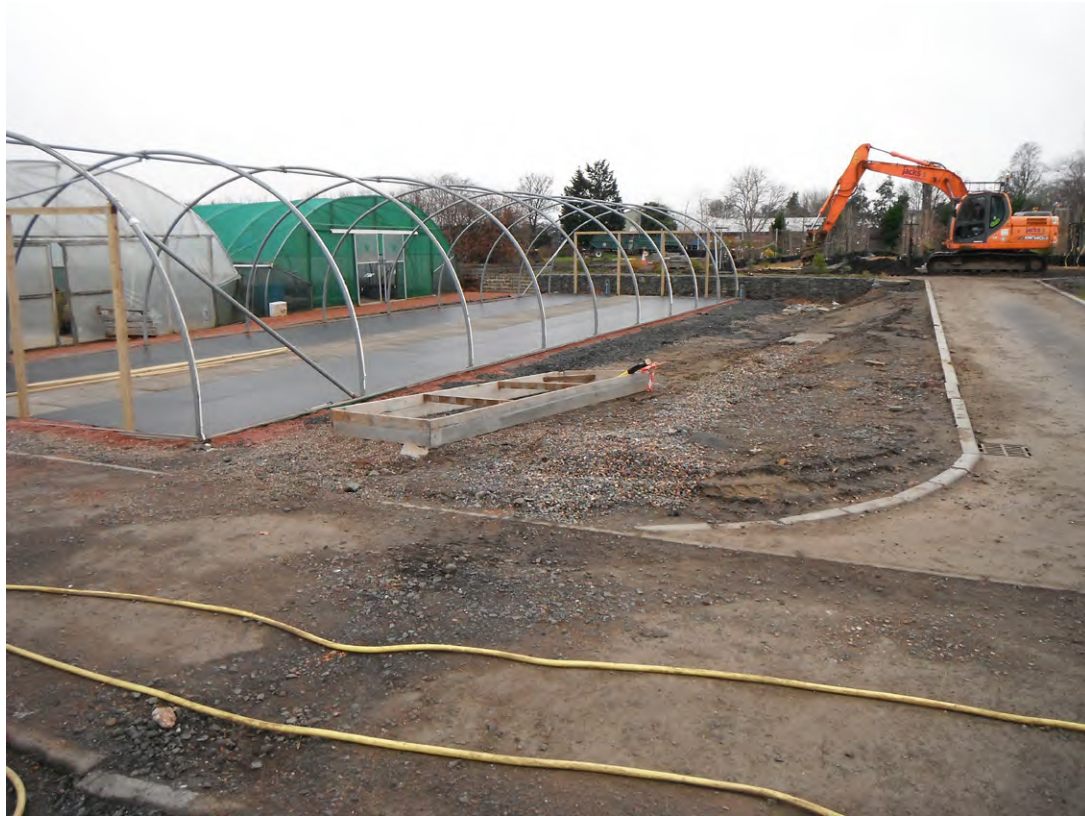
The area available for trial trenching in both locations was affected by on site constraints. In Area 1, much of the southern part of the area was occupied by the base of a polytunnel and associated drainage (Figs. 2-3). In Area 2, modern drains were present at the western end of the area.

Fig. 2 - Area 2, pre-excitation view of the southern end

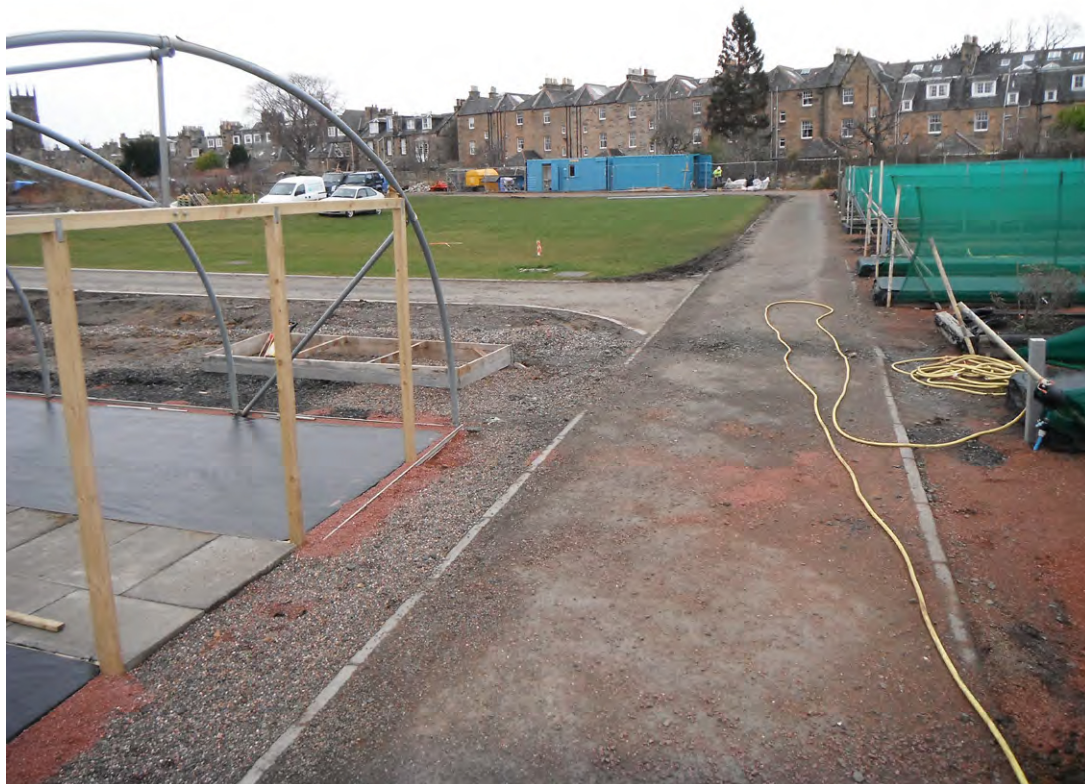
Fig. 3 - Area 1, pre-excitation view of the southern end

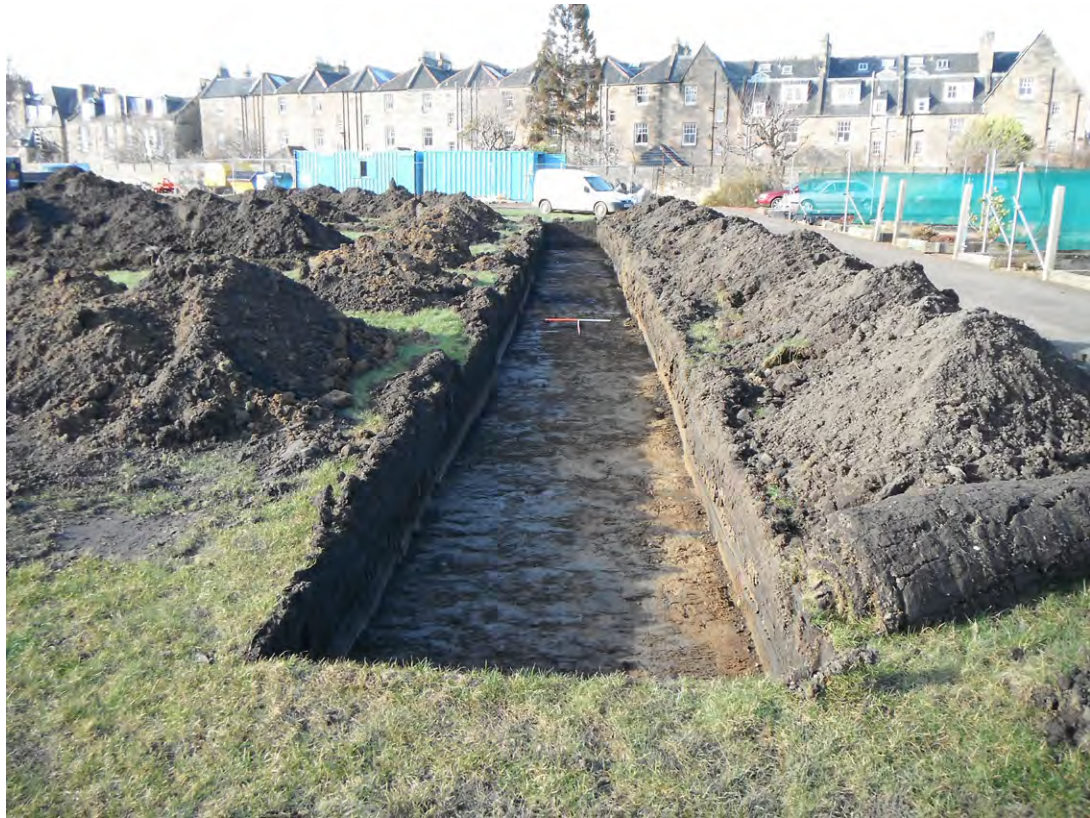
Trench 2 (27m x 1.8m, Fig. 4)

A linear feature (**201**) was partially exposed at the southern end of the trench. This was aligned roughly NW-SE and was also identified in Trenches, 5 and 6 (**505 & 601**). Its full width was not exposed but it was 0.16m deep.

At the northern end of the trench, a layer of dark soil (**003**) at the base of the topsoil profile contained frequent inclusions of coal and many sherds of broken plant pots. This was also recorded in Trench 6 but it appeared to be contained within a modern cut (from the site surface) at that location.

Fig. 4 - Trench 2, general view from the south

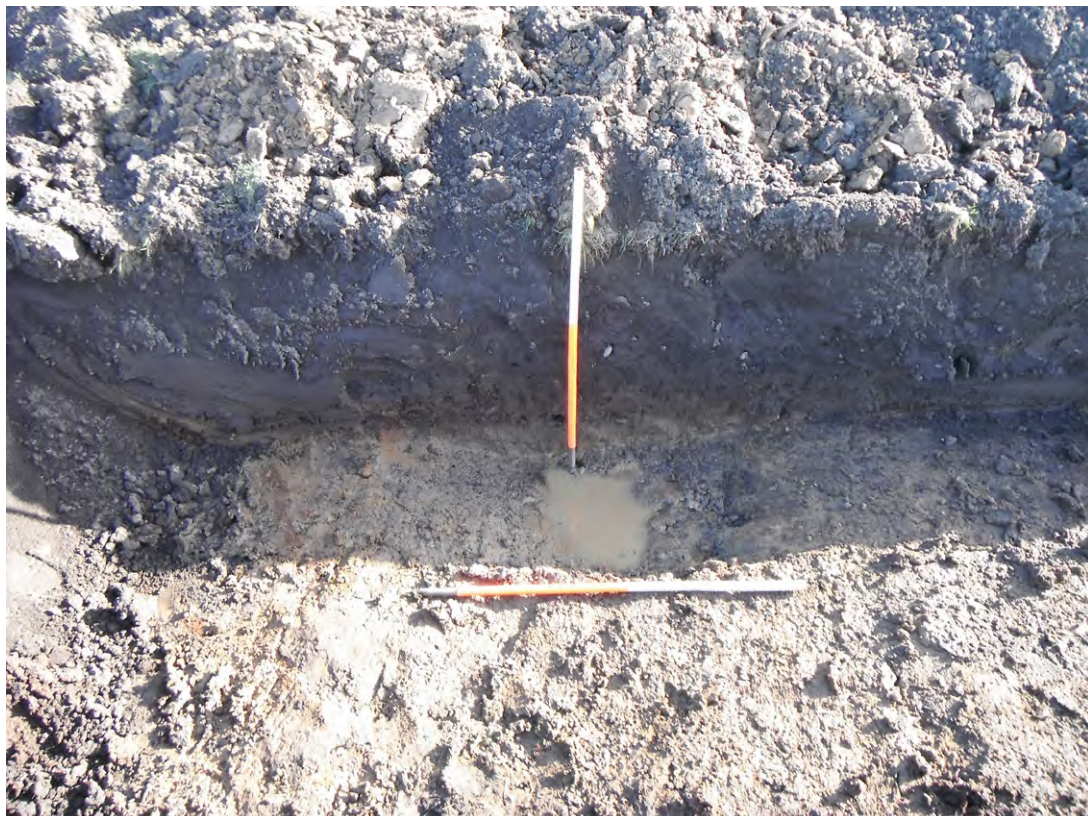
A second linear feature, (**205**) (Fig. 5) was exposed at the northern end of the trench. This was aligned E-W and had a width of 1.4m with a depth of 0.15m.

Fig. 5 - Linear feature 205 section from the west

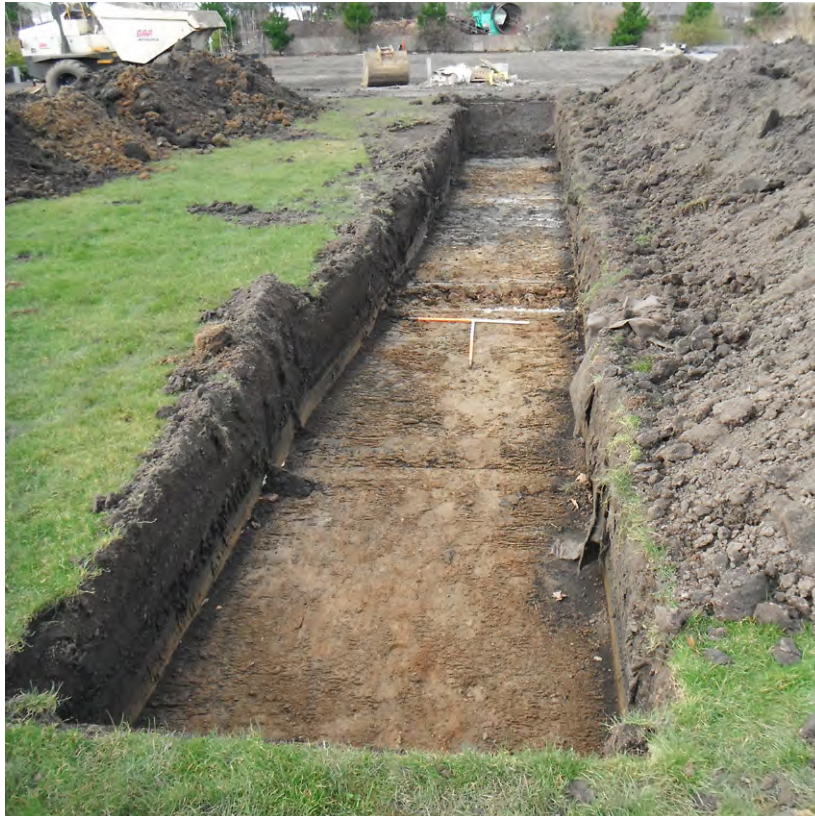
Trench 4 (17m x 1.8m, Fig. 6)

Fig. 6 - Trench 4, general view from north-east

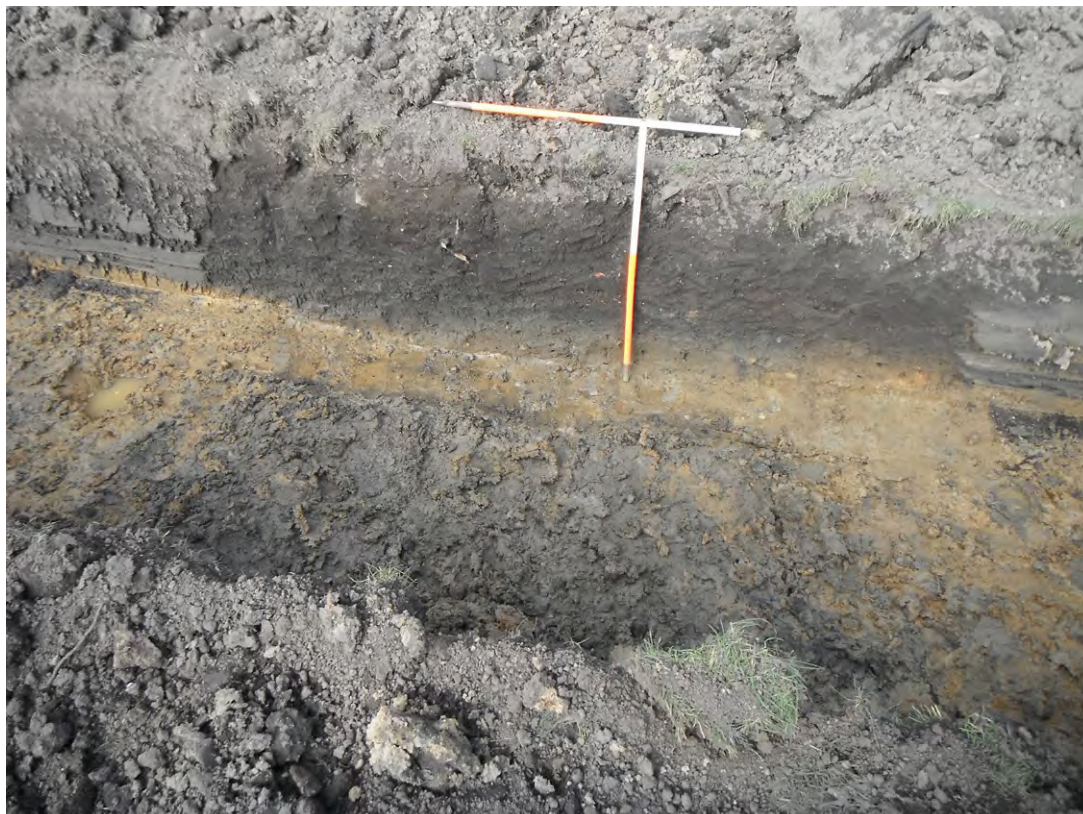
A linear feature (**403**) (Fig. 7) was exposed. This was aligned roughly NW-SE and had a width of 2.3m with a depth of 0.15m. This was also located in Trenches 3, 5 and 6 (**301, 505 & 611**).

Fig. 7 - Linear feature 403 section from the south

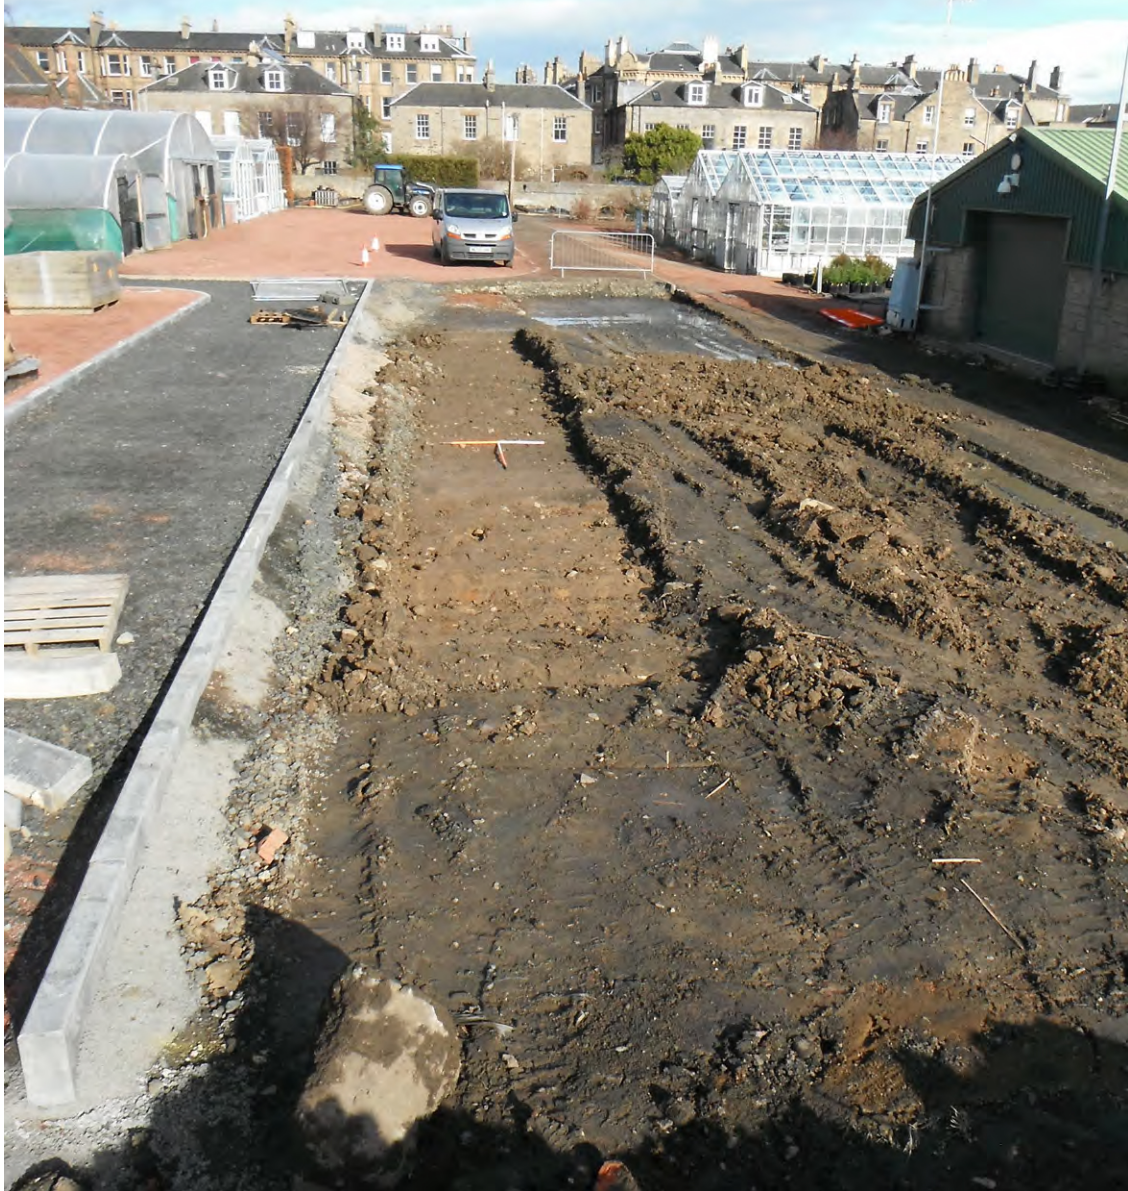
Trench 1 (16m x 1.8m, Fig 8)

No features were recorded.

Fig. 8 - Trench 1 from the west

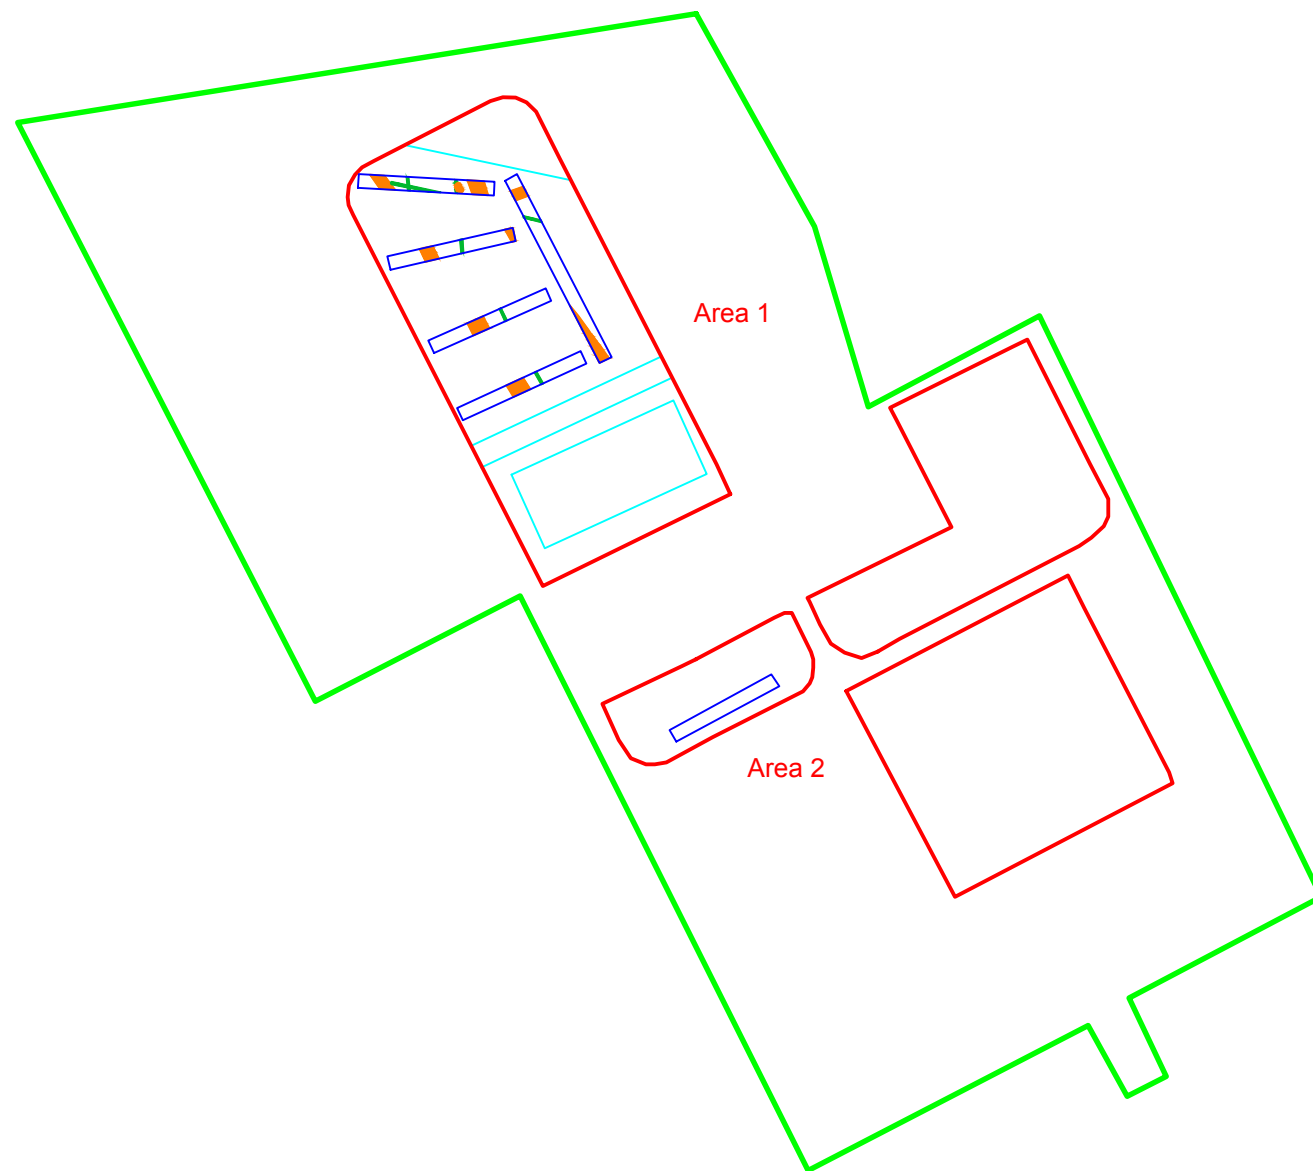
Fig. No: **9** Report No: **3274**

Historic mapping shows that the areas of the current fieldwork have been within what was called the Inverleith Nursery since the Ordnance Survey First Edition of 1853 (Fig. 9). These maps show a regular arrangement of rectangular plots, within which are depicted various alignments of what may be flower beds. Prior to this, the area formed part of the lands associated with Inverleith House built in the 1770's on the site of a medieval estate centre dating back to at least the early 12th century (John Lawson, pers comm).

Title:
**Evaluation area and trenches
 overlying Ordnance Survey,
 First Edition, 1853**
