**Cowes Blue Building, Bridge Street/West  
Street,  
Berwick-upon-Tweed**

**Archaeological Test Pitting**

**Report No. 3271**

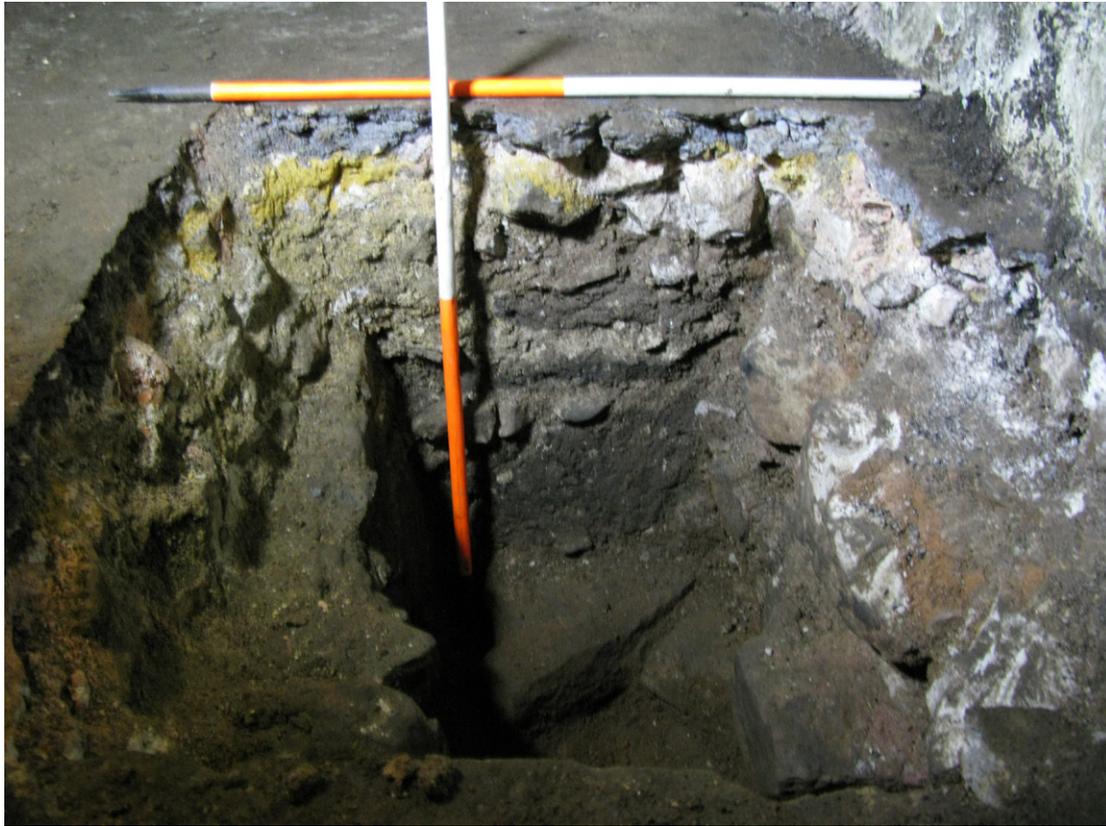
Fig. 2 - South-east-facing section of test pit 1

##### *Test Pit 1 (Figs. 2, 3 and 13)*

Test pit 1 measured 1.1m x 1.1m, with a maximum depth of 1.1m. It was located in the north-eastern half of Building 1 (Fig 1). The upper c. 0.15m of deposits consisted of a concrete floor (**1001**) and rubble levelling (**1002**). Below this was a yellow sand and rubble deposit (**1003**) that was c.0.15m deep.

A sandstone and mortar-bonded wall (**1005**) was identified below **1003** at a depth of 0.3m below the present surface. The wall was orientated NW - SE and was c.0.55m high at maximum, with its base occurring c.0.90m below the current site surface. It appeared to overlie a thin layer of light-mid grey clayey sand (**1011**). Underlying **1011** was orangey red sand (**1012**), starting at a depth of between c.0.8m and c.0.9m below the present surface.

Also sealed below **1001**, **1002**, **1003** large undressed stone blocks (**1013**) were recorded. These lay below the north-eastern wall of Building 1 and probably formed a foundation for that wall. These were founded on the orangey red sand (**1012**).

Between **1013** and **1005** a sequence of infilling deposits **1004**, **1006**, **1007**, **1008**, **1009**, **1010** and **1014** were identified.

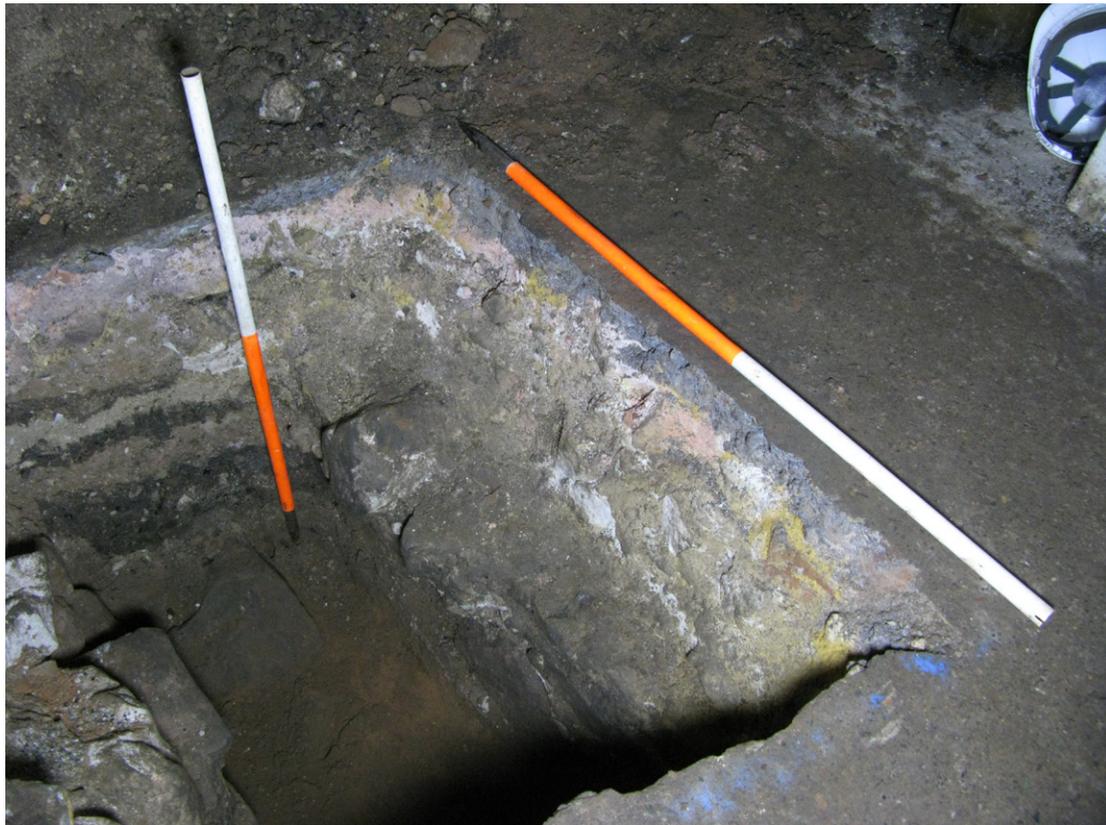
Fig. 3 - North-east-facing section of test pit 1

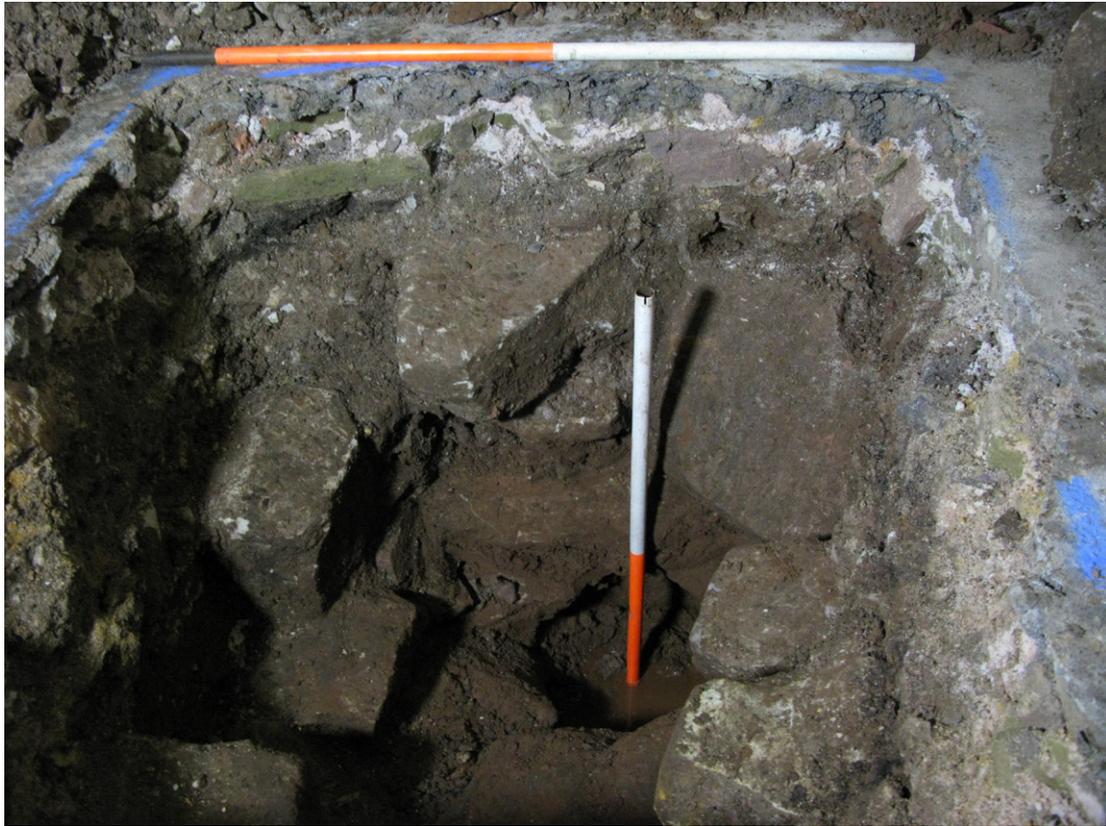
Fig. 4 - South-east-facing section of test pit 2

### ***Test Pit 2 (Fig. 4)***

Test Pit 2 measured 1.0m by 1.2m, with a maximum depth of 1.05m. It was located in Building 1 (Fig. 1). Concrete flooring (201) c.0.05m deep overlay of sandstone rubble levelling material (202) that was c.0.1m deep.

Underlying these deposits was c.0.5m of undressed sandstone blocks, cobbles and mortar fragments in a matrix of reddish brown silty sand (205). Below this and at a depth of c.0.7m below the existing surface, there was reddish, sterile sand (206), similar to 1012 in Test Pit 1 which is presumed to be natural. Waterlogging stopped any further excavation below a depth of c.1.05m.

A possible shallow cut feature (204) was indentified in the surface of the rubble deposit. Given its stratigraphic position this is not considered to be of significance.

No archaeologically sensitive deposits were identified in this test pit. The modern flooring and underlying rubble deposit appeared to overly what was identified as probably being natural sand (206), which was identified at a depth of c.0.7m below the site surface.

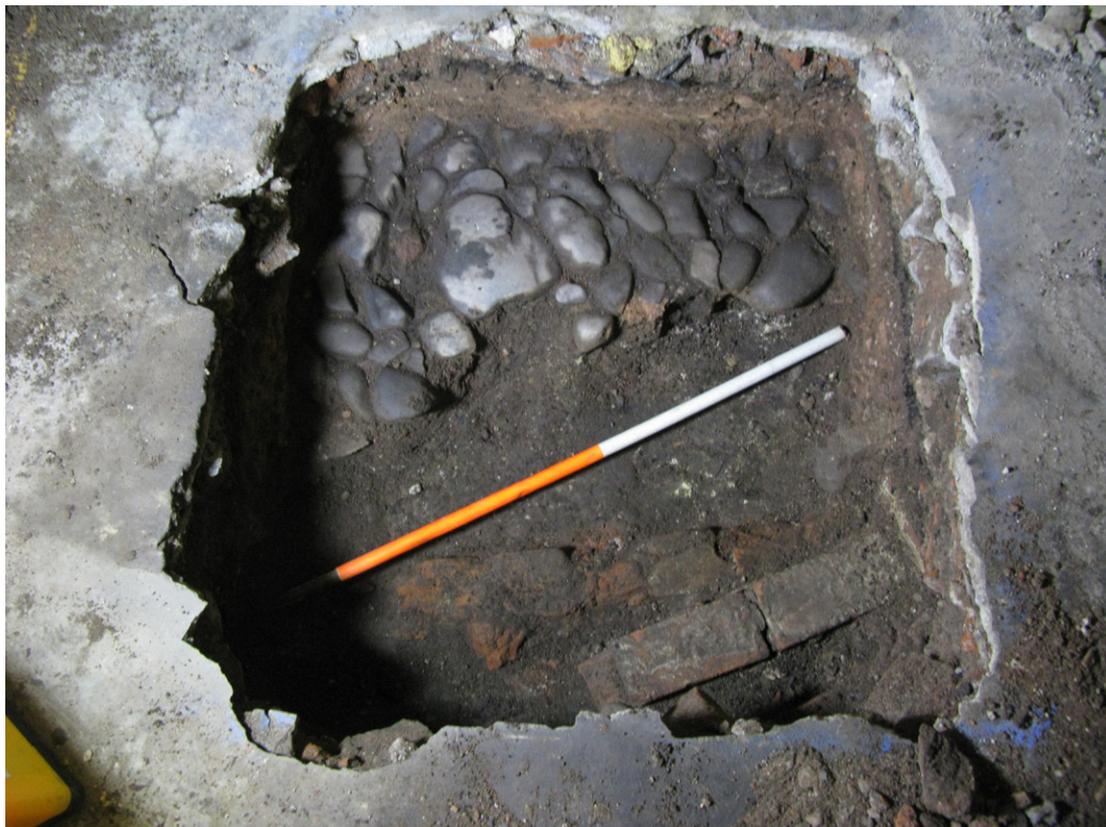
Fig. 5 - Plan view of walls 307 and 308 and cobbled surface 306 in test pit 3

### ***Test Pit 3 (Figs. 5, 6, 14 and 15)***

The levelling deposits directly overlay a mortar bonded red brick (307) wall and a cobbled surface (306) which were identified at a depth of c.0.3m (minimum) below the existing surface. The wall was orientated ENE-WSW and consisted of two skins of brick with a cavity between. The wall survived to a height of c.0.25m. The construction trench for the wall (323) was cut through a deposit of dark grey sand containing mortar and degraded sandstone fragments (309/310). This deposit also underlay the cobbled surface.

The remains of a second possible less substantial brick wall (308) was found underlying 307. The top of this possible wall was identified at a depth of c.0.55m below the existing surface. It had an NW-SE alignment and consisted of one course of blank, red clay bricks without any form of frogging.

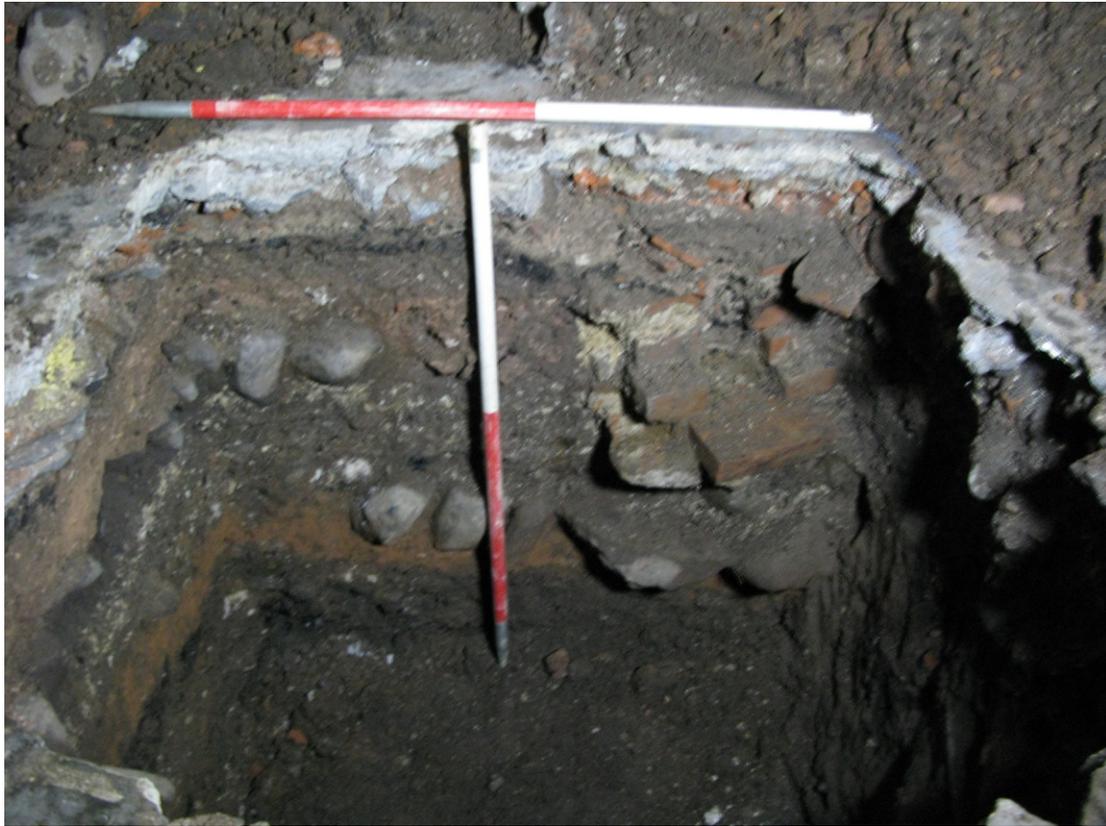
Fig. 6 - North-west-facing section of test pit 3

Test Pit 3 measured 1.0m by 1.0m, with a maximum depth of c.1.2m. It was located in Building 2 (Fig. 1). A concrete floor (301) and levelling deposits (302, 303, 304 and 305) were identified in Test Pit 3. These extended to a depth of between c.0.30m and c.0.43m below the current site surface. A recent service trench (314) was cut through 302.

Below 309/310 at a depth of c.0.65m below the current site surface a series of dark grey, silty deposits containing shells and charcoal (311, 320 and 312) were identified. These extended down to a depth of c.1.2m below the surface consisted. Below this depth augering identified that 312 continued to a depth of c.1.5m below the surface before changing to the sterile reddish sand encountered in test Pits 1 and 2, which probably represents natural.

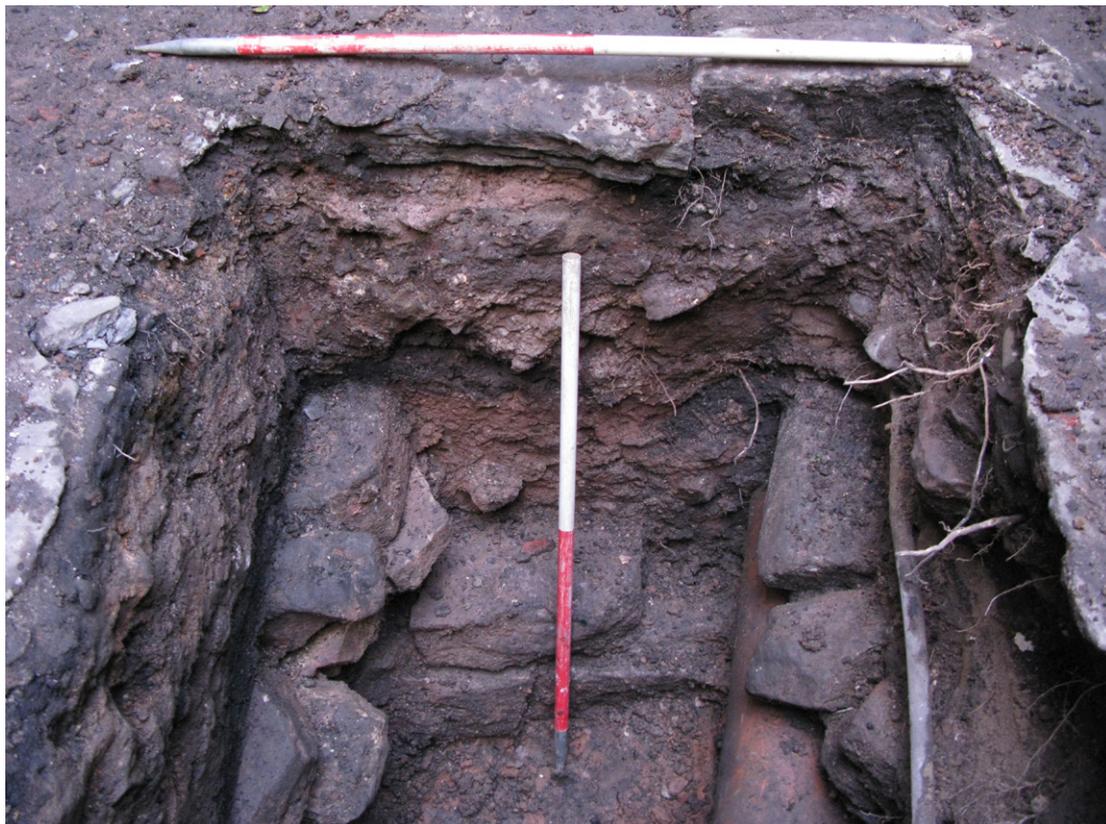
Fig. 7 - North-east-facing section of test pit 4

### ***Test Pit 4 (Figs. 7 and 21)***

The deposits from the top down consisted of flagstones (**401**) and levelling deposits (**402** and **403**) down to a depth of c.0.5m below the existing surface. These overlay a more compact, black silty/ashy layer (**404**) which overlay what appeared to be coursed stone slabs (**408**) with an apparently sandy, possibly degraded mortar between them (**409**), this was identified at a depth of c.0.45m below the current site surface. Within the confines of the test pit it was difficult to identify if this was walling or a surface or just a dump of stone. This overlay a deposit of Pink/brown mixed clay and rubble fragments (**405**), which in turn overlay a potential wall (**419**) consisting of a possible NW-SE alignment of coursed stone slabs at a depth of c.0.98m below the current site surface. These in turn overlaid probable natural (**418**). A modern service cut (**417**) containing a ceramic pipe (**416**) and a lead pipe (**411**) was cut from just below the current flagstone surface.

Recent surfacing extended to at least c.0.5m below the site surface. The stone slabs (**408**) were identified at c.0.54m below the current site surface. Whilst they appeared regular it is difficult to ascribe any function to them, and they could simply be a dump of rubble and possible mortar. At a depth of c.0.98m a possible wall (**419**) was identified in the north-east facing section of the test pit. None of the associated deposits appeared archaeologically significant. Possible natural was identified at c.1.3m below the current site surface.

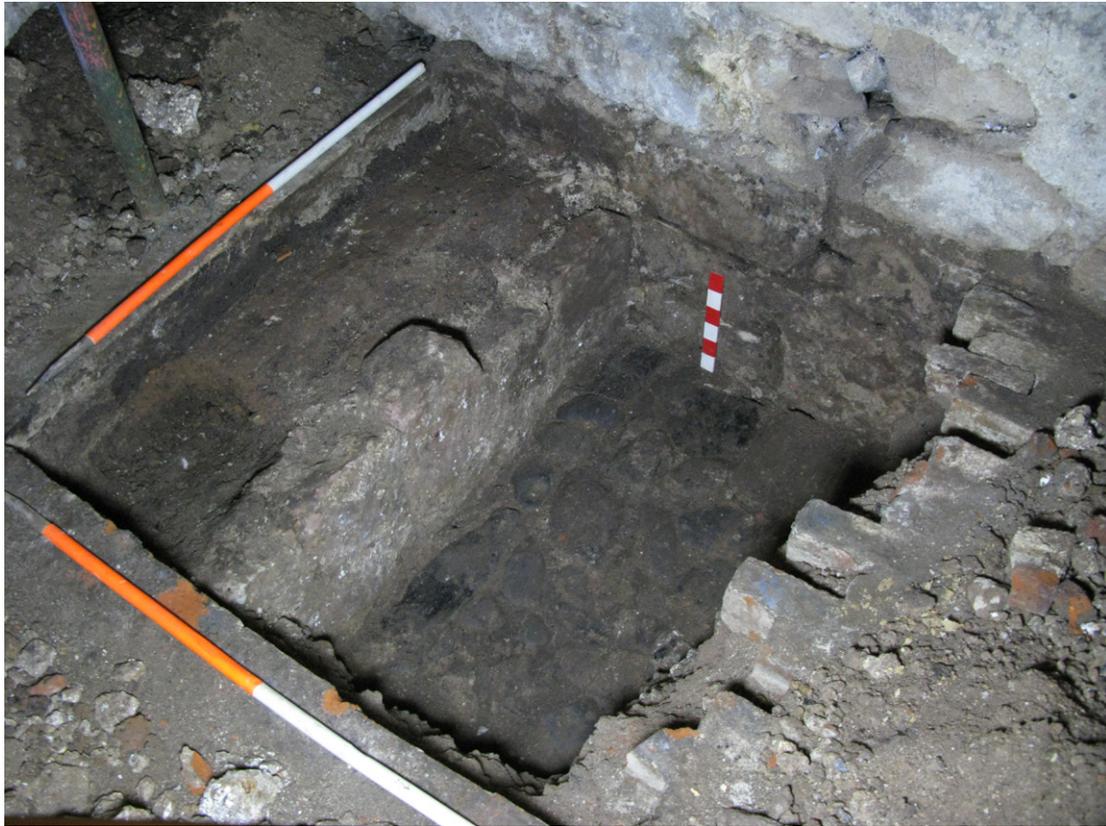
Fig. 8 - General view of wall **506** and cobbled surface **505** in test pit 5

### ***Test Pit 5 (Figs. 8, 9,10, 16, 17 and 20)***

The current floor consisted of sandstone slabs (**502**) and handmade bricks (**503**). These lay over a levelling deposit (**515**). At a depth of c.0.15m below the existing surface a mortared sandstone wall (**506**) was identified. This wall extended to a depth of c.0.7m below the existing surface. The wall was aligned NW-SE and was approximately 0.15m wide. This wall butted up against the main wall of Building 2 (**501**).

Underlying the levelling deposit (**515**) and contained between walls **501** and **506** was a deposit of compacted, degraded mortar (**504**). This extended down to a depth of c.0.55m below the existing surface to reveal a cobbled surface (**505**) which abutted walls **501** and **506**.

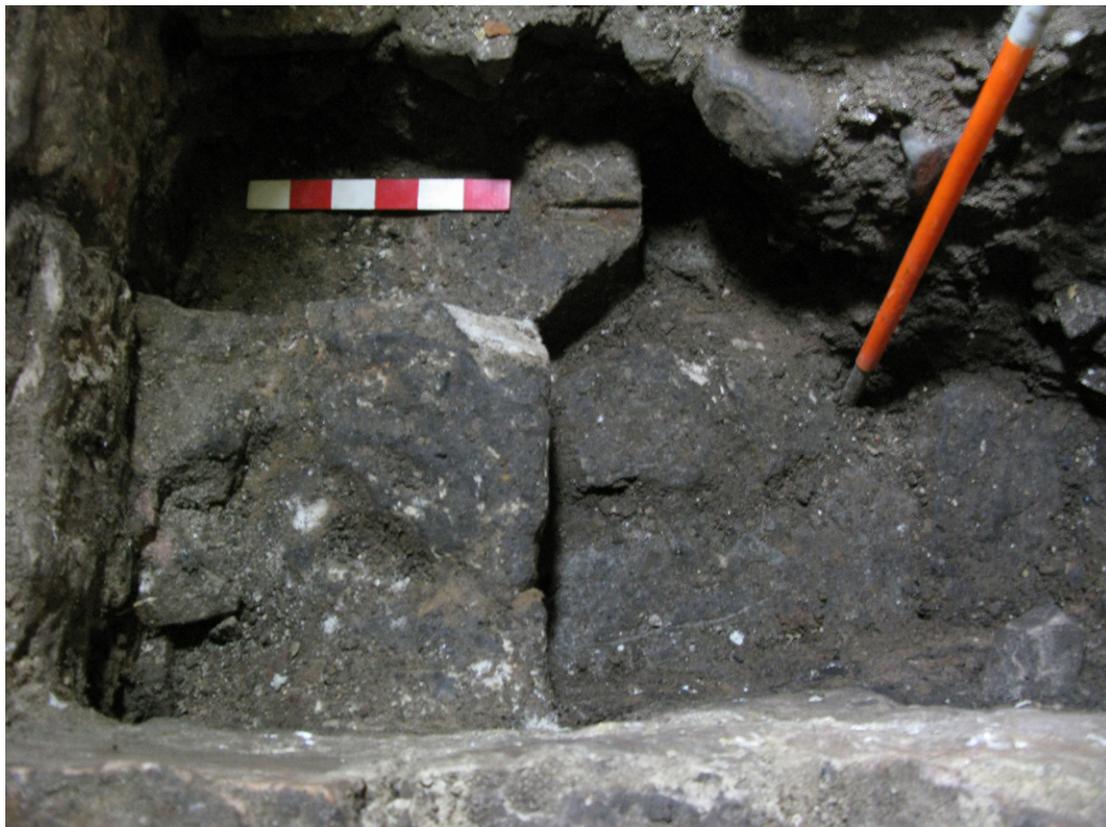
Fig. 9 - Plan view of foundation course **508** and flagstone floor **510**

These deposits overlay what was identified as probably being the foundation course (**508**) of the main wall of Building 2 (**501**). The top of the probable foundation course was identified at a depth of c.0.6m below the current site surface and extended to an identified depth of a c.0.8m below the current site surface. A 'T' shaped socket (**516**) was cut in to the upper face of one of the blocks in the foundation course. This may have been for securing some form of internal feature that was set against the wall.

Beneath (**511**, **512**, **513** and **514**) a sandstone flagstone surface (**510**) was identified at a depth of between c.0.8m and c.1m below the current site surface, this sloped slightly upwards to the east. It appeared to be associated with the foundation course (**508**) of wall **501**.

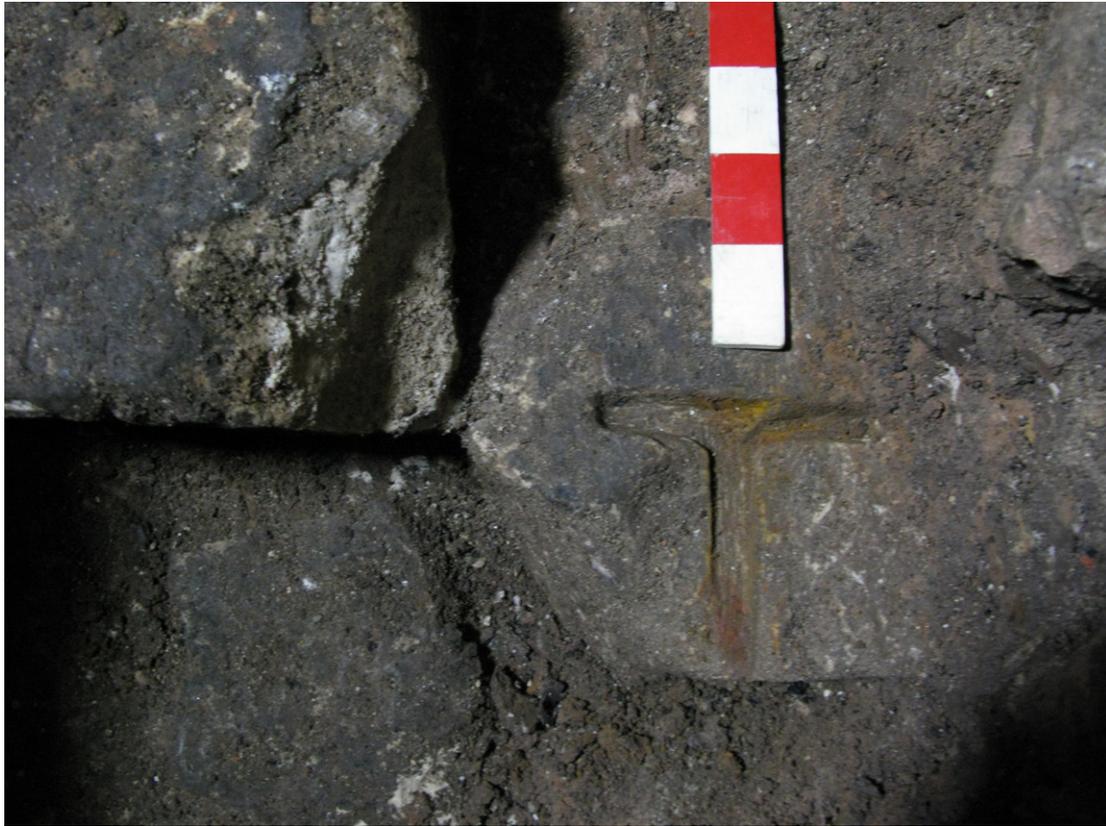
Fig. 10 - 'T'-shaped socket in foundation course **508**

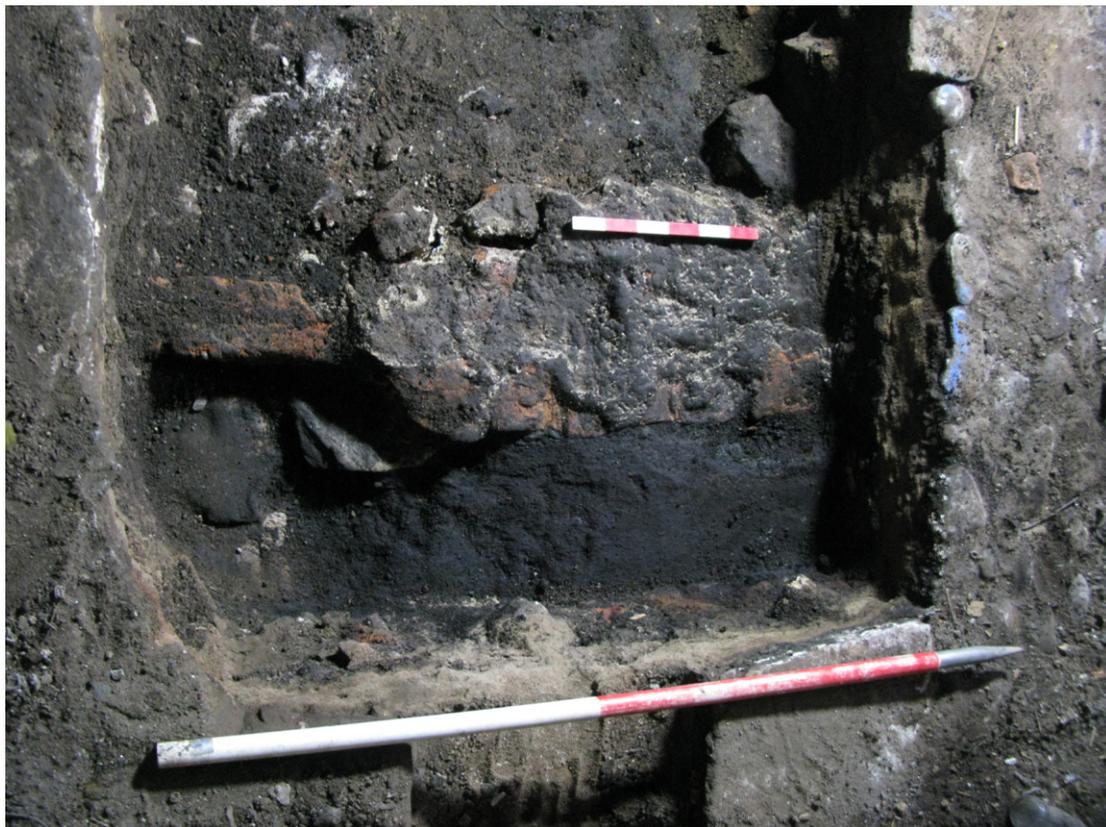
Fig. 11 - Plan view of wall **612** in test pit 6

### ***Test Pit 6 (Figs. 11, 12, 18 and 19)***

The current sandstone slab floor surface (**601**) and light grey sand levelling deposit (**602**) extended to a depth of c.0.15m below the current site surface. Below this a discontinuous charcoal rich deposit (**603**) present, which overlay a vestigial mortared red brick wall, that was aligned NE-SW with a possible return to run SE-NW (**604** / **612**). This survived at a depth of c.0.25m below the current site surface. The wall only survived to one course high (0.06m) with a maximum width of 0.2m. It had been built directly onto deposit **606** and did not appear to be a major weight-bearing wall. On the north side of the wall and abutting it was a compact black sooty deposit (**605**) this also overlay **606**.

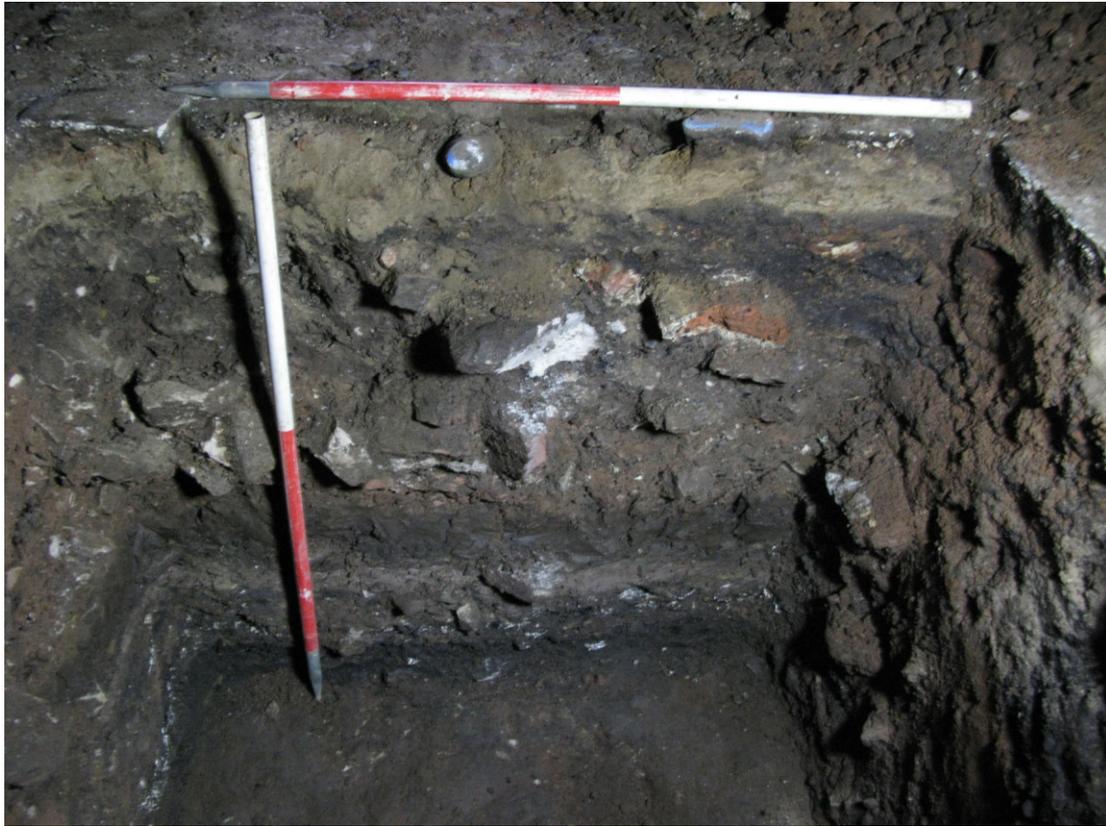
Fig. 12 - North-east-facing section of test pit 6

Deposits of containing mixed mortar, rubble and brick (**606** and **613**) continued to a depth of c.0.7m (minimum) below the existing surface. These overlay a clean, compact deposit of grey clay (**607**), c.0.1m thick, and approximately c.0.07m of lighter, sandier clay (**614**). These overlay deposit **608** / **615** which was a mixed dark grey sandy clay with mortar fragments, stones, bricks, shell, and charcoal inclusions. Below this was a thin deposit consisting mainly of shells (**616**) and below this of was a deposit of almost black sand (**617**). Below this a very compacted deposit of silty sand (**611**) was identified at a depth of c.1.1m below the current site surface. Hand augering was only possible to an additional depth c.0.3m below this. The augering identified that **611** was only a few centimetres thick and that below this was a mixed deposit of dirty pinkish sand, rubble, sandstone and mortar fragments.

A cut feature (**609**) apparently aligned NW-SE was cut through deposit **606**. The cut started at a depth of c.0.5m below the existing surface. The cut was c.0.7m deep and 0.45m wide but was only partially exposed and continued beyond the limits of the test pit. The fill of the cut feature was fairly clean reddish brown sand (**610**).

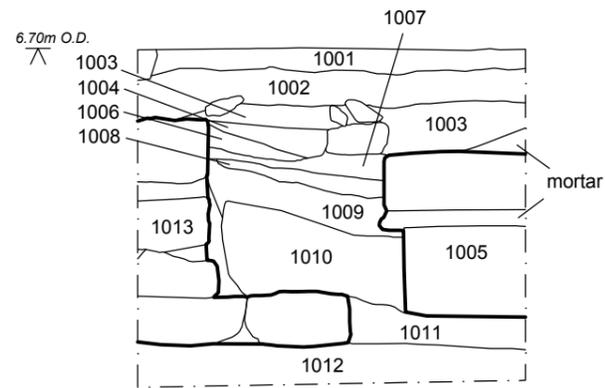
Fig. 13 - North-west-facing section of test pit 1

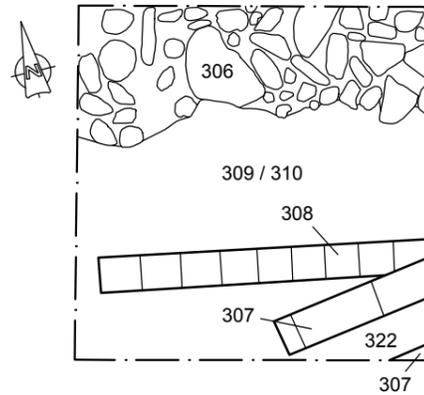
Fig. 14 - Plan of test pit 3

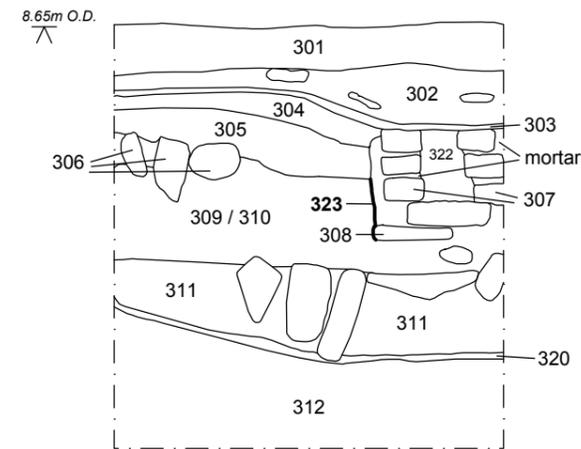
Fig. 15 - North-west-facing section of test pit 3

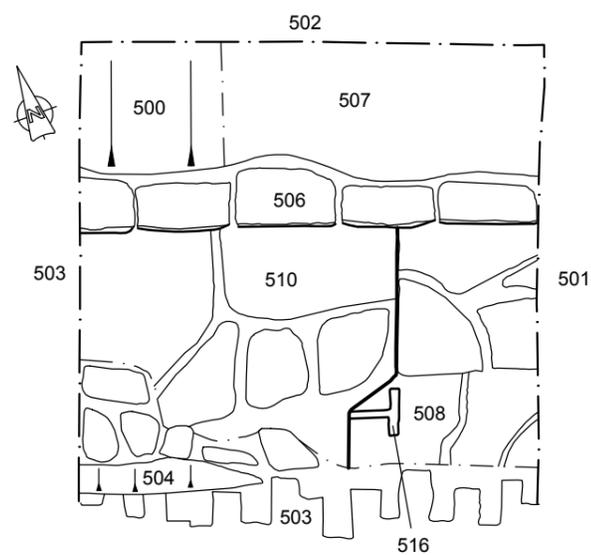
Fig. 16 - Plan of test pit 5

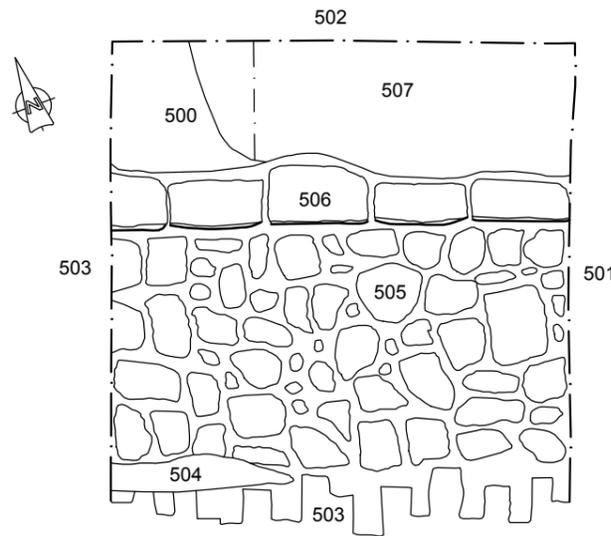
Fig. 17 - Overlay of test pit 5

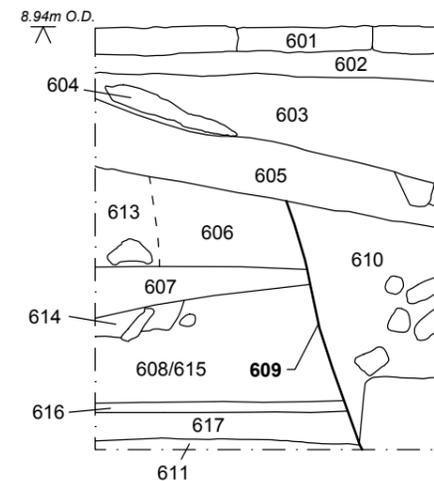
Fig. 18 - South-east-facing section of test pit 6

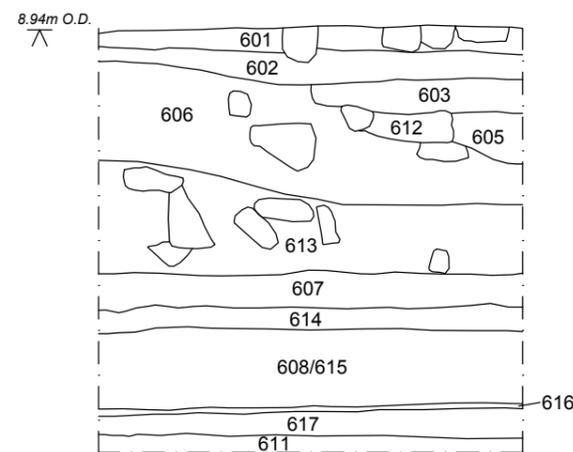
Fig. 19 - North-east-facing section of test pit 6

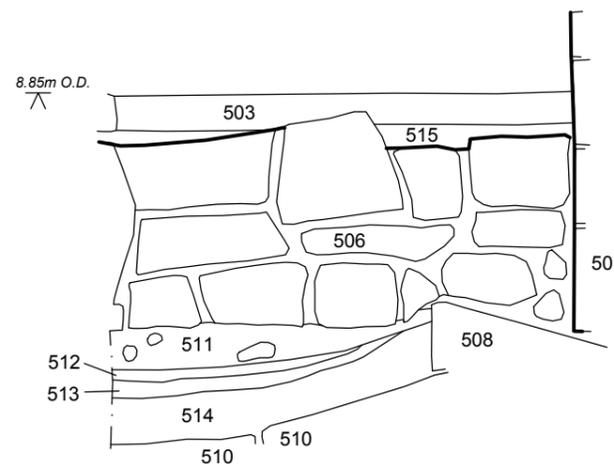
Fig. 20 - South-west-facing section of test pit 5

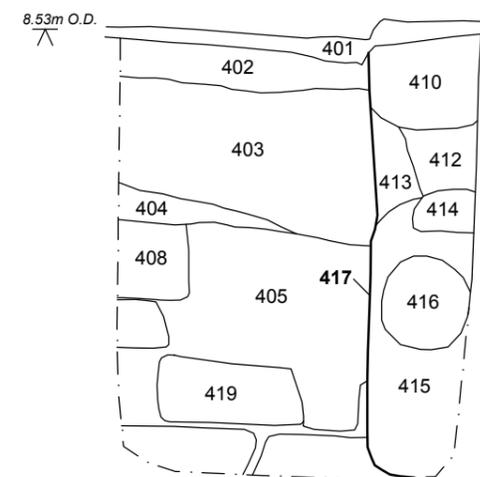
Fig. 21 - North-east-facing section of test pit 4
