**Kingsburn Windfarm,
Fintry, Stirling**

Archaeological Mitigation Works

Report No. 3282

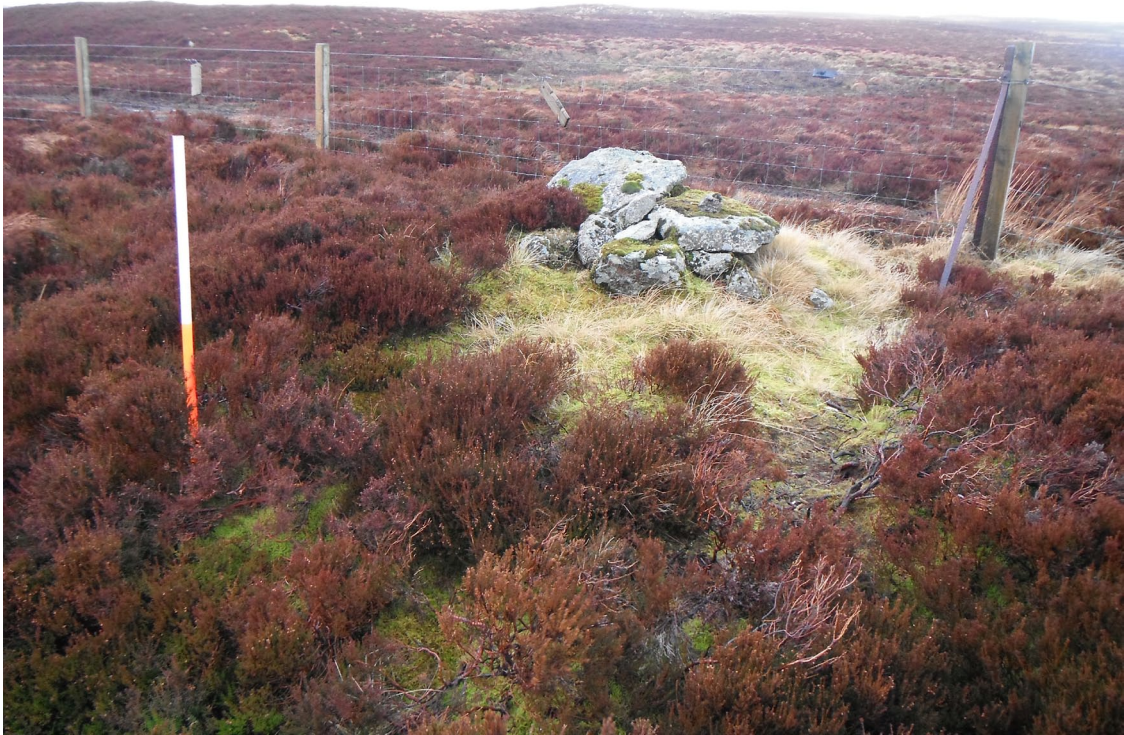
Fig. 2 Site 1, a stone boundary marker

Site 1 consists of a small stone cairn at NS 69397 90687. This site lies approximately 20m to the north-east of Turbine 8 (Fig. 2). Three stone piles are depicted on the Ordnance Survey First Edition map⁵, marking the alignment of the Parish boundary. However, field survey for the ES identified only the easternmost of the three, as a pile (3m x 2m x 0.5m high) of unworked stone blocks on the line of a modern post and wire fence. No trace was detected of the two other stone piles previously recorded in this area, which appear to have been removed.

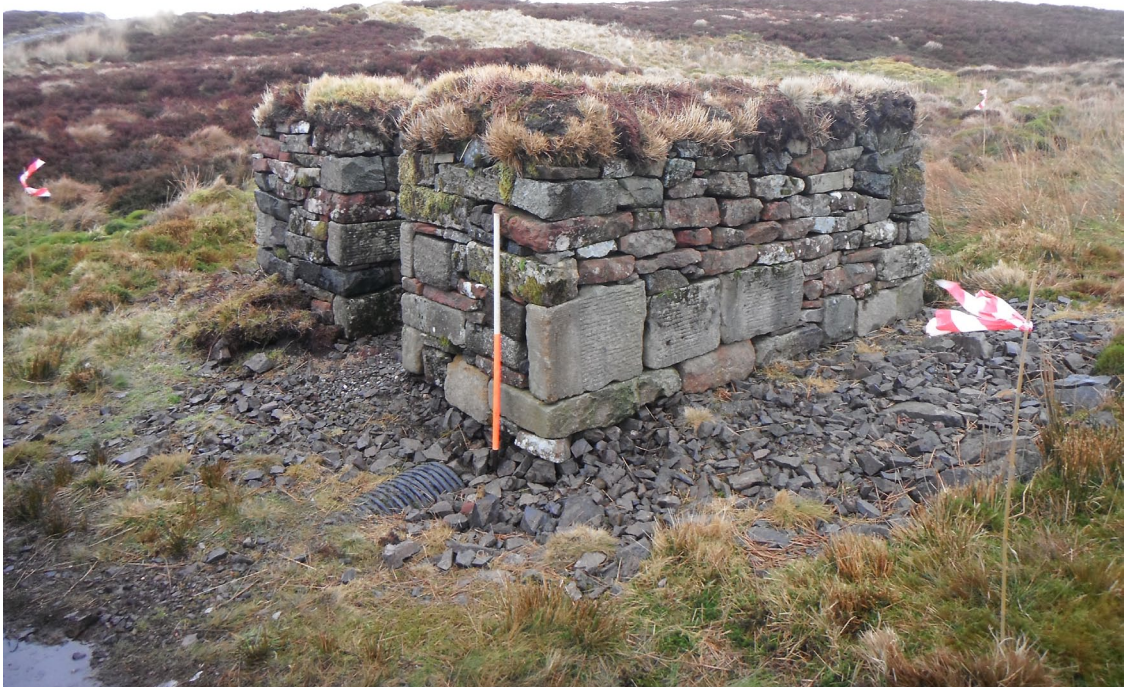
Fig. 3 Site 2, a grouse butt, adjacent to the existing track

Site 2 consists of a stone-built shooting butt at NS 67440 90867, which included a number of large dressed stones in the wall. This butt is the south-easternmost of a line of nine grouse butts shown on current Ordnance Survey maps. The well preserved structure is 3m long x 2m wide and 1m high; the wall is 0.3m thick. This example was unusual in that the other shooting butts in the line were made of wood and were sunk into the peat. The existing estate track passed within 1m of this site (Fig. 3).

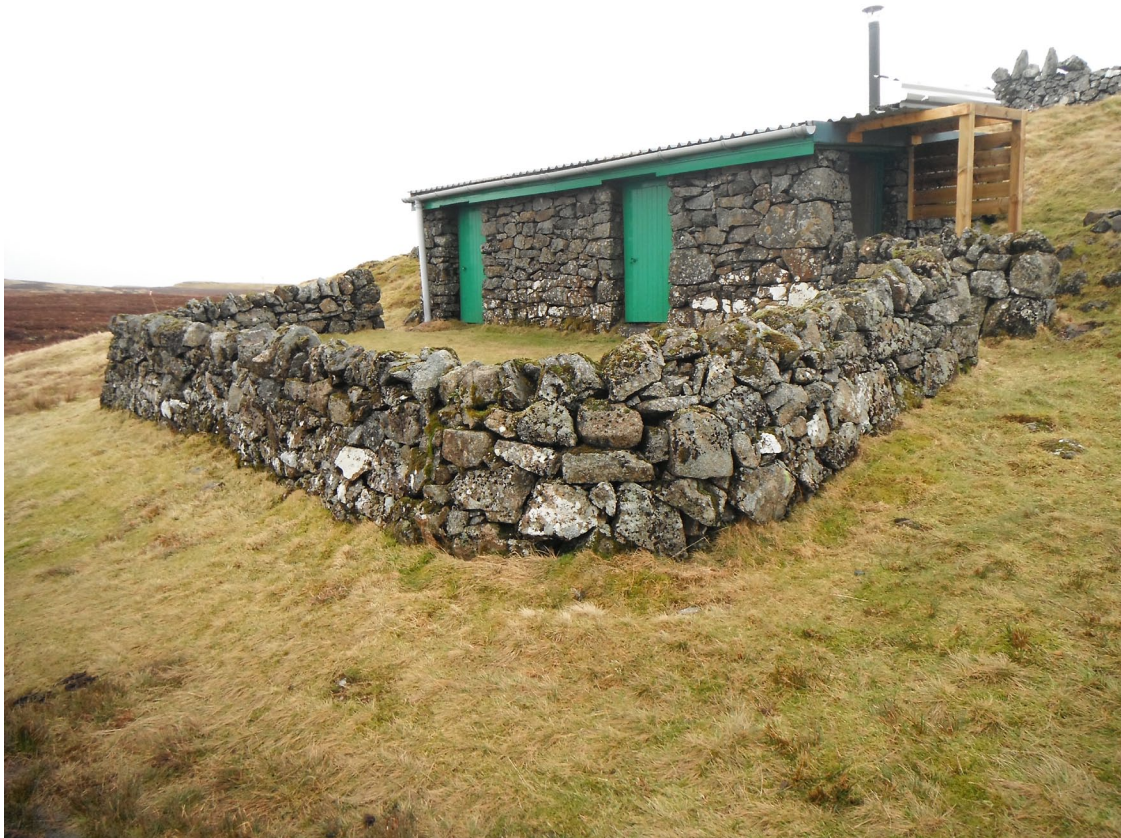
Fig. 4 Site 3, a bothy, adjacent to the existing track

Site 3 consists of a roofed bothy set within a stone-walled enclosure at NS 67410 90745. Field survey identified a well preserved, single-storey stone-built bothy measuring 7m long x 5m wide externally with a rectangular stone-walled enclosure attached to the north side (9m x 5m) and a sub-rectangular stone-walled enclosure 22m x 7m on its south side. There are two doorways in the north side of the building. The building is presently roofed and in use as a gamekeeper's bothy and for shooting parties. The existing estate track passed within 2m of the enclosure wall (Fig. 4).

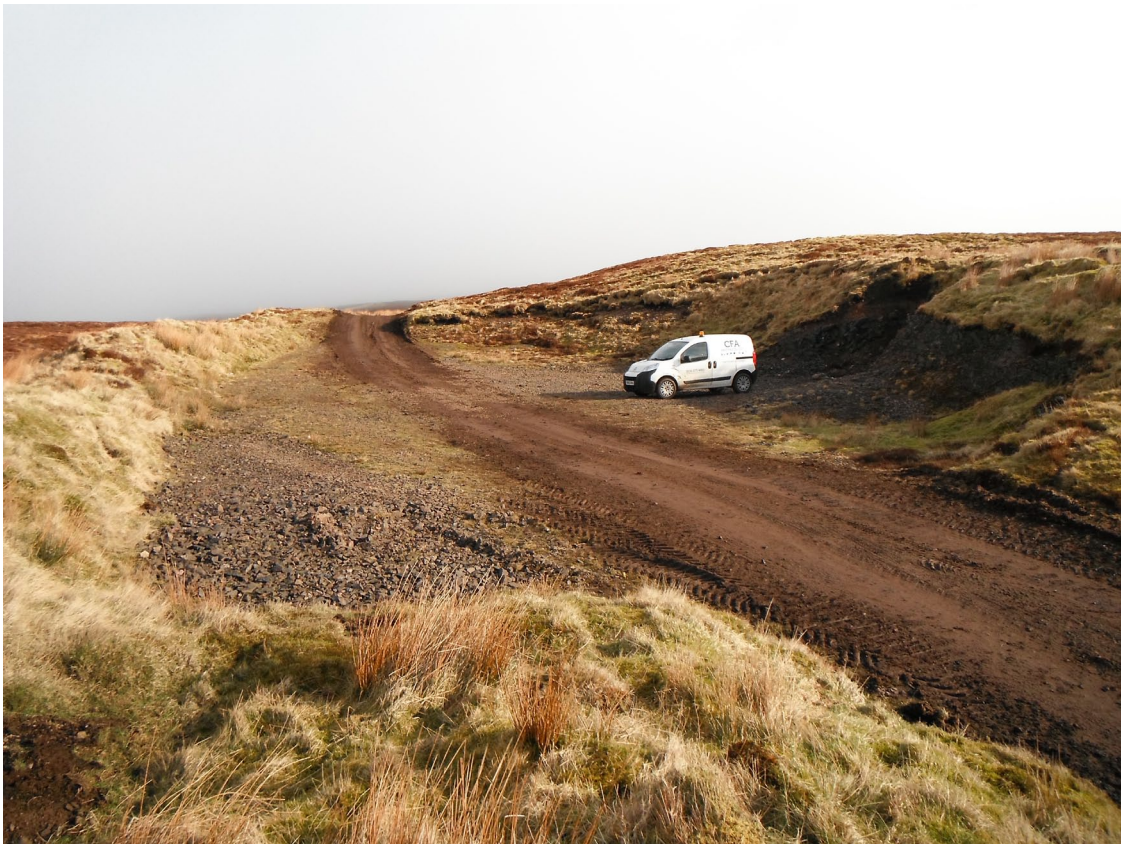
Fig. 5 Site 4, a modern quarry

Sites 1-3 (Fig. 1) were demarcated for the duration of the works. The width of the buffer zone around each site varied according to the proximity of the works but a buffer of at least 5m was used where possible. Site 4, a quarry (Fig. 5), was not demarcated as it is modern in origin and was assessed in the ES as being of *Lesser* archaeological importance.

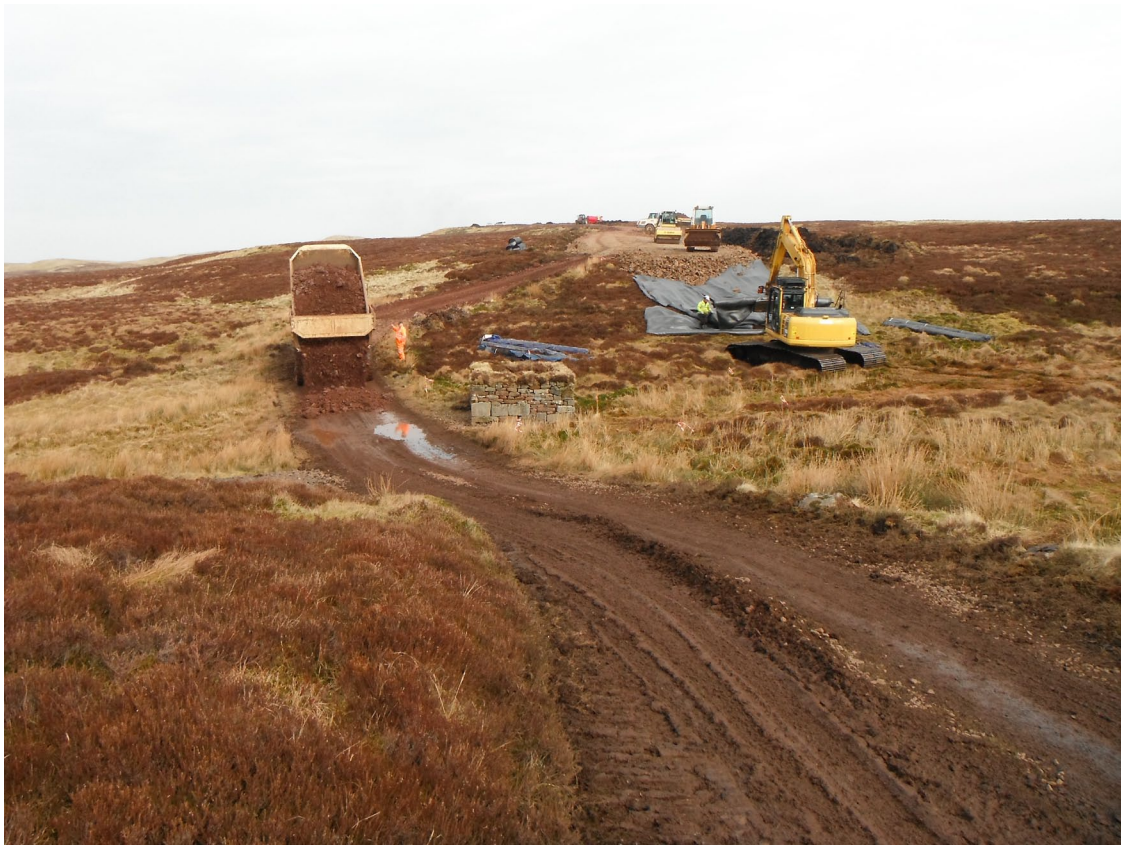
Fig. 6 The new access road passing to the east of Site 2

monitored. To the north of Site 2 and to the south of Site 4, the existing track was widened. A new road was made to the east of Site 2 (Fig. 6) and to the west of Site 3 (Fig. 7) to remove the bends. This then passed to the west of Site 4 before rejoining the original estate track alignment. No archaeological remains were revealed.

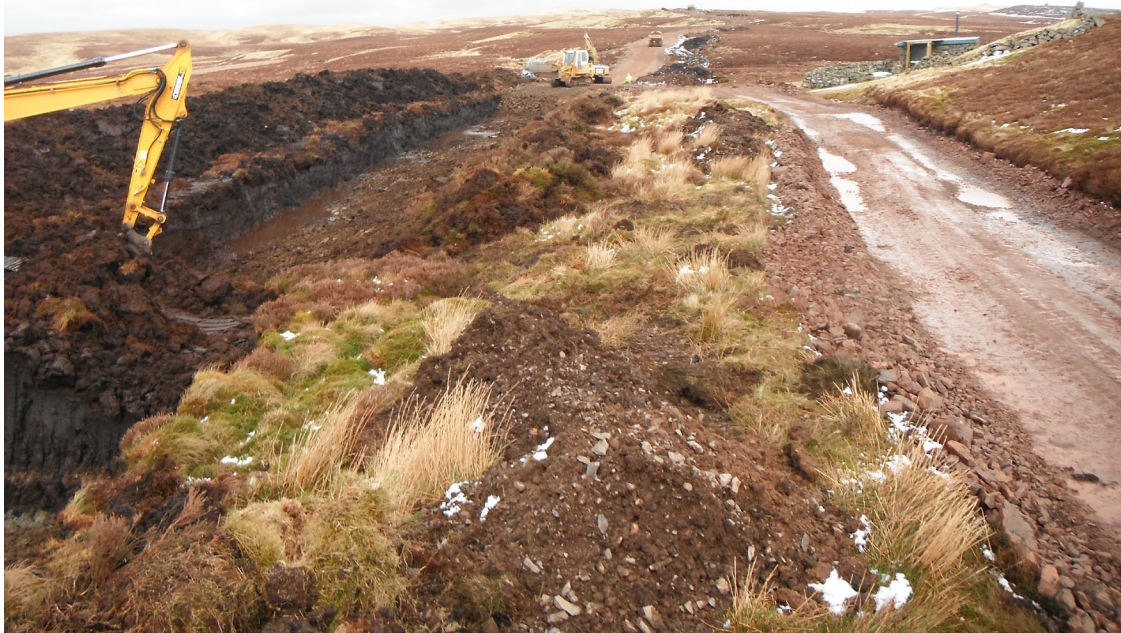
Fig. 7 The new access road passing to the west of Site 3

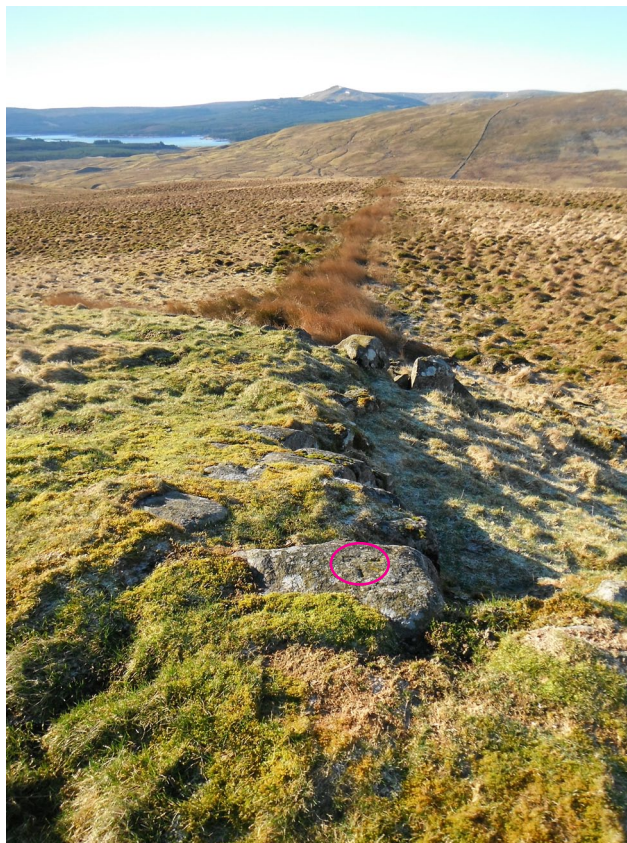
Fig. 8 General view of Site 5, a turf bank, from the summit of Ling Hill. The Ordnance Survey Benchmark arrow can be seen on the bedrock in the foreground (circled)

The formation of a new access road between just north of Turbine 2 and just north of Turbine 3 was monitored (Fig. 9), as the projected alignment of Site 5 (Fig. 8) would cross this area. Site 5 is a linear bank running SSW for 250m from near the summit of Ling Hill, down-slope to Backside Burn, between NS 67264 89281 and NS 67211 89038. The bank measured 2m wide x 0.5m high and appears to denote a boundary between the farmsteads of Backside and Burnfoot.

During an initial walkover, it was noticed that an Ordnance Survey Benchmark had been cut into bedrock at the northern end of the boundary bank (Site 5, Fig. 8). Despite the area being named as Ling Hill on the maps, no heather is present. Peat depth is typically less than 0.5m overlying natural boulder clay with frequent knolls of bedrock. No continuation of this boundary bank was present and no other archaeological remains were recorded.

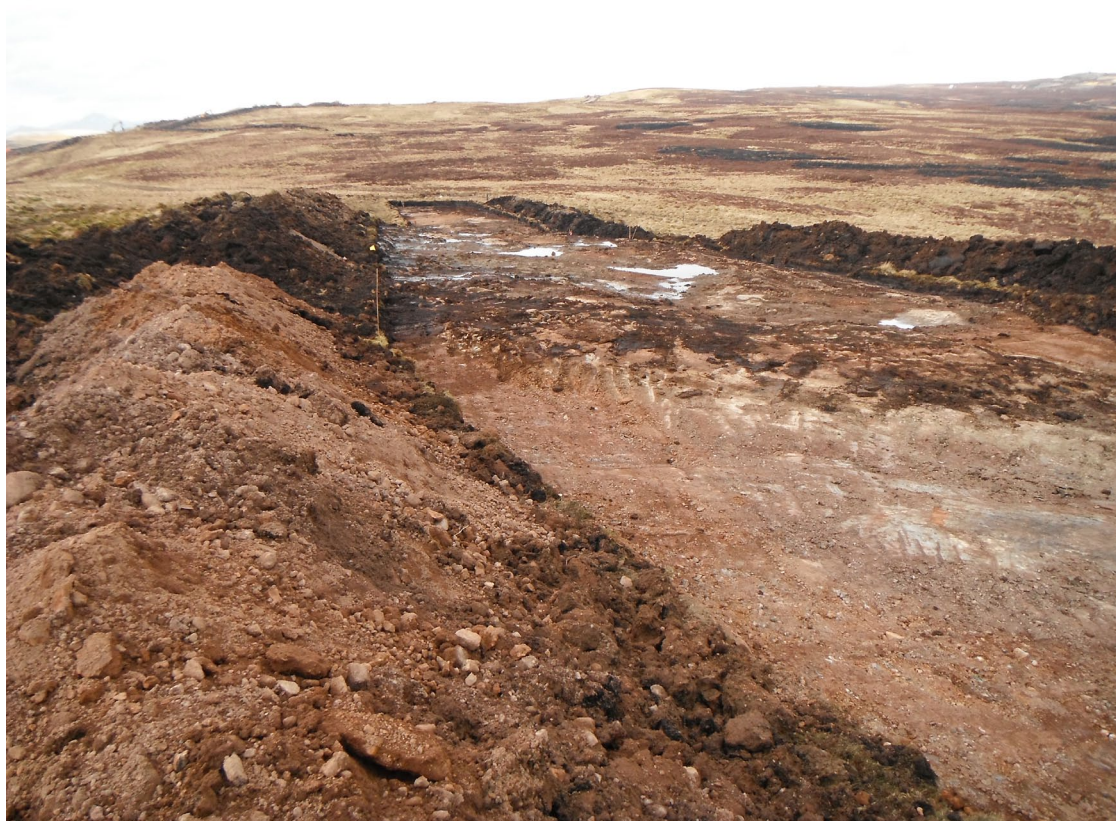
Fig. 8 General view of the watching brief area between Turbines 2 and 3
