**Castle Inn, Dennis Road, Hugglescote
Leicestershire**

Historic Building Recording

Report No. MK017/15

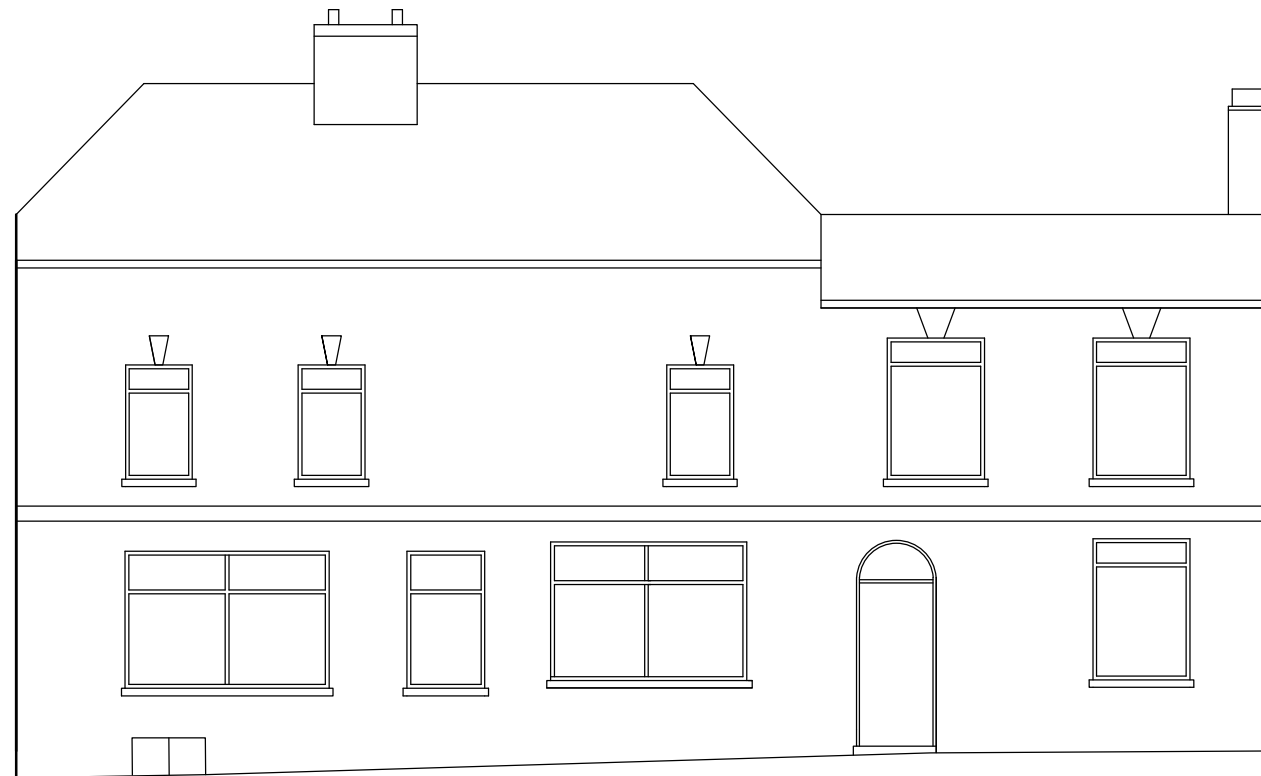
Fig. No: 4 Report No: MK017/15

This unit, the original property, is a rectangular building fronting Dennis Road with two floors, an attic and a cellar. The front elevation is painted with white paint and covered in modern render (Figs. 7-8). Inspection of the walls (where exposed) in the cellar, ground floor and 1st floor showed that the original fabric of the building is mortared red brick (each brick measuring 24cm x 12cm x 6cm and of a high clay content). On the east half of the cellar it can be seen that the walls have been set on mortared stone foundations. The building originally had a central chimney stack of brick, but this has been removed on the ground floor and in the cellar. Floor joists and supporting beams are original on the 1st and attic floors and are of pit-sawn and adze trimmed hardwood, probably oak. The beams supporting the joists for the 1st floor are connected to the steel beams inserted to support the remaining chimney stack. The roof is half-hipped with hewn and adze-trimmed hardwood purlins, corner ties and hip rafters visible in the attic. There were formerly two windows below each hip in the attic but the eastern one is now blocked. The roof is covered in clay roof tiles and the chimney on the outside of the building has been re-lined or re-built in cream brick with four ceramic chimney pots.

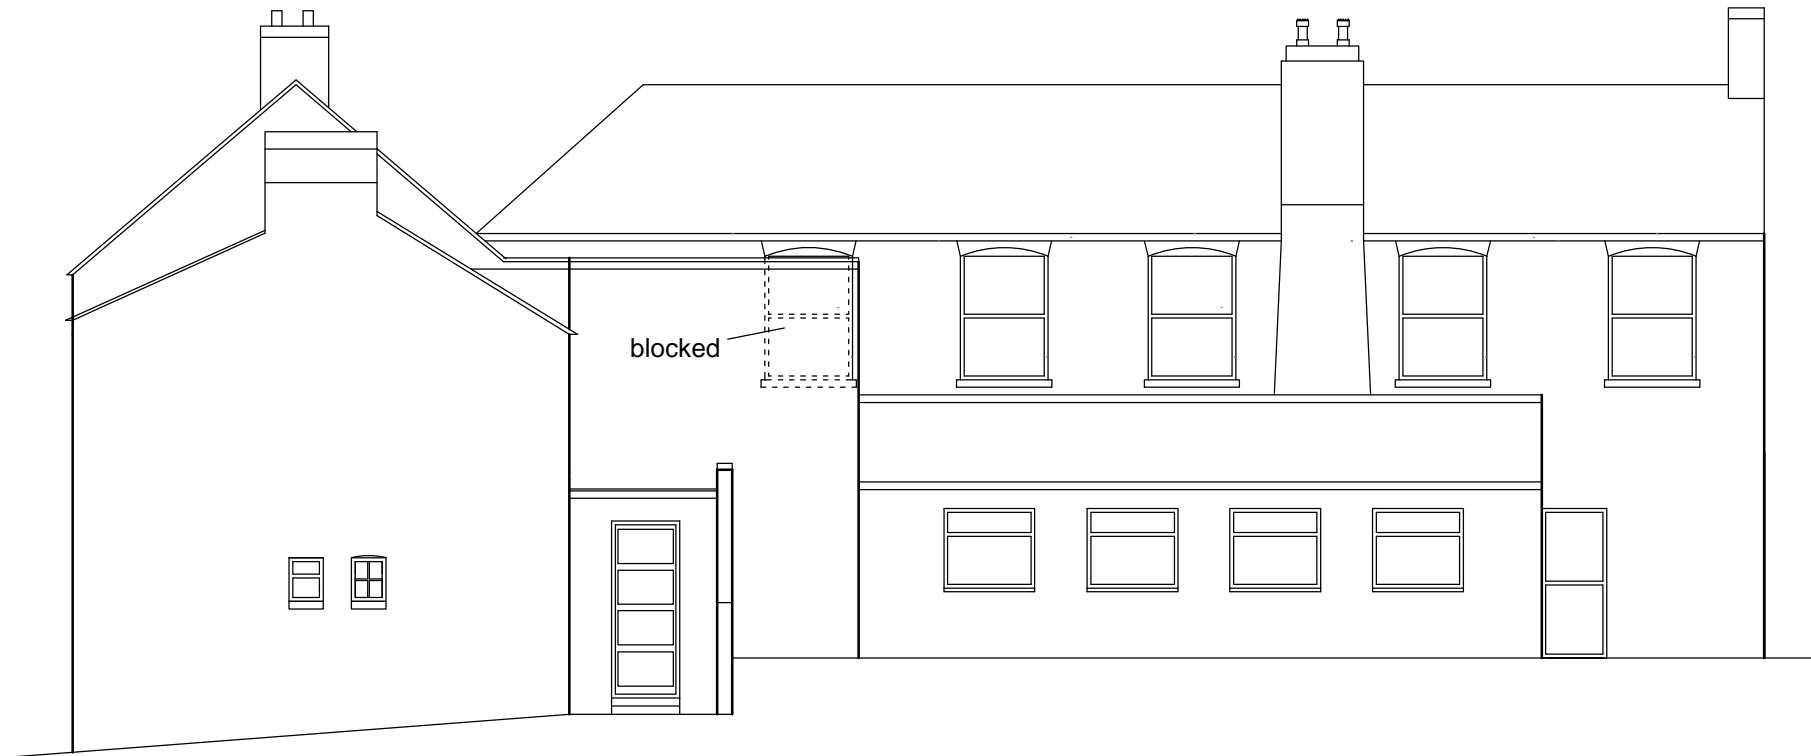
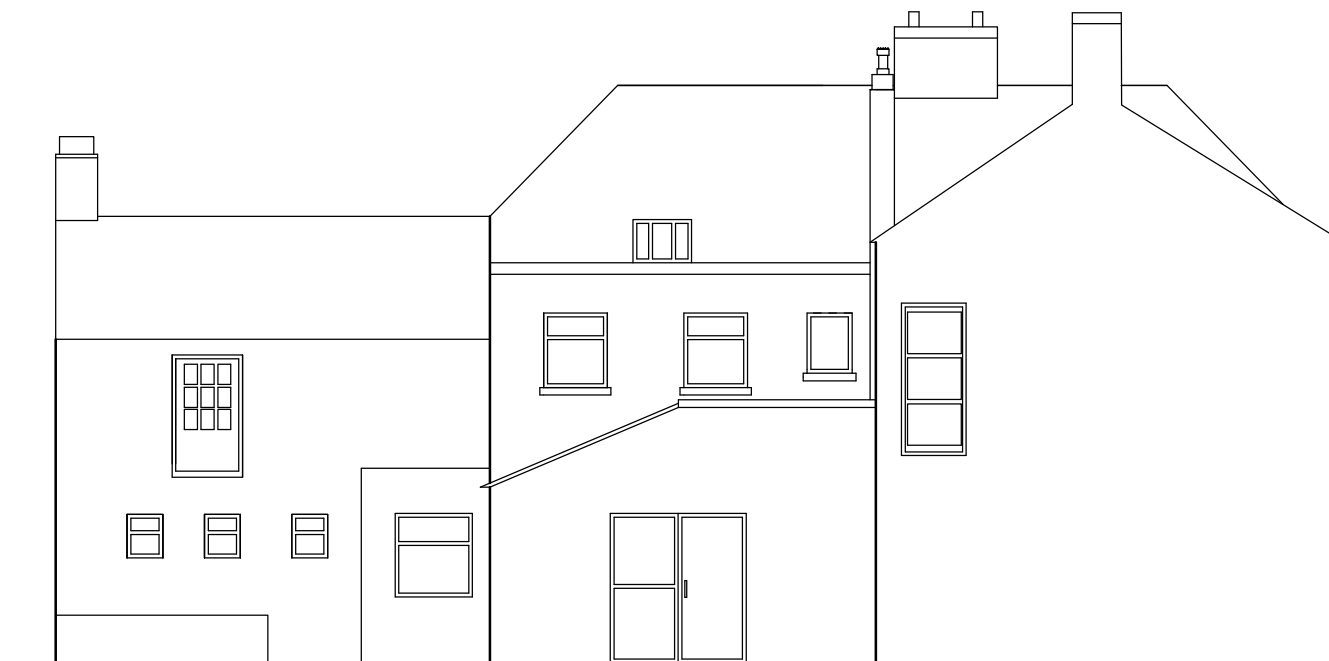
Fig. No: 5	Report No: MK017/15
------------	---------------------

The Inn comprises a complex of buildings (Figs. 2-5) that can be split into five units reflecting the original building (Unit 1) and four extensions (Units 2-5).

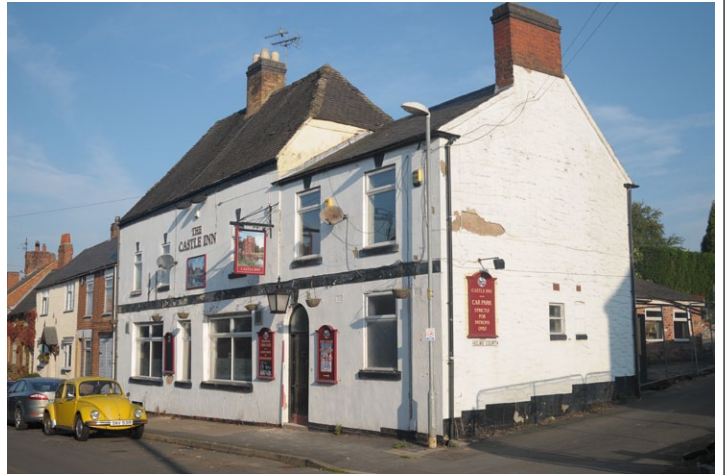
Fig. 8 - Front elevation of The Castle Inn, looking north-west

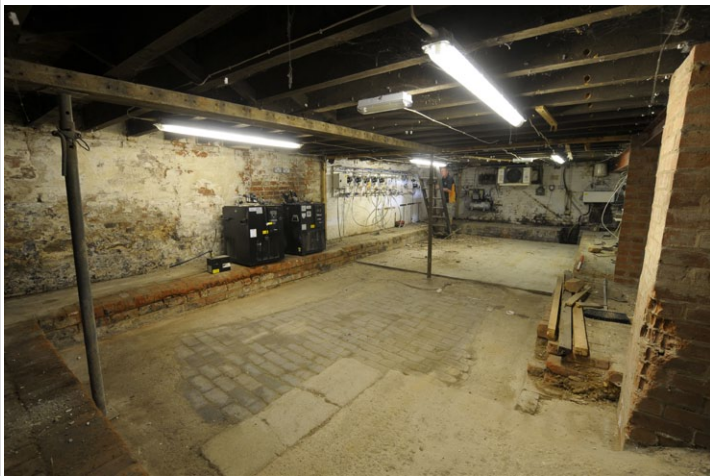
The original brickwork of the building can be seen on the west side of the cellar. This is bonded to limestone wall footings which are exposed up to 1m above the cellar floor (Fig. 11). The height of footings suggests that the cellar was part of the original design. Later alterations include a chute leading out under the pavement and a brick plinth around the cellar walls for beer barrels. The original stone footings have been cut back for the chute and it is lined in grey brick with bull-faced corner bricks of apparent late 18th or early 19th century date. The plinth is red brick and of a similar date. It measures 0.3m high and 0.7-0.8m wide and would have been a ledge for the beer barrels. On the west half of the cellar the plinth is slightly wider suggesting the plinth on the east is of a different date. The eastern plinth is built with bricks of a lighter hue which appear to be less weathered/damaged and therefore are probably later. The barrel shelf to the east is also narrower and the cut-in may indicate a former east wall of the cellar which is now removed. The floor of the west half of the cellar is grey brick with patches of concrete. The east half of the cellar has white painted brick walls and a modern concrete floor. Two pairs of modern brick pillars are present along the south wall. The earlier and smaller pair support the steel reinforcing beams for the chimney stack on the 1st floor. The second pair support two modern I-beams inserted along the south-wall of the building to reinforce the ground floor joists which appear to have slipped. The ground floor joists have diagonal bracing are of circular-sawn pine, probably dating to the 1930s. A single joist at the west end is painted and clearly earlier, though still circular-sawn. The floor joists have rotted away in the north-east corner through water percolation from the damp bar area. The original wall on the west half of the cellar has been patched with modern and 19th century brick in places. Some of these patches may relate to the removal of the original chimney stack.

Fig. 9 - The Cellar, Unit 1, looking north-east

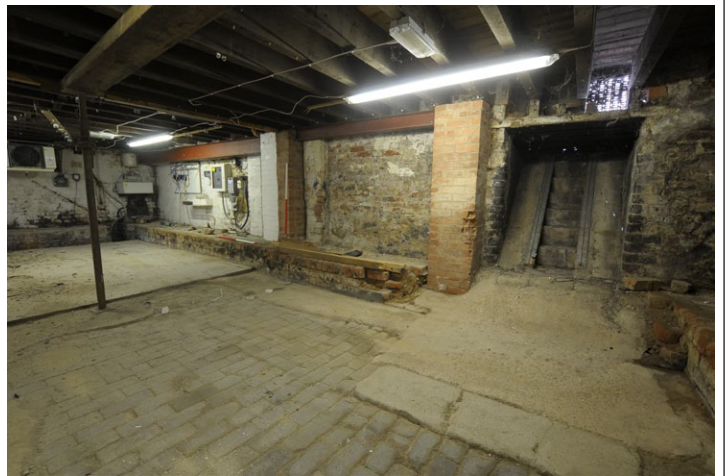
Fig. 10 - The Cellar, Unit 1, looking south-east

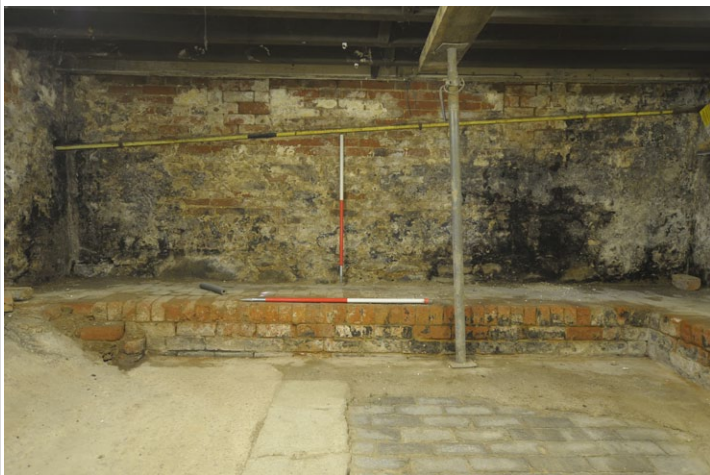
In the late 18th or early 19th century the cellar was converted for storage of beer barrels. The chute projecting out into the street and the brick plinth around the west side of the cellar are clearly later than the original fabric of the building. At this stage the chimney stack had not been modified and would have reached into the cellar. It is likely that at this stage the cellar space only comprised a small area on the west side of the stack. The more recent appearance of the east side of the cellar and the difference in plinth width suggests that this side was created after the chimney stack was removed.

Fig. 11 - West elevation of Cellar, Unit 1, looking west

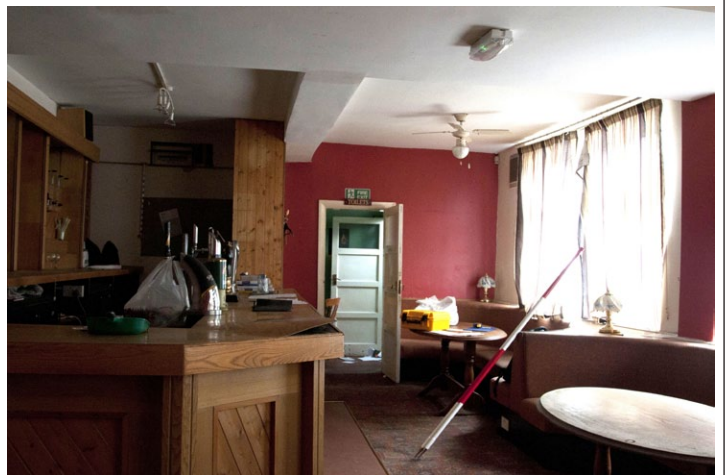
The ground floor comprises a single open space created by the removal of the original chimney stack. This space is lit by three modern UPVC windows and two doorways lead into Units 2 and 3. A hole in the floor in the north-east corner leads down to the cellar and was formally behind a bar. A serving hatch in the east wall (now blocked) leads through to Unit 2. The

Fig. 12 - Photo of east end of ground floor, Unit 1, looking east

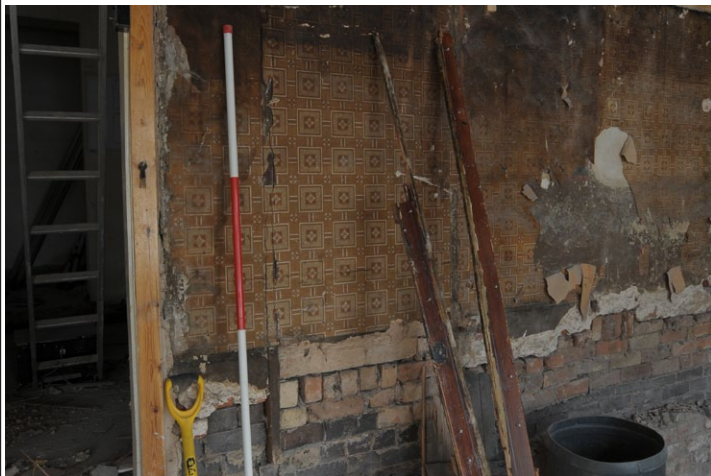
floorboards are narrow and heavily worn but they are probably no earlier than the joists which may well be 1930s. The brickwork was only exposed on the lower half of the east side of the north wall. This wall has been modified in the 20th century or even more recently. A variety of bricks including some of the original ones and a block of limestone (probably from the building footings) have been re-used. Some of these alterations probably date to the re-laying of the floor. A wooden frame next to the current doorway is likely to be a blocked narrow doorway (Fig. 15). All decoration and fittings are modern. The ceiling (removed during the survey) was white painted MDF fixed to laths. The original pit sawn and adze trimmed hardwood beams for the first floor (Figs. 16, 17) were enclosed in varnished pine cladding. Removal of the ceiling exposed the reinforced concrete laid between steel beams to support the chimney stack (fig. 18). Original floor beams are connected to the steel beams using large hand-made iron straps and bolts.

Fig. 15 - Shot of blocked doorway in north wall, ground floor, Unit 1, looking north

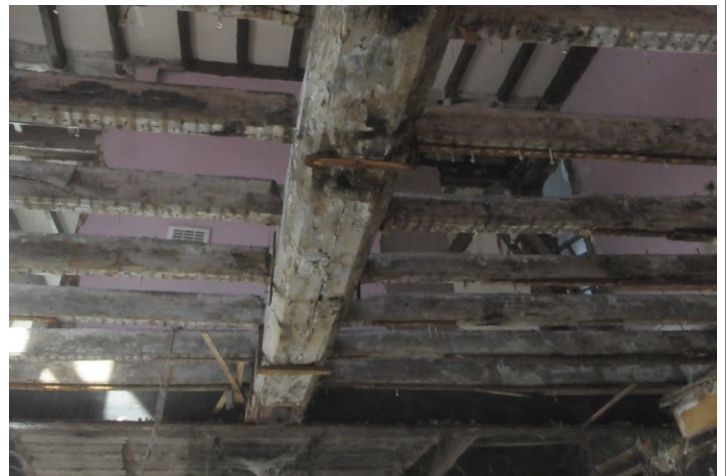
Fig. 16 - Shot of original beam in ceiling, ground floor (east side) Unit 1, looking west

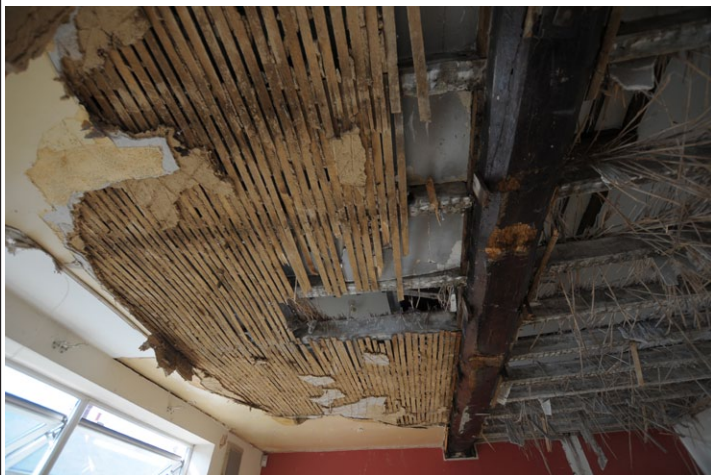
Fig. 17 - Shot of original beam in ceiling, ground floor (west side) Unit 1, looking west

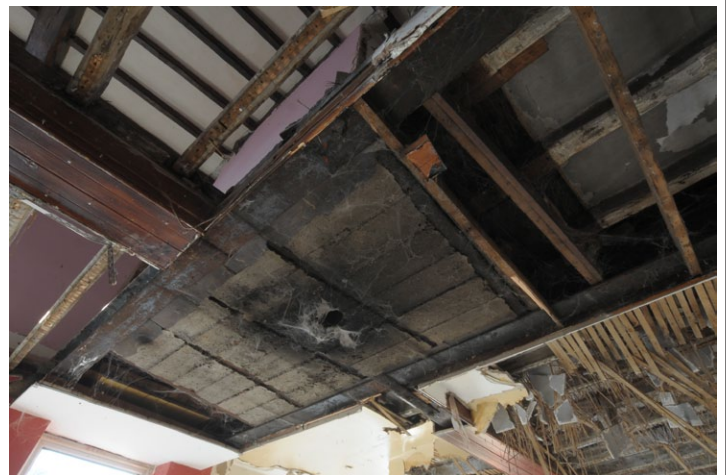
Later twentieth century alterations to the pub included inserting steel beams along the front wall of the original Inn and replacing most of the windows in the Units. Unit 5 was built to create a large ground floor dining area in the 1980s or 1990s.

Fig. 18 - Photo of concrete and steel beams holding up chimney above ground floor, Unit 1

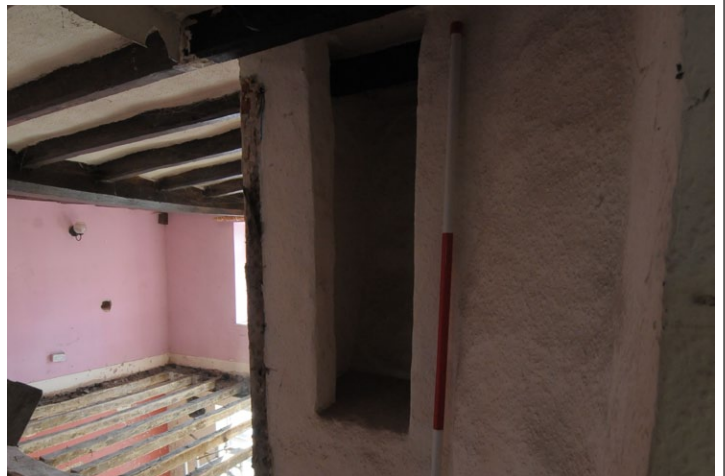
The floor comprises two rooms separated by a chimney stack (Figs. 19-21). The walls of both rooms have modern paint and fittings. The fireplace in the west room is partly blocked and the fireplace in the east room completely blocked. A short beam supporting the fireplace in the attic is visible in the west room. Two small spaces have been created on either side of the chimney stack. The space to the north is essentially an entrance lobby or landing with a recess in the chimney stack (Fig. 22). The space on the south side of the chimney is painted grey and may have been a WC or closet. The structure of the floors in both rooms were exposed. Original beams running east-west are made from pit-sawn hardwood timber and have chamfered undersides (originally they would have been visible on the ground floor). Pit-sawn hardwood floor joists (Fig. 23) fit into angled slots in the beams and their other ends are built into the brick walls. Long hand-wrought square nails are visible on the upper side of the joists (Fig. 24). These would have fixed floorboards. Reeds had been laid down above the joists and paper stuffed into the remaining spaces in the beam slots (Fig. 25). The reeds were fixed down with short laths nailed the upper sides of the joists (Fig. 26). Concrete had been laid on the reeds forming a solid though imperfectly level floor. This floor extended over the lobby area above the steel beams supporting the chimney stack. During the survey the paper stuffed into the slots for the joists was examined and revealed newspaper dating to 1897 (Fig. 27). This provides a terminus post quem for the concrete/reed floor and removal of the lower half of the chimney stack.

Fig. 22 - Recess in chimney stack, 1st floor, Unit 1, looking south-east

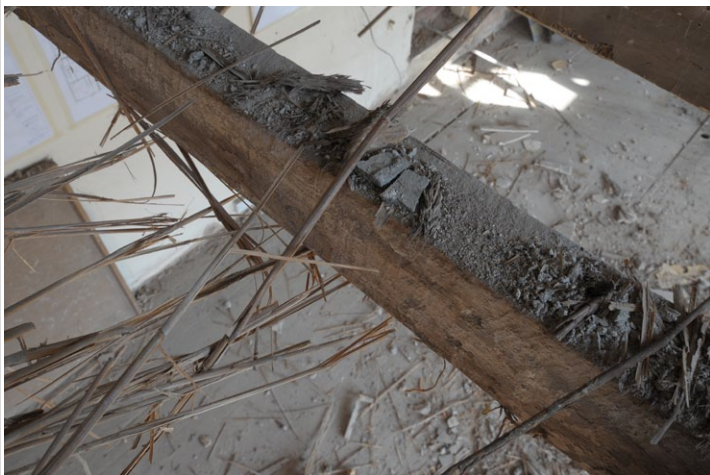
Fig. 23 - Shot of pit sawn floor joist, west room, 1st floor, Unit 1, looking north-east

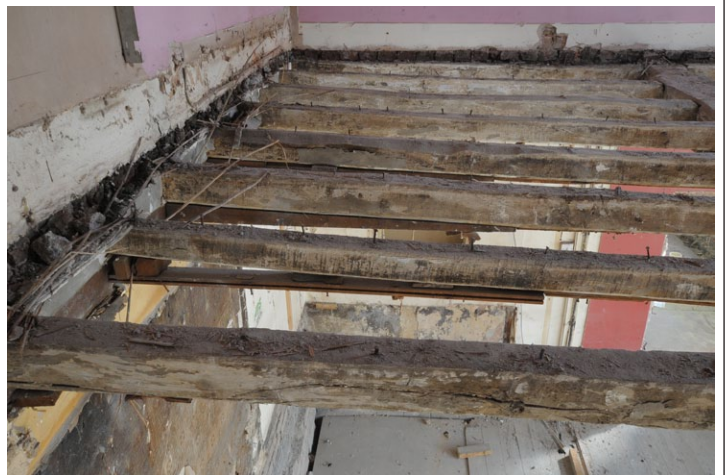
Fig. 24 - Squared floorboard nails in joists, east room, 1st floor, Unit 1, looking east

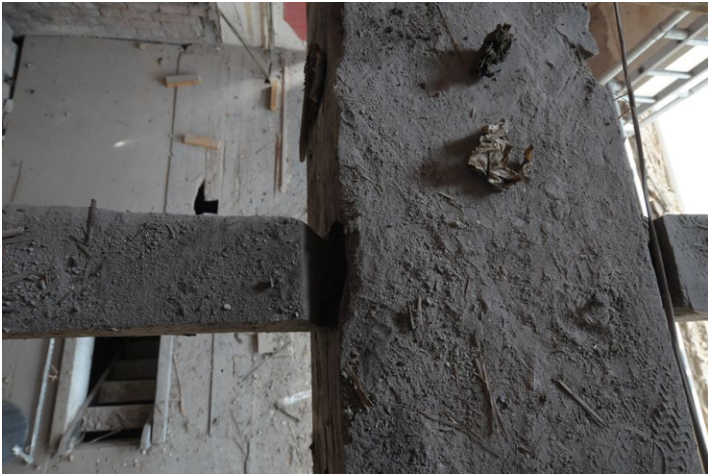
Fig. 25 - Close-up of slot in beam for joist and newspaper inserted into remaining void, east room, 1st floor, Unit 1, looking east

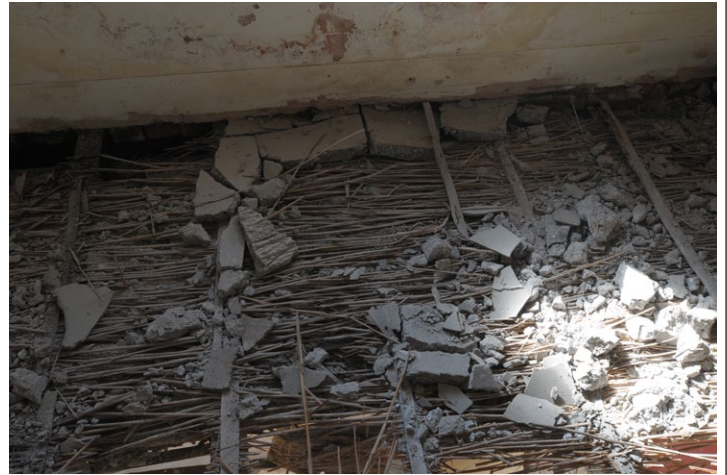
Fig. 26 - Close up of reed and concrete floor, west room, 1st floor, Unit 1, looking south

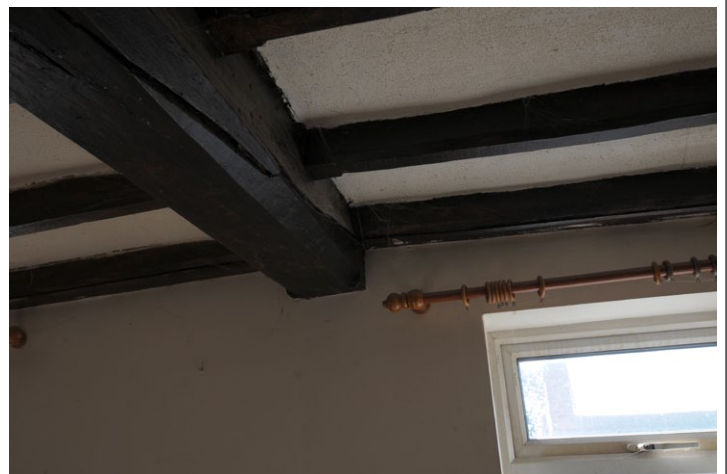
Fig. 30 - Shot of beam supporting attic floor, west room, 1st floor, Unit 1, looking south-east

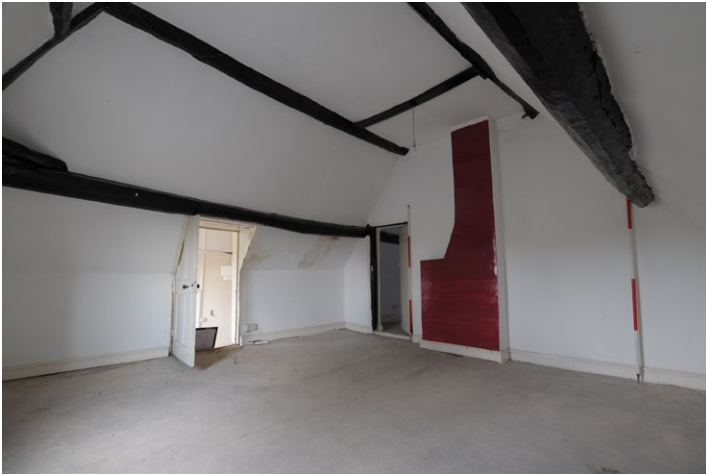
This area was viewed though the space is not going to be modified. The attic is accessed via a small door leading from the west side of Unit 3 into the west room. The space is divided into two rooms (Figs. 28 and 29) by the chimney stack and a partition wall. Access between the rooms is via a door in the north half of the partition. The floors of the two attic rooms are essentially the same as the 1st floor though the beams run in the opposite direction. Large pit-sawn hardwood beams with chamfered undersides run north-south across the centre of the floors (Fig. 30). Pit-sawn floor joists run east-west connected to the outer walls of the building and hidden beams spanning the gap between the north and south walls and the chimney stack. The floor is uneven concrete and is likely to have been laid on reeds. The fireplaces in both rooms are blocked (Figs. 31 and 32). The western room is lit by a small window below the hip which has been replaced. A corresponding window was located in the eastern room but was blocked when Unit 2 was added (Fig. 33). A more recent skylight now lights this room dating the late 19th or early 20th century. The rooms are both painted white with roof purlins and corner ties painted black. In the east room the hip rafters are also showing. The roof timbers are made from hewn, adze-trimmed hardwood. Purlins are joined at the partition walls with pegged

Fig. 31 - Shot showing fireplace in west room, 2nd floor (attic), Unit 1, looking north-east

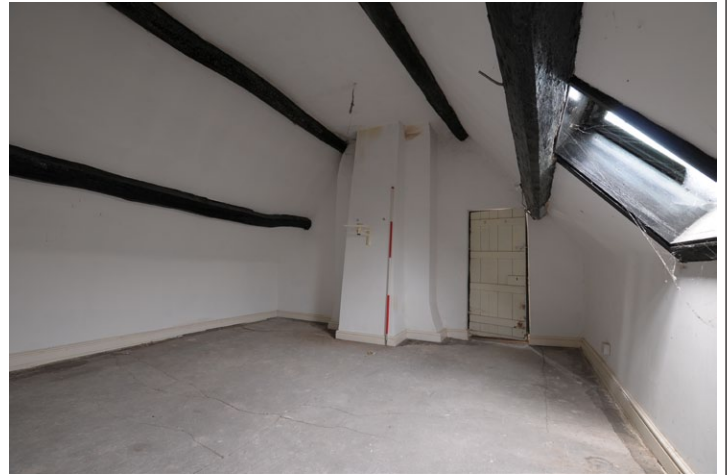
splayed scarf joints (Fig. 34). Some of the corner ties have open peg holes suggesting they have been re-used (Fig. 32).

Fig. 32 - Shot showing fireplace in east room, 2nd floor (attic), Unit 1, looking north-east

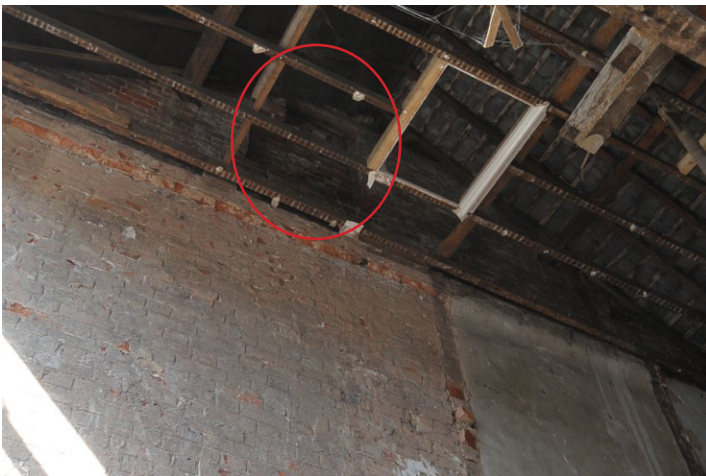
Fig. 33 - Blocked window at east end of Unit 1 attic, shot taken from Unit 2, view north-west

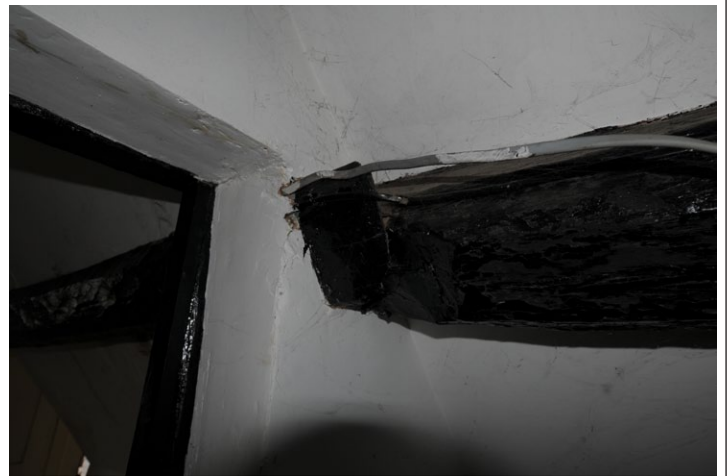
Fig. 34 - Splayed scarf joint for hewn purlins on north pitch of roof, 2nd floor (attic), Unit 1, looking north-west

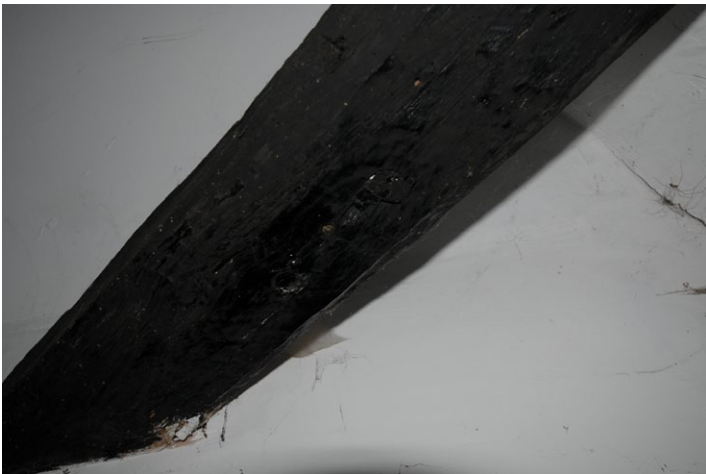
Fig. 35 - Shot of unused pegged holes, corner tie in south-east corner of east room, 2nd floor (attic), Unit 1, looking east

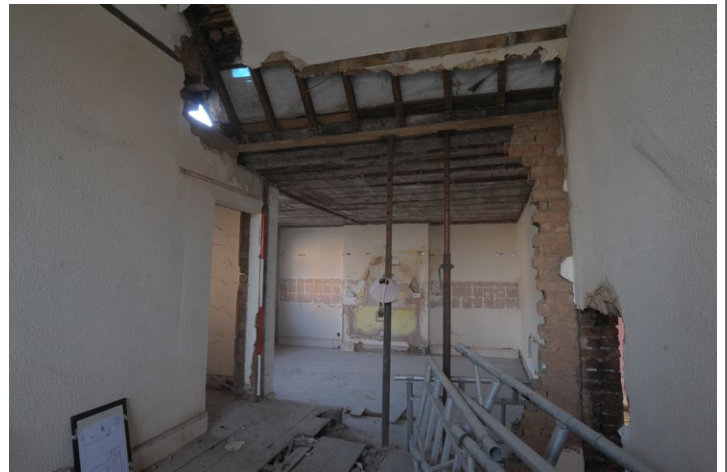
This extension is a flat-roofed structure built north of Unit 1 in-between Units 2 and 4 (Figs. 38-40). On the ground floor the north wall of the extension has been opened to provide access to Unit 5. On the first floor there are three windows facing north, all replaced recently. The unit was built against the southern end of Unit 4 and blocks one of its windows. The extension is built of red brick and the roof is reinforced concrete (Fig. 41).

Fig. 41 - Internal view of upper floor of Unit 3 after stripping and wall demolition, looking east

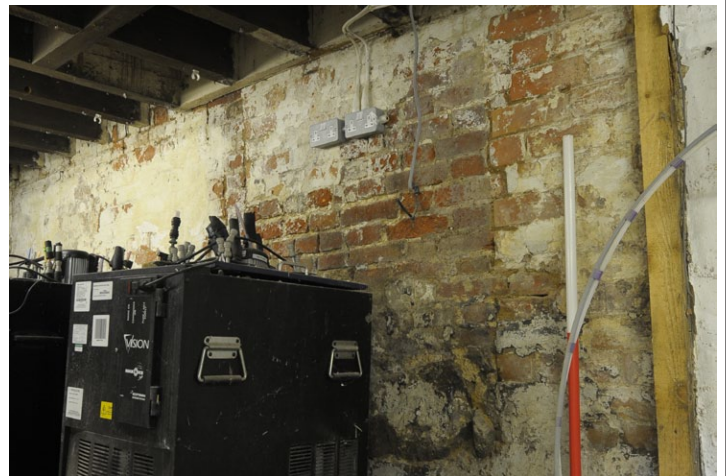
Fig. 49 - Original bricks above stone foundations, Cellar, Unit 1, looking north-west. Patching of walls in later brick can be seen on either side
