**66 Buccleuch Street,
Edinburgh
Odeon Cinema Fly Tower,
Archaeological Watching Brief**

Report No 3263

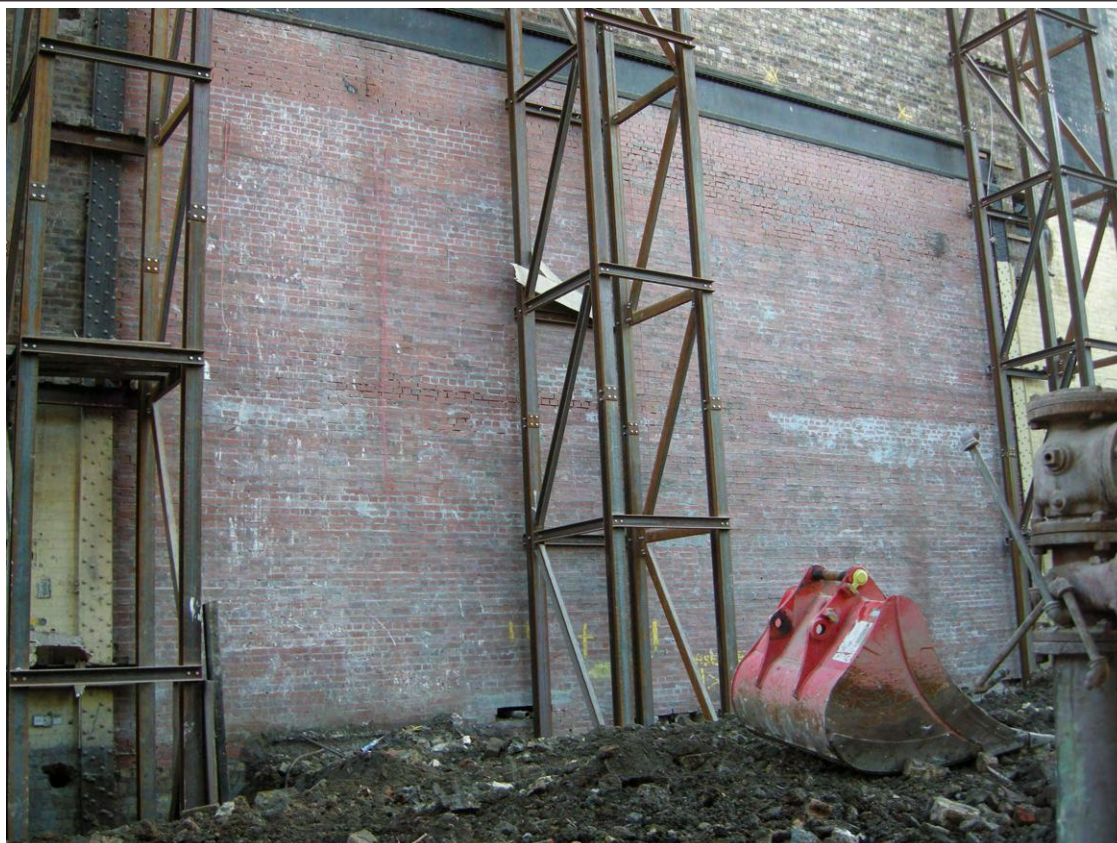
Plate 1 - Exposed wall of the Odeon Cinema with modern infilling between the 1930 rivetted steel frame

3.1 Exposed wall of Odeon Cinema (Plate 1)

During the initial building survey of the interior of the fly tower (Cressey & Mitchell 2014) the partition wall between the fly tower and the Odeon Cinema was found to contain a large horizontal composite bessumer beam supported by a stanchion at each end. Later building recording during the demolition of the fly tower roof (Cressey 2014) confirmed the presence of a series of pulley wheels that hoisted the auditorium curtains. Owing to the constraints of recording this large wall whilst the fly tower was still standing it was decided to photograph it once the tower had been demolished. As the wall incorporating the 1930s steel frame was now unsupported it was braced by purpose-built steel buttresses. Plate 1 shows the full extent of the 1930s steel framework.

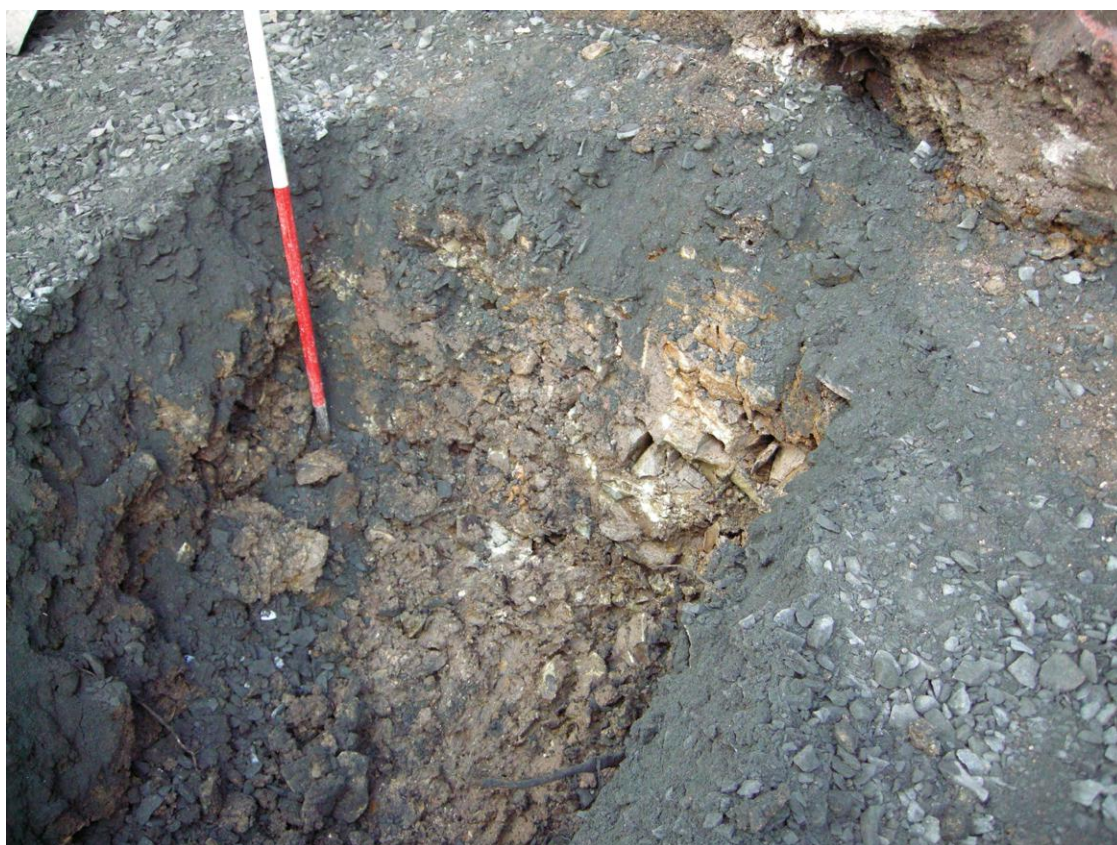
Plate 2 - Test Pit 1 and exposed sandstone bedrock close to ground level

Two engineer's test-pits were excavated between the footprint of the demolished queue shelter and the gable wall of a tenement building. Test pit 1 (Plate 2) revealed a deposit of mixed rubble above natural yellow sandstone bedrock at 0.4m below the present ground level. Test pit 2 (Plate 3) revealed a deposit of mixed clay over natural yellow clay at a depth of 0.9m below the present ground level.

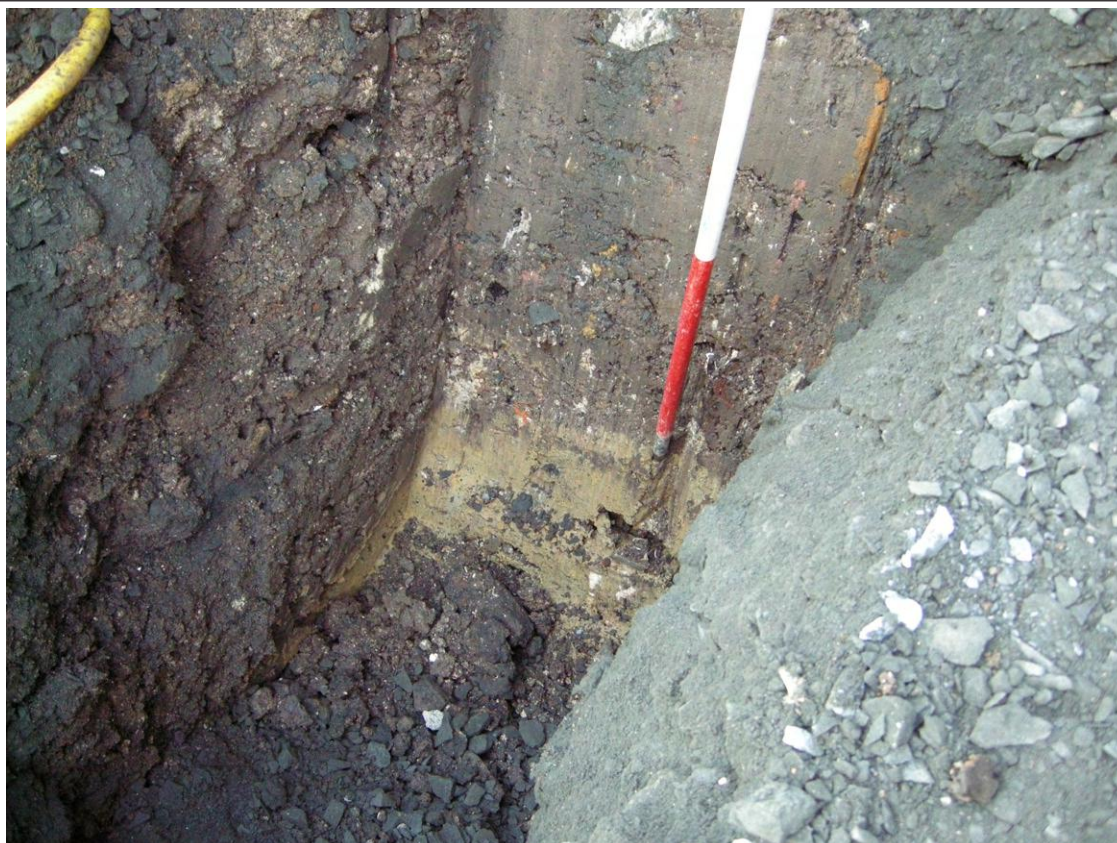
Plate 3 - Test Pit 2 showing the depth of natural clay approximately 0.9m below ground level

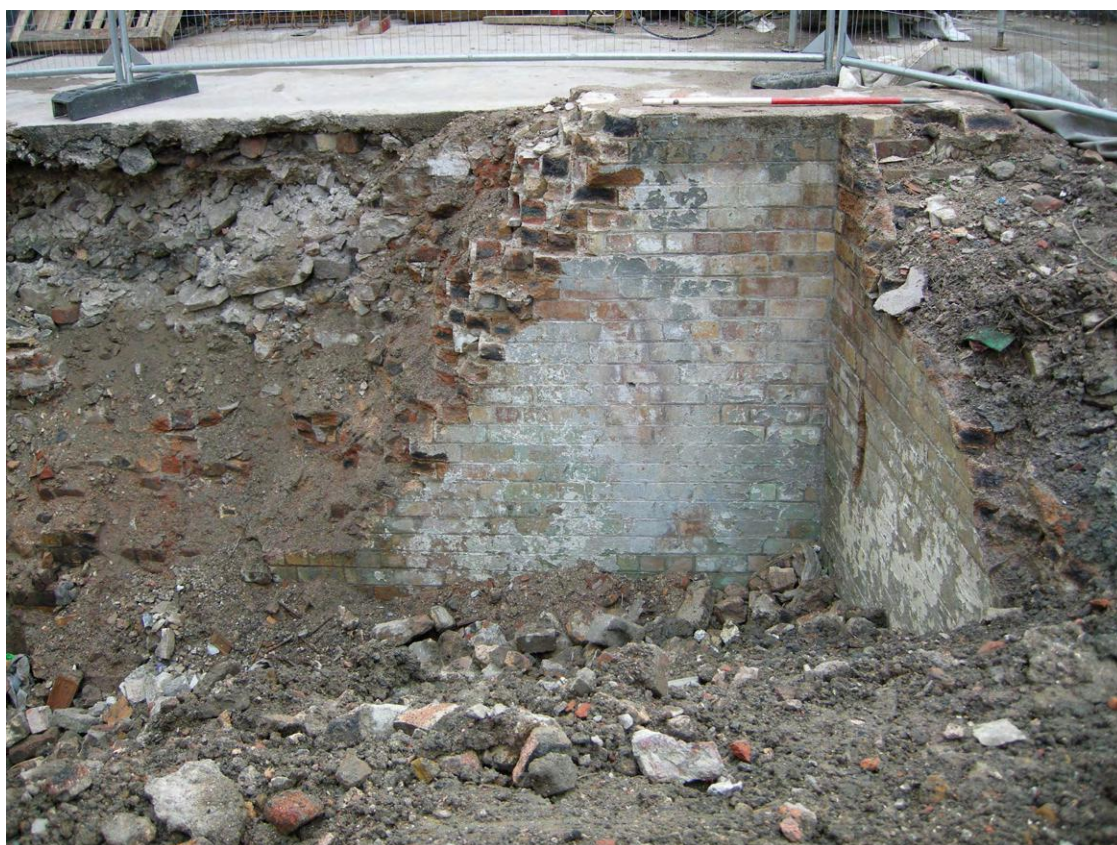
Plate 4 - Area 3 showing the depth of the fly tower basement walls and made ground behind

Area 3 comprised the basement foundation wall (Plate 4) which was c.3.5m high and 0.6m wide, and built of five courses of brick. No construction trench was present, but immediately behind the foundation, an assortment of concrete, brick and rubble back-fill capped with thick concrete was found to be present.
