**Aikengall II Community Windfarm
East Lothian
(Planning Ref. 09/00001/SGC)**

Archaeological Watching Brief

Report No. 3281

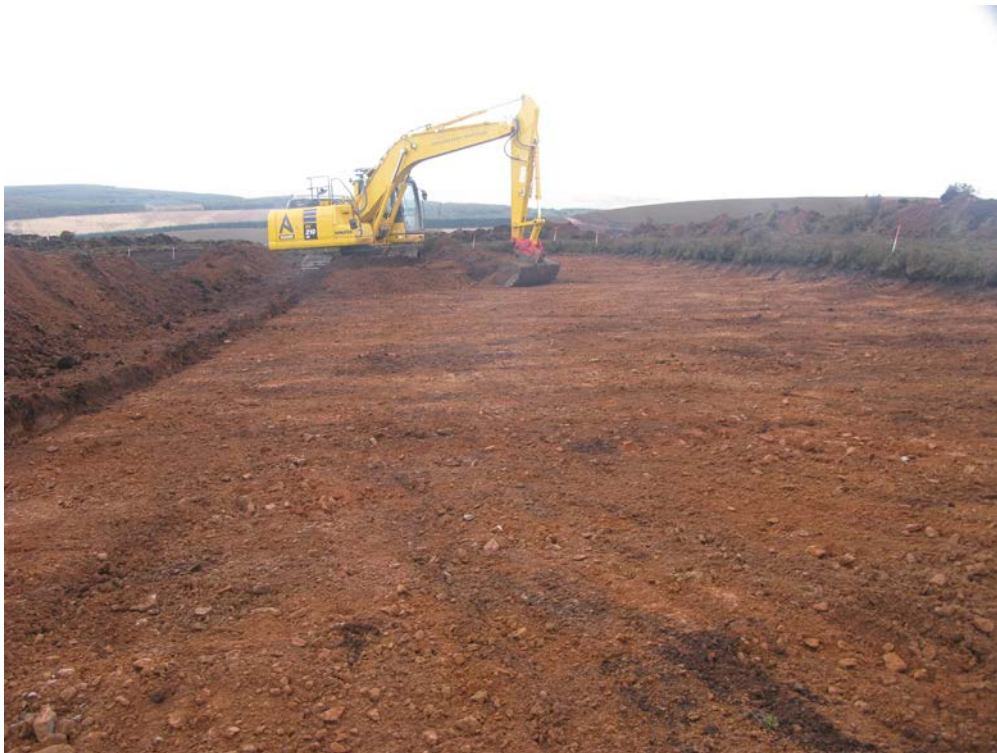
Fig. 6 Final topsoil and subsoil stripping at Turbine10

Topsoil (**001**) across the development site is firm black peaty material varying from 0.1 to 0.2m in depth (Figs 3 to 6), which overlay a dark grey/brown gravel/silt subsoil (**002**), which contained occasional sub rounded stones up to 0.1m in diameter. The subsoil (**002**) directly overlay the natural substrate (**003**) which varied from orange to brown/pink gravelly silts and clays across the site (Figs 3 to 6). No archaeological remains and no traces of a crashed aircraft were uncovered during the watching brief.
