**Edinburgh Road
Biggar
South Lanarkshire
Archaeological Evaluation**

**Data Structure Report
No. 3158**

Author	Graeme Carruthers MA MifA
Illustrator	Graeme Carruthers MA MifA
Editor	Bruce Glendinning BSc PGDip MifA
Commissioned by	Story Homes
Date issued	May 2014
Version	0
Planning Application No	CL/12/0358
Grid Ref	NT 04272 38157

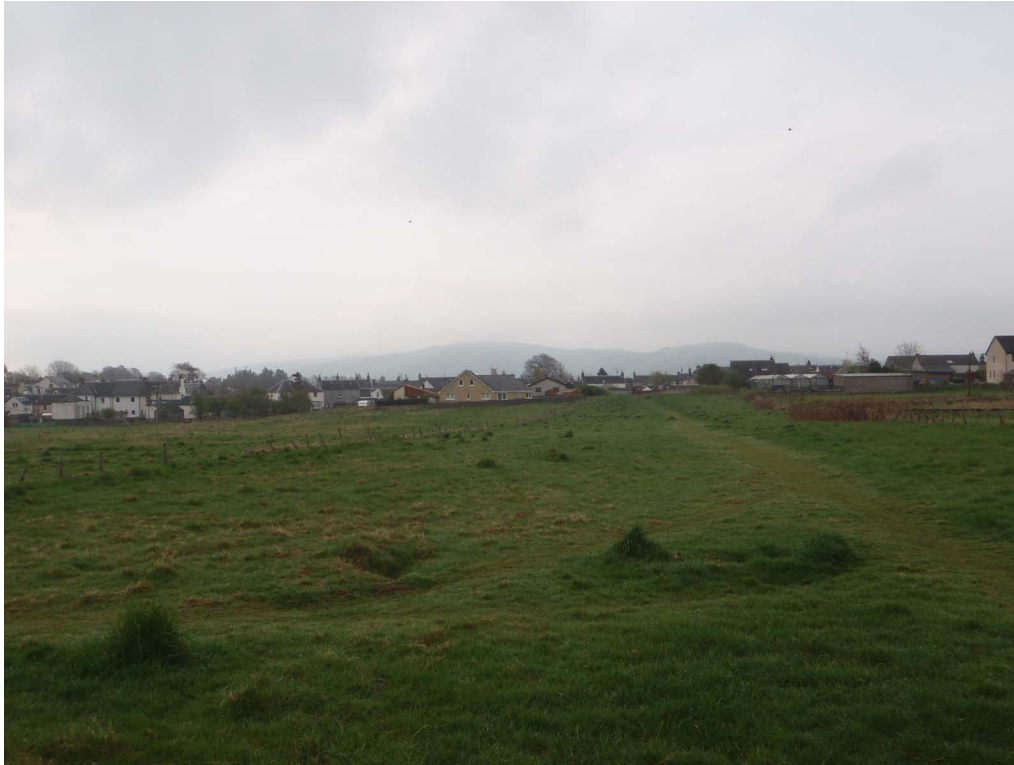
Fig. 6 - Photograph of site prior to evaluation works looking south

A planning application (Ref. No. CL/12/0358) has been approved for the redevelopment of former nursery land into housing (Fig. 6). The planning approval was subject to an archaeological condition that required an archaeological evaluation. Ordnance Survey map editions dating to 1864 (Fig. 2) and 1896, (Fig. 3) show the land as open farmland. Subsequent OS map editions in 1909, (Fig. 4) and 1950 (Fig. 5) record the parcelling of the land and the development of the nurseries in the 20th century.

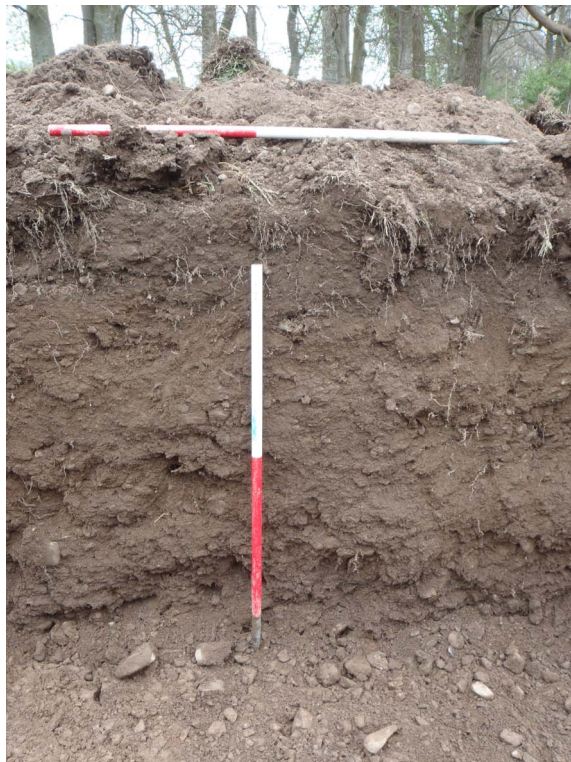
Fig. 7- West facing section of Tr. 2 showing depth of soil

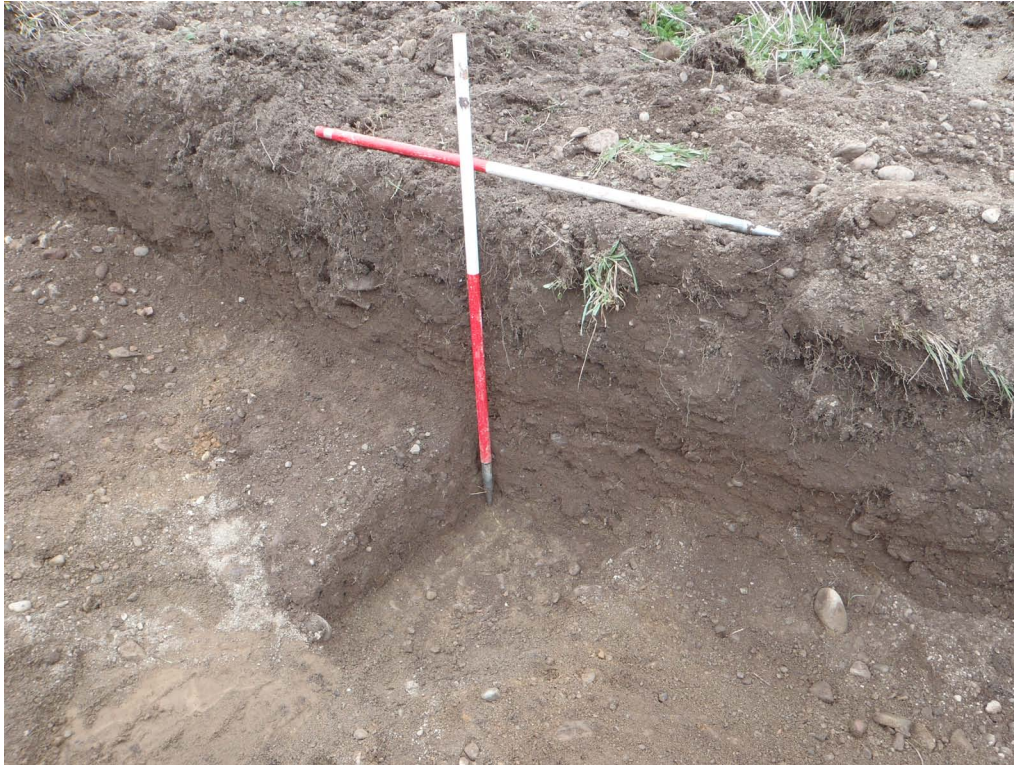
Only a single feature was identified within the trenches (Fig. 8). A small, 1.1m, sub circular pit like feature, **004**, was uncovered in Tr. 4. It was shallow sided and had a flat base. The fill, **005**, was the same as the overlying subsoil **002** and was possibly the remains of a stone hole. A number of medium to large irregular stones were removed from within the top of **003** in various trenches during excavation, (Fig. 11). The void created instantly filled with soils and were very similar to the appearance of **004/005**

Fig. 8 - Feature 004 in Tr. 4 from the south west

Only one feature was uncovered, a small pit **004** that was most likely a stone hole.

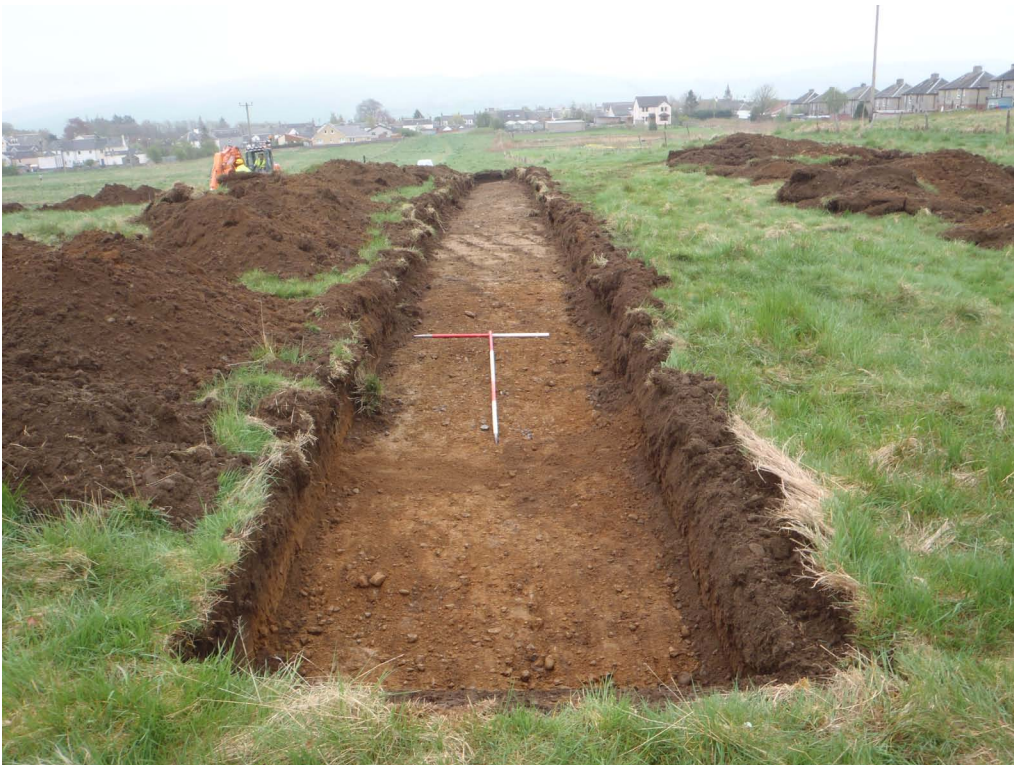
Fig. 9- Tr. 14 post excavation, looking south

Numbers in bold refer to contexts, a full list of which is contained in Appendix 2. A summary of the trenches excavated is contained in Appendix 3. General trench shots are provided on Figs. 9 & 10.

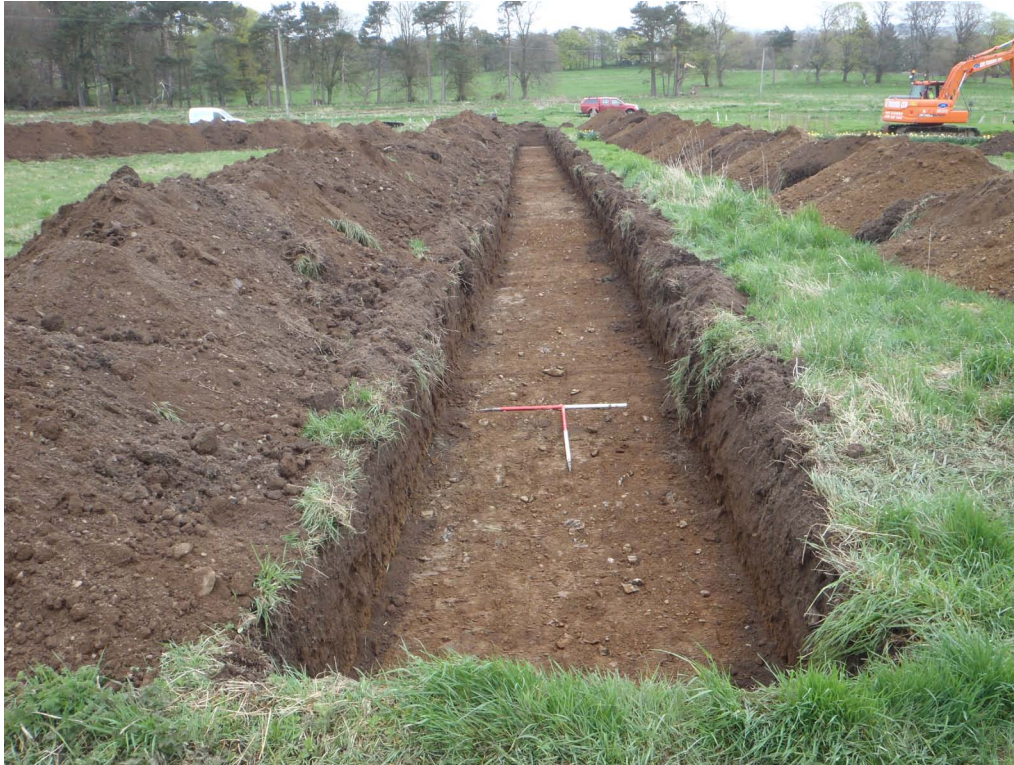
Fig. 10 - Tr. 22 post excavation, looking east

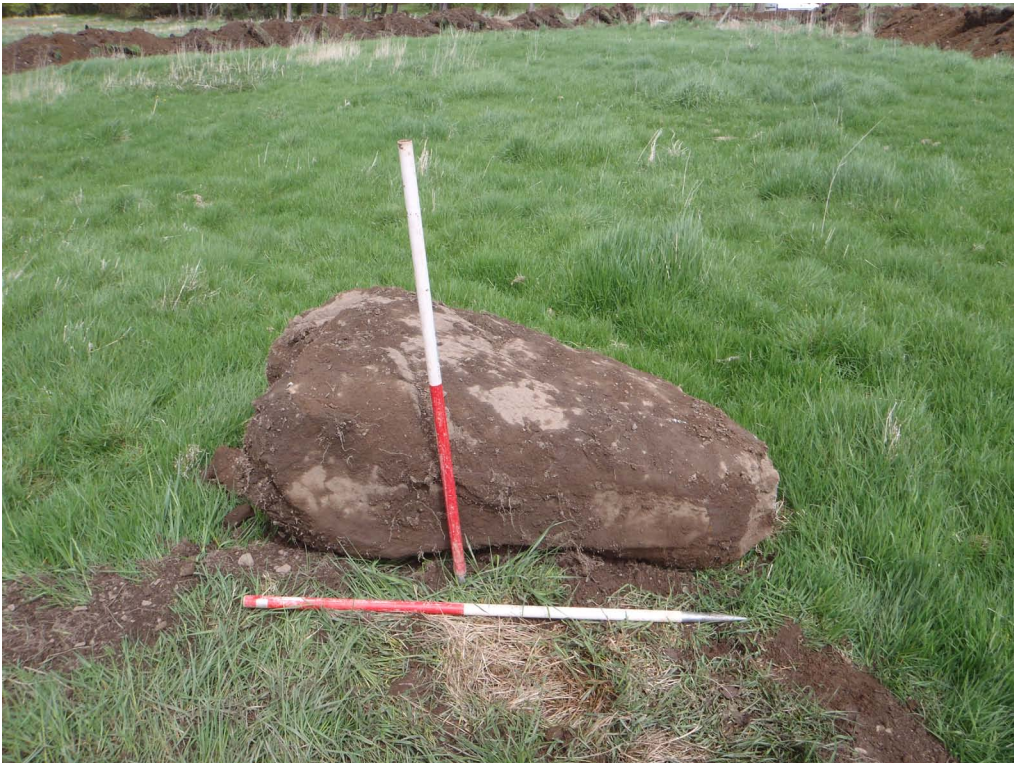
Fig. 11- Large stone from Tr. 44
