The Boathouse, Pitcastle Estate, Strathtay, Perth & Kinross

Historic Building Survey

Report No. 3296

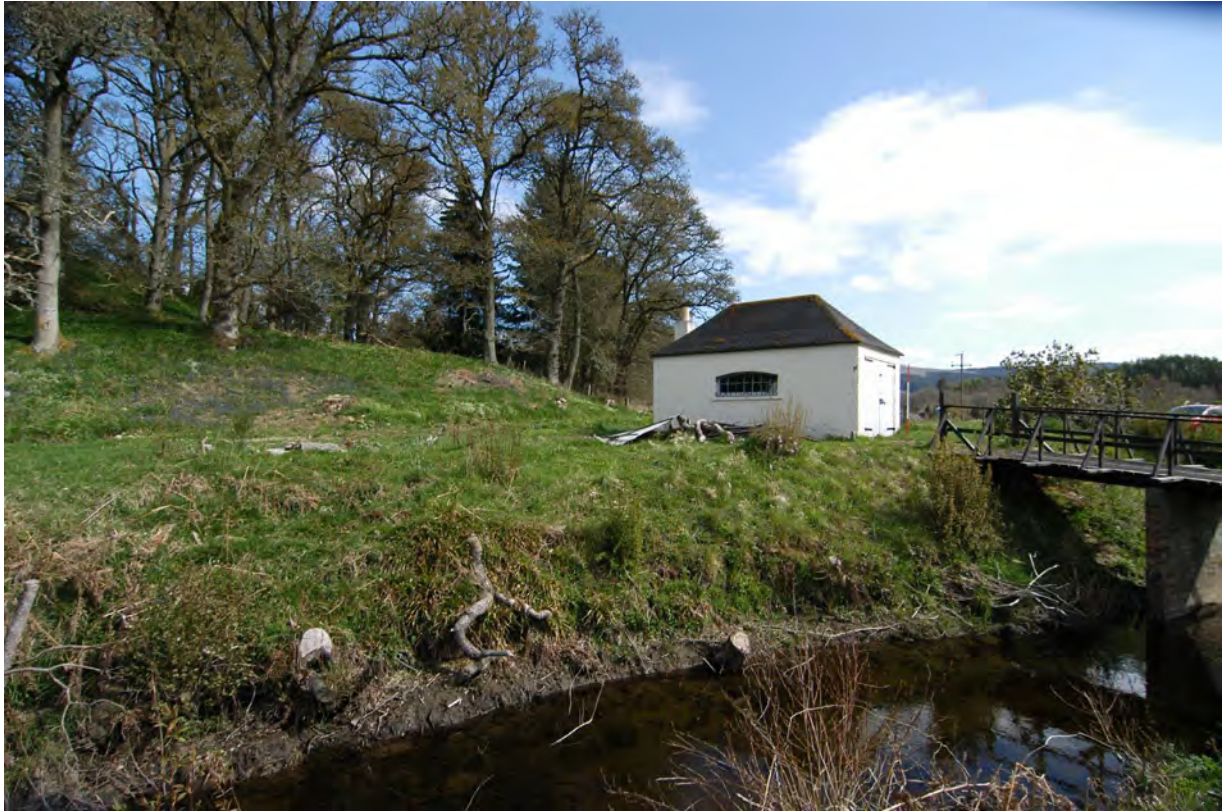
Fig. 3 General view of the boathouse

The boathouse (otherwise known as the fishing hut) (Fig. 3) was situated on the north bank of the River Tay close to a large derelict headrace of a 1920s hydro-electric scheme¹. A small wooden bridge crossed the headrace allowing access to the 'boat pool'. A steep river terrace was present on the north side of the boathouse.

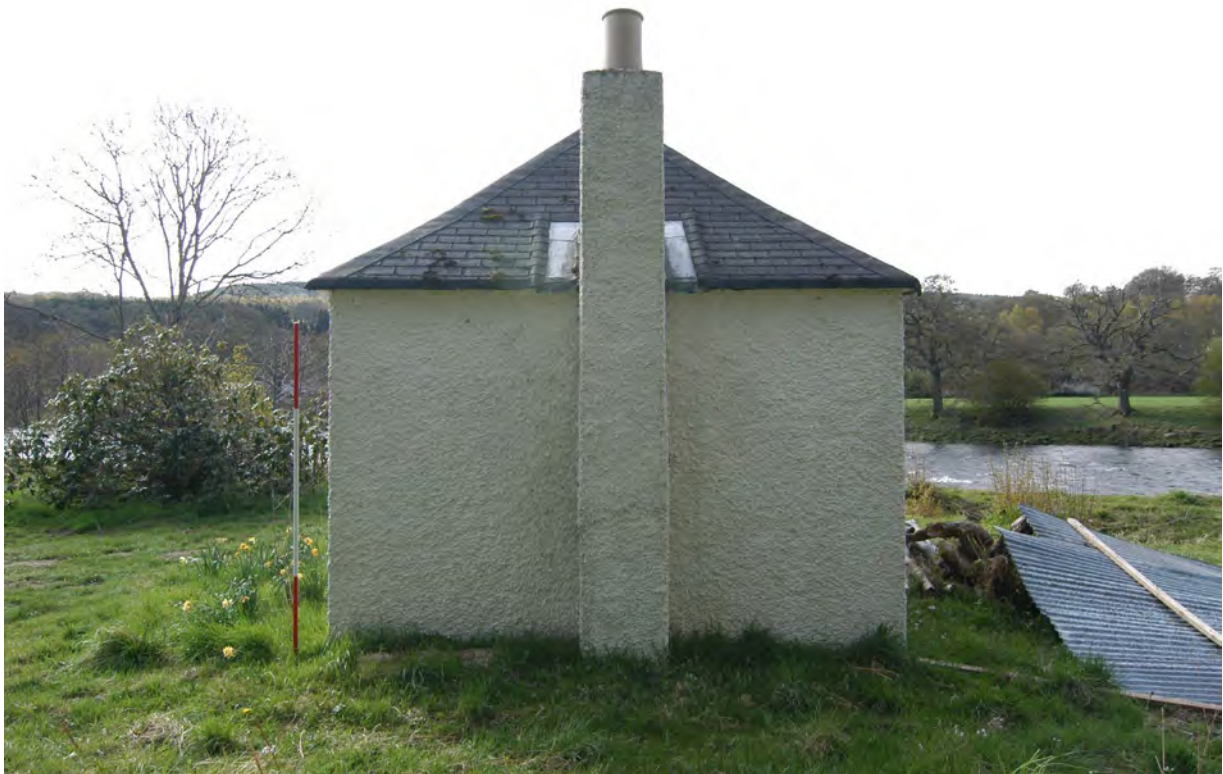
Fig. 4 North-facing elevation

North-facing gable (Fig. 4)

The only feature on the north-facing gable was a central chimney stack with a single terracotta chimney pot.

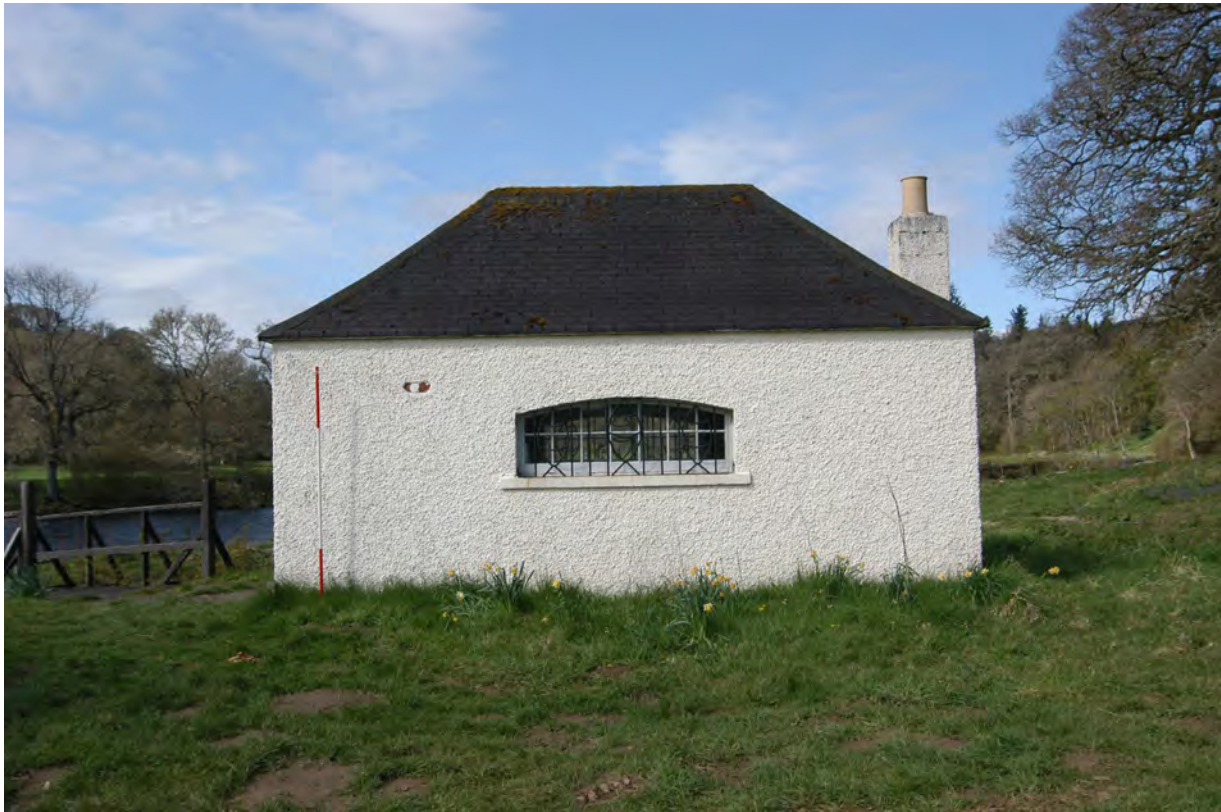
Fig. 5 East-facing elevation

East-facing elevation (Fig. 5)

The east-facing elevation contained a centrally placed single arched wooden window containing 14 panes. Fixed within the interior of the window opening was a set of black-painted steel window bars containing three equally spaced vertical fish motifs.

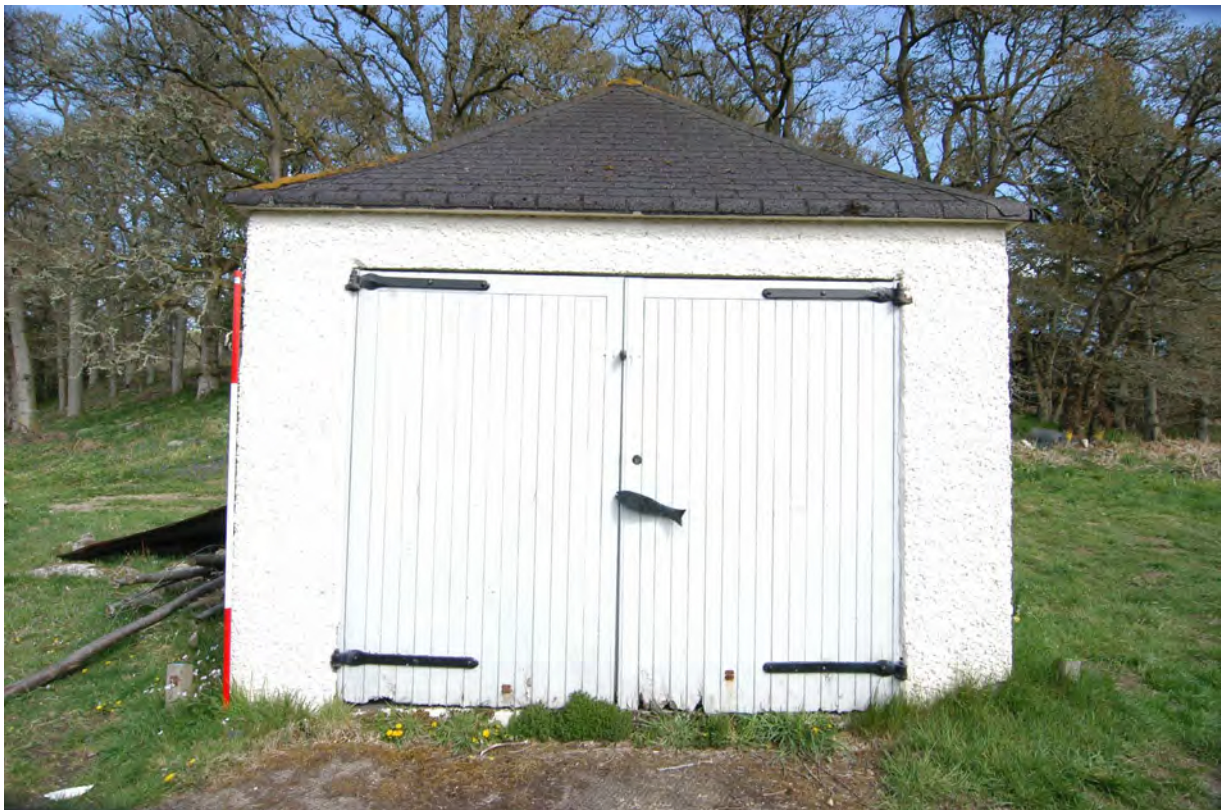
Fig. 6 South-facing elevation

South-facing elevation (Fig. 6)

The south-facing elevation contained a pair of grey-painted plank-built double-leaved doors suspended on steel door hangers. The doors measured 2m high and c.1.2m wide. The door handle was fashioned as a curved wrought-iron fish embellished with diamonds and rivets to represent the scales of a salmon.

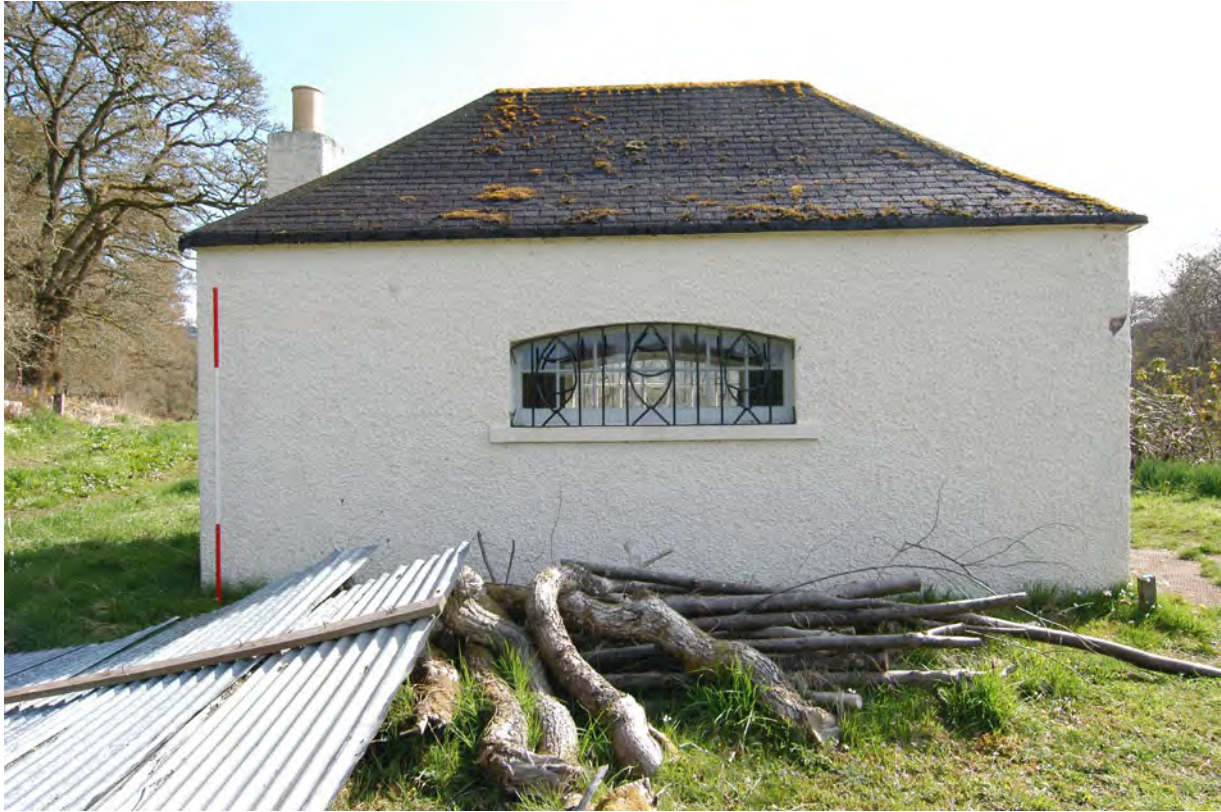
Fig. 7 West-facing elevation

West-facing elevation (Fig. 7)

The west-facing elevation mirrored the east-facing elevation.

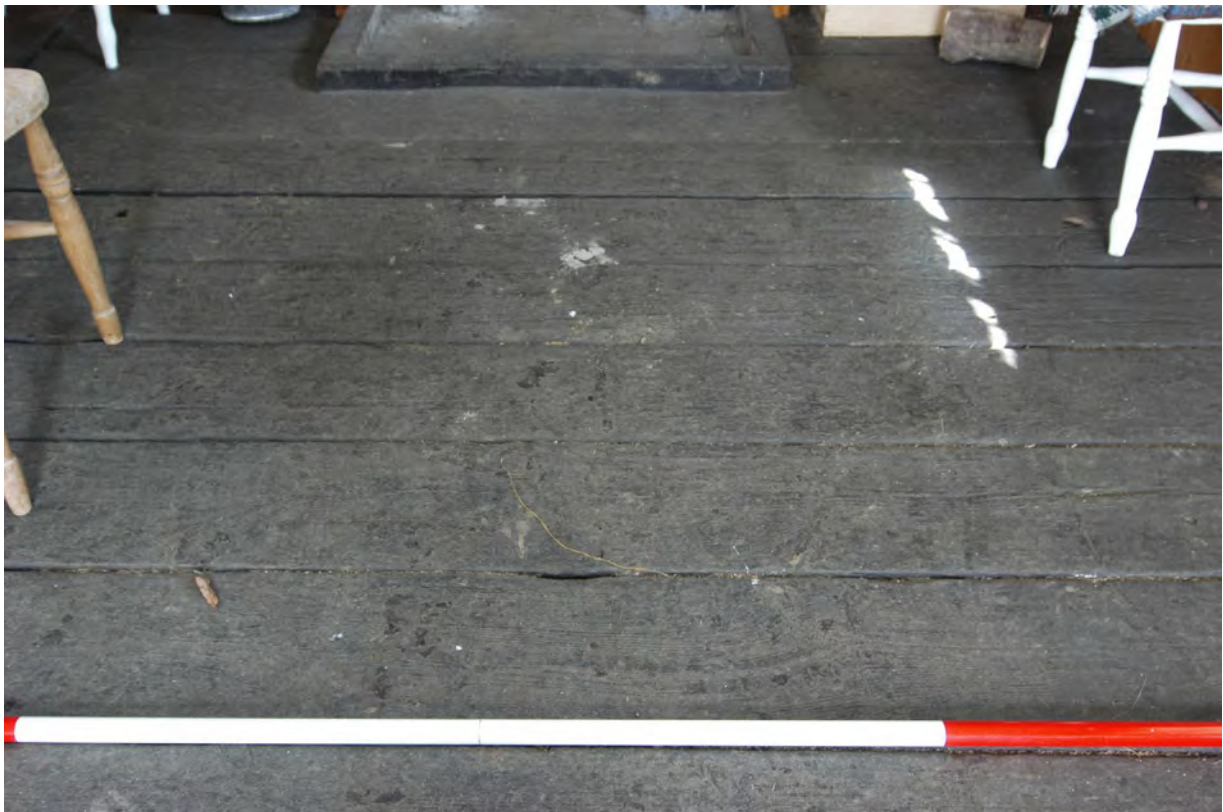
Fig. 10 Floor detail (reused railway sleepers)

Floor (Fig. 10)

The floor comprised 20 re-used railway sleepers laid on an east-west alignment.
