## **Lauriston Castle, Edinburgh, Water Main Installation: Archaeological Watching Brief**

**Report No. 3143**

Author	Gary Savory MA & Bruce Glendinning BSc Pg Dip MifA
Illustrator	Leeanne Whitelaw BSc MifA
Editor	Bruce Glendinning BSc PGDip MifA
Commissioned by	RPS
Date issued	April 2014
Version	0
Grid Ref	NT 20315 76100

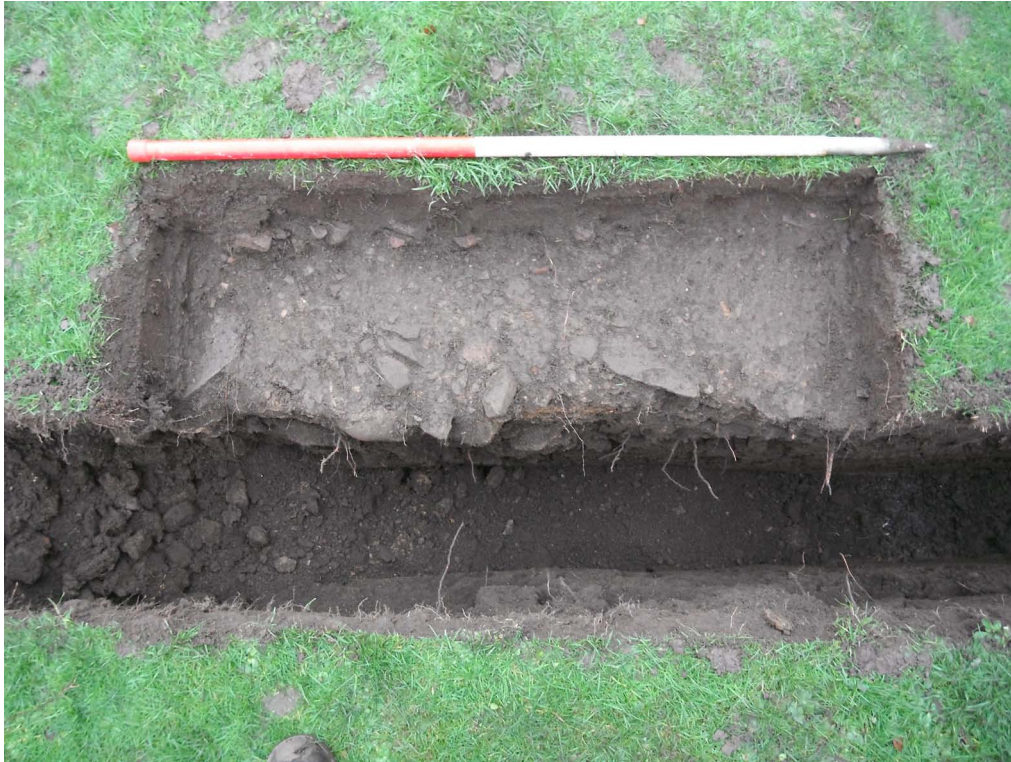
A possible stone surfaced path (**004**) (Fig. 2) aligned north – south was identified and this overlay a base of crushed sandstone (**003**). It was overlain by topsoil (**001**) and overlay the subsoil (**002**).

Fig. 2 - Possible path surface (004)

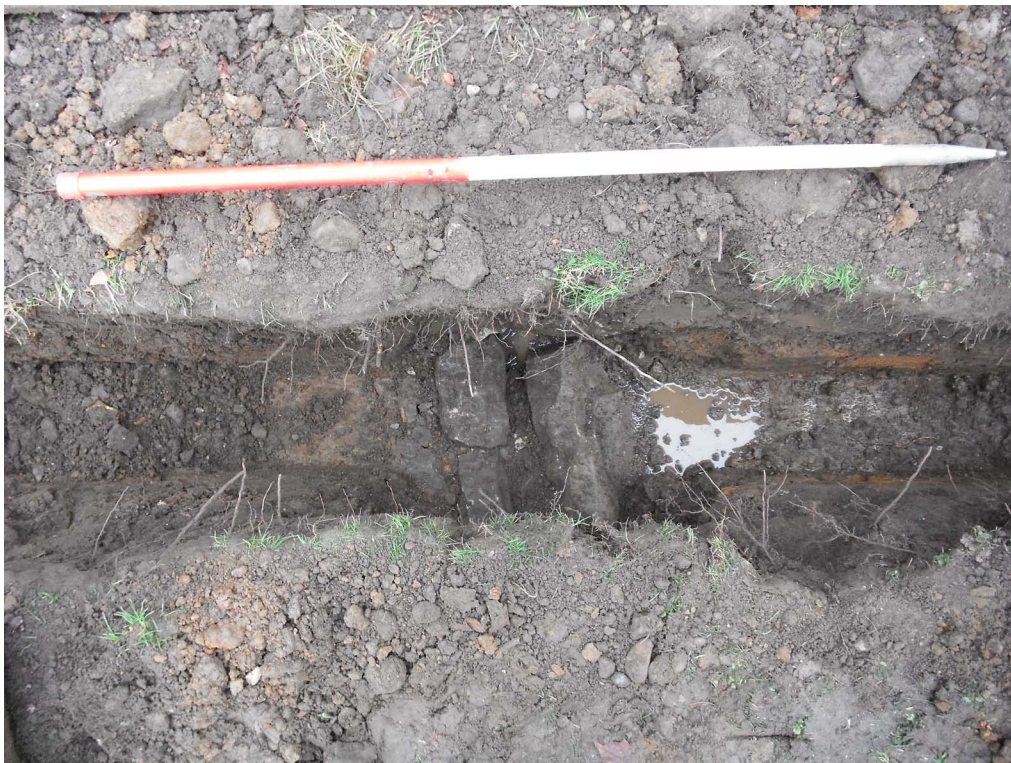
The cut for a stone-capped drain (**008**) (Fig. 3) running approximately east – west was located. It was cut through the made ground (**005**). The drain itself was constructed from sandstone side slabs (**007**) which supported sandstone cap stones (**006**).

Fig. 3 - Drain (008) showing side slabs (007) following renewal of cap stones

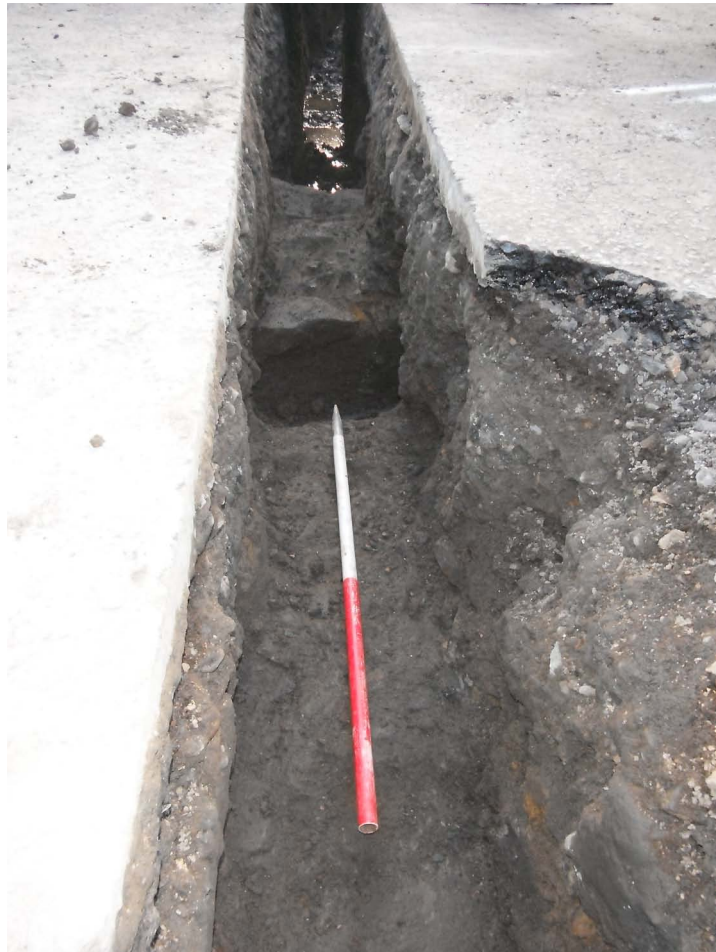
The cut for another stone-capped drain (020) (Fig. 4) with a southwest – northeast alignment was identified running across the trench. This was cut through made ground (021). The capstones (013) were large rough sandstone blocks and the sides appeared to be constructed from angular stones in a brown clay matrix (019). It had been silted up with grey sandy silt (018).

Fig. 4 - Stone capping (013) of drain (020)

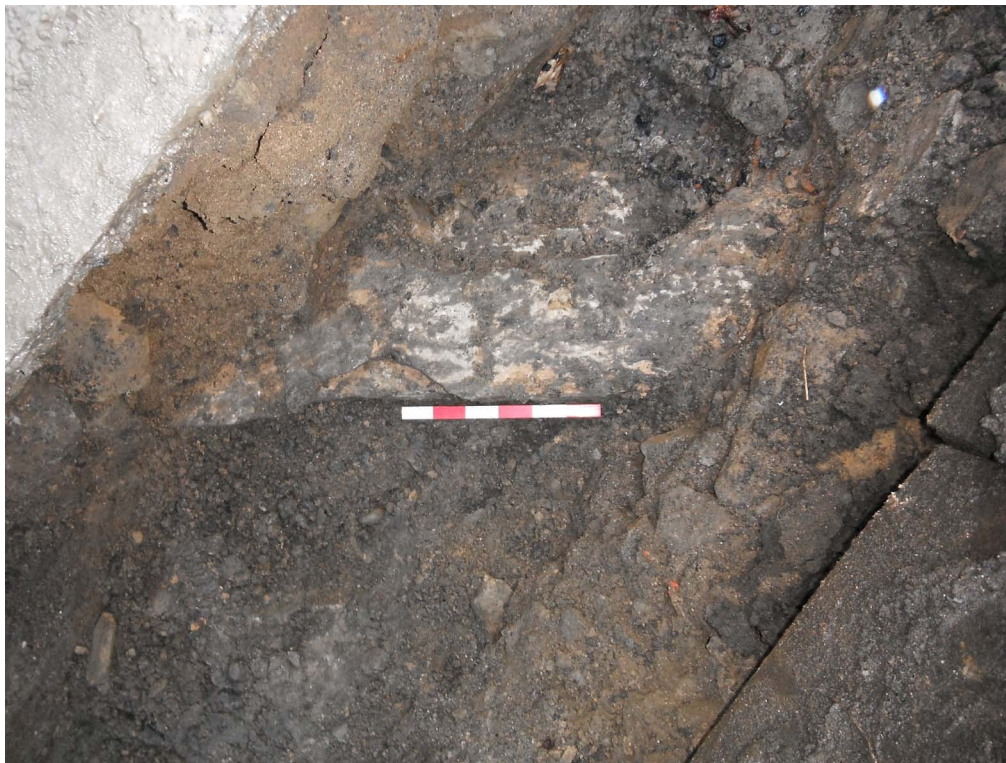
A possible wall (022) (Fig. 5) 0.28m wide crossed the trench aligned approximately east –west. It was of a mortared sandstone build with the sandstone being roughly shaped suggesting that this may have represented the foundation course of a wall. A spread of crushed sandstone rubble (023) extended to the north of this. This could represent the remains of the wall following demolition or the remains of debris left from the shaping of the stones for the construction of the wall.

Fig. 5 - Possible wall (022)
