Pitfourie Standing Stone, Moulin, Perth & Kinross

Archaeological Investigation and Reinstatement

Report No. 3144

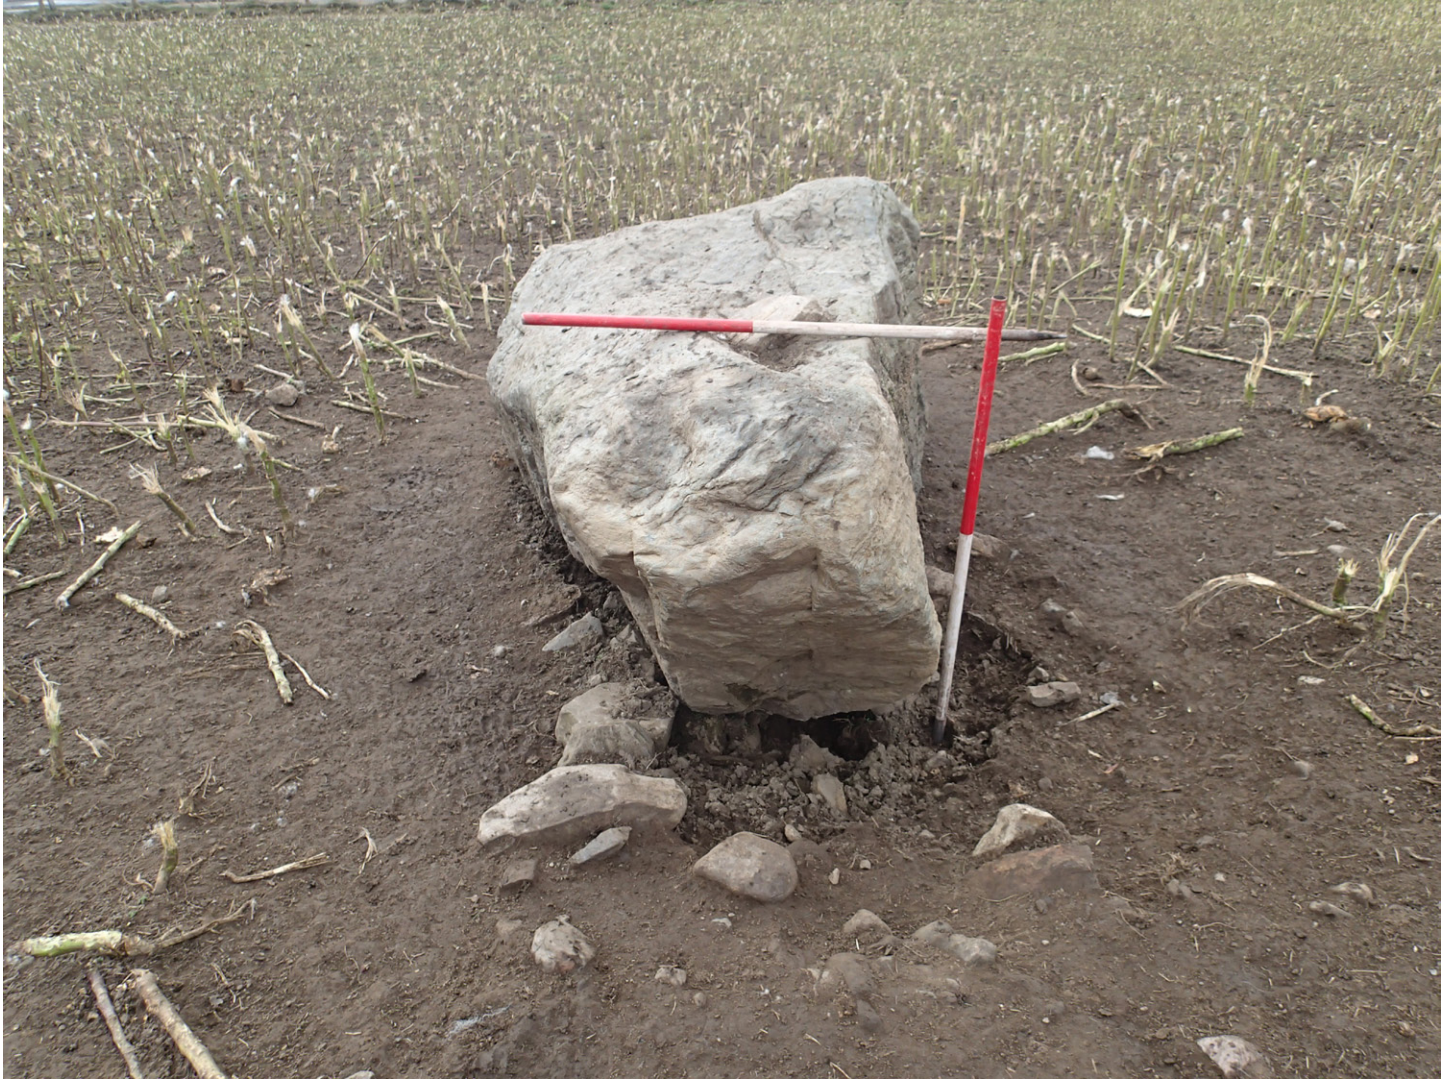
Fig. No: 2	Revision: A	Project: Pitfourie Standing Stone, Moulin

After Scheduled Monument Consent for the works had been obtained by the CFA, the prone position of the stone was recorded (Fig. 2-4) and the stone moved under the supervision of Stockdale & Lyall Masonry. The stone was removed without damage and placed on wooden battens nearby.

Fig. 2 - View of prone stone

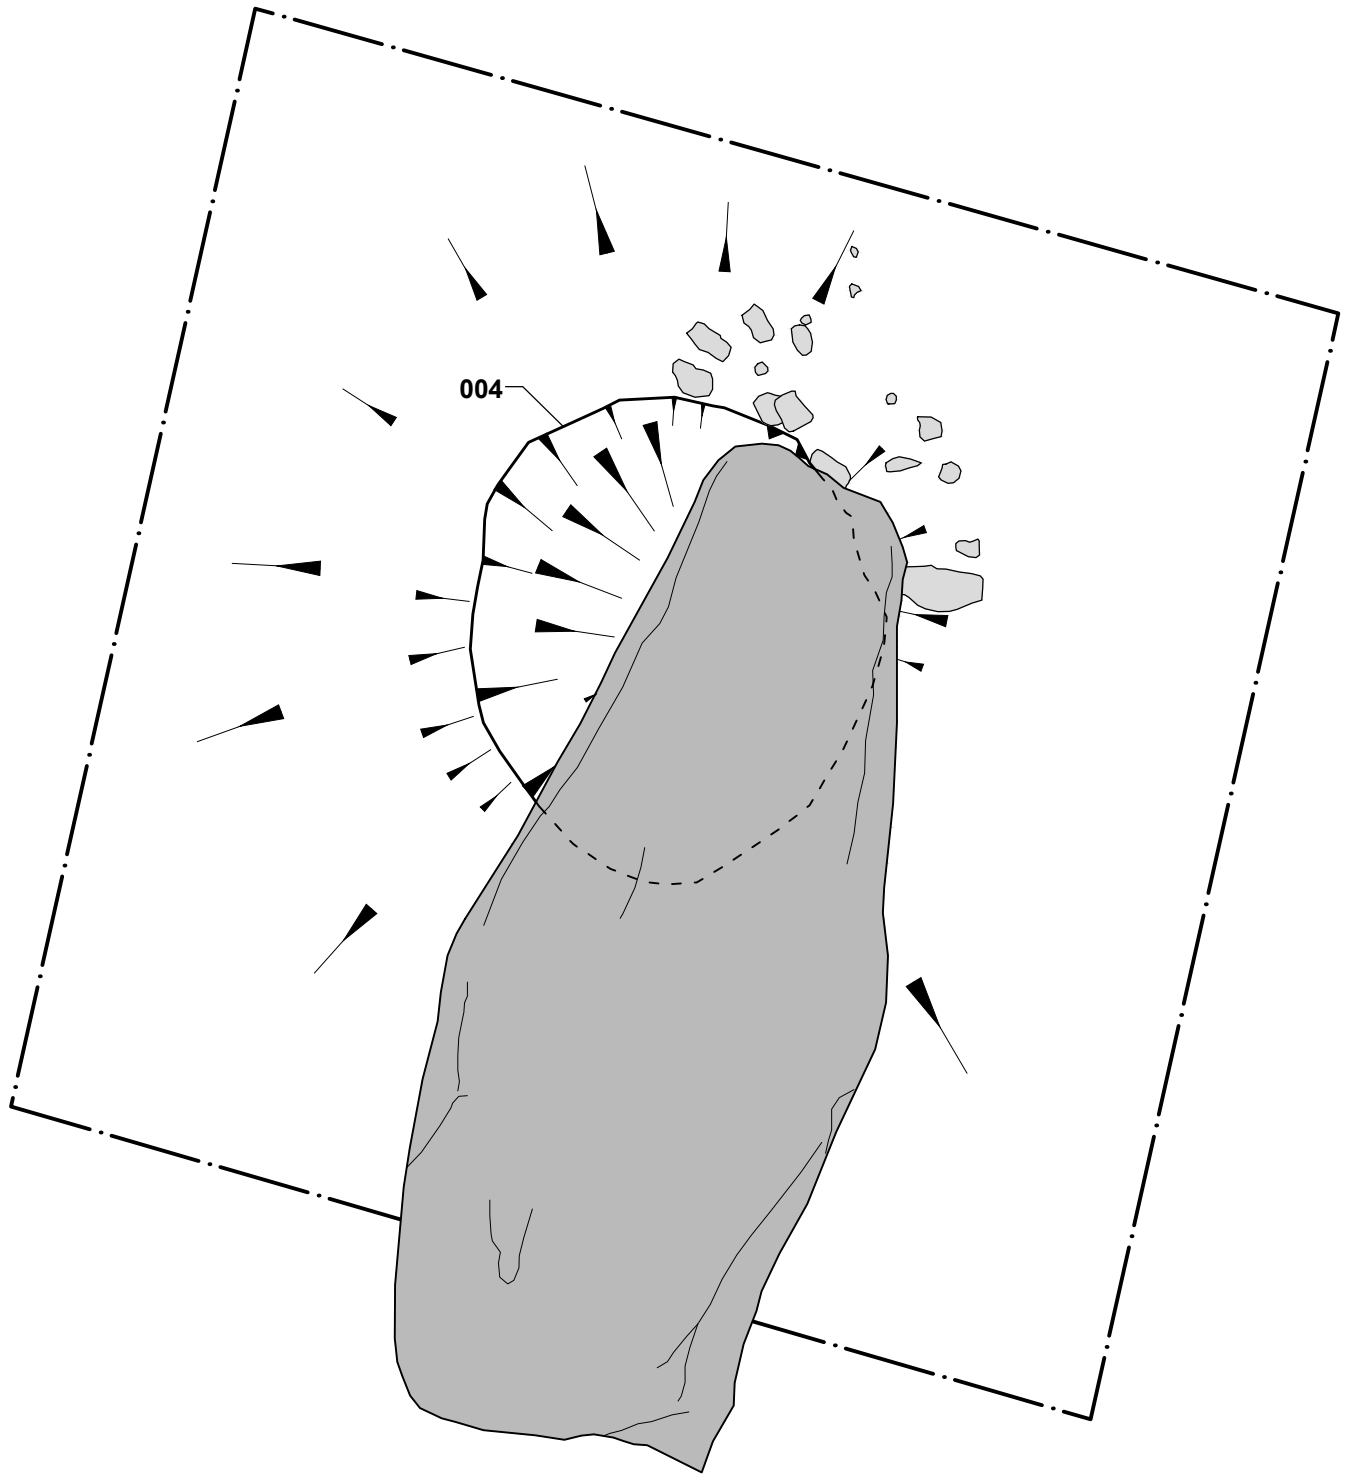
Fig No: 3 Revision: 0 Client: A

Title:
Plan showing prone stone in relation to excavation trench

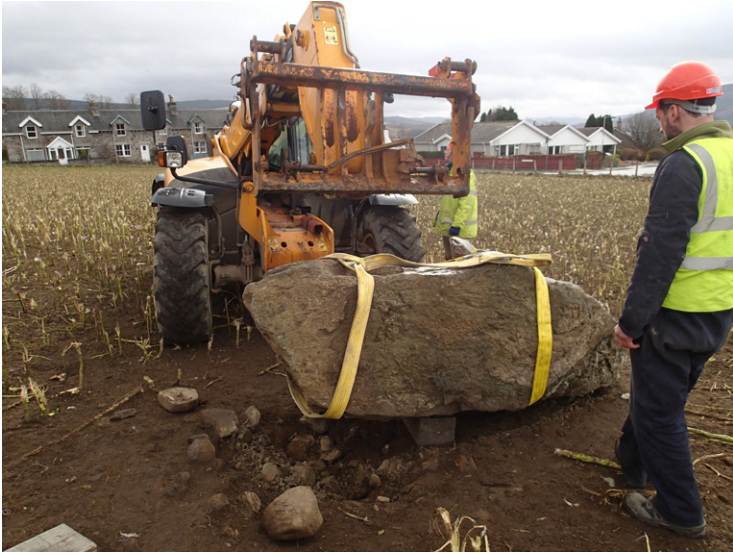
Fig. 4 - Stone being moved prior to excavation

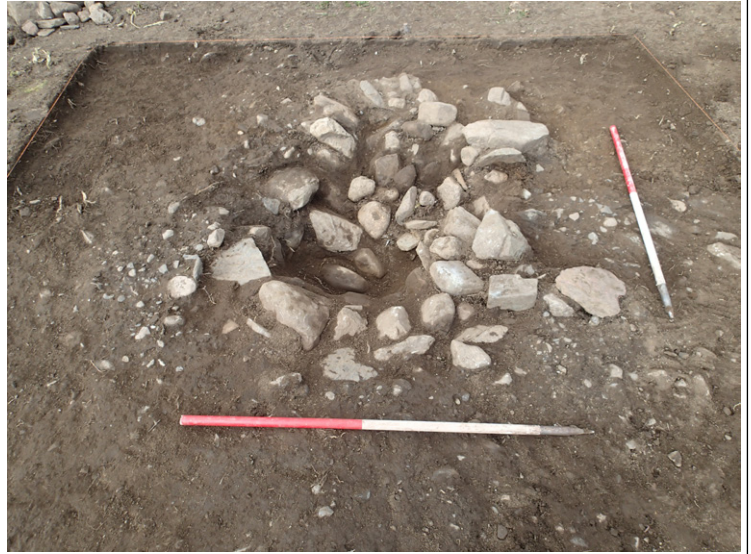
A 3m by 3m trench (Fig. 5), centred on the visible surface remains of the socket, was laid out and the exposed socket and partially scattered packing stones were recorded prior to any excavation. The trench was then excavated by hand.

The excavation revealed a thin, 0.10m thick skim of modern silty topsoil (**001**) covering the entire area of the trench, with the exception of the area of the stone socket itself (**004**). This was removed to expose the underlying subsoil (**002**), a mid-brown sandy silt containing frequent sub-angular stones and which extended across the trench except in the socket (**004**).

Fig. 5 - View of trench with topsoil removed

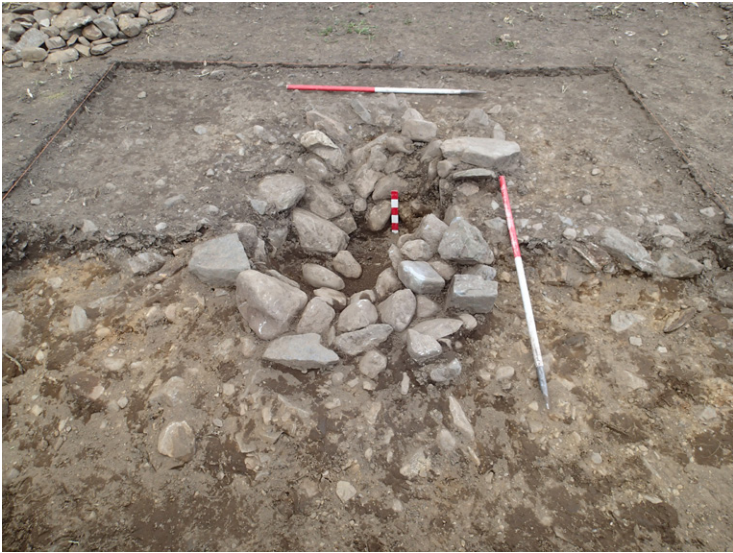
The upper surface of (**002**) was compacted and trampled, presumably by grazing animals, and was preserved at a slightly higher elevation immediately around the socket itself (Fig. 6). The subsoil deposit (**002**) thickened appreciably downslope to the south, with a maximum depth of 0.35m.

Fig. 6 - View of trench with subsoil half-sectioned around socket

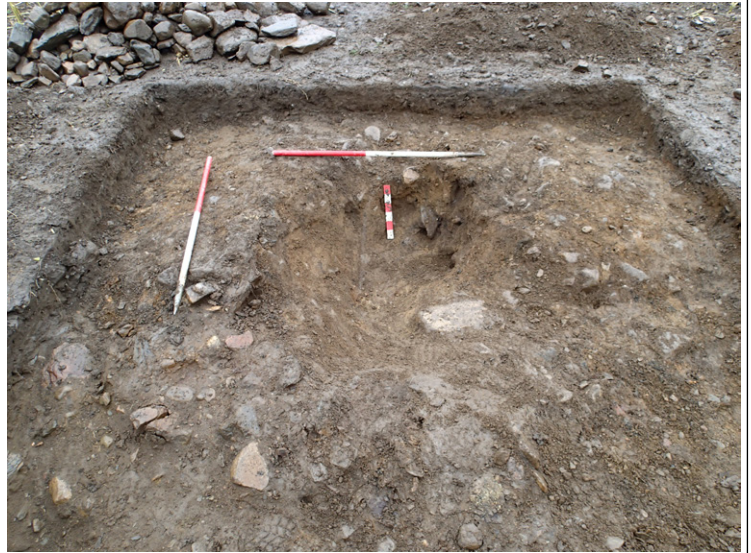
With the removal of the standing stone itself and light cleaning, the stone socket (004) and its associated packing stones (005) were revealed. The packing stones, relatively poorly-sorted small to medium sub-angular stones, had been disturbed by their exposure above ground (as visible in photographs of the stone prior to its fall) and by the falling of the stone. With the removal of loose and disturbed stones, a ring of in situ packing stones was revealed and recorded (Figs. 7, 8).

Fig. 7 - Socket fully excavated

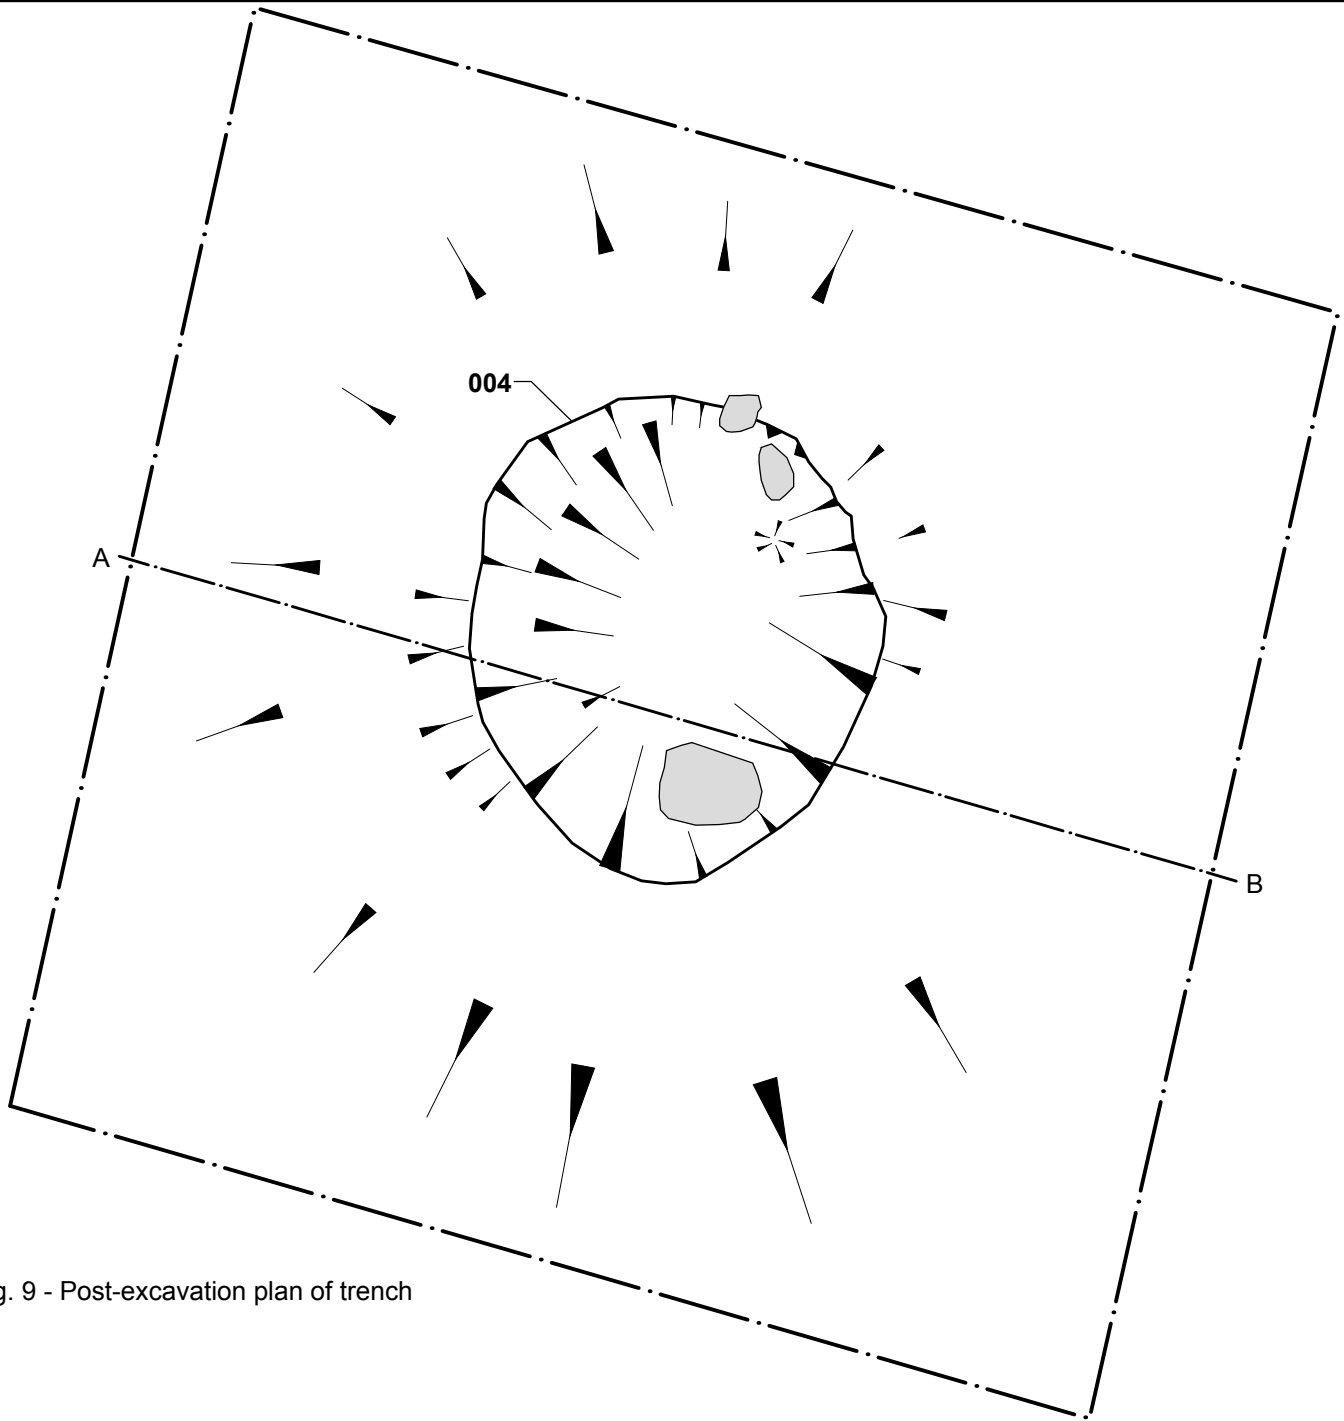
The packing stones (005) were removed by hand and the cut of the socket (004) revealed (Fig. 9, 10). The surrounding natural gravel (003), into which it had been cut, was loosely compacted and liable to crumbling and erosion; (004) therefore was not sharply defined. It appeared as a roughly oval cut oriented approximately N-S, some 1.25m long and 1.10m wide. It was preserved to a depth of 0.42m on its north side. It had a flat, irregular base and sloping sides with a gentle break of slope at its Southern extent, where the stone fell.

The top of the natural (003) was carefully cleaned by hand. It rose slightly in the middle of the trench around the socket and sloped away to all sides, suggesting attrition of the natural substrate over time, with the immediate area around the foot of the stone being slightly protected. Slight bioturbation was evident but no other cut features or deposits were noted in the excavated area.

Fig. 9 - Post-excavation plan of trench

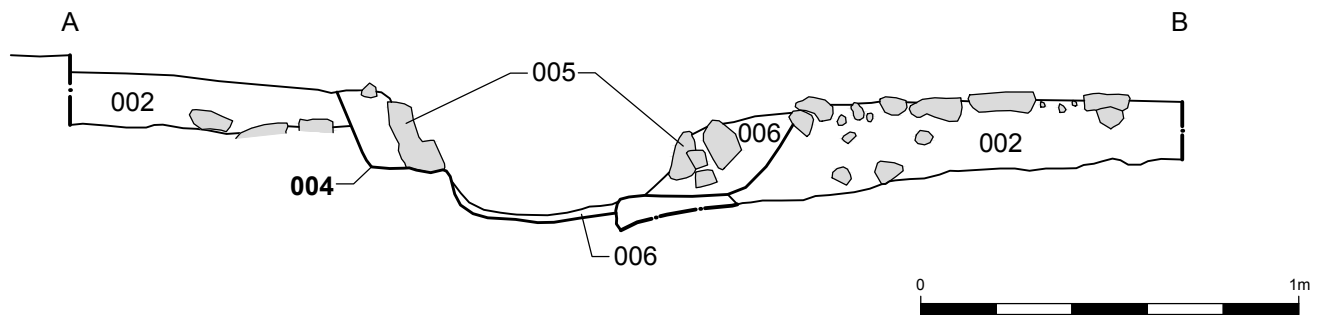
A trench measuring 3m by 3m was excavated, centred on the stone's socket. The standing stone socket was found to be oval in plan, 1.25m by 1.10m by 0.42m deep, packed with sub-angular stones. The stone socket was nearly empty, containing a thin deposit around the packing stones. No further archaeological features were identified.

Fig. 10 - Section/profile of socket

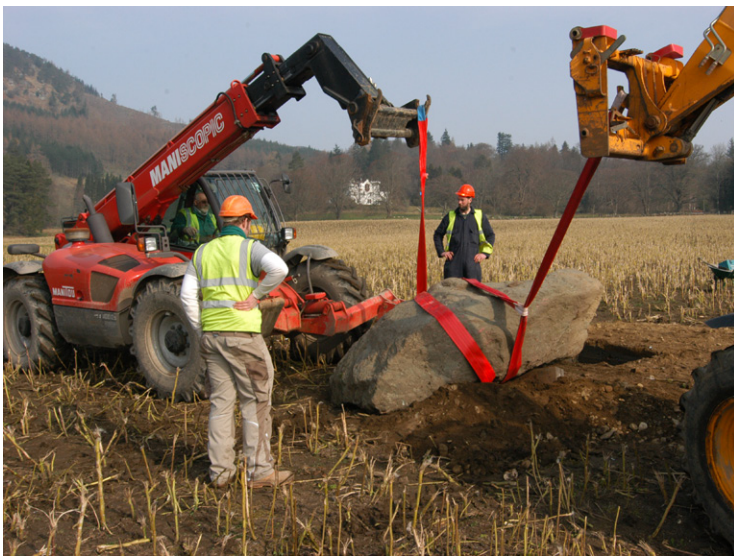
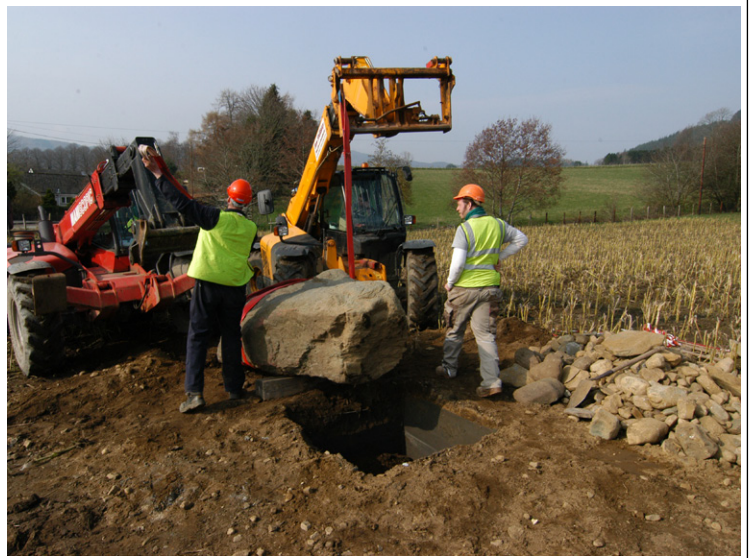
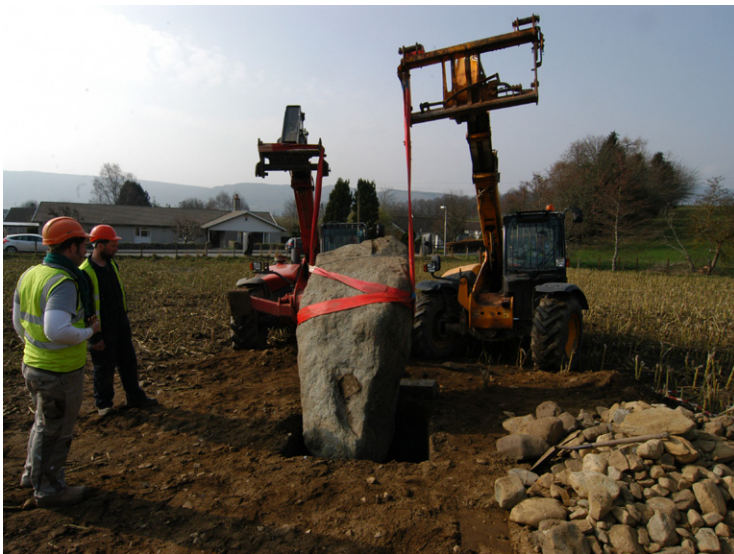
Fig. 11a - Reinstatement: working sequence

Fig. 11b - Reinstatement: working sequence

Fig. 11c - Reinstatement: working sequence

The socket was shuttered and a ring of concrete was poured to create a socket into which the stone could be received and then packed with stone to make it rigid but to still allow drainage into the subsoil without compromising the fabric of the stone itself.

The stone was lifted into a vertical position using two telehandlers with appropriate straps (Figs 11a-11c) and lowered into the excavated socket. The stone was held in place by the machine before packing it firmly using dry stone techniques (Figs 12a-12c).

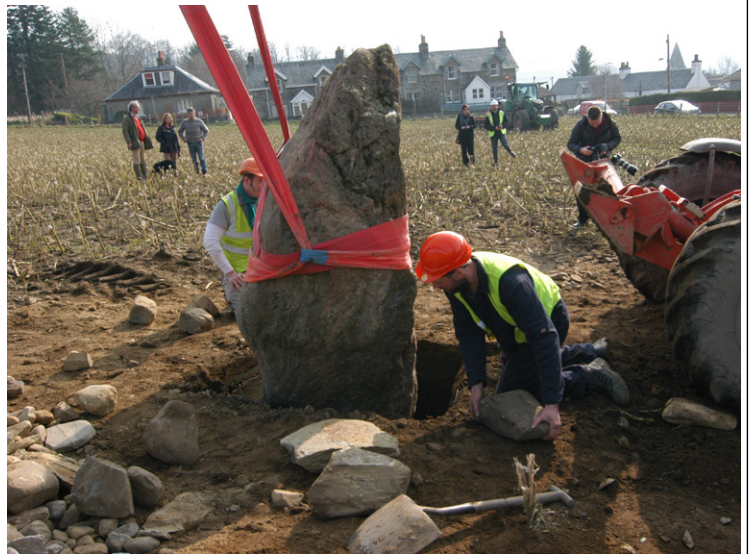
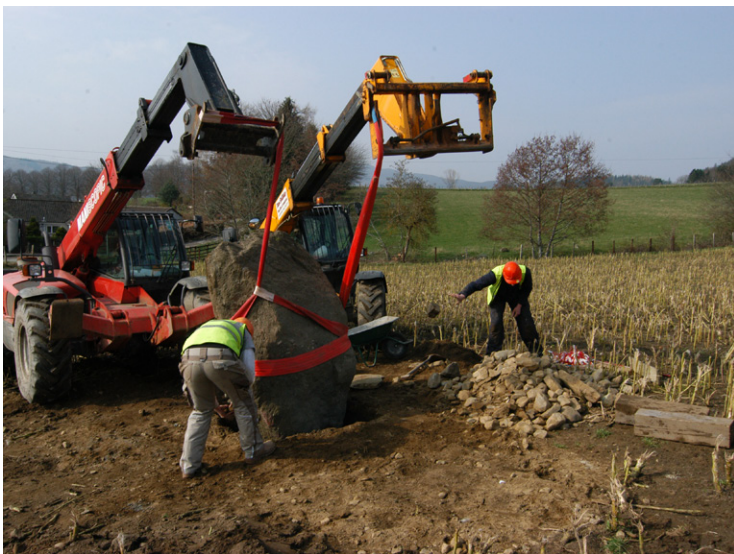
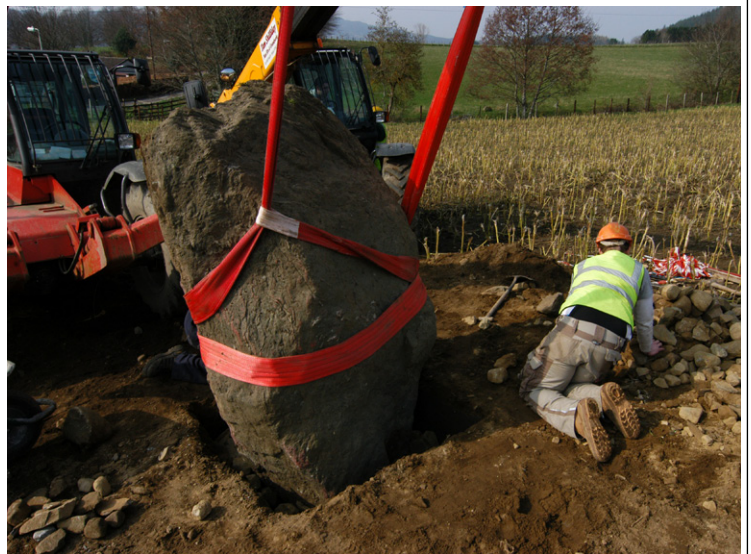
Fig. 12a - Packing stones into the socket

Fig. 12b - VPacking stones into the socket

Fig. 12c - Packing stones into the socket

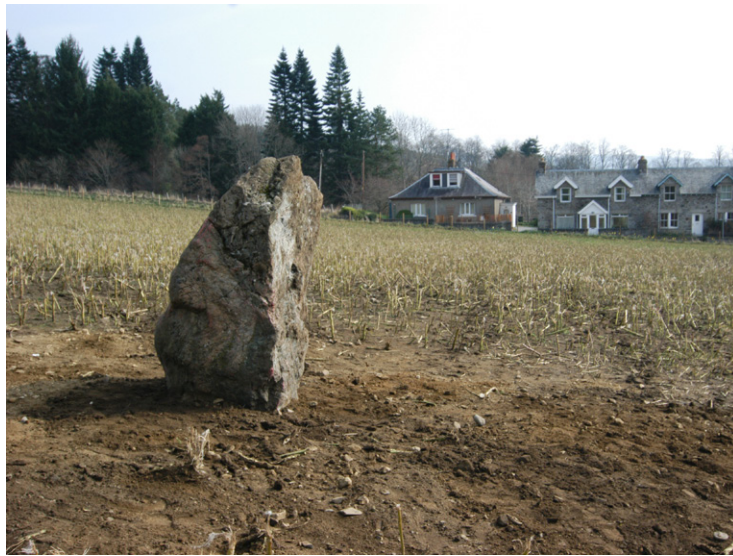
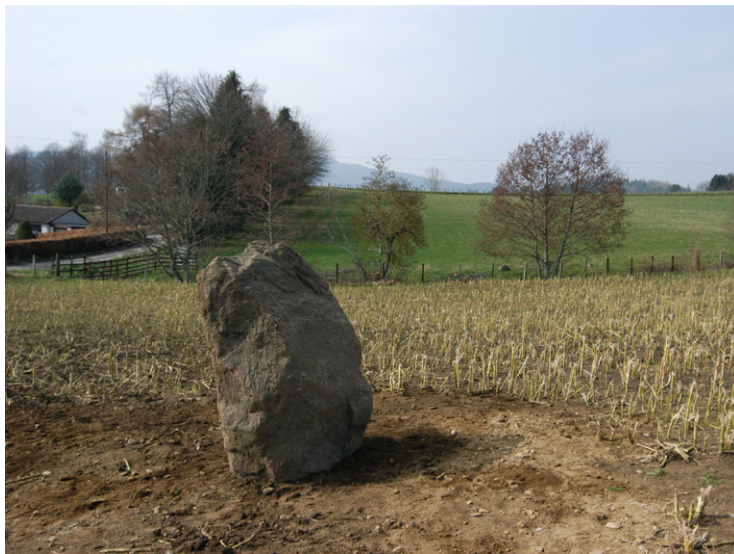
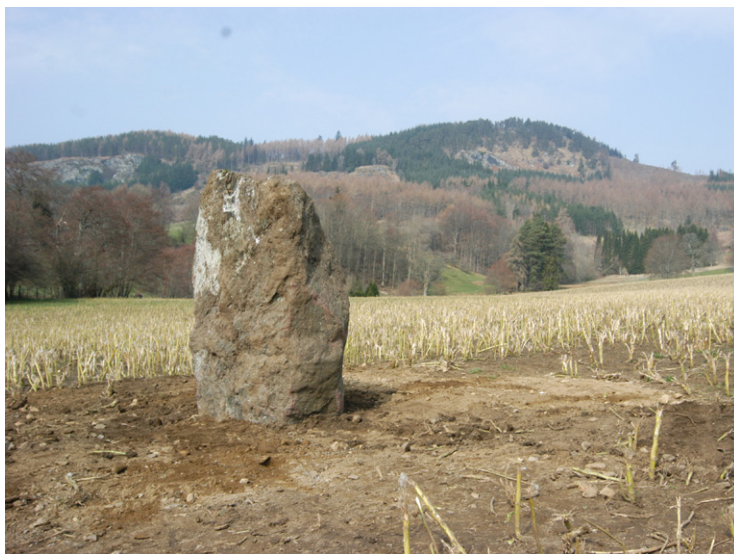
Fig. 13 - Pitfourie Standing Stone from the west

Fig. 14 - Pitfourie Standing Stone from the east

Fig. 15 - Pitfourie Standing Stone from the south

The stone was installed vertically (Figs 13-15) at the request of Historic Scotland. It was also set c.0.3m deeper into the ground than prior to the time of collapse which more accurately reflects its likely original height as well as adding the required degree of stability.
