Kenmore Bore Hole Upgrade Kenmore, Perth & Kinross

Archaeological Watching Brief

Report No. 3061

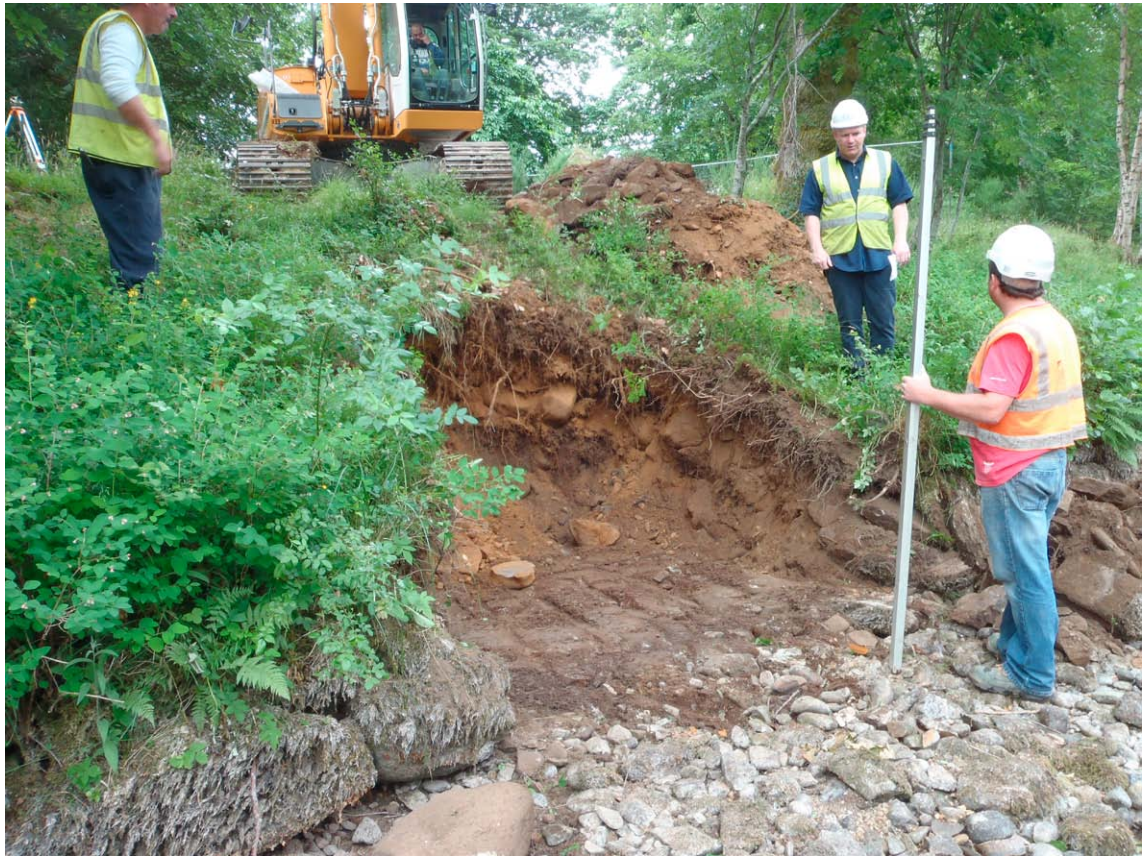
The new outfall headwall was cut into the bank (**002**) of the River Tay and measured 0.5m wide and up to 0.7m deep. It was cut c.2.5m back from the edge of the bank (Fig. 2) to accommodate a concrete outflow. Natural deposits of yellow stony sand (**003**) and coarse brown sand (**004**) were exposed. No archaeological remains or deposits were identified.

Fig. 2 - Trench excavated for the new concrete outflow, looking S

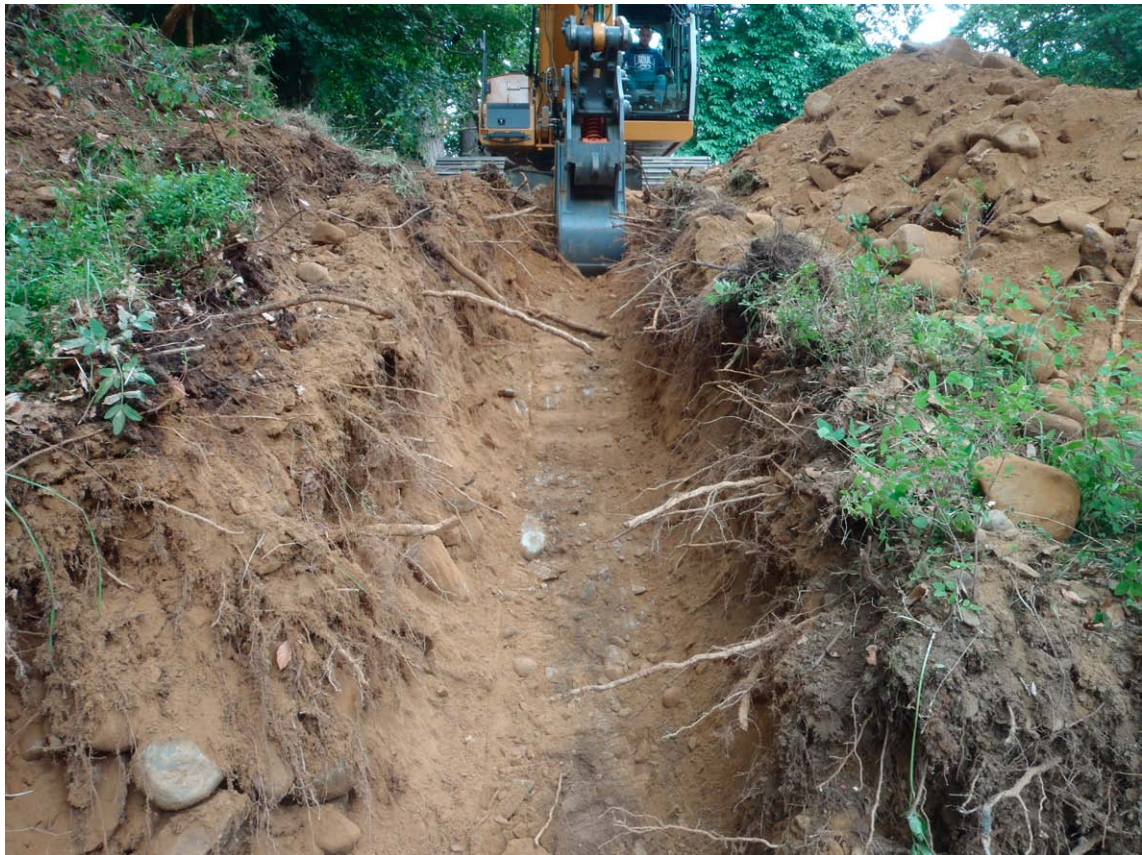
The trench extending to the manhole measured 0.8m wide and 0.9m deep and extended for approximately 20m. It was cut into natural stony yellow sand (**003**) (Fig. 3).

Fig. 3 - Trench excavated between the Outflow and the Manhole

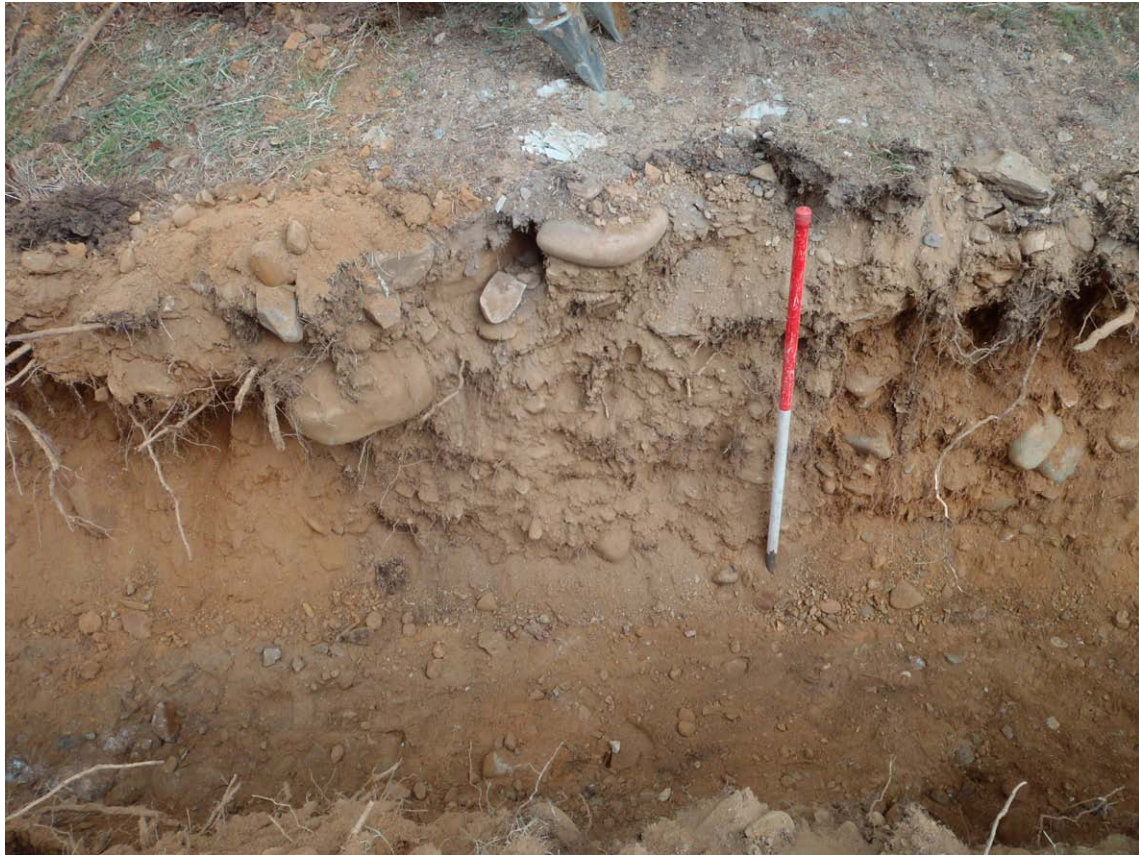
A linear ditch (**005**) was revealed in the trench section (Fig. 4). It was aligned east to west and ran underneath a compacted gravel path. Its full depth remains unknown as it extended deeper than the base of the trench. It measured 0.8m wide. The fill (**006**) was a mix of sand, silt and stones, similar to the topsoil. The trench may be for a buried service or be a boundary or drainage ditch relating to the path. No finds were recovered.

Fig. 4 - Linear feature 005 revealed in section, looking E
