Hallhill Farm, Dunbar, East Lothian

Archaeological Evaluation

Report No. 3229

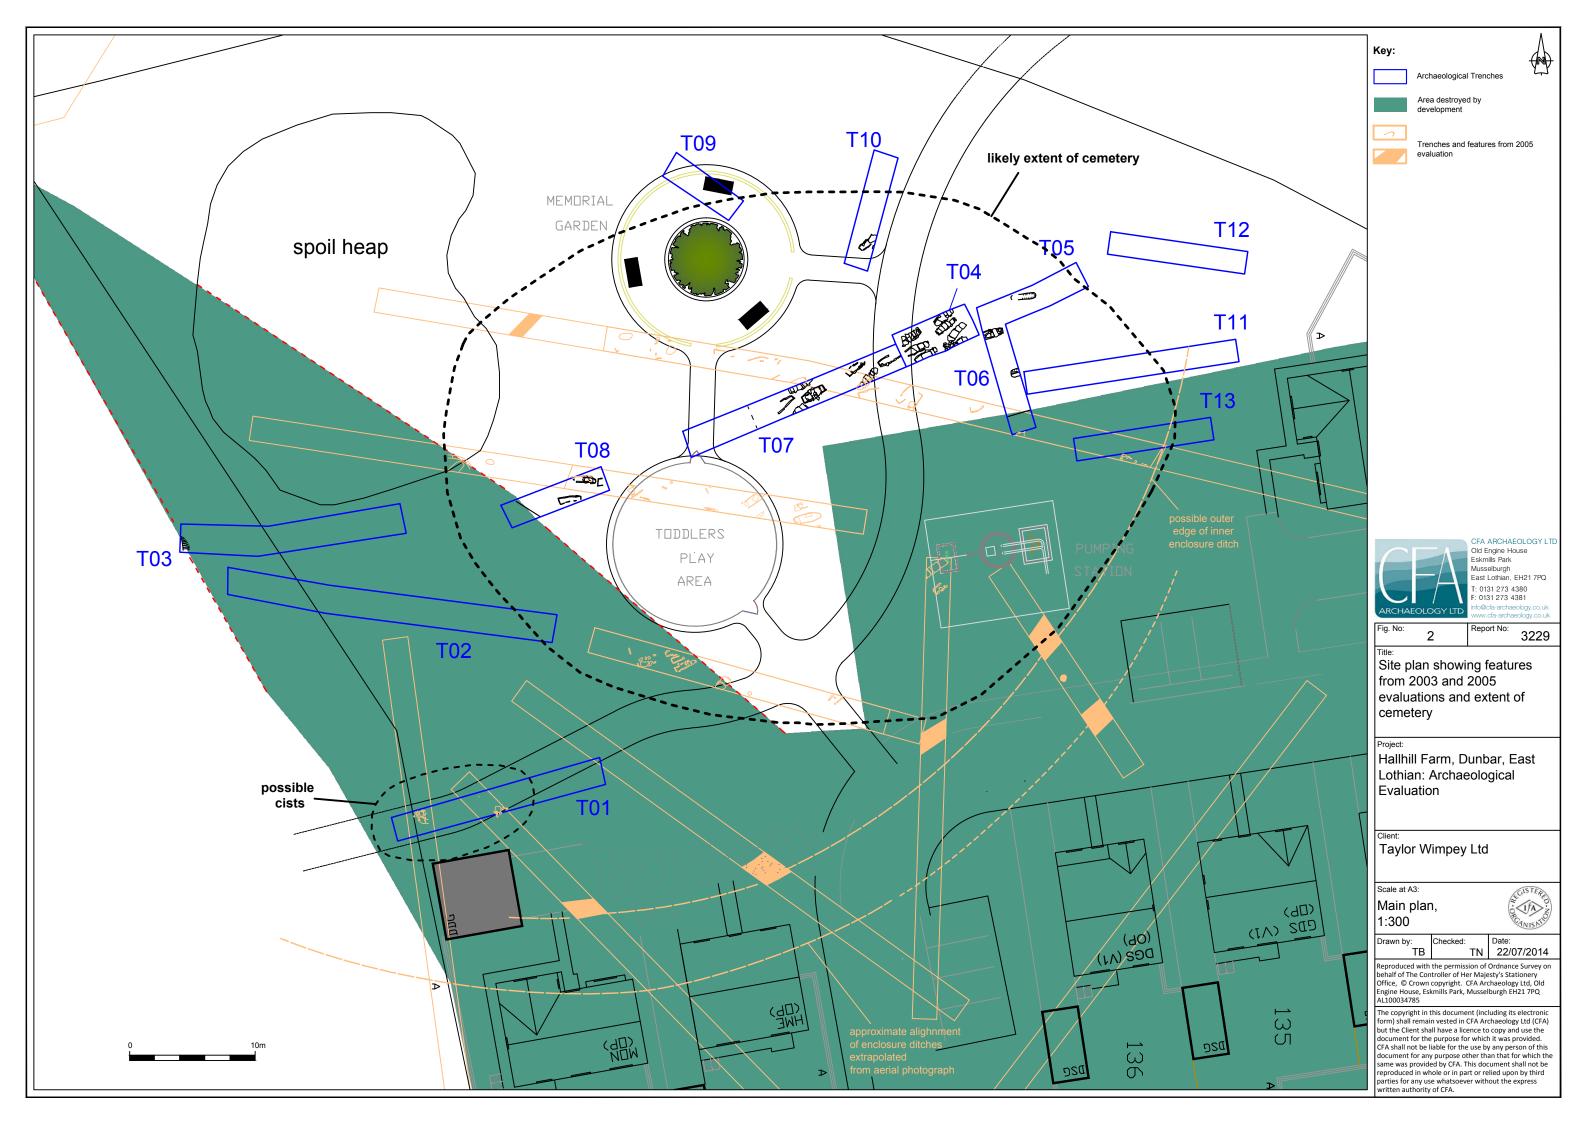
Thirteen targeted trial trenches (Trenches 1-13) (Fig. 1) were excavated within the area of the long cist cemetery and ditched enclosure identified in the 2003/2005 evaluations (Fig. 2). Any cists that were identified were cleaned and recorded. Undisturbed skeletons were left in situ and their locations noted. Disturbed skeletons were excavated.

Long cists and cut graves were recorded in Trenches 4-8 and 10 within the central part of the evaluation area and preservation has been shown to be good, with capstones often remaining in situ. In combination with the evaluation results from 2003 and 2005, the likely extent of the known cemetery can be plotted and is shown on Fig. 2. It appears that approximately 60% of the likely extent of the cemetery still survives in situ, despite the unauthorised excavation. The most densely occupied part of the cemetery, which is in and around Trench 4, has survived.

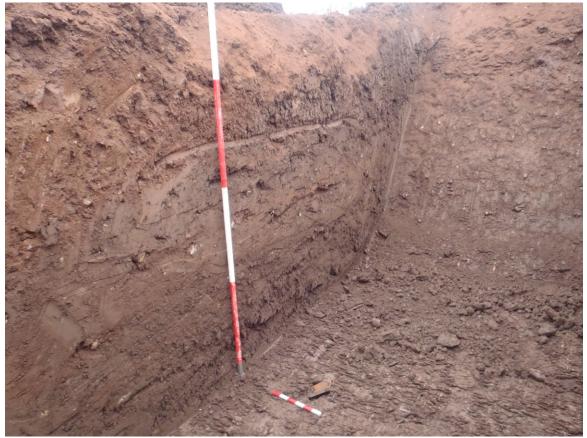
Fig 4 - Oblique north-facing section of Trench 2 showing redeposited topsoil/subsoil

Trench 2 (25m by 2m; Fig. 2, 3a): Trench 2 was excavated to a depth of 3.2m at which point it was clear none of the original ground remained. Re-deposited midbrown/orange clay sand subsoil (104) was present down to a depth of 0.6m which overlay 1.1m of very firm mid-brown/pinkish sandy silt (105). This, in turn, overlay re-deposited topsoil (106) which contained numerous modern inclusions, such as polystyrene, clay pipes and a rubber glove (Fig. 4).

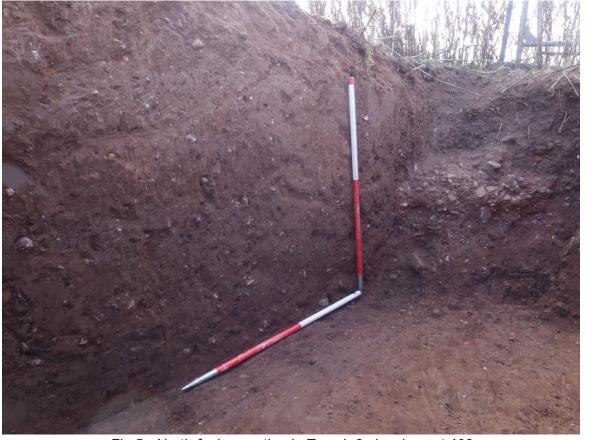
Fig 5 - North-facing section in Trench 3 showing cut **103**

Trench 3 (17m by 1.8m; Fig. 2, 3a, 5): A cut (103) into the natural was identified at the western end of Trench 3. This cut represented the western extent of the topsoil/subsoil removal. The trench was excavated to a maximum depth of 1.95m but the base of the cut was not identified. At this depth the trench was considered unsafe and excavation ceased.

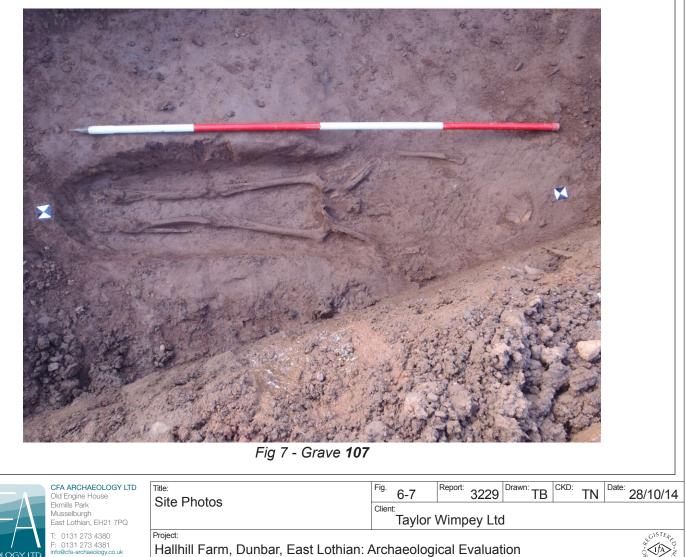
Trench 5 (8.5m by 2m; Figs 2, 3c, 7): One grave cut (107) was revealed, cut into natural (100), which contained an articulated skeleton. The grave was under 0.5m of topsoil (115). The majority of the upper half of the skeleton had been damaged but the bottom half remained largely intact. It was orientated east-north-east to west-south-west.

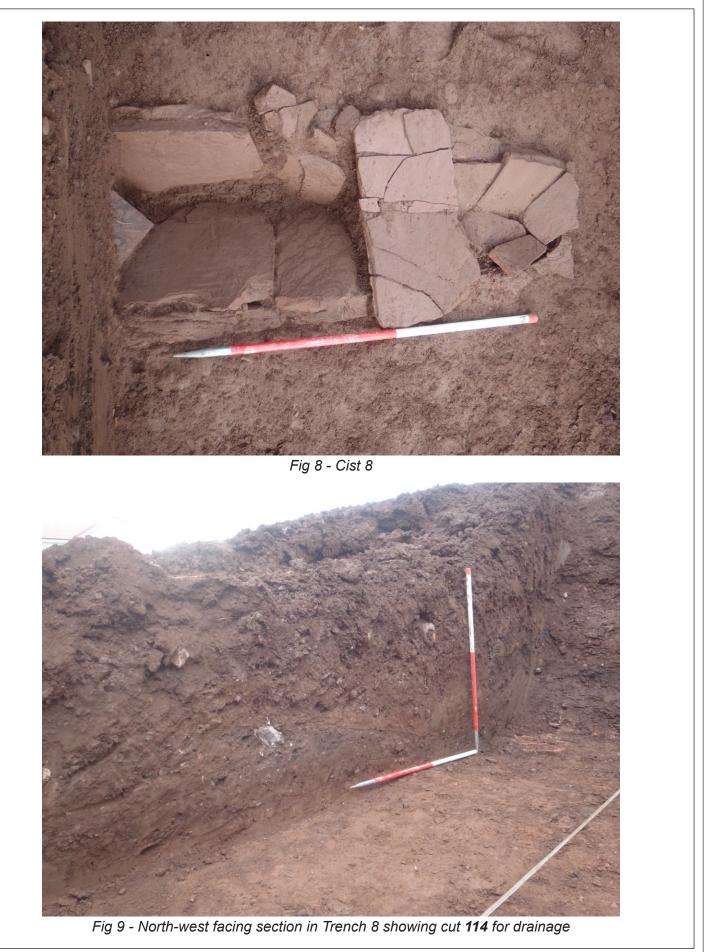
Trench 6 (8.7m by 1.9m; Figs 2, 3c, 8): One long cist was located at the northern end of the trench (8). All of the capstones were present but had collapsed and the side slabs were visible. Part of a linear feature or pit **(112)** was also identified within this

Trench 8 (8m by 1.9m; Figs 2, 3b, 9): This trench was excavated in order to identify a known drainage trench cut. The drainage trench (114) was identified approximately 1.5m from the western end of the trench and was orientated north-west to south-east. Three long cists (18-20) were also identified. These were below approximately 0.1-0.2m of subsoil (110) and it appeared that in this location the topsoil had been previously removed. Cist 19 appears to be a cist which was identified during the 2003 evaluation. The costs were primarily defined by their side slabs, and were orientated east-west.
