Glendevon Steading, Winchburgh

Archaeological Watching Brief

Report No. 3197

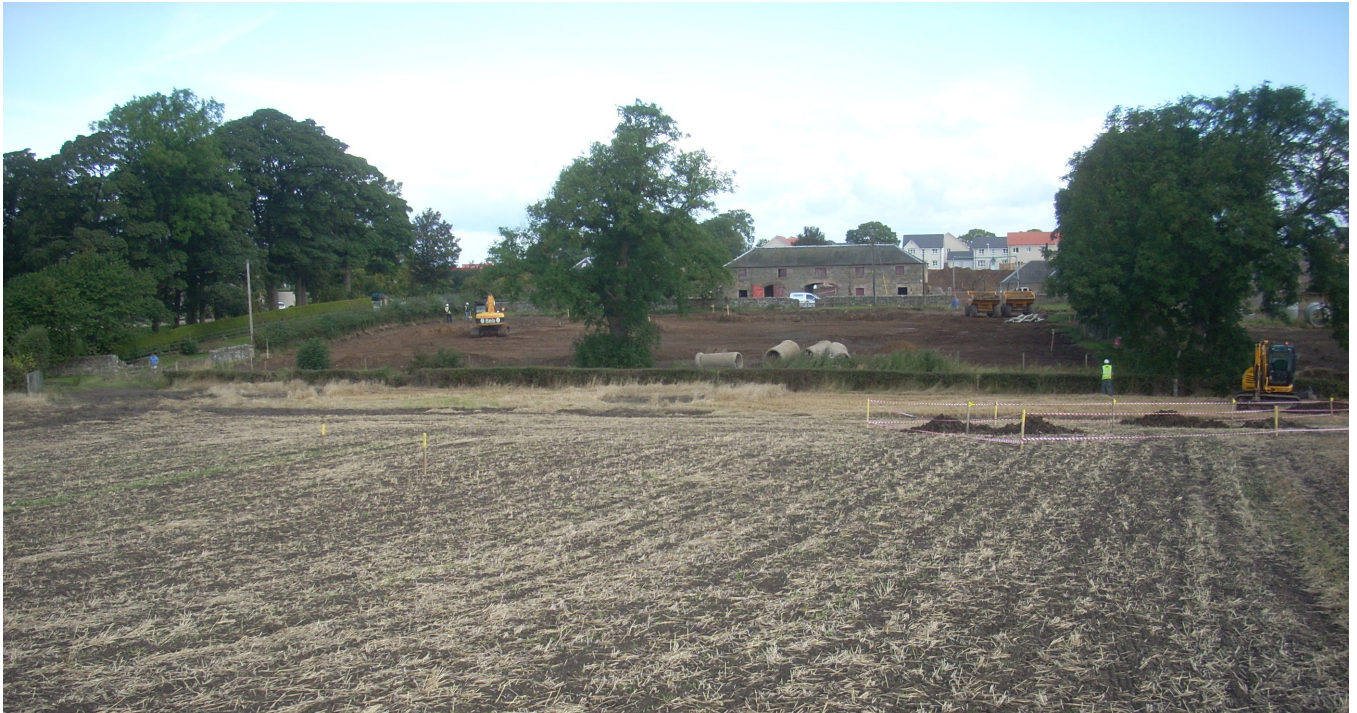
Fig. 2 - View of the watching brief area from the south

The watching brief took place in a small, south-facing grass field measuring approximately 60m by 60m (Figs. 1-2).

The topsoil (**001**) was generally 0.2m deep and it overlay a stony subsoil (**002**) with a depth of around 0.3m. The natural subsoil (**003**) below was very varied, consisting mainly of sandy gravels with bands of sandy silt. There was none of the boulder clay which is prevalent elsewhere around Winchburgh.

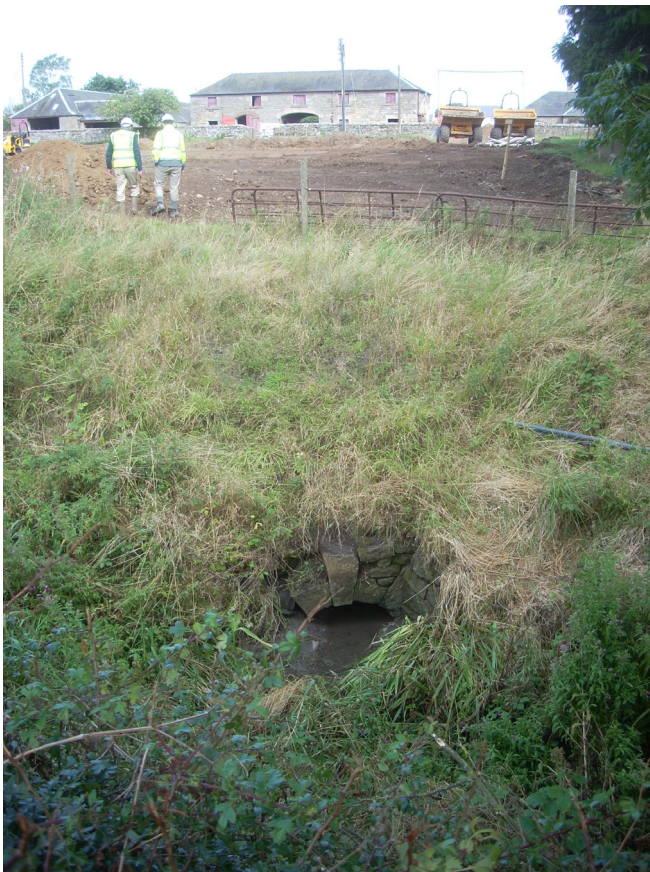
Fig. 3 - The outflow from the culvert

Upon arrival on site, CFA were informed by the contractors that a culvert ran through the field where the watching brief was to take place. This culvert reportedly emanated from a mill-pond located to the north-west of the site. An exit into a canalised stream to the south of the watching brief area was identified and this is shown in Fig. 3.

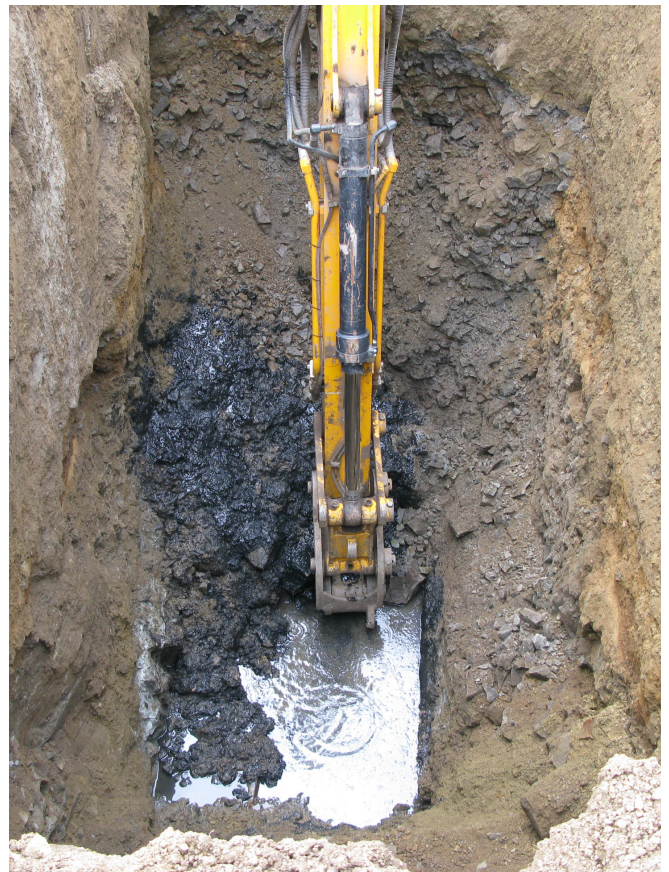
Fig. 4 - Working shot showing the removal of the culvert structure

The cut for the culvert (**004**) was around 2.5m wide at the top, tapering to around 1.5m wide at the base. The culvert (**005**) itself was built from roughly dressed local sandstone and was located in the base of the cut at a depth of around 4m below the level of the natural. The cut for the culvert was filled with angular crushed quarried stone (**006**).

A series of parallel features were identified in the sides of the cut for the culvert (Figs. 4-6) and these were interpreted as post-holes for shoring used during its construction. Several roughly hewn logs, probably the remains of the shoring, were seen within fill **006**.

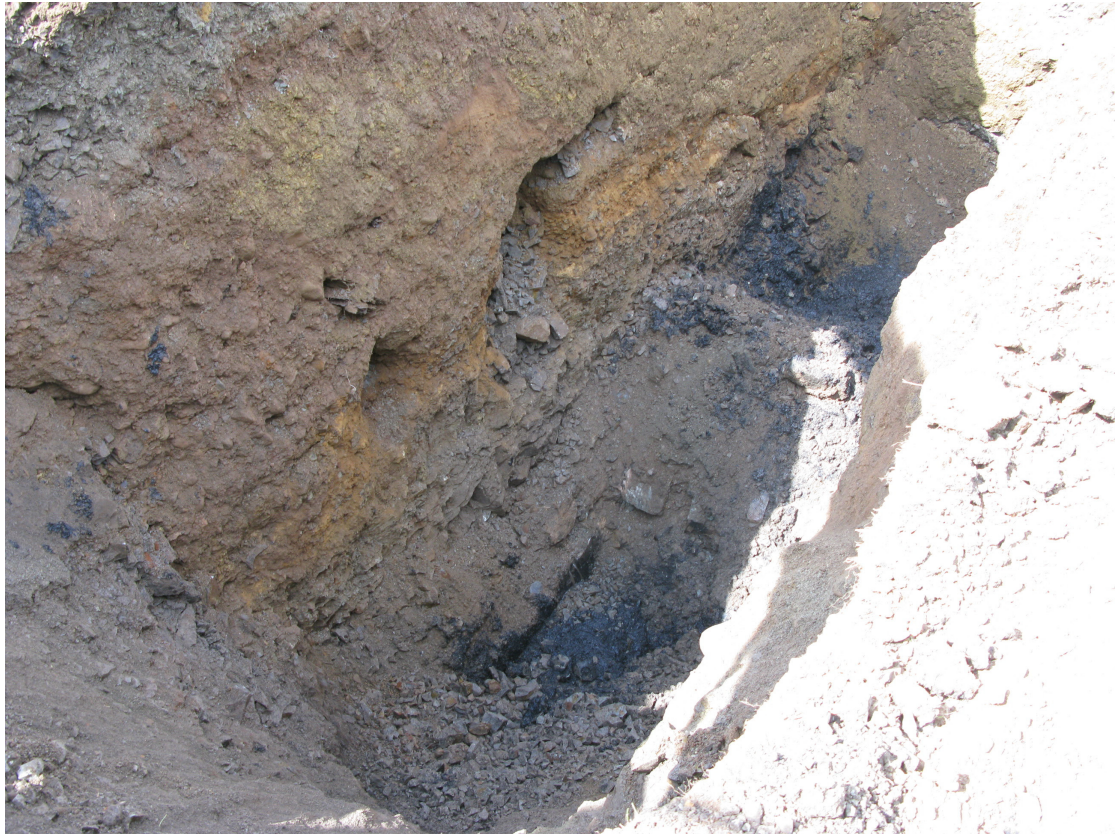
Fig. 5 - View of the post-holes in the sides of the culvert trench

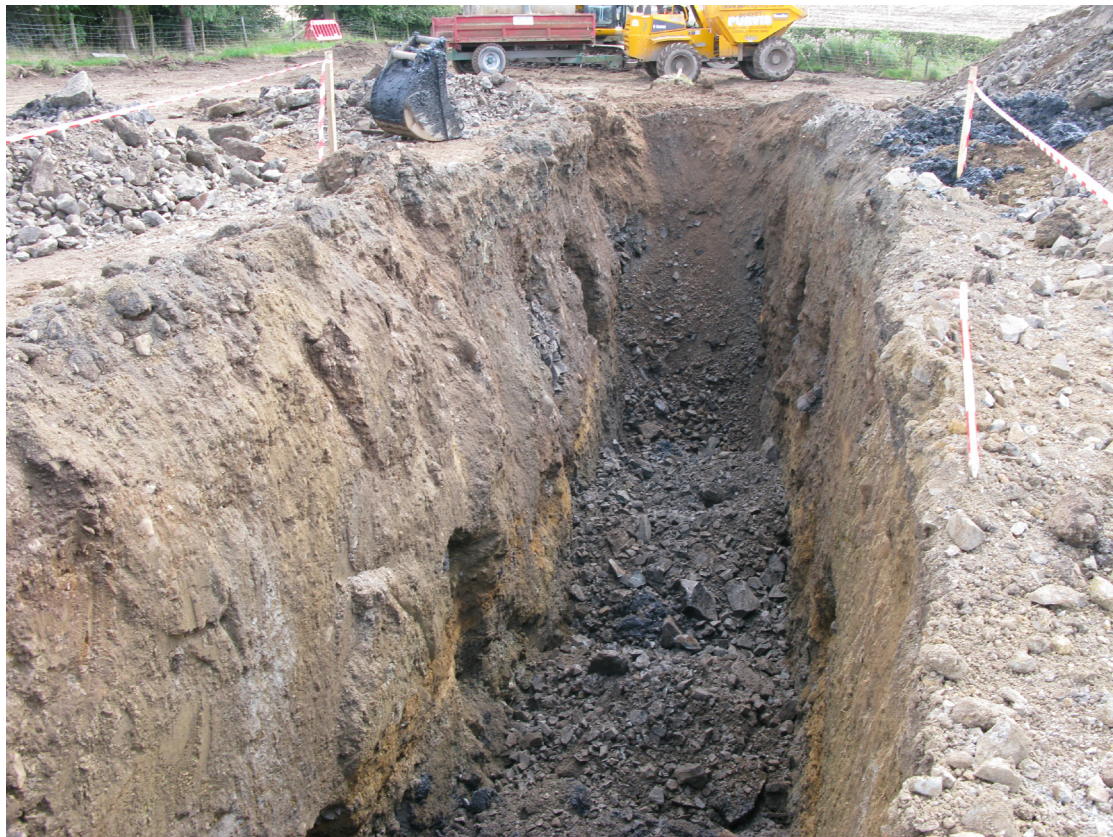
Fig. 6 - View from the north showing the parallel pairs of post-holes in the culvert
