Minor Archaeological Services Call-Off Contract Kildrummy Castle, Aberdeenshire PIC250

Watching Brief: Interpretation Board Installation, April 2018

Report No. HES-PIC250-2018-01

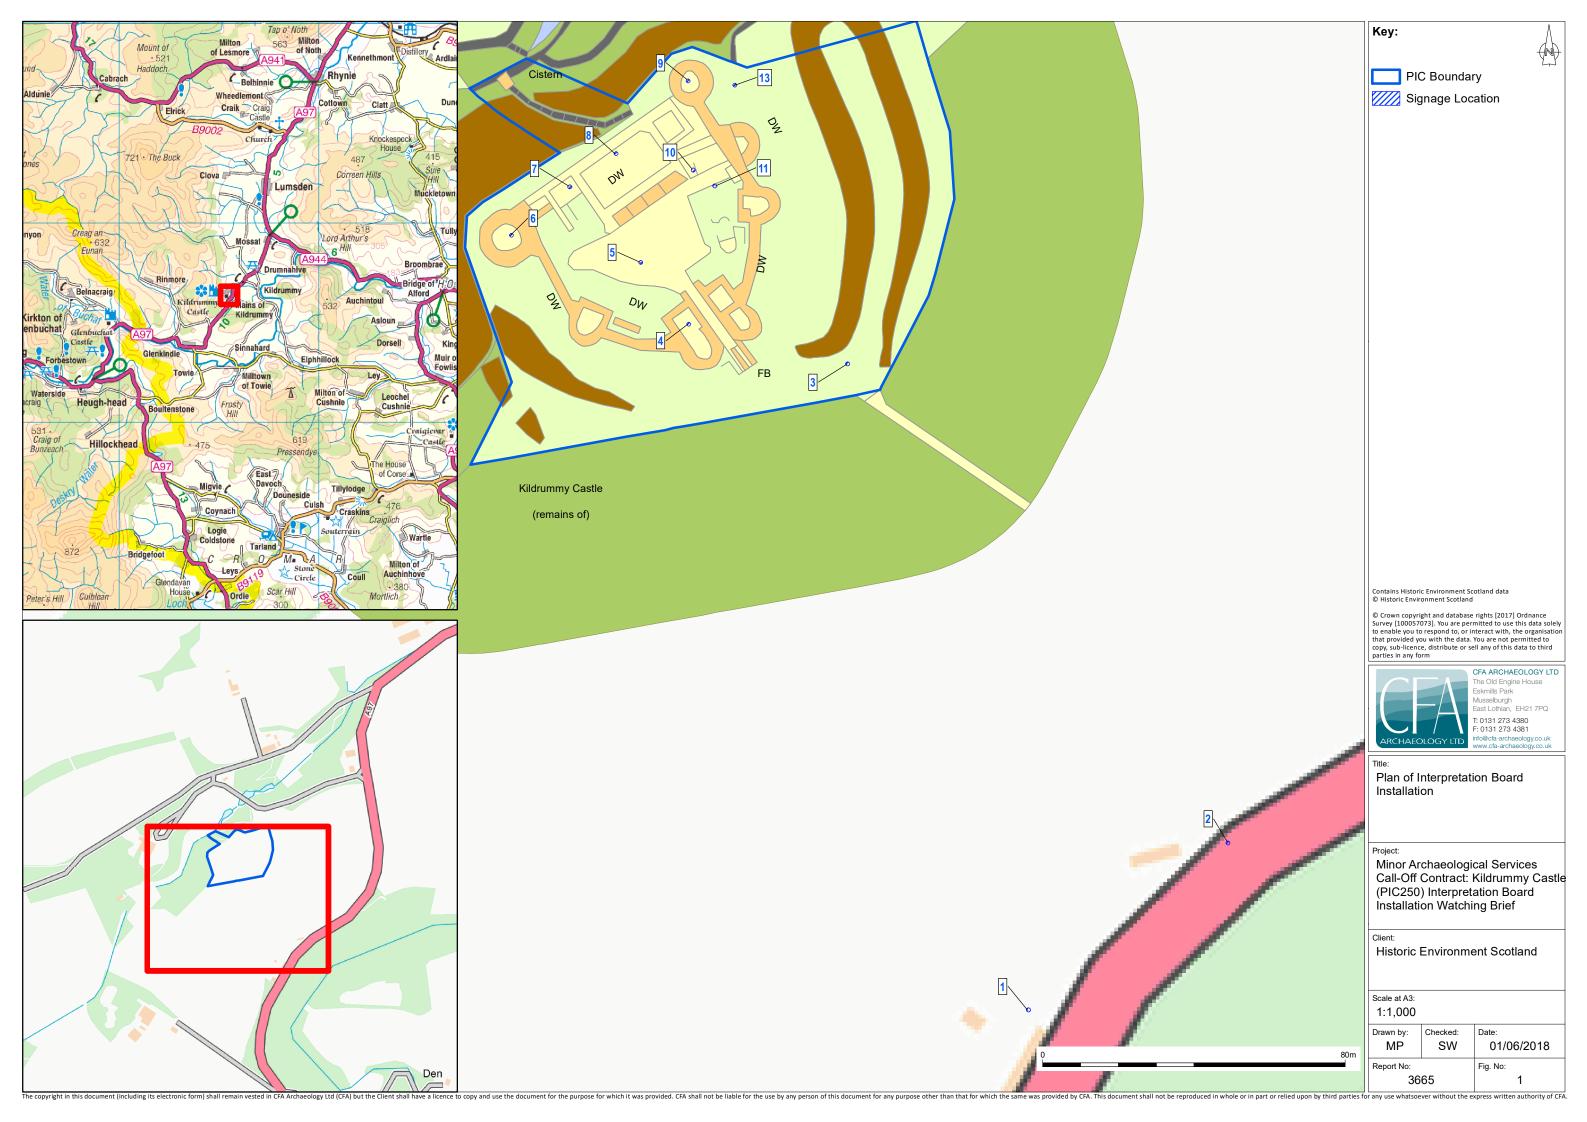
Panel KDR11 was located in the central courtyard close to the wall, south of the chapel (leaving at least 1.2m clearance on all sides) and will be a lectern style panel (Fig. 1). The photographic record shows a timber lean-to structure built against this wall. It is not clear how deep its foundations were, if indeed it had any. There is no apparent trace of it on the surface so there has been some clearance work in this area. Even if it had no foundation it seems to have held a large collection of carved stones for some time, so would likely have left some surface trace. An early plan of unknown date, but pre-clearance works, shows the area as 'heaps of rubbish overgrown with grass and bushes'. A pre-clearance photograph on Canmore shows a less 'manicured' inner courtyard than at present. Files indicate that historic surfaces that were discovered during earlier clearance and excavation were left uncovered, while other areas were returfed.

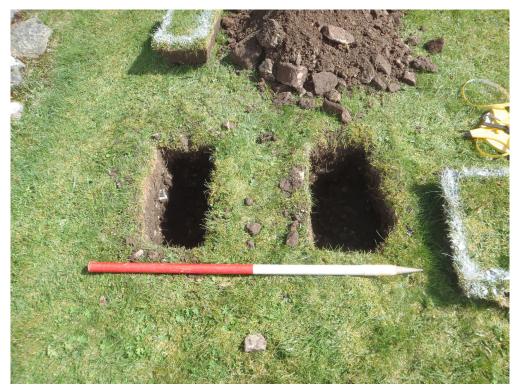
Fig. 2 - KDR11

Panel KDR11 was in the re-turfed area of the courtyard, and the excavated area for its foundations revealed topsoil (001) up to 0.15m deep below which was a loose silt deposit (002), up to 0.15m in depth, containing sandstone inclusions (Fig. 2).

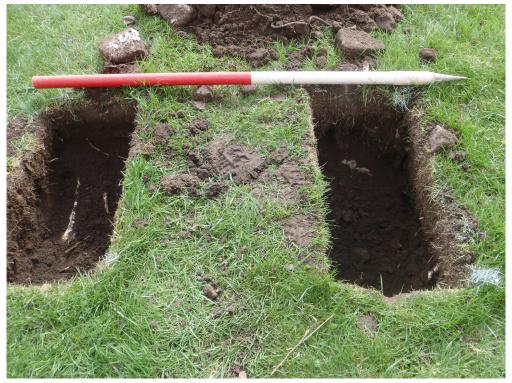
Fig. 3 - KDR13

The excavation of foundations for Panel KDR13 revealed topsoil (001) up to 0.15m deep below which was a brown silt (003), up to 0.15m in depth, with heavy rooting activity from nearby vegetation (Fig. 3).
