Riddle's Court, Lawnmarket, Edinburgh

Historic Building Survey

Report No. 2164

CFA ARCHAEOLOGY LTD

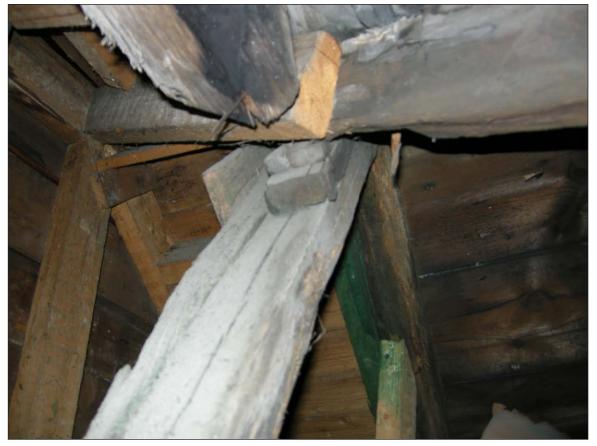
Plate 7 - South Block, north side, complicated arrangement of timber repair work

The examined section of the roof space on the north side of the south block roof showed that the single pitched roof timbers rested on a transverse timber plate supported by corbels (Plates 5 and 6) built into the head of the rear wall. The corbels had been carved to accommodate the main transverse and the principal rafters. The roof at this location also included more recent timber repair work (Plate 7). The timbers appear to be machine sawn and rough-hewn oak covered with pine sarking boards (Plate 8).

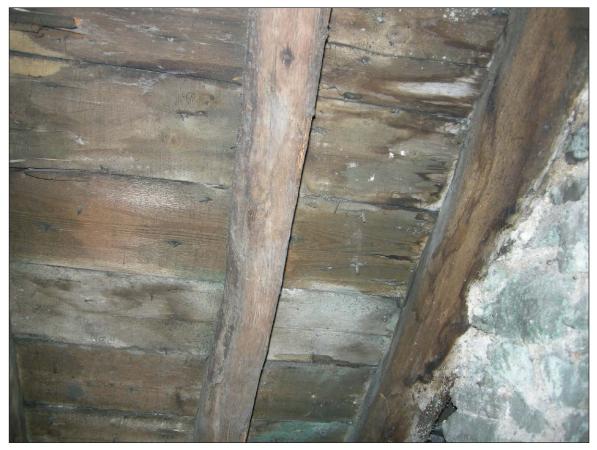
Plate 8 - South Block, north side, pine sarking boards nailed to oak rafters

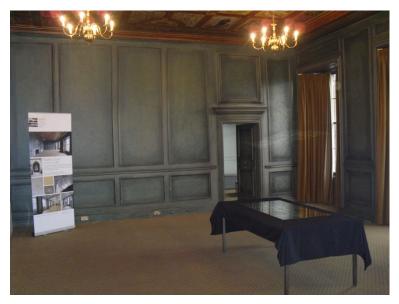
East wall ahead with 18th century panelling and entrance to F.10. Windows on right facing Victoria Street and Terrace (south side of building).

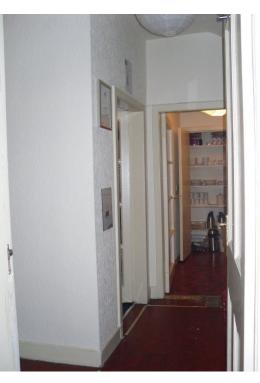
View of S.16, with first left leading to S.20 and kitchen straight ahead. Evidence of worn laminate floor in front of kitchen entrance.
