**Aikengall II Community Windfarm  
East Lothian  
(Planning Ref. 09/00001/SGC)**

**Archaeological Watching Brief**

**Report No. 3281**

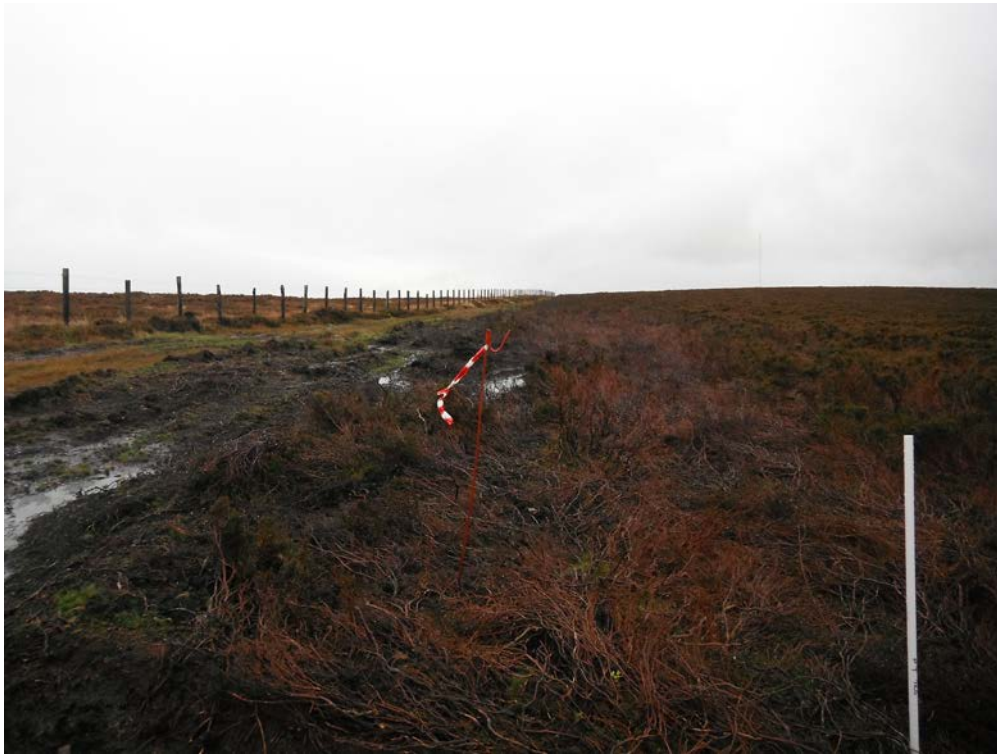
Fig. 2 Area of heather moorland at supposed site of aircraft wreckage

A targeted walkover survey was carried out within the 100m buffer zone for the crash site, and along the proposed route of the intra-site access roads within the vicinity of the crash site, as well as the access route to Turbine 14 (Figs 1 & 2). Any archaeological remains or aircraft debris were to be recorded and mitigation measures were to be put in place should the need arise. The ground cover at the time of the survey consisted of dense heather and unimproved upland pasture.

No archaeological features or traces of aircraft wreckage were discovered during the targeted walkover survey which was undertaken over the 100m buffer zone surrounding the location of the crash site and along the proposed route of the intra-site access roads within the vicinity of the crash site.

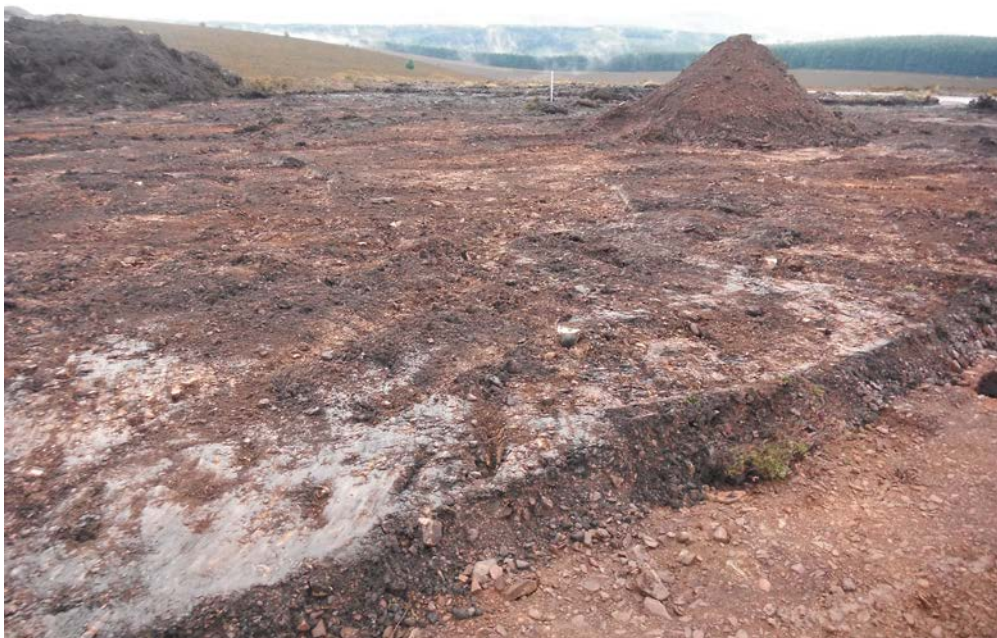
Fig. 3 Final removal of subsoil from Turbine 5 area to reveal archaeologically sterile natural

Topsoil (**001**) across the development site is firm black peaty material varying from 0.1 to 0.2m in depth (Figs 3 to 6), which overlay a dark grey/brown gravel/silt subsoil (**002**), which contained occasional sub rounded stones up to 0.1m in diameter. The subsoil (**002**) directly overlay the natural substrate (**003**) which varied from orange to brown/pink gravelly silts and clays across the site (Figs 3 to 6). No archaeological remains and no traces of a crashed aircraft were uncovered during the watching brief.

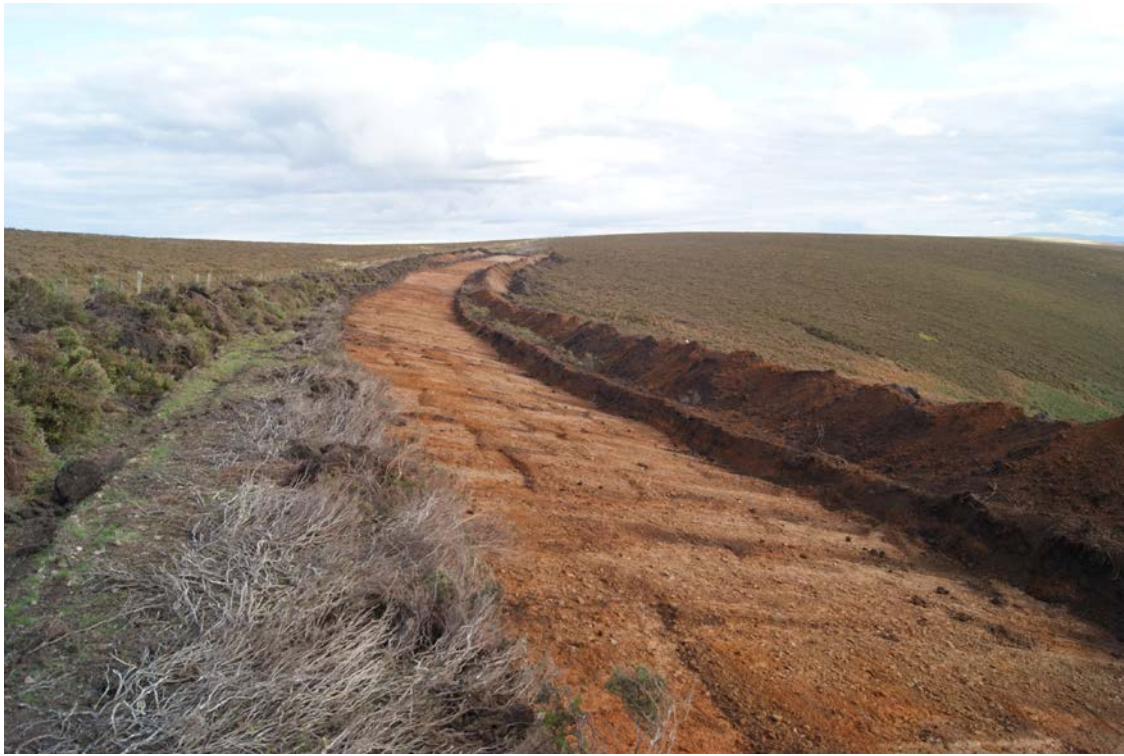
Fig. 4 Access track between Turbines 10, 14 and 16 stripped

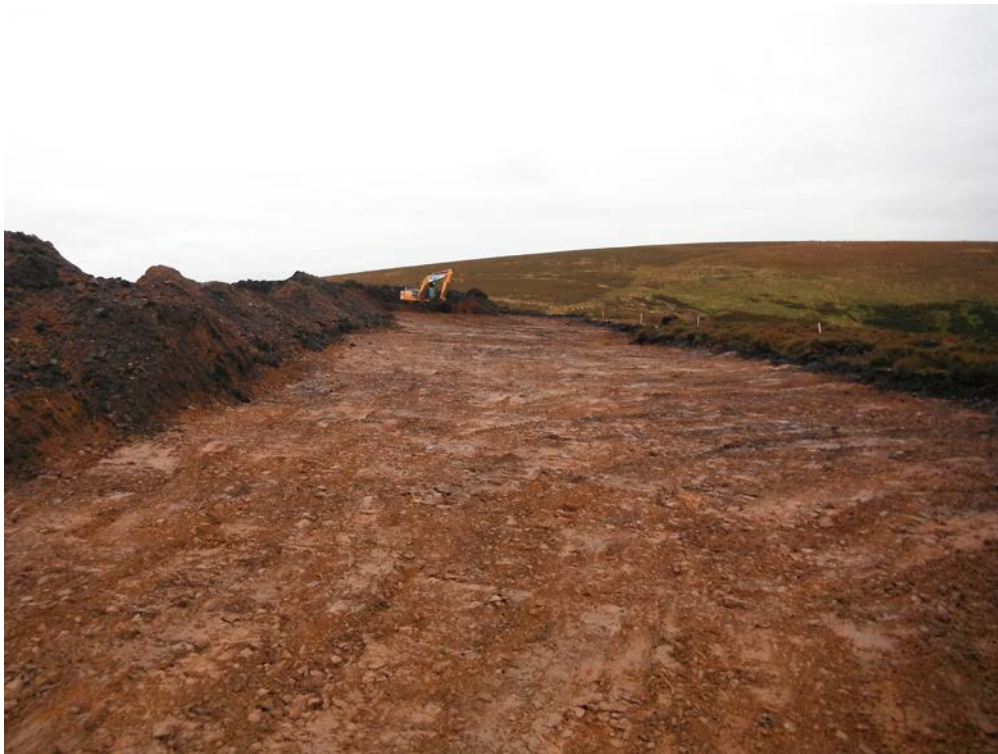
Fig. 5 Final topsoil stripping at Borrow Pit C.

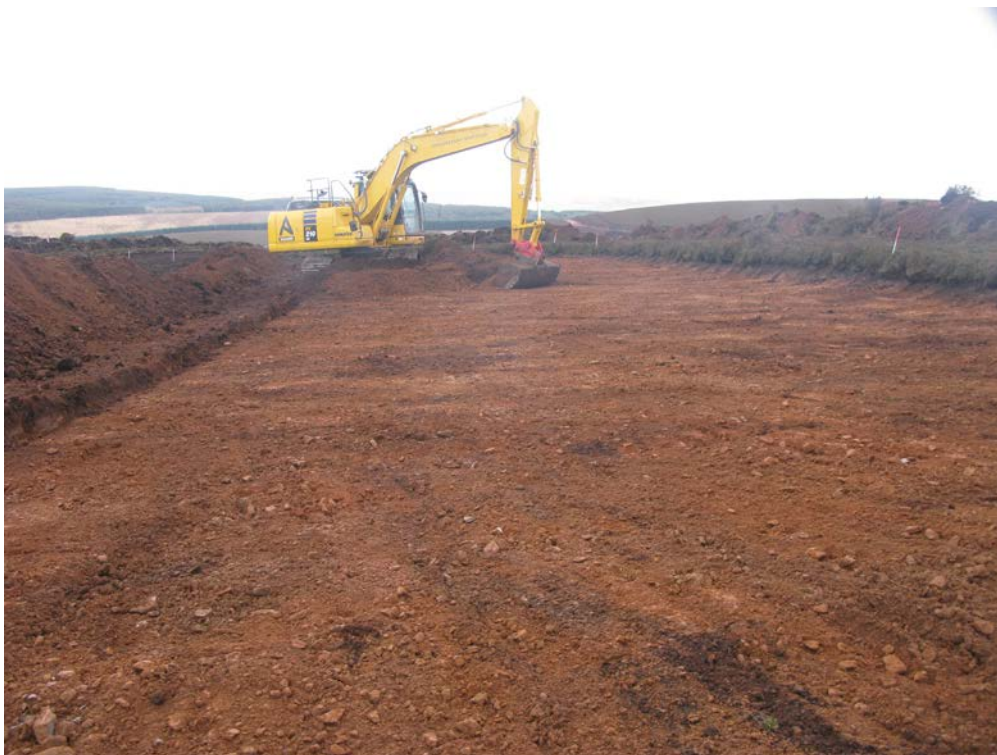
Fig. 6 Final topsoil and subsoil stripping at Turbine10
