**Yester House, Gifford, East Lothian**

**Archaeological Watching Brief**

**Report No. 3308**

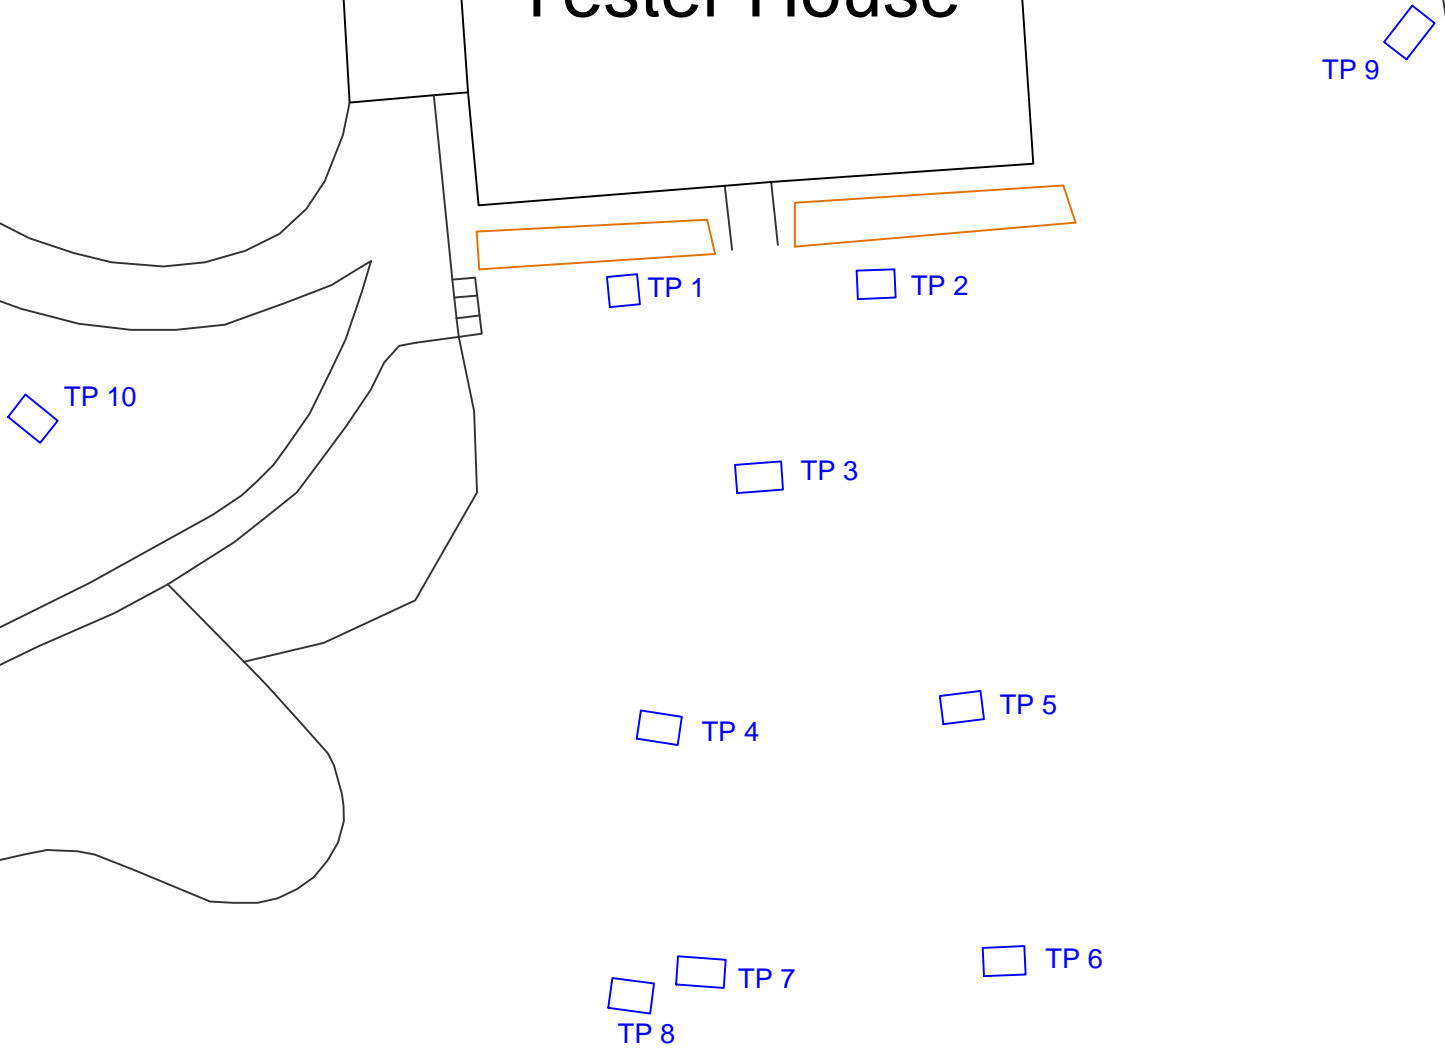
<b>Title:</b> Location of trial-pits	Fig No:	1	Report:	3308	Drawn by:	SW	CKD:	TN	Date:	08/07/2015
	<b>Client:</b> Yester House									
<b>Project:</b> Yester House, Gifford, East Lothian: Trial Pits	<b>Scale:</b> 1:500

Trial-pit location

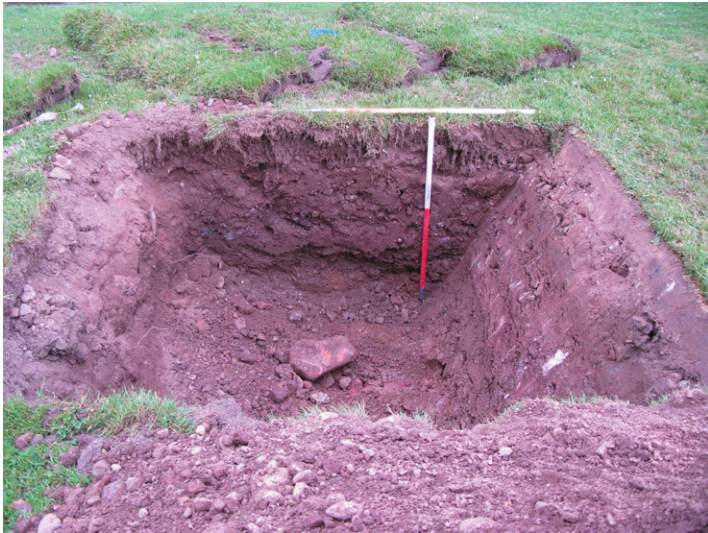
Fig. 2 - Photograph of Trial Pit 1

Trial-pit 1 measured 1.8m by 2.3m by 1.1m deep and was located 5m to the south of the west wing of the house. A 0.3m thick mid-brown silty sand topsoil (**001**) overlay a dark red sandy gravel 0.35m thick, containing clay and small rounded stones (**002**). This may be redeposited natural used to build up the area in front of the house. A lens of redeposited topsoil (**003**) may represent a former ground surface, lending credence to **002** being redeposited natural. Below this lay dark brown/red sandy gravel (**004**), which is considered to be probable natural.

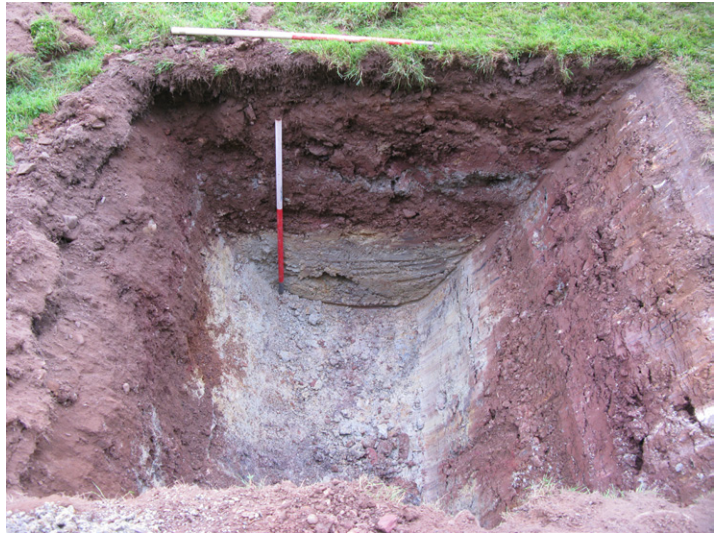
Fig. 3 - Photograph of Trial Pit 2

Trial-pit 2 measured 1.8m by 2.6m by 1.5m deep and was located 6m south of the east wing of the house. Topsoil (**001**) overlay subsoil (**002**), as in trial pit 1. Below this was darker brown/red sandy gravel with no clay (**005**), which lay on top of a light grey sandy clay (**006**); both deposits appear to be natural.

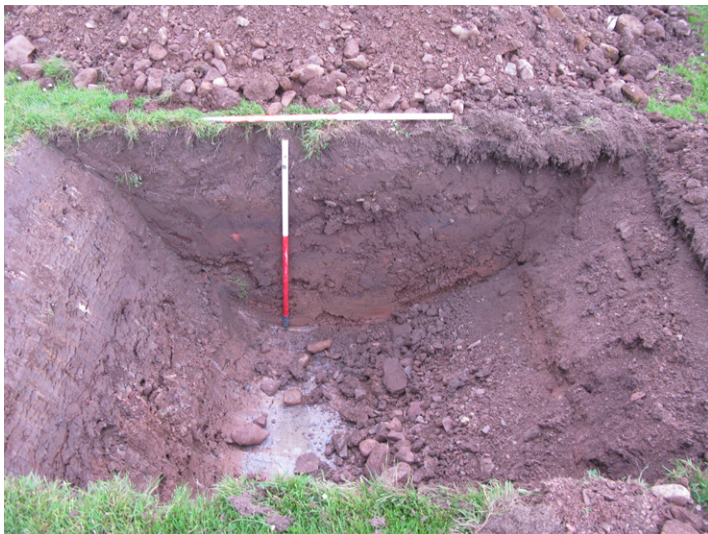
Fig. 4 - Photograph of Trial Pit 3

Trial-pit 3 measured 1.8m by 2.6m by 0.95m deep and was located approximately 14m due south of the stairs leading up to the main door of the house. 0.25m of topsoil (**001**) was followed by 0.5m of **002** which lay on top of 0.2m of a clayey sand (**007**). Below this, **006** was visible in the base of the trial pit.

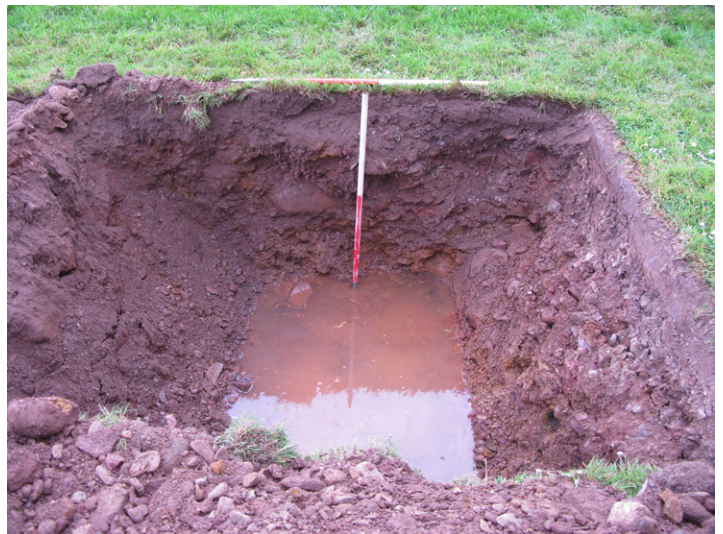
Fig. 5 - Photograph of Trial Pit 4

Trial-pit 4 measured 1.8m by 2.7m by 1.25m deep and was located 27m south of trial pit 1. 0.3m of topsoil overlay 0.45m of dark red brown sandy gravel (**004**). A bright orange sandy gravel (**008**) was visible in the base of the trial pit.

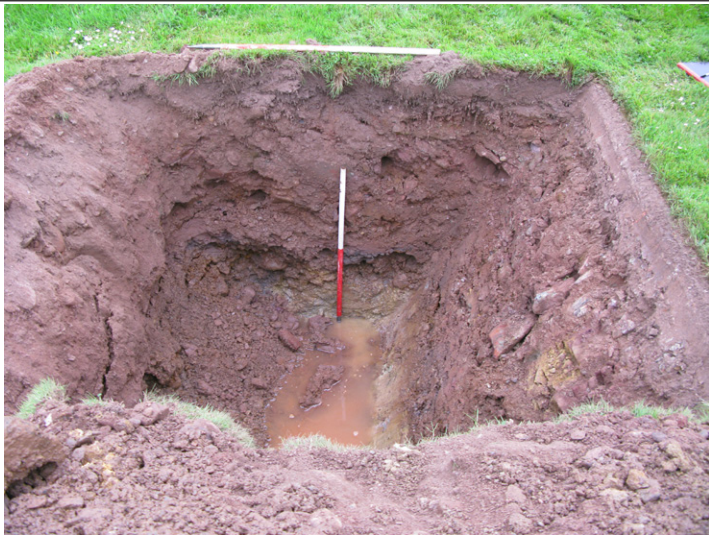
Fig. 6 - Photograph of Trial Pit 5

Trial-pit 5 measured 1.8m by 2.4m by 1.5m deep and was located 27m south of trial pit 2. In this trial pit 0.2m of topsoil overlay 0.55m of the red/brown gravel (**002**), which in turn lay on top of darker red/brown sandy gravel (**003**). 0.3m of yellow grey sandy clay (**006**) was visible in the base of the trench.

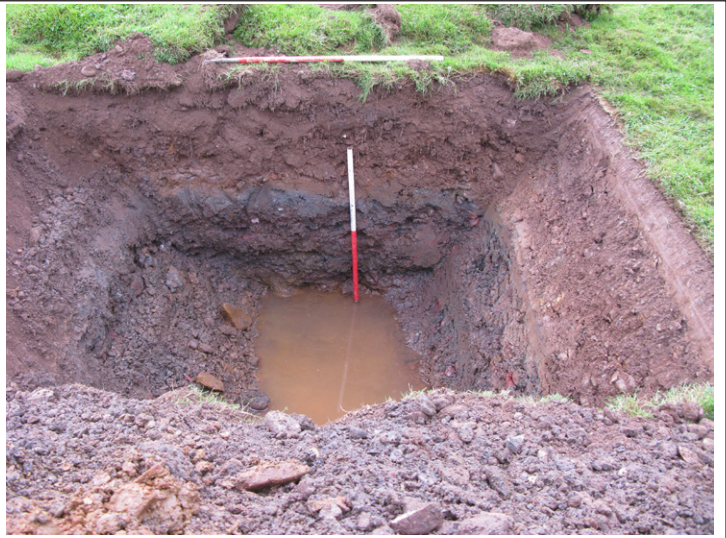
Fig. 7 - Photograph of Trial Pit 6

Trial-pit 6 measured 1.8m by 2.8m by 1.5m deep and was located 15m south of trial pit 5. 0.2m of orange/red sandy gravel containing clay (**009**) lay beneath 0.2m of topsoil (**001**). Below the gravel was 0.7m of mixed grey/orange sandy silt (**010**). Bright orange sandy gravel (**008**) was visible in the base of the trial pit.

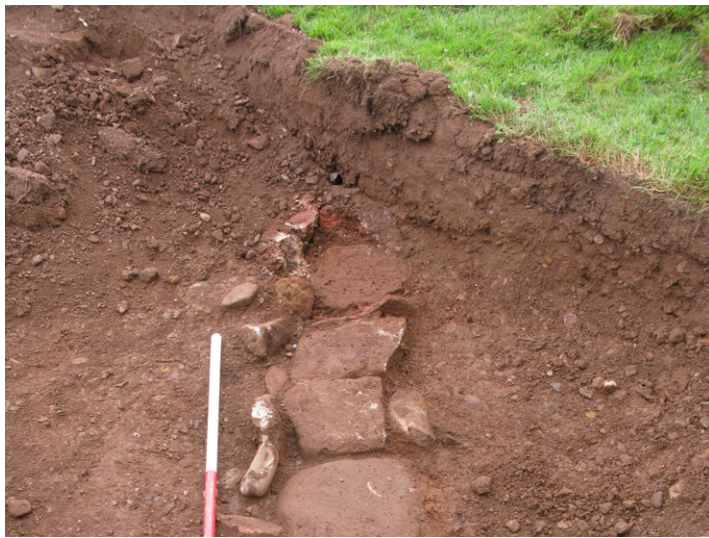
Fig. 8 - Photograph of Trial Pit 7

Trial-pit 7 measured 1.8m by 2.9m by 0.3m deep and was located 15m south of trial pit 4. This trial pit was only excavated to 0.3m deep, as a stone culvert (**011**) running NW-SE was encountered at this level. The culvert itself was not excavated but was cleaned and recorded before the trial pit was backfilled.

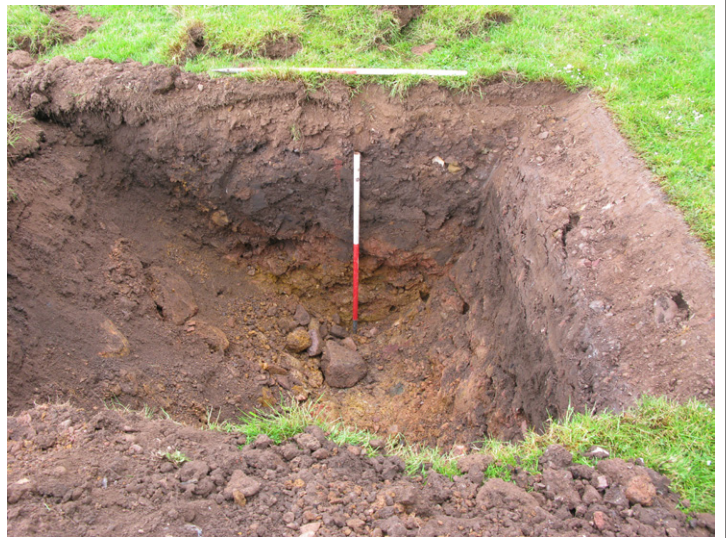
Fig. 9 - Photograph of Trial Pit 9

Trial-pit 9 measured 1.8m by 2.5m by 1.1m deep and was located to the east of Yester House. A layer of topsoil (**001**) 0.3m thick overlay a 0.5m thick layer of dark brown soil with charcoal inclusions (**013**), which may be redeposited topsoil or garden soil, as seen in trial-pit 1. Below this deposit was orange/yellow sandy silt containing angular and rounded stones (**014**).

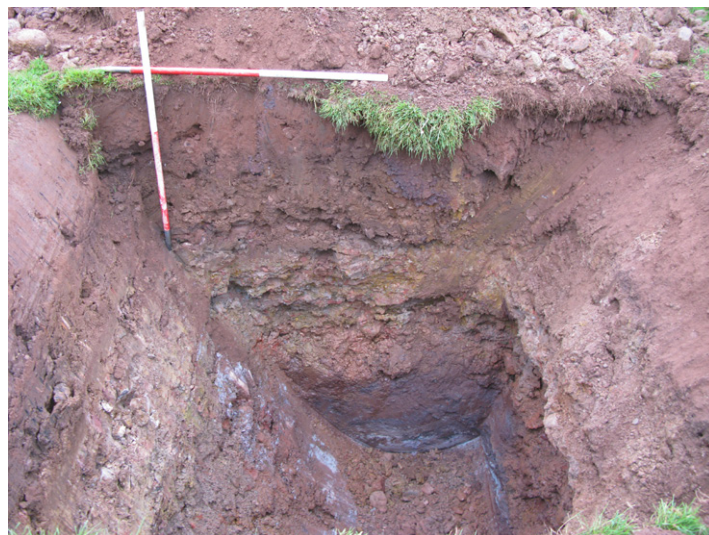
Fig. 10 - Photograph of Trial Pit 10

Trial-pit 10 measured 1.8m by 2.5m by 2.4m deep and was located to the west of Yester House. Excavation revealed that the topsoil (001) overlay dark brown sandy silt which in turn covered mixed grey/brown sandy silt (016). Very friable, dark red/burgundy clayey silt was uncovered in the base of the trial pit.
