## **Greenhouse 1 Drainage System, Newhailes Estate, Musselburgh**

### **Archaeological Watching Brief**

**Report No. 3331**

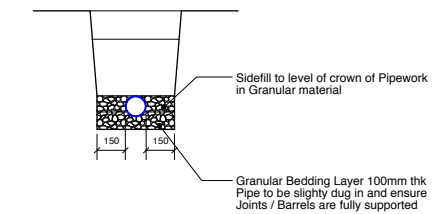
**Class P Bedding Detail**  
 Suitable for Flexible / PVCu Pipe  
 Subsoil - Sand, Silty Sand, Clayey Sand - Loose  
 Scale 1:20

Granular material in accordance with the recommendations of BS 5955:Part 6 1980  
 Graded particle size not exceeding 4/10mm for both 110mm OD and 160mm OD Pipes

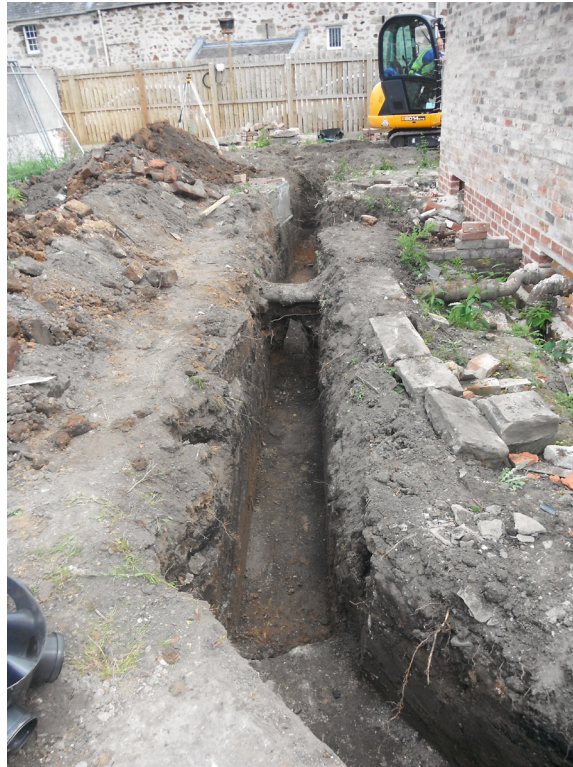
Fig. 3 Photograph of drainage trench on the northern side of greenhouse, from the west

Along the northern elevation of the greenhouse, the drainage trench was 0.8m deep at its north-western end, increasing to 1.5m in depth at the point where the two trenches converged at the southeast gable. This trench was excavated through 0.15m to 0.3m of re-deposited topsoil (**003**), overlying 0.3m to 0.4m of dark brown/black silty sand (**002**) which contained brick fragments, rubble and glass. This deposit overlay 0.3m of dark brown/green sandy clay subsoil (**001**). Towards the eastern end of the trench, near the convergence point, beige/orange gravelly clay natural (**000**) was revealed at a depth of 1.0m.

Three features (Figs. 2-3) were discovered in the trench along the northern glasshouse elevation, all of which were related to the greenhouse and associated drainage visible on the surface outwith the trench under watching brief. A concrete surface (**007**) was discovered close to the western end of the trench cut into silty sand (**002**) and overlying subsoil (**001**). A modern drainage inspection chamber was visible on the surface immediately adjacent, and given their proximity it is likely these are related, with the concrete surface being a form of foundation for the inspection chamber.

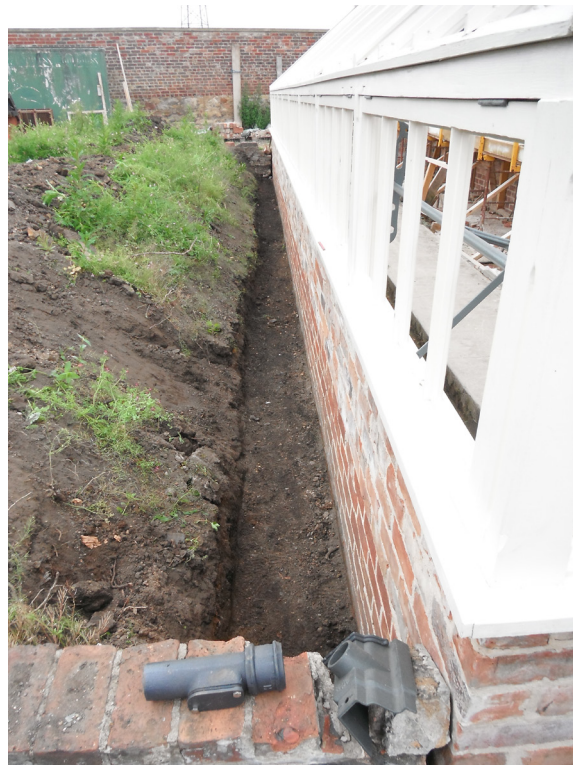
Fig. 4 Photograph of drainage trench on the southern side of greenhouse, from the east

The trench running along the southern elevation of the greenhouse was hand excavated to a depth of 0.1m, through re-deposited topsoil (**003**). No archaeological remains were discovered (Fig. 4).
