## **Muirhall South Wind Farm, South Lanarkshire**

### **Archaeological Watching Brief**

**Report No. 3354**

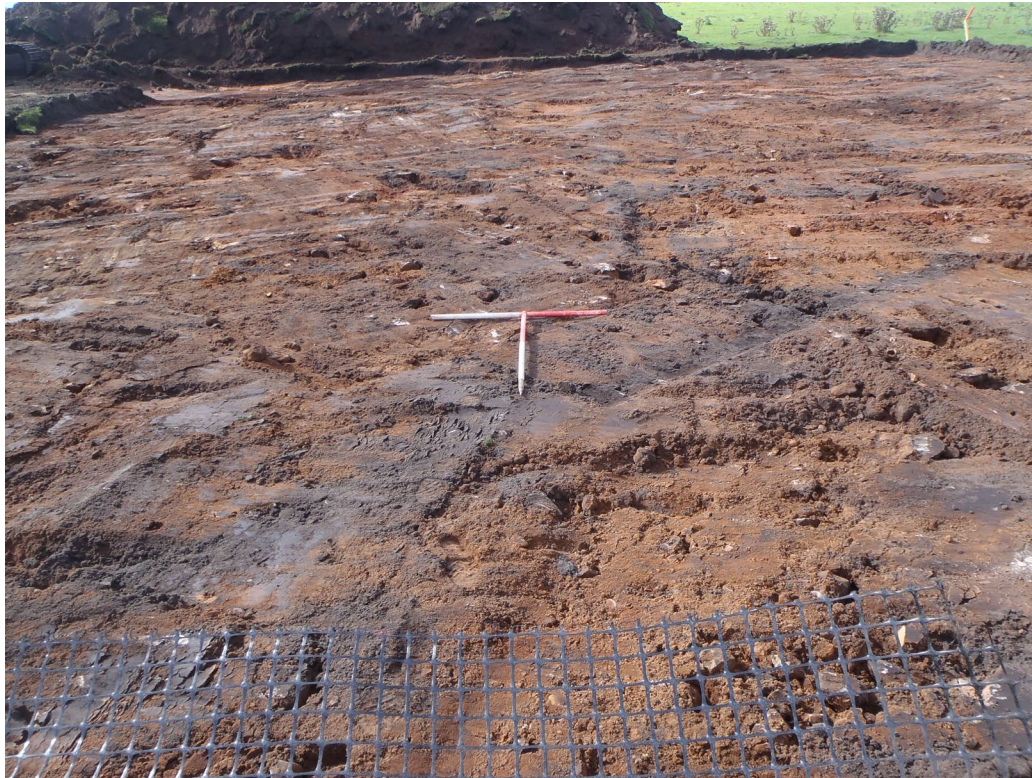
Fig. 2 Stripped topsoil at Turbine 10

In all groundworks monitored, stratigraphy consisted of 0.3m to 0.4m of dark brown and black silty sand topsoil (**001**) overlying natural geological substrate (**000**) comprising mid orangey-brown clayey sand and sandy gravel. In isolated instances up to 0.2m of orange-brown sandy clay subsoil (**002**) was observed overlying natural

showing a diffuse horizon with the overlying topsoil (Figs. 2, 3). No buried archaeological remains were discovered during ground breaking works.

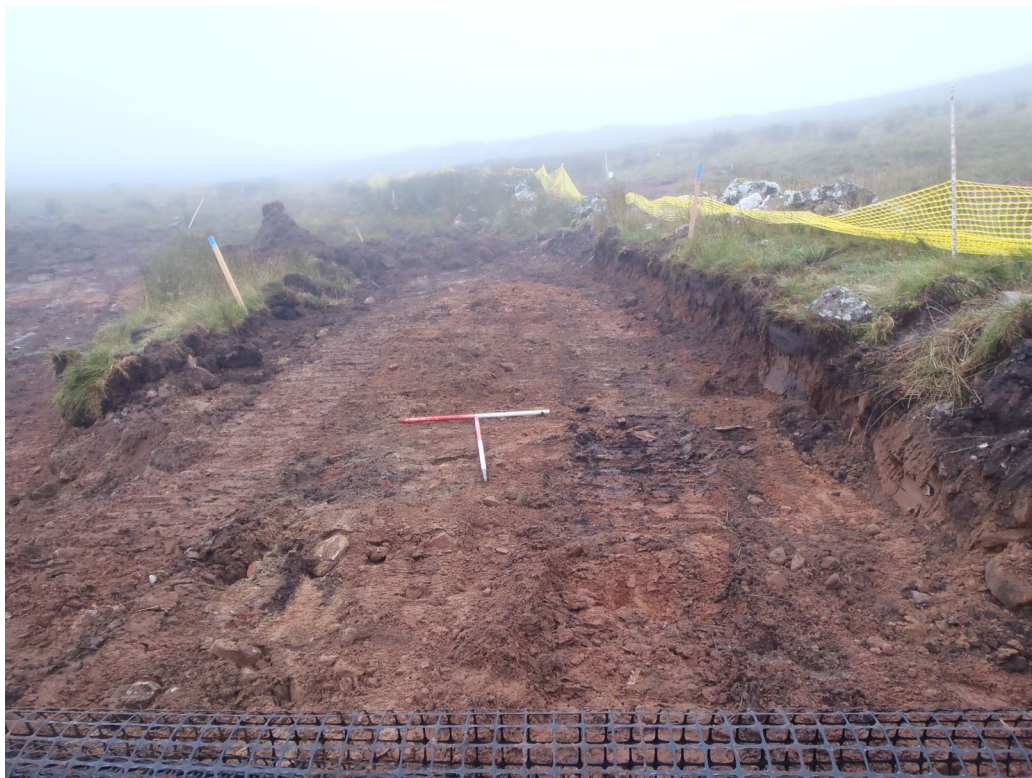
Fig. 3 Access road at Turbine 9 junction

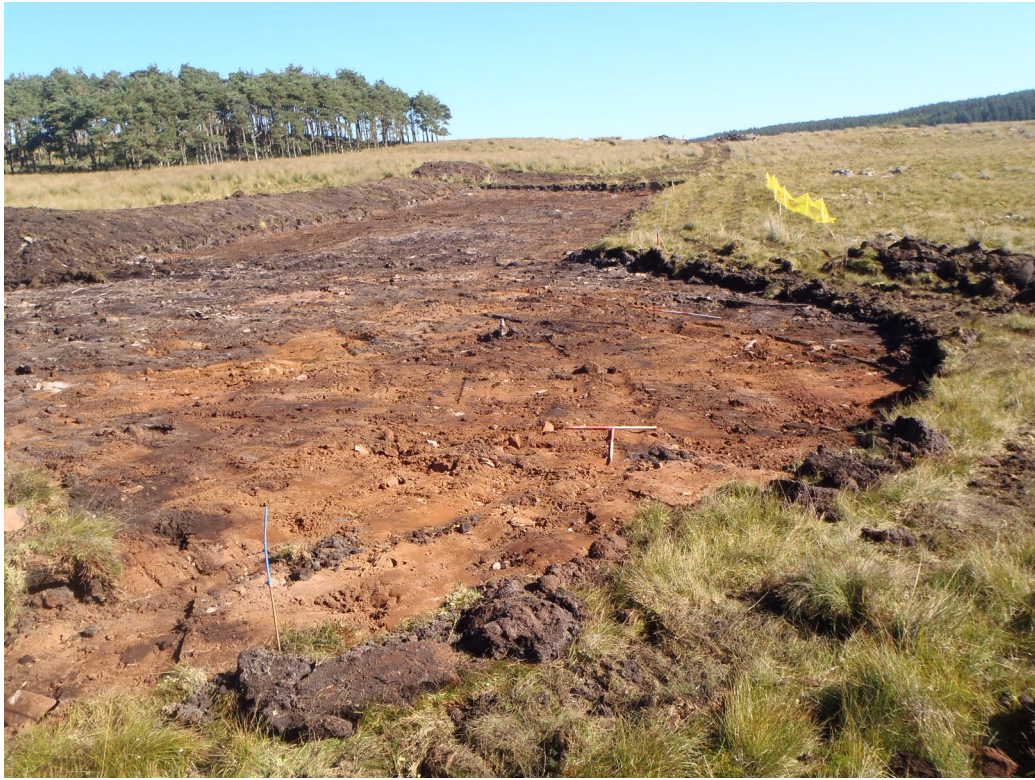
Fig. 4 Site 9 fenced off next to excavated Crane Pad at Turbine 11

Sites 2a, 7a, 7b, 9s, 9t and 9m (Fig. 1) were all fenced off with canes and high visibility marker tape, or high visibility nylon mesh fencing accordingly (Fig. 4).

The topography of the site consisted of undulating upland, with ground cover of heather and rough pasture (Fig. 4). Numbers in bold refer to contexts, a summary of which can be found in Appendix 2 at the rear of this report.
