**Defence and National Rehabilitation Centre,
Stanford Hall,
Nottinghamshire
Archaeological Watching Brief**

Report No. MK029/15

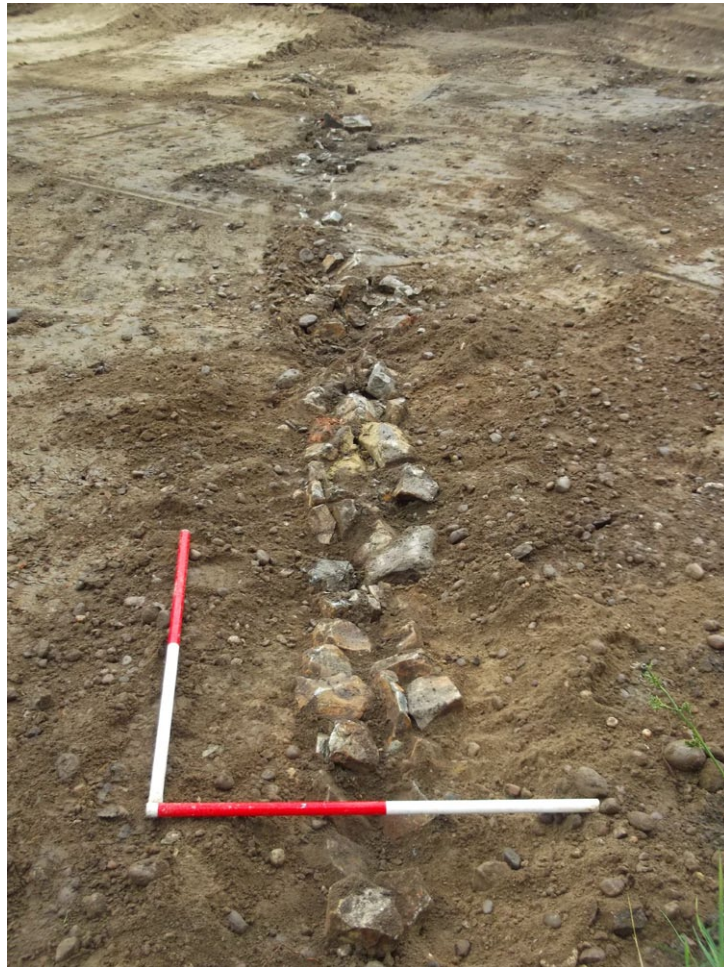
Fig. 8 - Shot of stone soakaway / drain **1002** in Area 1, looking NE

4.2.1 This was located in parkland to the north of Stanford Hall near to the northern entrance of the site. Topsoil was stripped off this area in preparation to a temporary site compound. Two flint and brick rubble drains were exposed during this work (**1002** and **1004**) (Fig. 8). These represent drainage for the parkland and date to the late 18th or early 19th centuries. The topsoil in this area was approximately 0.25m deep and the natural geology exposed was mixed sands and gravels (Fig. 9).

- 7.4.1 The stone drains / soakaways found in Area 1 were clearly intended to drain the grass of the parkland in this area. These will are likely to have been installed as part of the redevelopment and enlargement of the estate by the Dashwoods dating to the late 18th century or early 19th. The drains are unlikely to be associated with the earlier deer park and are possibly too rugged to be from the post-1887 Ratcliffe phase of garden development for which one would expect ceramic drains.

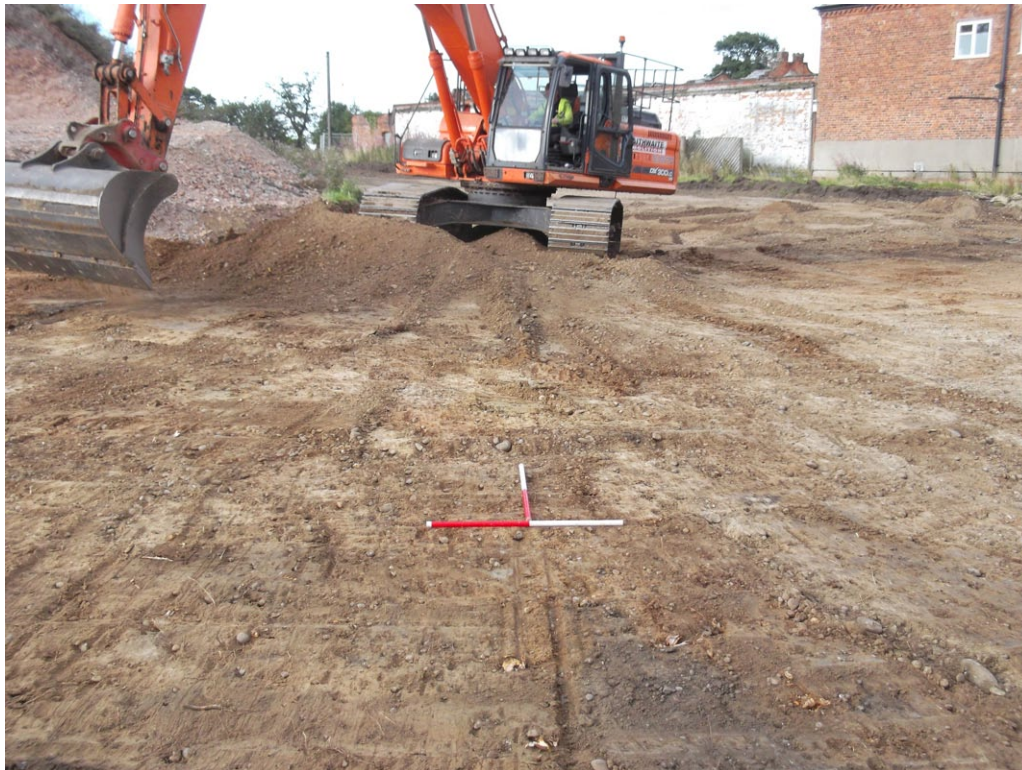
Fig. 10 - Area 2.1 being stripped, looking NE

4.3.1 This was located around the walled garden (Areas 2.1-2.4) and inside it (Area 2.5). The area included a former cricket field and areas around the listed swimming pool. Topsoil was stripped down to natural gravels prior to the construction of new buildings and redevelopment of the walled garden. Overall the topsoil was approximately 0.1-0.4m thick and natural geology revealed was natural sands and gravels with occasional larger stones (see Figs. 10-12). The foundations of two mortared brick structures were exposed to the north of the walled garden (Figs. 13 and 14). Structure A (**2003**) comprised a rectangular brick wall foundation measuring approximately 6m x 10m with wall thicknesses of between 0.25-0.38m. The structure was sub-divided by a number small rectangular brick walls. Next to this was Structure B (**2004**), a rectangular brick wall (0.25m wide) measuring 3.25m by 10m in extent enclosing a linear brick surface (8m x 0.87m). Both structures were built from late 19th or early 20th century bricks. Stripping inside the walled garden revealed a cast iron pipe (**2007**, Fig. 15) which may have been used for heating a greenhouse and a short length of brick wall (**2002**) that turned at a right angle wall located close to existing greenhouses (Fig. 16). The wall may have been part of a brick-lined bed or part of a demolished building.

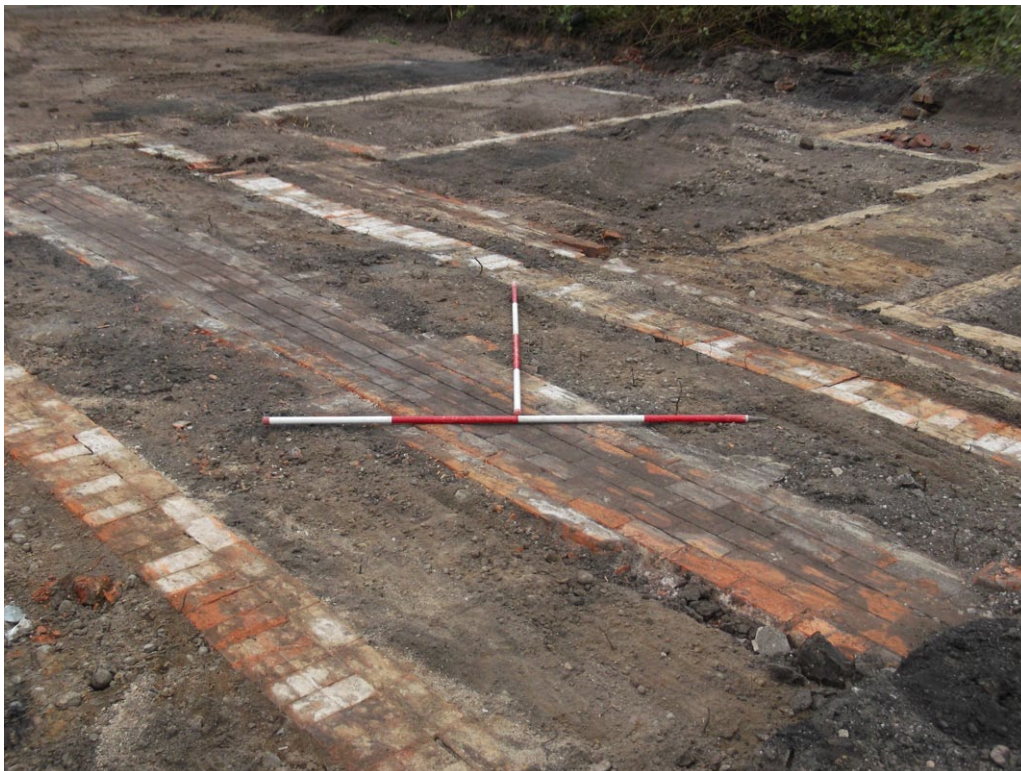
Fig. 13 - Shot of Structure B after cleaning, Area 2.2, looking NE

- 7.3.1 Structures A and B are the foundations of buildings north of the walled garden. Both relate to a building that is first shown on the 6 inch 1901 OS map (revised in 1899) which survived until the 1990s. It is not possible to distinguish the two structures on the historic 6 inch mapping. By 1999, Aerial mapping from Google shows Structure A as roofless with partially collapsed walls. By 2007 the structure has been completely demolished. The brick divisions are evidence that Structure A was divided into several rooms but there was no clear indication of its function. However, given the close proximity of the walled garden this may have been for storage of garden equipment or a greenhouse similar to Structure B. The brick remains of Structure B are the plinth and central linear brick pathway for a greenhouse. This is shown clearly on Google mapping from 2004 onwards. The greenhouse appears to have been demolished shortly before the current development.

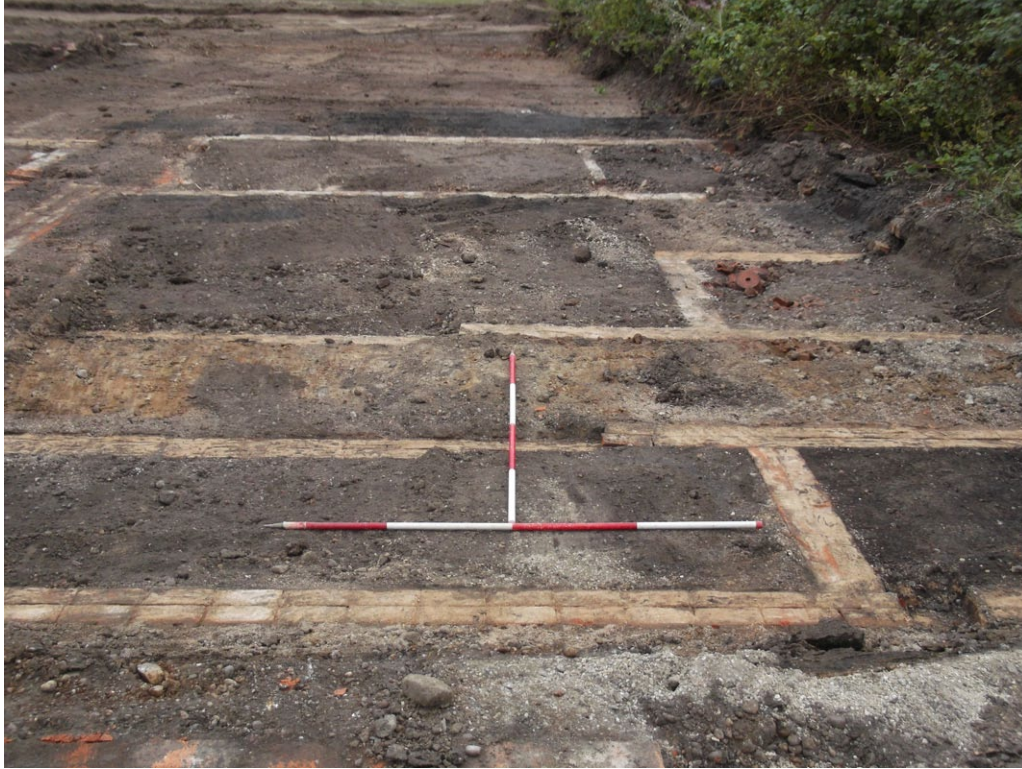
Fig. 14 - Photo of Structure A after cleaning, Area 2.2, looking NW

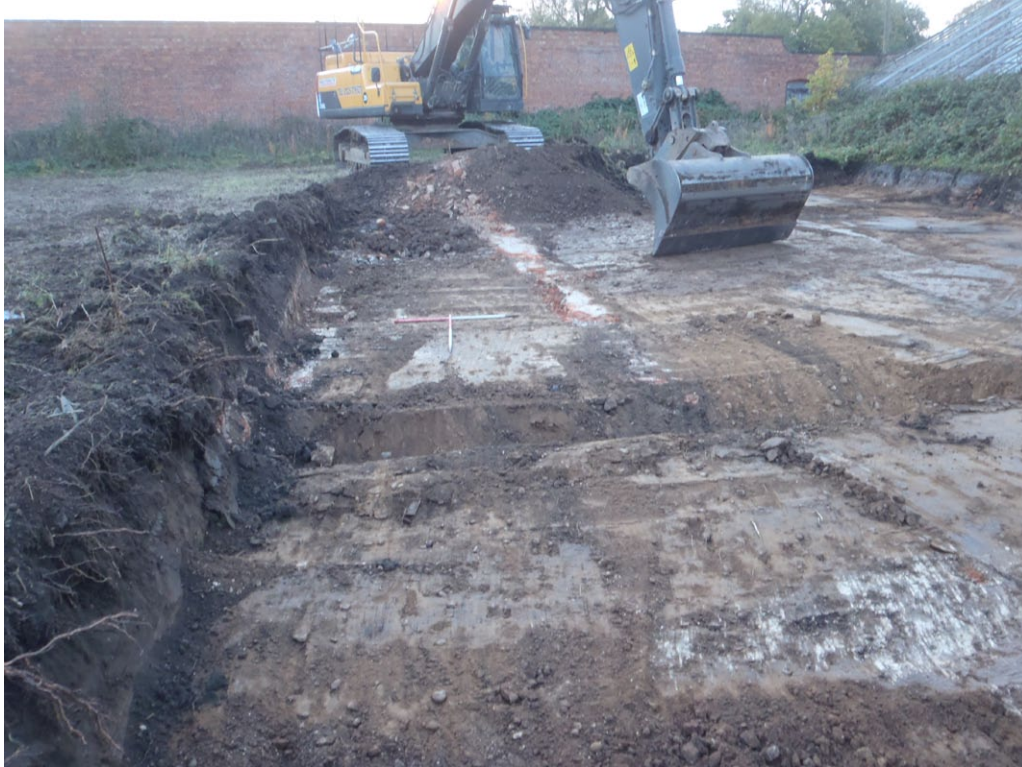
Fig. 16 - Wall 2002 exposed in Area 2.2, the Walled Garden, looking W

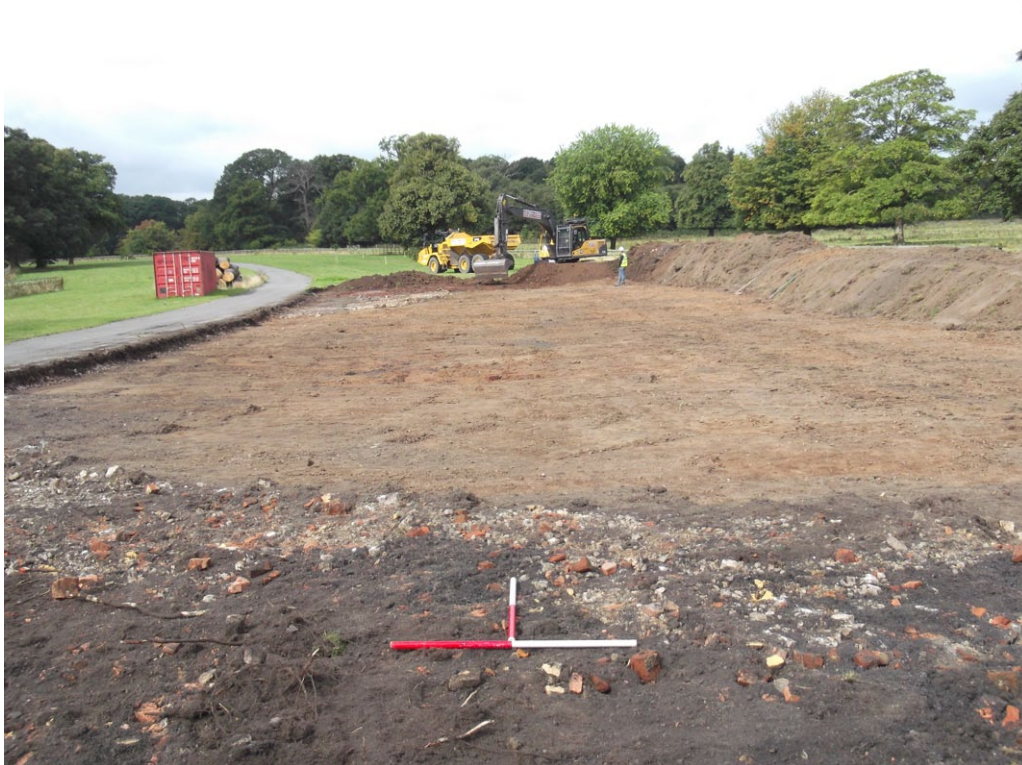
Fig. 17 - Area 3 during stripping, looking NW

4.4.1 This was located to the north of Area 2 and was stripped to a depth of 0.4m (Fig.17). The topsoil was a mid brown sandy silt and the natural geology was orange-grey sands and gravels. No archaeology was found.

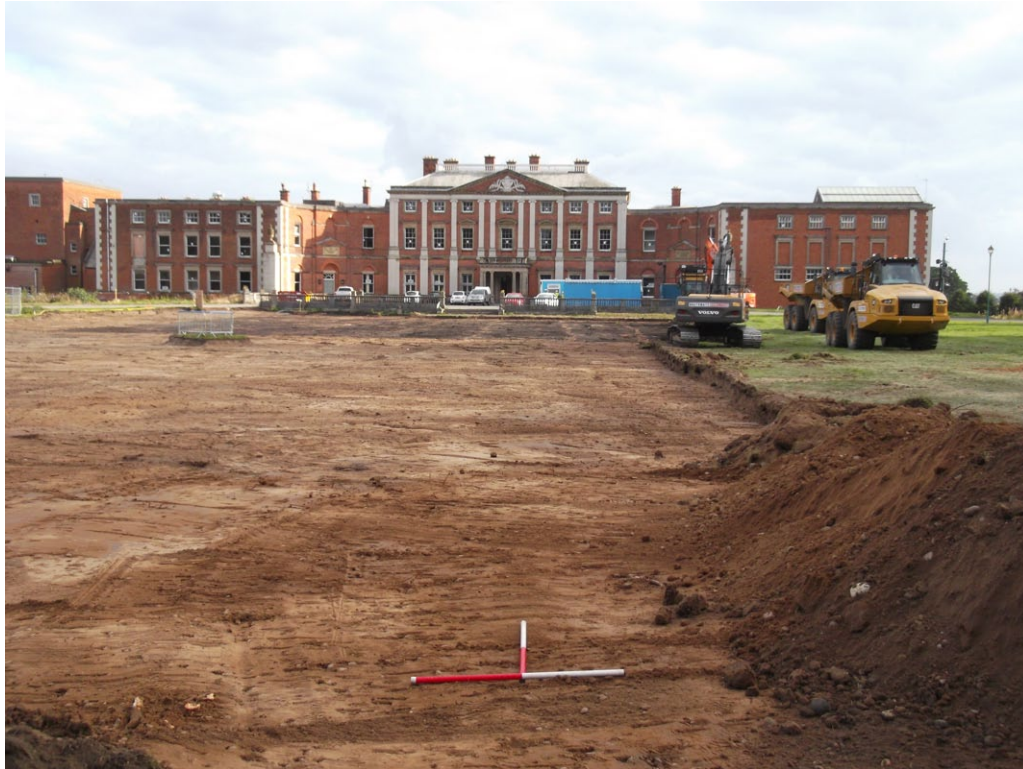
Fig. 18 - General shot of Area 4 being stripped, looking SE

- 4.5.1 This was located in front of Stanford Hall and was stripped of topsoil for a temporary car park and site compounds. The area had formerly been used as a putting green. Overall stripping was carried out to a depth of 0.32m down to the natural geology (Fig. 18). The topsoil was a mid brown loamy silt and the natural, orange-grey sands and gravels. A series of archaeological features were revealed cut into the natural (see Figs. 3-5). Feature A was a linear ditch exposed for 37m aligned NW-SE (Figs. 19-20). The NW end of the ditch ran under the existing road and could not be exposed further in this direction. The ditch became shallower to the SE and had been truncated by modern activity 10m to the south of Feature B. Four sections were excavated across the feature from NW to SE, **4002/2003**, **2004/2005**, **2006/2007** and **2015/2016**. The ditch had a width of 1.09-1.39m, a depth of 0.48-0.78m and a V-shaped profile. The ditch had a single fill, a light grey sandy silt with occasional sub-rounded pebbles and no finds. A section excavated at the S end of this feature revealed that it cut linear Feature B. In plan it was clear that it was cut by drainage feature C. Feature B was a shallow linear ditch running on an E-W alignment exposed for 32m (Figs. 21-22). The ditch had been truncated at either end by modern activity probably relating to the creation of the putting green. Four sections were excavated running E to W, **4008/2009**, **2010/2011**, **2012/2013** and **2017/2018**. The ditch measured 0.6-0.8m wide and 0.18-0.27m deep and had a shallow dish to flat profile. The fill was a light sandy silt with occasional sub-rounded stones and a single sherd of grey ware – probably Roman in date. The ditch was cut by Feature A, drainage feature C and a brick culvert (**4014**). Feature C was a 0.4m wide drainage channel (**4021**) exposed for approximately 14m filled with rubble (**4020**) including post medieval brick and brown silt (**4019**). This feature cut Feature A and B. A relatively modern brick culvert **4014** (0.4m wide) ran NW-SE across the area and was connected to a further culvert running NE-SE. Located in the NE of Area 4 were two shallow pits (**4023** and **2025**) measuring 0.32-0.39m in diameter and 0.1m deep revealed below the topsoil (Figs 23-24). The pits were both filled with fine black-grey sandy silt which included decorated late Neolithic / early Bronze Age pottery fragments (see below). The shallow nature of the features show that they had been heavily truncated.

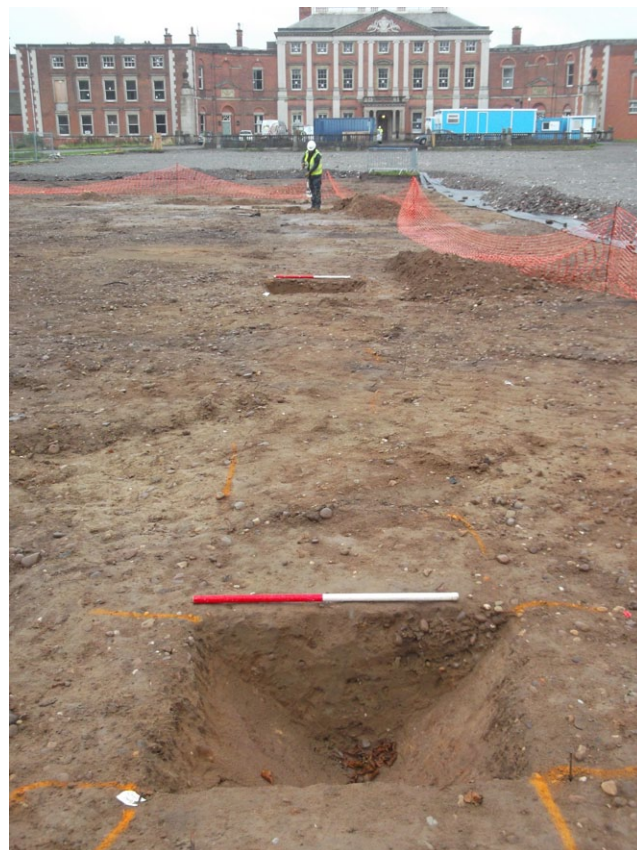
Fig. 19 - Overall view of linear feature A, Area 4, looking SE

- 7.1.2 Excavation of linear features A and B recovered a single sherd of probably Roman pottery. The ditches may be field divisions or boundary ditches. Remains from this period has been found in nearby in East Leake quarry which lies just over 1km to the north. Feature C and the brick culvert are clearly later features and relate to the landscaping of Stanford hall grounds, the former possibly in the 18th century or earlier; the latter from the 19th century.

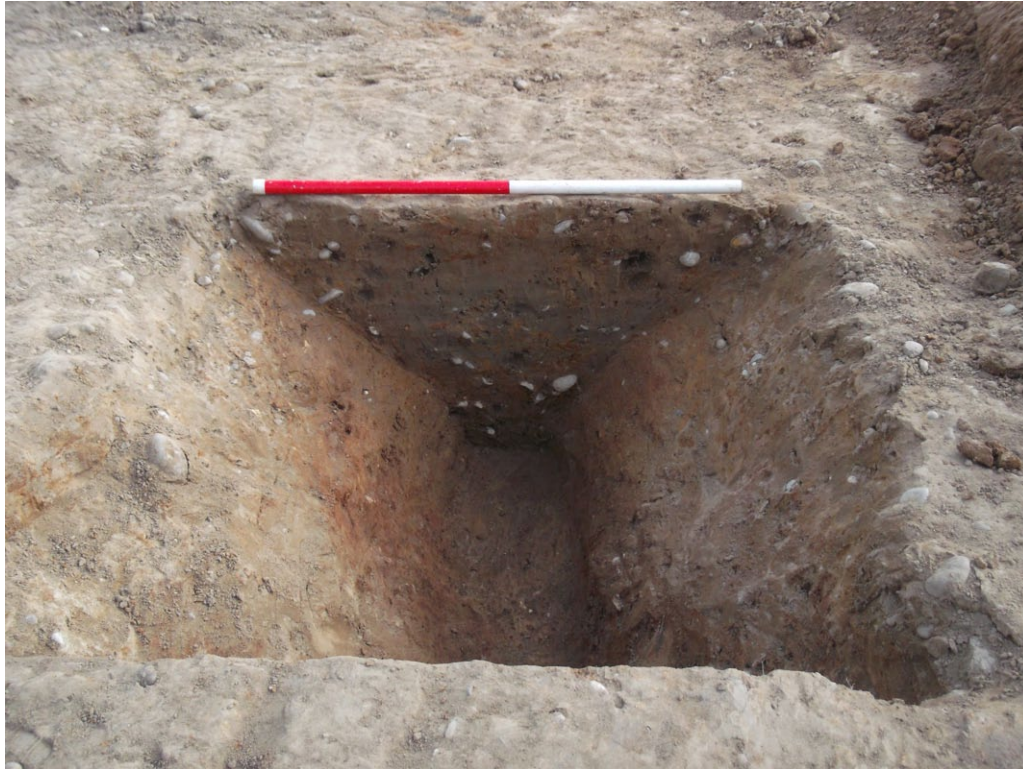
Fig. 20 - Photo of slot **4004 / 4005** across linear feature A, Area 4, looking SE

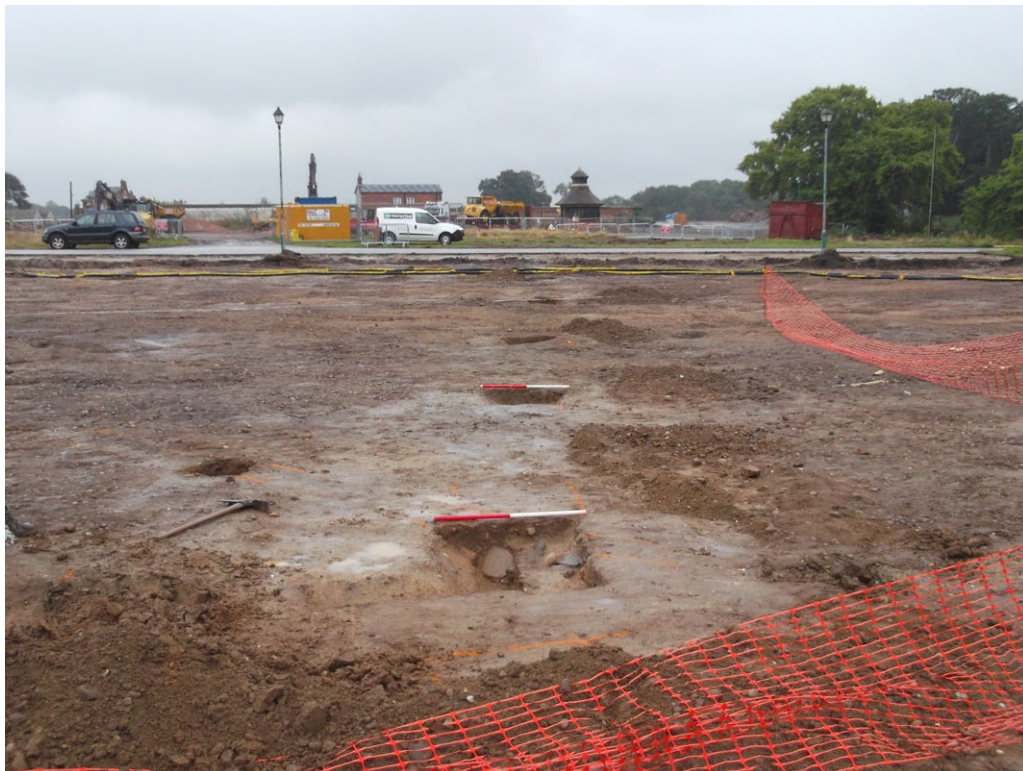
Fig. 21 - Overall view of linear feature B, Area 4, looking SE

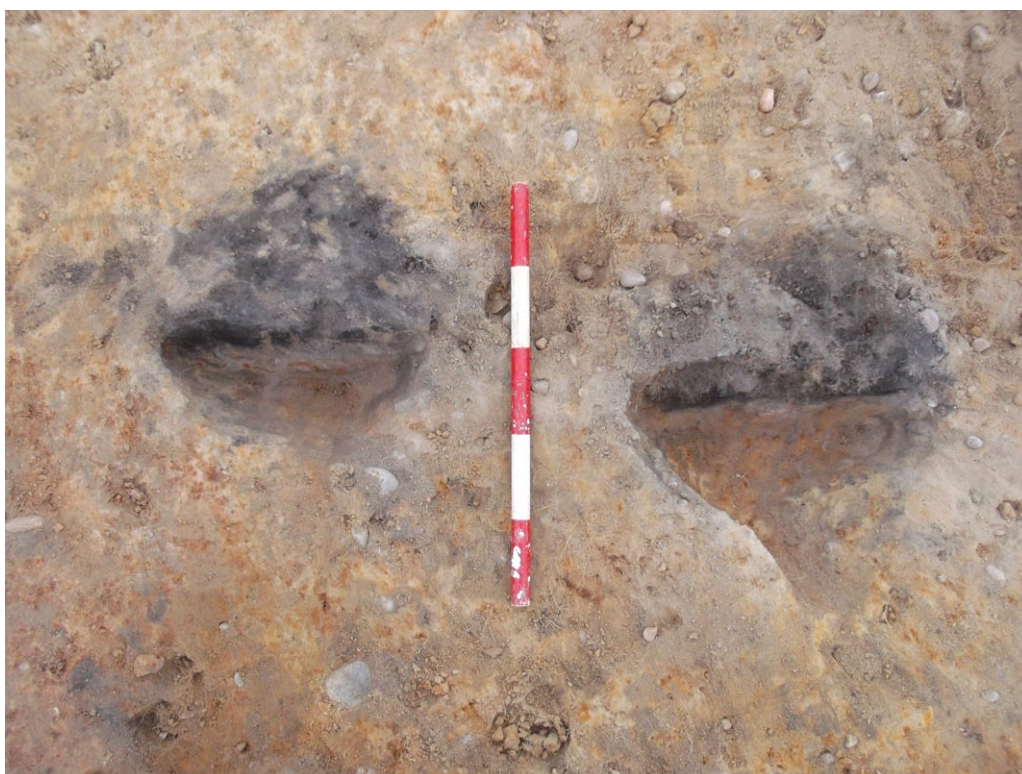
Fig. 23 - Photo of post holes **4023** and **4025** half-sectioned, Area 4, looking NE

7.1.1 The fragments of late Neolithic/early Bronze Age beaker recovered from Pit **4025** can be used to date this feature as well as Pit **4023** which had a similar fill and appears to be contemporary. It is likely that they may have been part of a small group of pits that were truncated by the landscaping around Stanford Hall. The small fragments of burnt bone from **2025** and large quantities of charcoal recovered from both features shows that they were filled with burnt material. The high level of charcoal vitrification suggests a high temperature was achieved during the burning event, though it is unclear if this activity was ritual (such as a pyre burning associated with cremation) or domestic in nature.

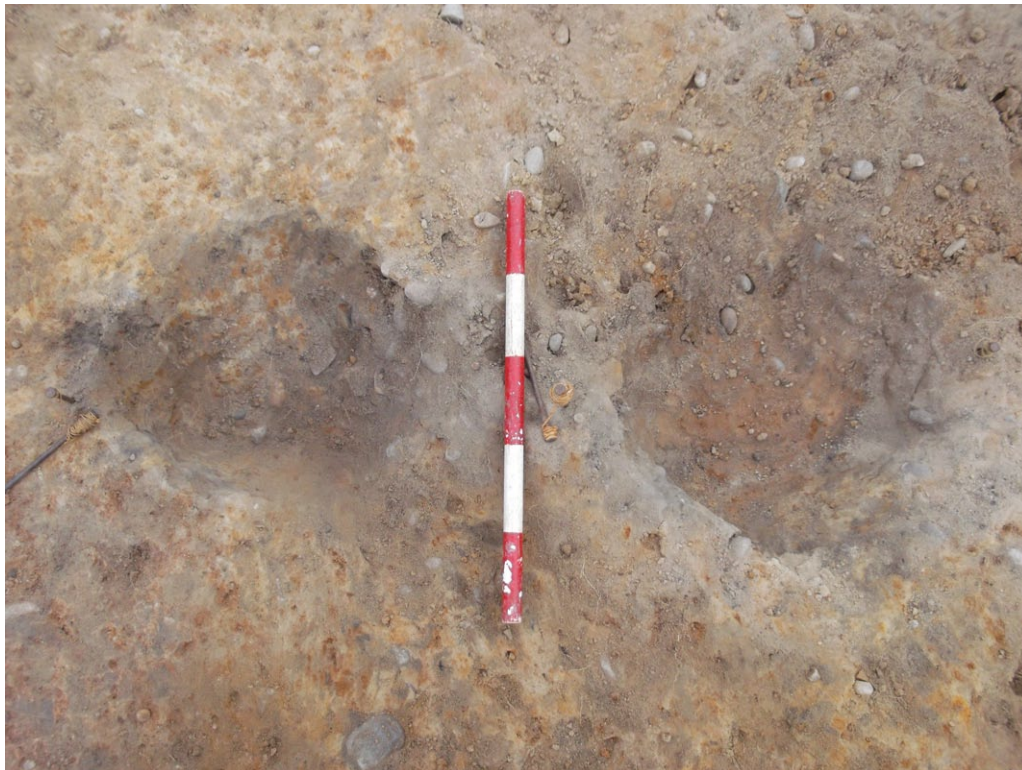
Fig. 24 - Photo of post holes **4023 / 4025** after excavation, Area 4, looking NE

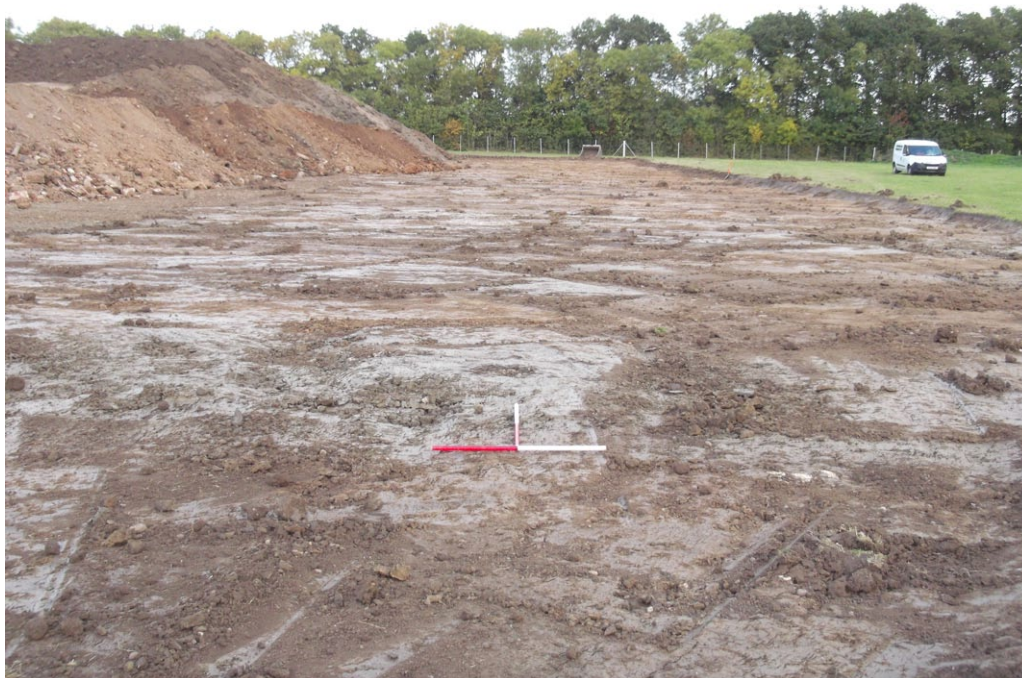
Fig. 25 - Area 6 after stripping, looking NE

- 4.7.1 This was located to the SE of Stanford hall and was stripped prior to being used as a spoil storage bund. The area was stripped to a depth of 0.28-0.38m and exposed natural red-brown clay (Fig. 25) below a mid grey-brown loam topsoil. No archaeological remains were revealed.

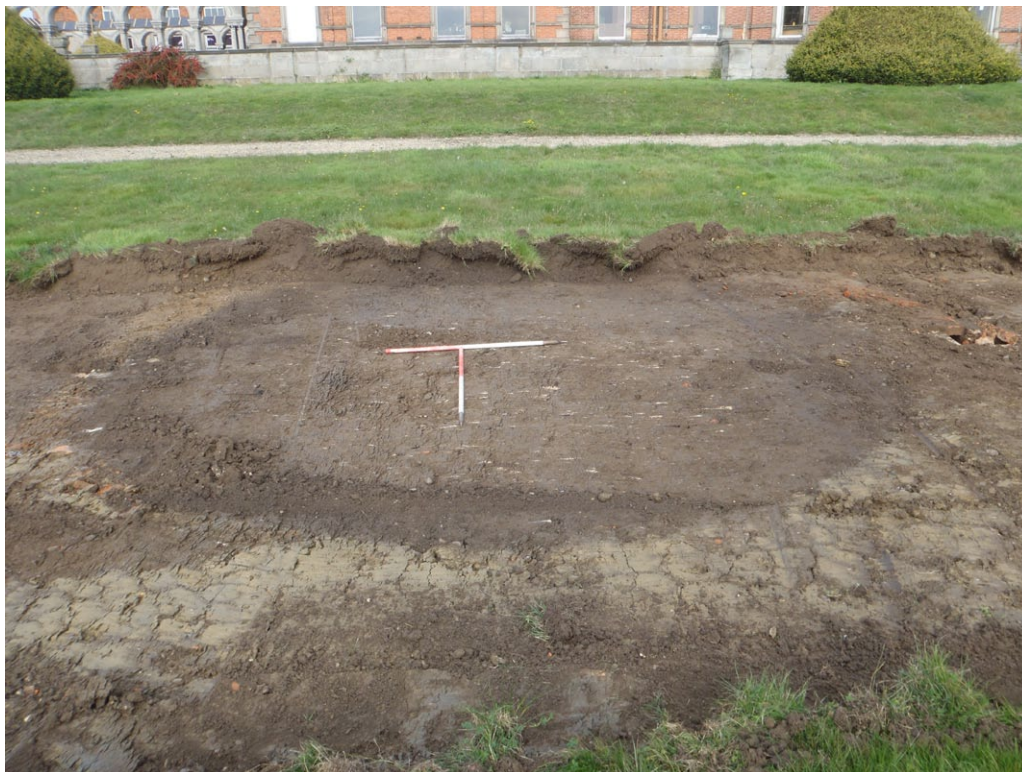
Fig. 26 - Photo of garden feature **7007 / 7008**, Area 7, looking N

- 7.4.2 The remains uncovered to the rear of Stanford Hall in Area 7 mostly relate to the terraced garden created by Ratcliffs after 1887. Culverts **7002**, **7003** and **7006** probably supplied water to the different beds or water features in the terraced garden. Stone **2004** may have been a step on path leading down to the from the central stairs behind Stanford Hall. The function of wall feature **2005** is unclear but it may have been the edge of a path or garden bed. The large circular cut feature filled with topsoil is likely to be a garden bed or tree pit. Pipe **7009** uncovered to the west may be utilitarian and may simply have been a waste water / drainage pipe running from the hall.

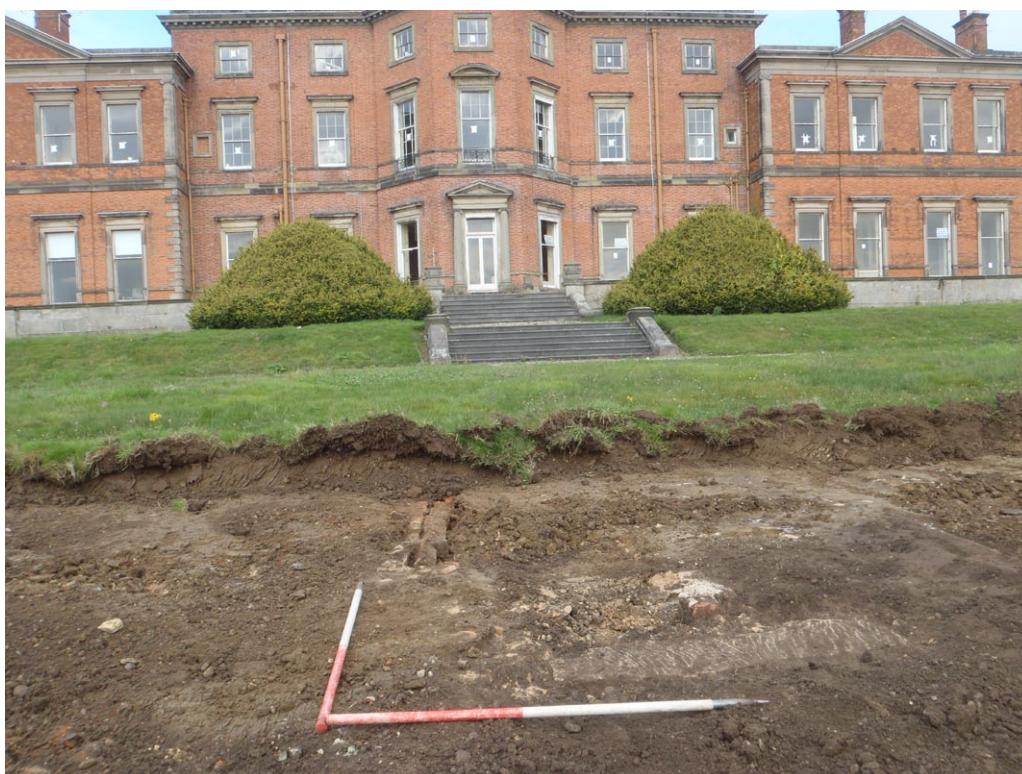
Fig. 27 - Photo of brick feature **7003** and stone **7004**, Area 7, looking NE
