The Butts, Fowlmere, Cambridgeshire **Topographical Survey**

Report No. MK032/15

CFA ARCHAEOLOGY LTD

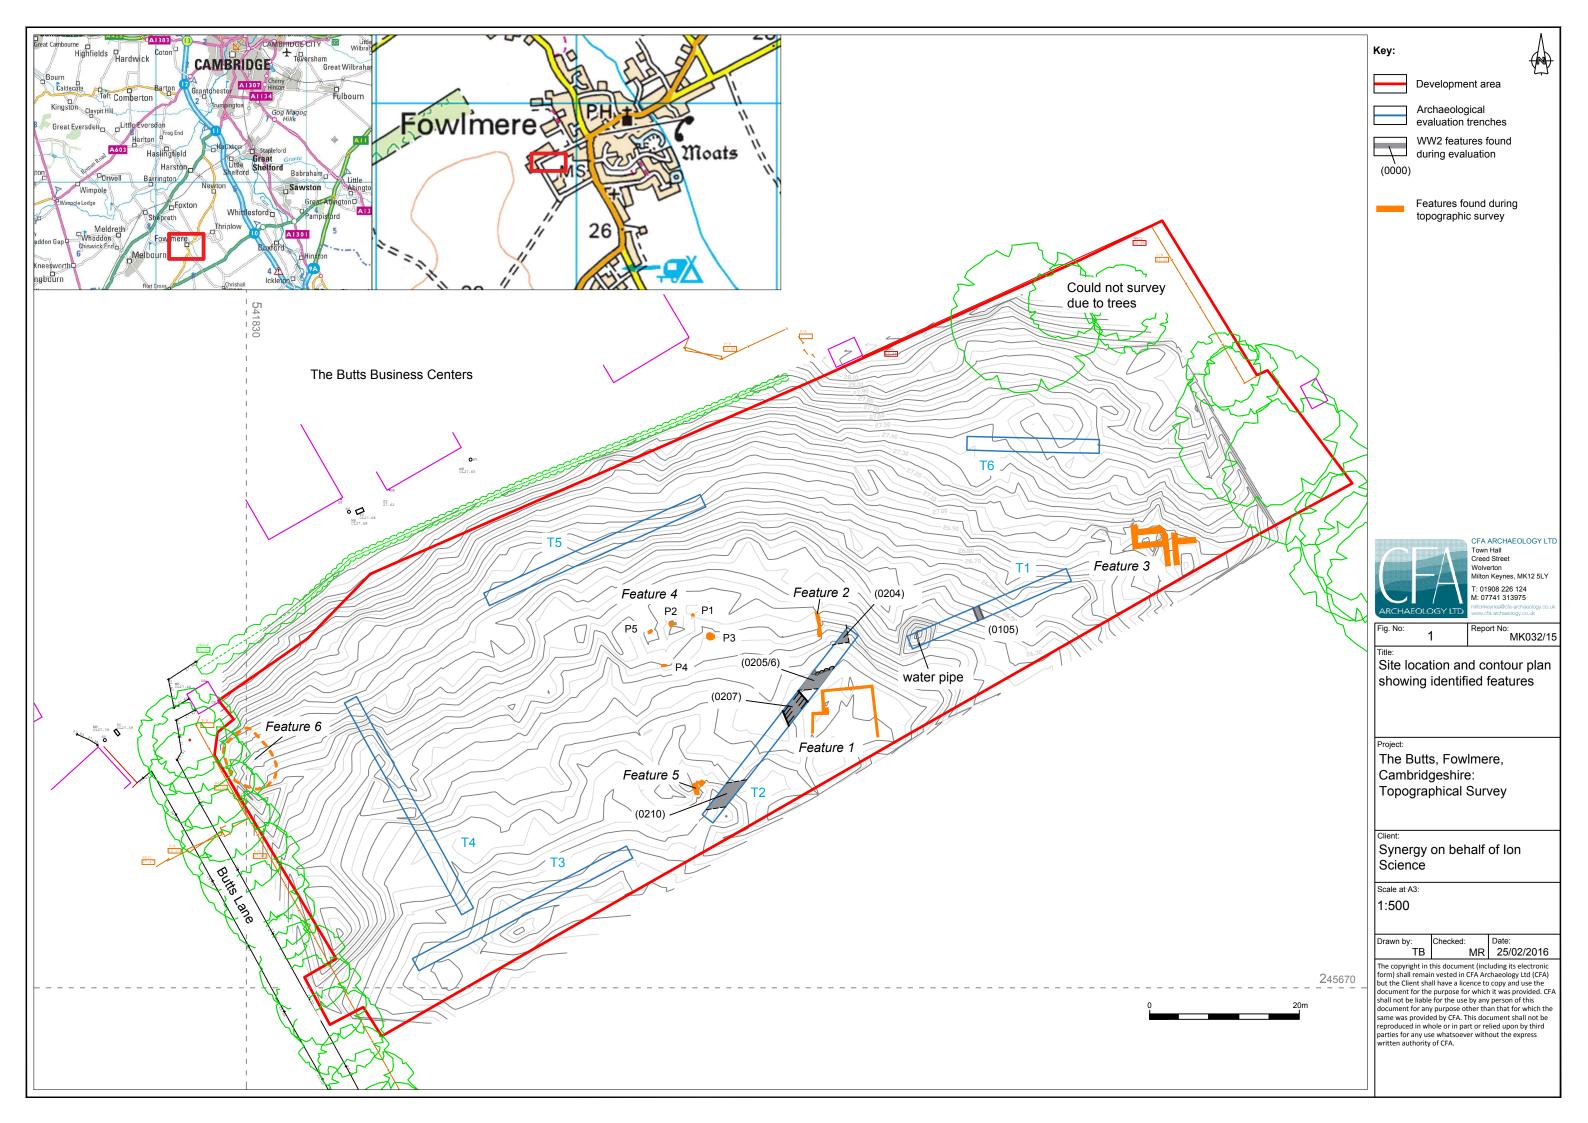
4.1.1 A contour plan and the locations of features identified are shown on Fig. 1. Specific details of features can be found in Appendix 1. The features have also been superimposed on a hillshaded plan of Lidar data (1m resolution) taken before the site was stripped of turf/vegetation (Fig. 2). Features identified are highlighted in bold and discussed below; no sunken or ditch features were revealed by the topographic survey.

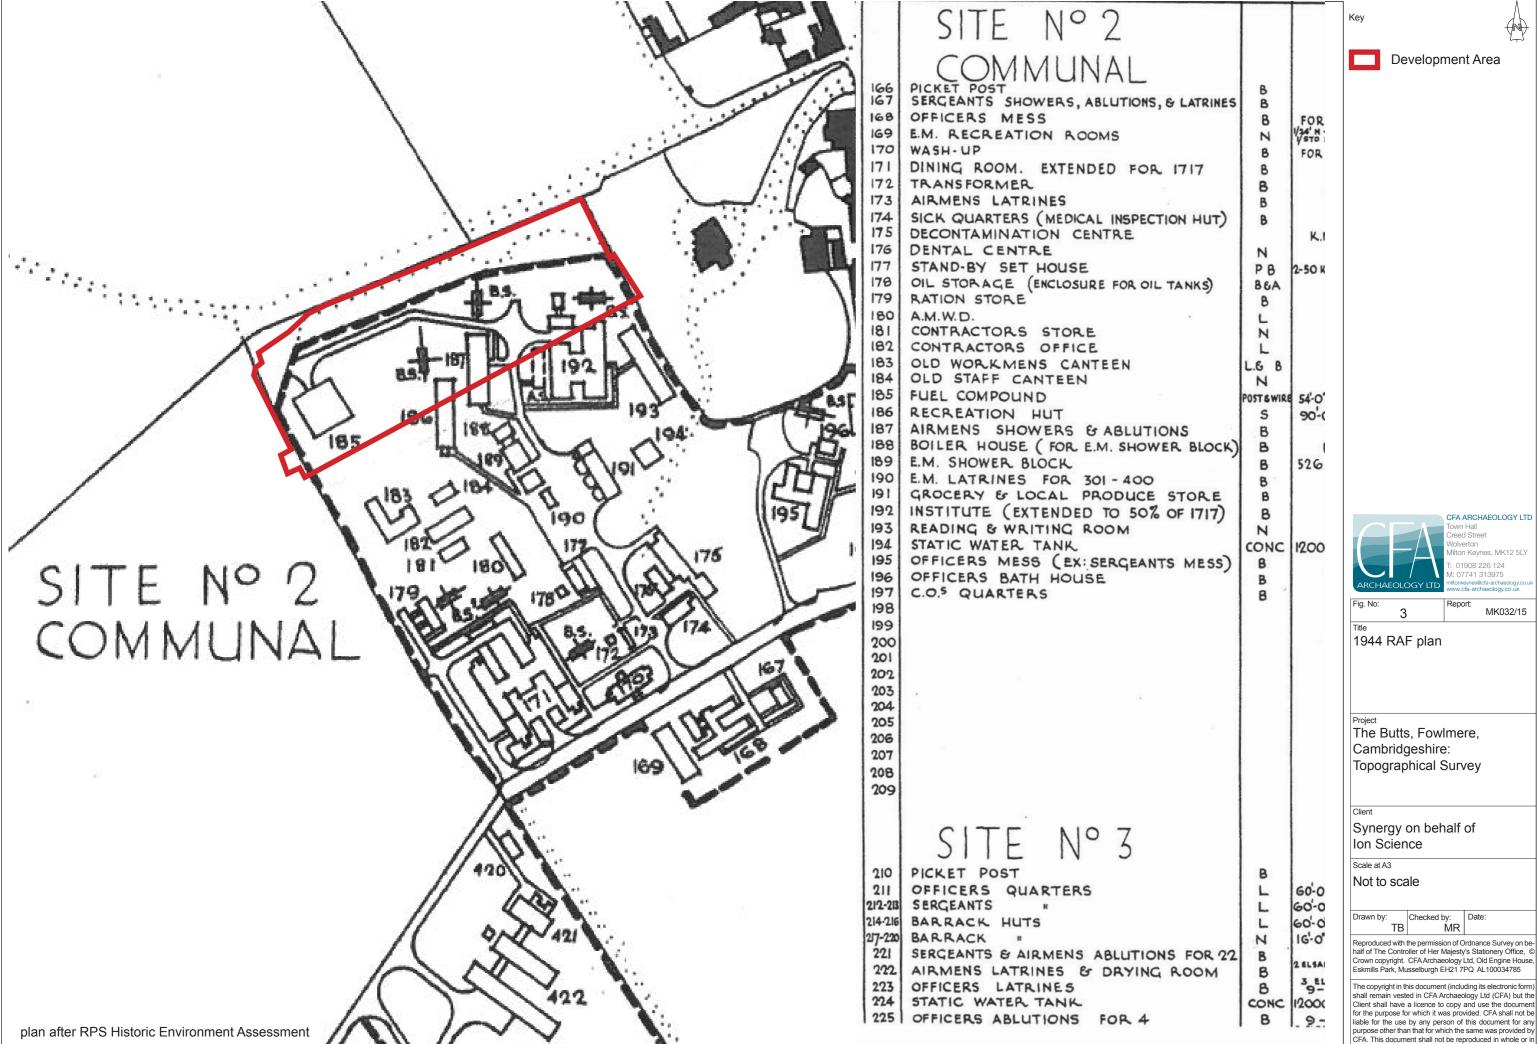
4.2.1 Five features date to WW2. These are either verified by the 1944 RAF plan (Fig. 3) or composed of concrete which is of war-time appearance.

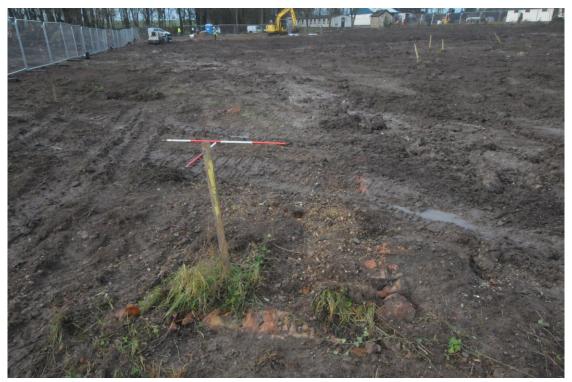
Feature 1 represented the brick foundations for the N end of building 187 on the RAF plan (Figs. 4-6). These lay S of evaluation Trench 2 rather than being the deposits identified in the trench. The analysis of the Lidar data has led to a reinterpretation of (0205/6) and (0204) from the Evaluation. This data, which provides a highly accurate location for the RAF buildings, was previously not available during in May 2015 when the evaluation report was issued. Layers (0205/6) can now be seen to relate to hard standing outside and to the N of 187 (the airmen's showers and ablutions block) with the sacks filled with concrete probably representing the edge of the road to the fuel compound (185) to the N. Ditch (0207) appears to run along the W side of this building. A corresponding shallow ditch on the E side was identified during the survey. The foundations for the interior of building 187 were gravel.

Fig. 4 - Feature 1, looking south-west

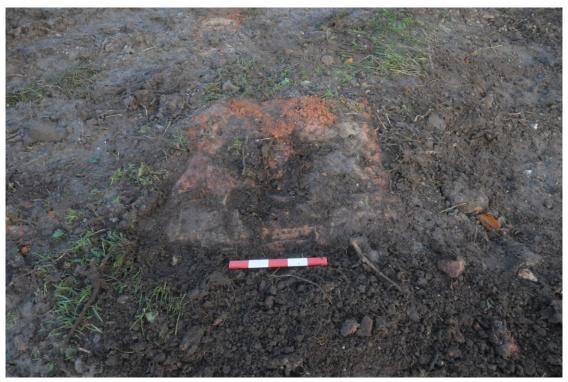
Fig. 5 - Brick pillar, Feature 1, looking north-west

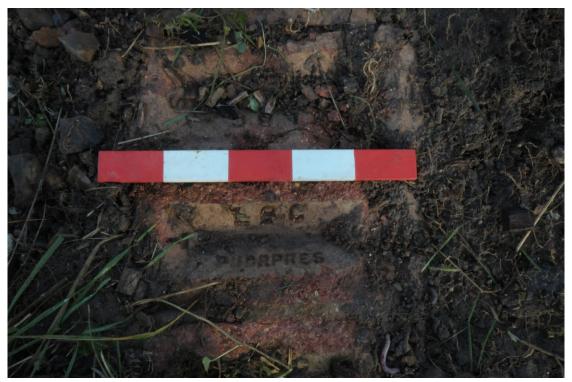
Fig. 6 - Detail of bricks in east wall of Feature 1

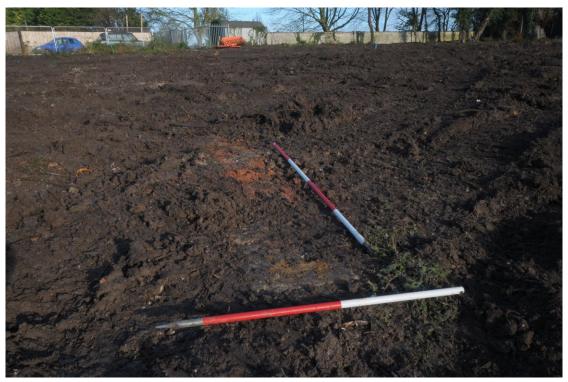
Feature 2 (Figs. 7 & 8) was a small length of brick wall found to the north of building 187 which lies close to concrete slab (0204) from the evaluation. Both these features could relate to the BS marked on the 1944 plan, presumably a bomb shelter.

Fig. 7 - Feature 2, looking north

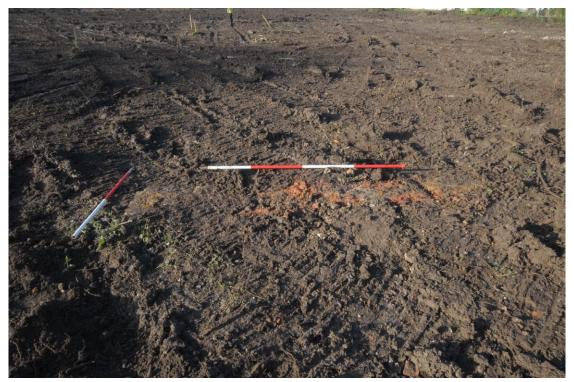
Fig. 8 - Feature 2, looking west

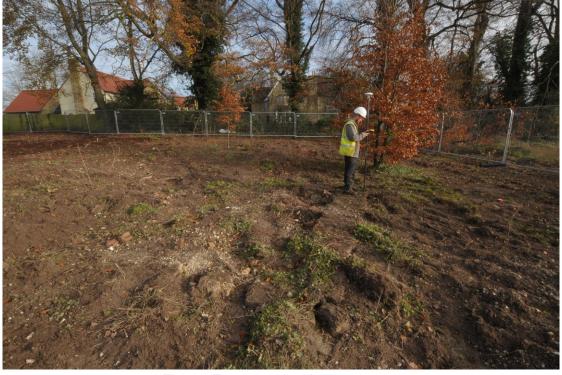
Feature 3 (Figs. 9 & 10) lies to the E of the site and to the N of building 192, the USAF institute. The institute can be seen to lie just outside the site. The remains comprised narrow rectangular slabs of concrete set as right-angles. The feature was partly buried under the post-war landscaping. This corresponds to a BS (?bomb shelter) on the 1944 plan.

Fig. 9 - Feature 3, looking north-east

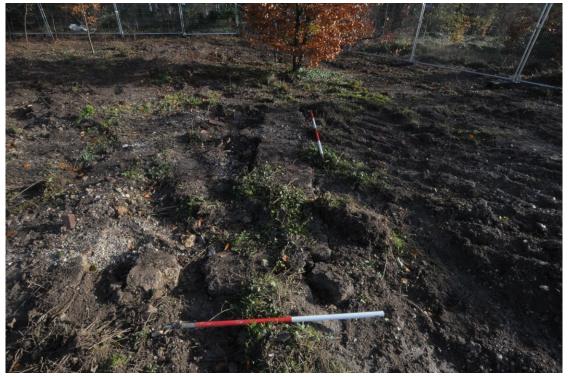
Fig. 10 - Feature 3, looking east

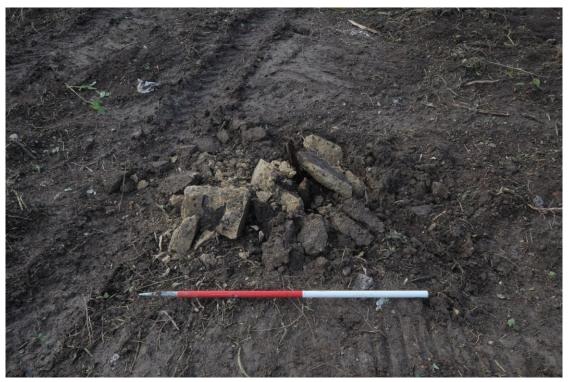
Feature 4 (Figs. 11-16) is a group of five squared concrete posts aligned in a rectangle in the centre of the site. Three of the posts were small (Post A, D and E). Post B was a large square block which had been set around a wooden post which had rotted away. Close by were two cast iron fragments from a pig feeder. Post C was similar to Post B but had been damaged by the site clearance. The feature does not correspond to any structures on the RAF plan but it could have been a temporary post and wire compound or similar structure. Though the concrete of the features appears to be war-time (due to its poor quality) it is possible that this structure may post-date WWII. The feeder shows that the site was used for pig rearing probably after the war.

Fig. 11 - Feature 3, concrete block C, looking south-west

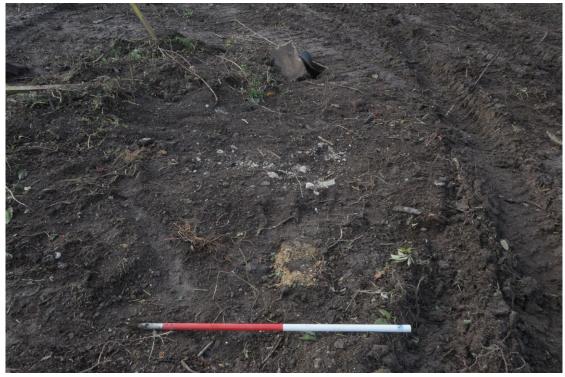
4	Concrete Posts	541887.5 245716.3	A group of 5 concrete post features in a rectangular arrangement covering an area of c. 7m (E-W) by c. 5m (N-S). Post A is a small concrete block 0.25m by 0.3m. Post B which lies 3m to the W is a concrete block 0.3m by 0.35m which has been set around a wooden post which has rotted. Post C which lies 3m north of Post A is the same as post B (i.e. had a central wooden post) but was damaged by site clearance. Post D lies 6m to the W of Post C and measures 0.7m (E-W) by 0.25m (N-S). Post E lies 5m N of post D and measures 0.4m by 0.4m. All the posts are all aligned except Post C which was damaged by a digger. Near to Post B were two fragments from a cast iron bell-shaped object, a pig feeder. WW2 post and wire compound?	WW2
5	Concrete platform	541889.8 245696.3	An irregular slab of cracked concrete measuring 1.7m by 1.7m of unknown thickness. The feature appears to have been damaged by site clearance. WW2 platform.	WW2

Fig. 12 - Feature 4, concrete block A, looking south-west

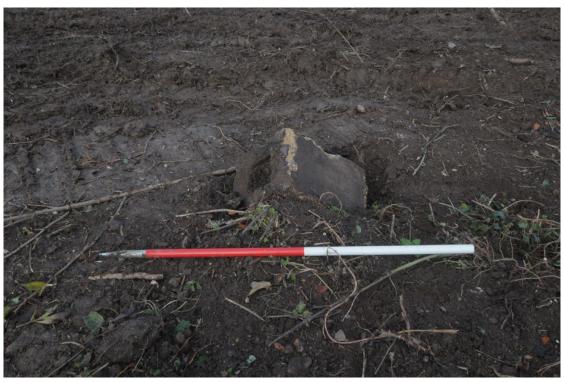
Fig. 13 - Feature 4, concrete block B, looking north

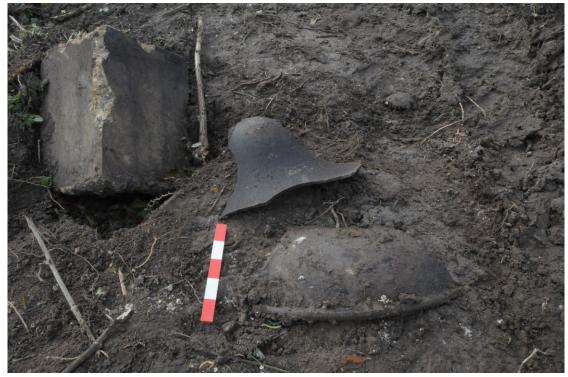
Fig. 14 - Feature 4, cast-iron pig feeder near concrete block B, looking south-west

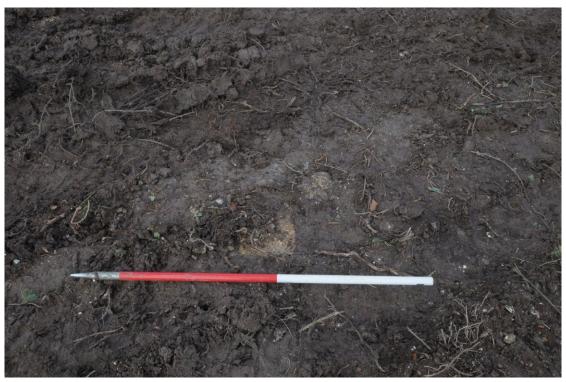
Fig. 15 - Feature 4, concrete block D, looking north-west

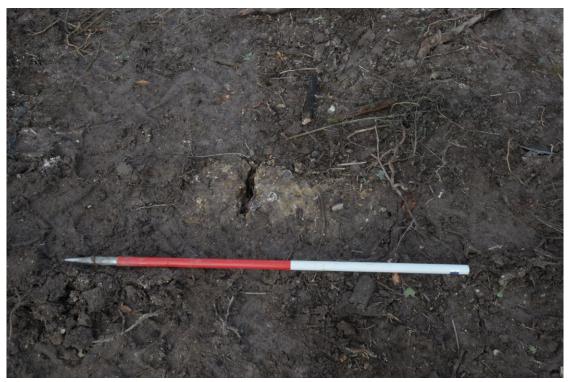
Fig. 16 - Feature 4, concrete block E, looking north-west

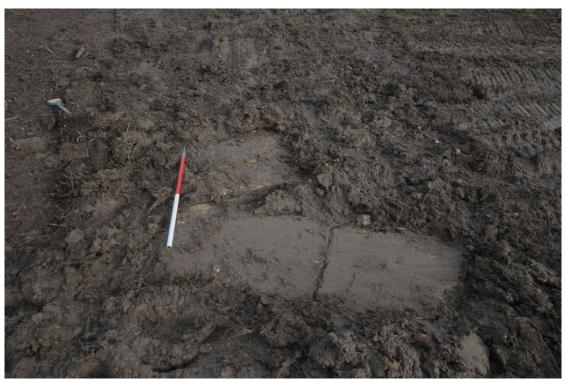
Feature 5 (Fig. 17) was a cracked slab of concrete corresponding to (0210) from the evaluation. It is likely that this concrete relates to hard standing north of building 186 (recreation hut) from the 1944 RAF plan though the Lidar data does not show up the building outline well and perhaps the site here was heavily disturbed after its demolition. The concrete may have spanned the gap between buildings 186 and 187 and the BS (?bomb shelter).

Fig. 17 - Feature 5, looking north-east

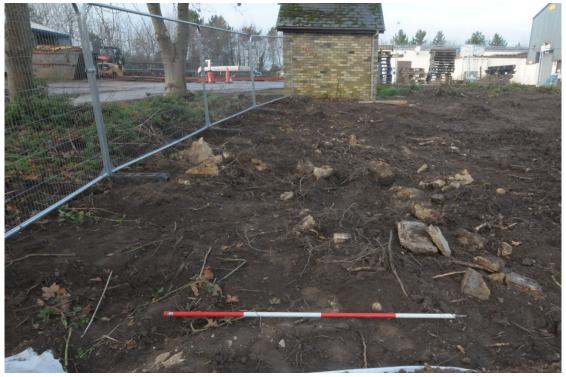
Feature 6 (Fig. 18 & 19) was an area of rubble that had been disturbed (though not created) by site clearance. The rubble comprised blocks of concrete, occasional brick and fragments of worked stone. Decorated encaustic tiles were found amongst the rubble attached to concrete. No structure or foundations were found in this deposit. The rubble appears to be from a 19th century building decorated with tiles. The deposit has probably been dumped from elsewhere as no building is marked in this location on the 1st or 2nd edition OS maps. It is possible that the rubble was spread during the WW2 when this area was developed for the access road and the fuel compound (185) for the base.

6	Demolition rubble of Summerhouse	541831.2 545699.2	An area of concrete rubble mixed with topsoil with many broken stone blocks and a few encaustic arts and crafts tiles.	19 th century

Fig. 18 - Feature 6, remains of summerhouse, looking north-west

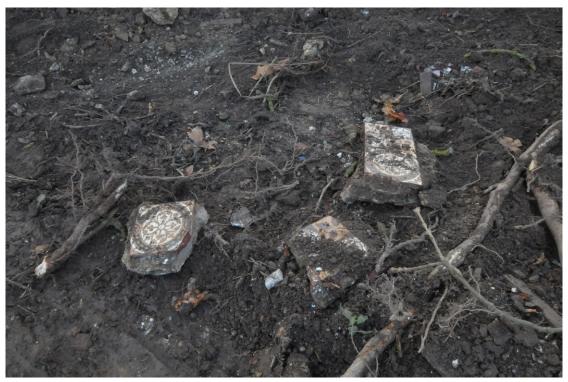
Fig. 19 - Encaustic tiles found in Feature 6 rubble
