Proposed Construction Compound, Crystal Rig III Wind Farm, Bransly Hill, East Lothian

Archaeological Works

Report No. 3384

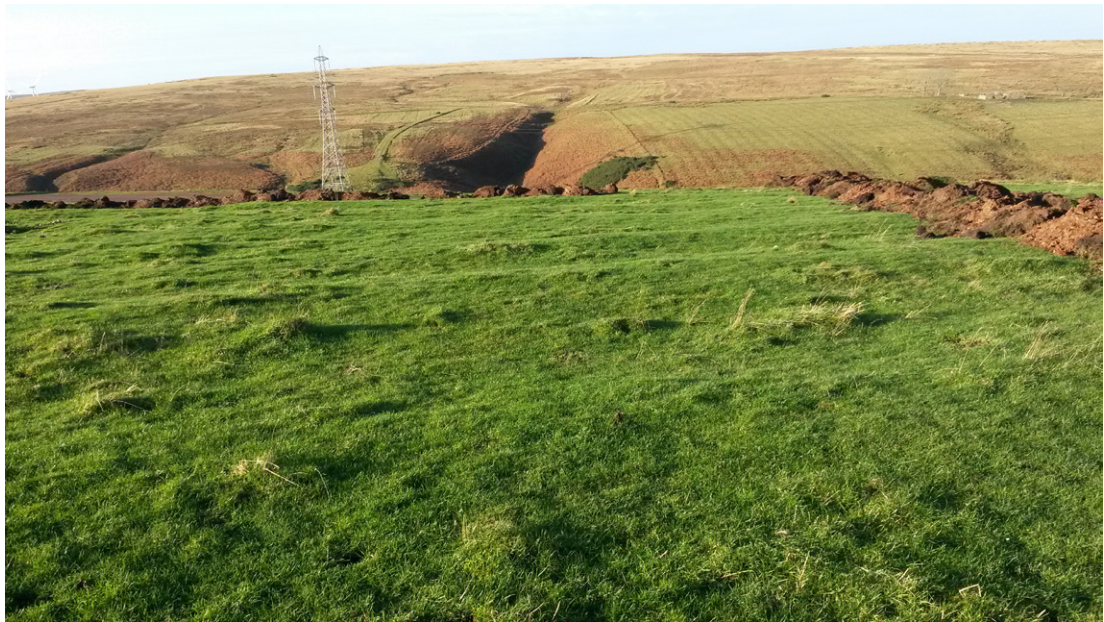
This trench was excavated across possible rig-and-furrow identified during the pre-evaluation survey. Whilst the rig-and-furrow could be seen on the surface in low sunlight there was nothing discernible in the section of the trench or cut into the natural subsoil (**002**). The topsoil (**001**) measured c. 0.2m deep. No other archaeological features or deposits were found.

Fig. 2 - General view of the proposed compound location showing rig-and-furrow remains on the south side of Trench 2

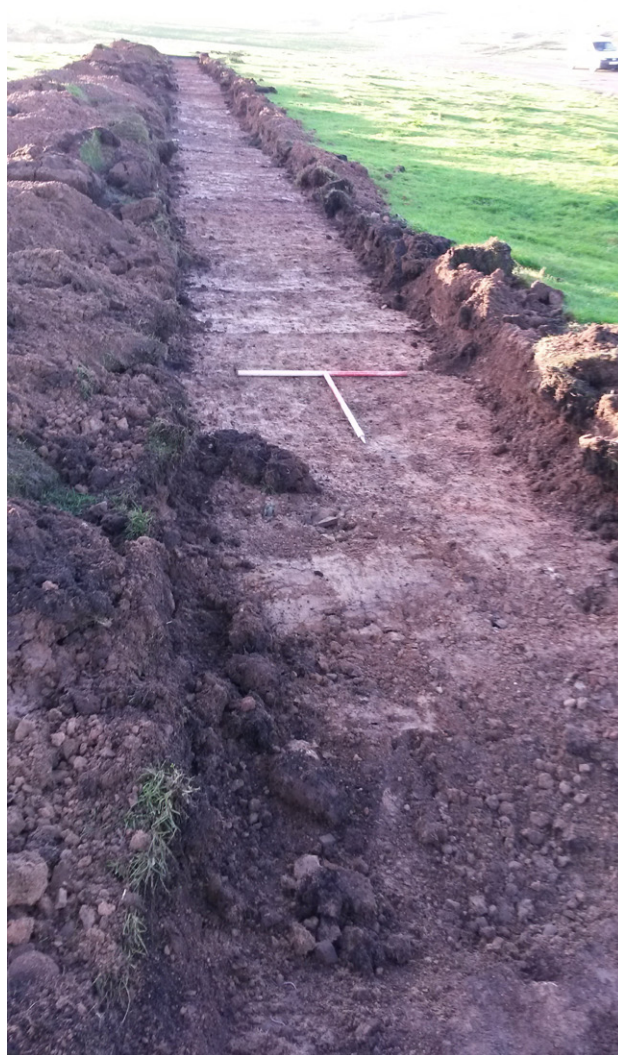
Fig. 3 - Trench 1

This trench was excavated across the proposed location of rig-and-furrow identified from aerial photographs, although this was not identified by the subsequent walkover survey. The rig-and-furrow was not present and the topsoil (**001**) measured c. 0.2m deep. No other archaeological features or deposits were found.

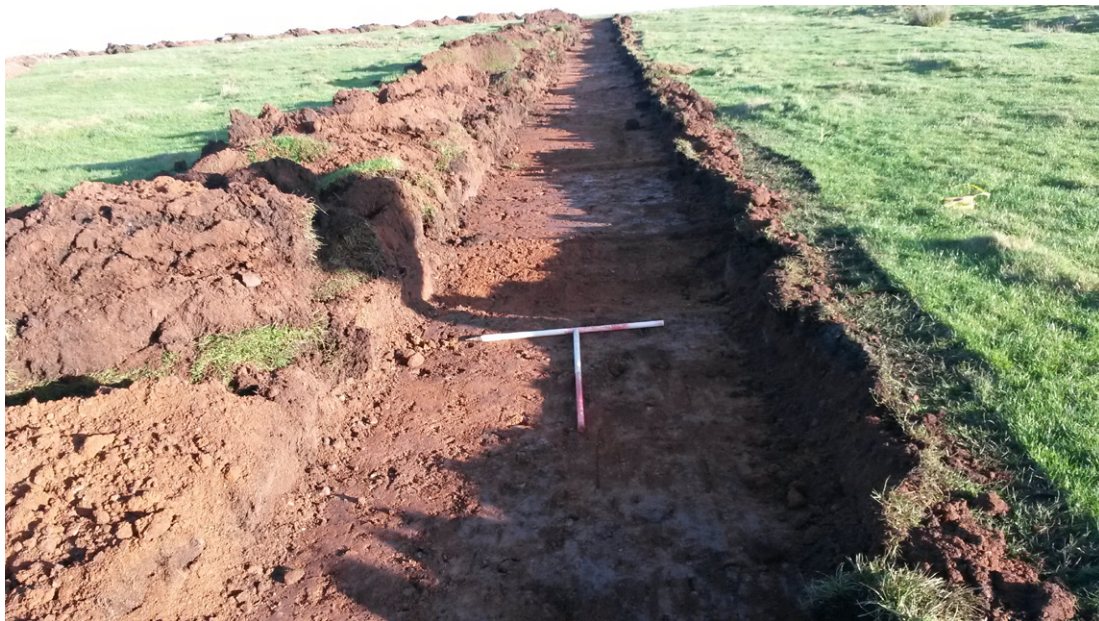
Fig. 5 - Trench 3

This trench was excavated to cross the southernmost end of the possible rig-and-furrow identified during the survey and the easternmost extent of the possible rig-and-furrow identified from the aerial photographs. Whilst the rig-and-furrow identified from the walkover survey could be seen on the surface in low sunlight there was nothing discernible in the section of the trench or cut into the natural subsoil (**002**). The topsoil (**001**) measured c. 0.2m deep. No other archaeological features or deposits were found.

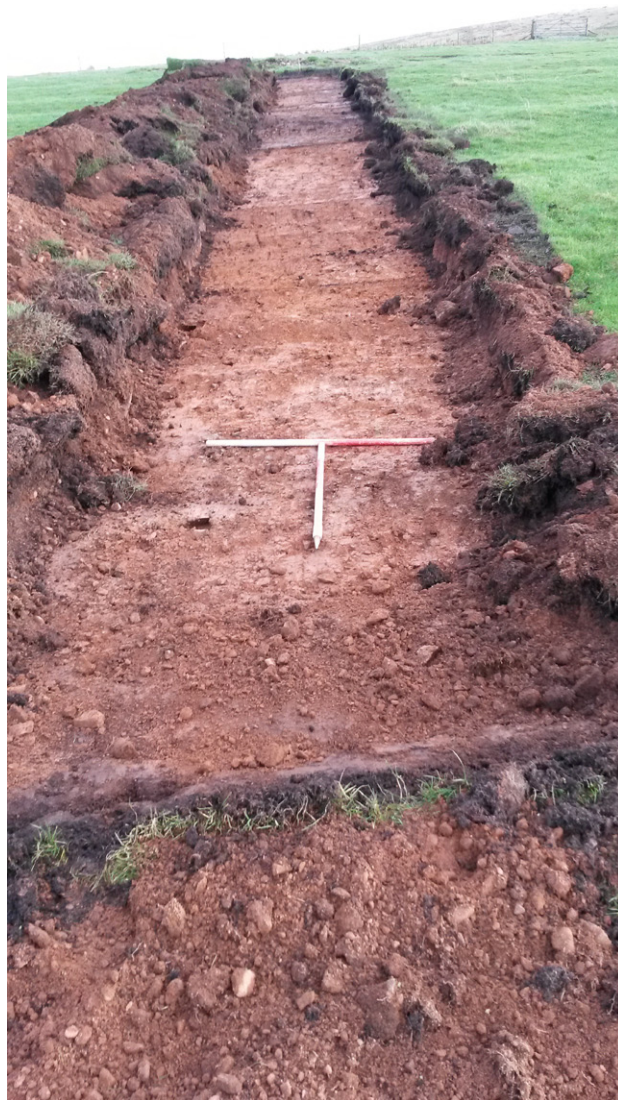
Fig. 6 - Trench 4

This trench was excavated across possible rig-and-furrow identified during the pre-evaluation survey. Whilst the rig-and-furrow could be seen on the surface in low sunlight there was nothing discernible in the section of the trench or cut into the natural subsoil (**002**). The topsoil (**001**) measured c. 0.2m deep. No other archaeological features or deposits were found.
