**Lord Deramore School
Heslington
York**

Archaeological Evaluation

Report No. Y199/15

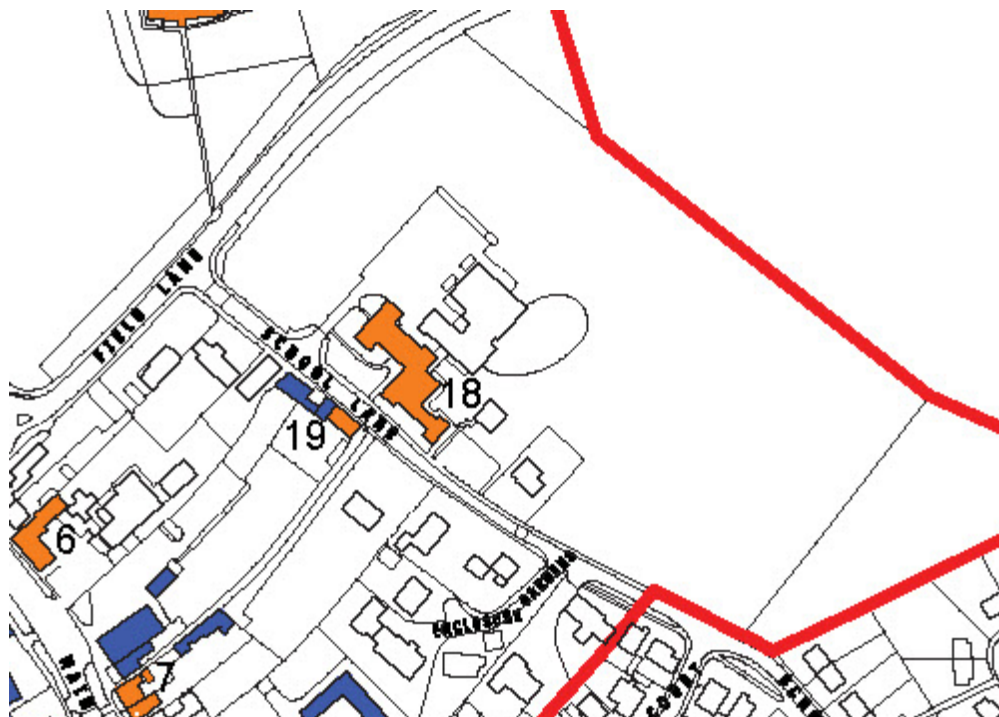
Fig. 1 Site location showing extent of Heslington Conservation Area (red line) and Listed buildings (orange)

Lord Deramore Primary School is situated within the suburb of Heslington approximately 2.8km south-west of York city centre. The 3ha site is bounded to the north-east and east by landscaped ground associated with the University of York campus, the grounds of Heslington church across Field Lane to the north, with residential buildings on all other sides (Fig. 1). The proposed new school building will be situated north-west of the existing school buildings.

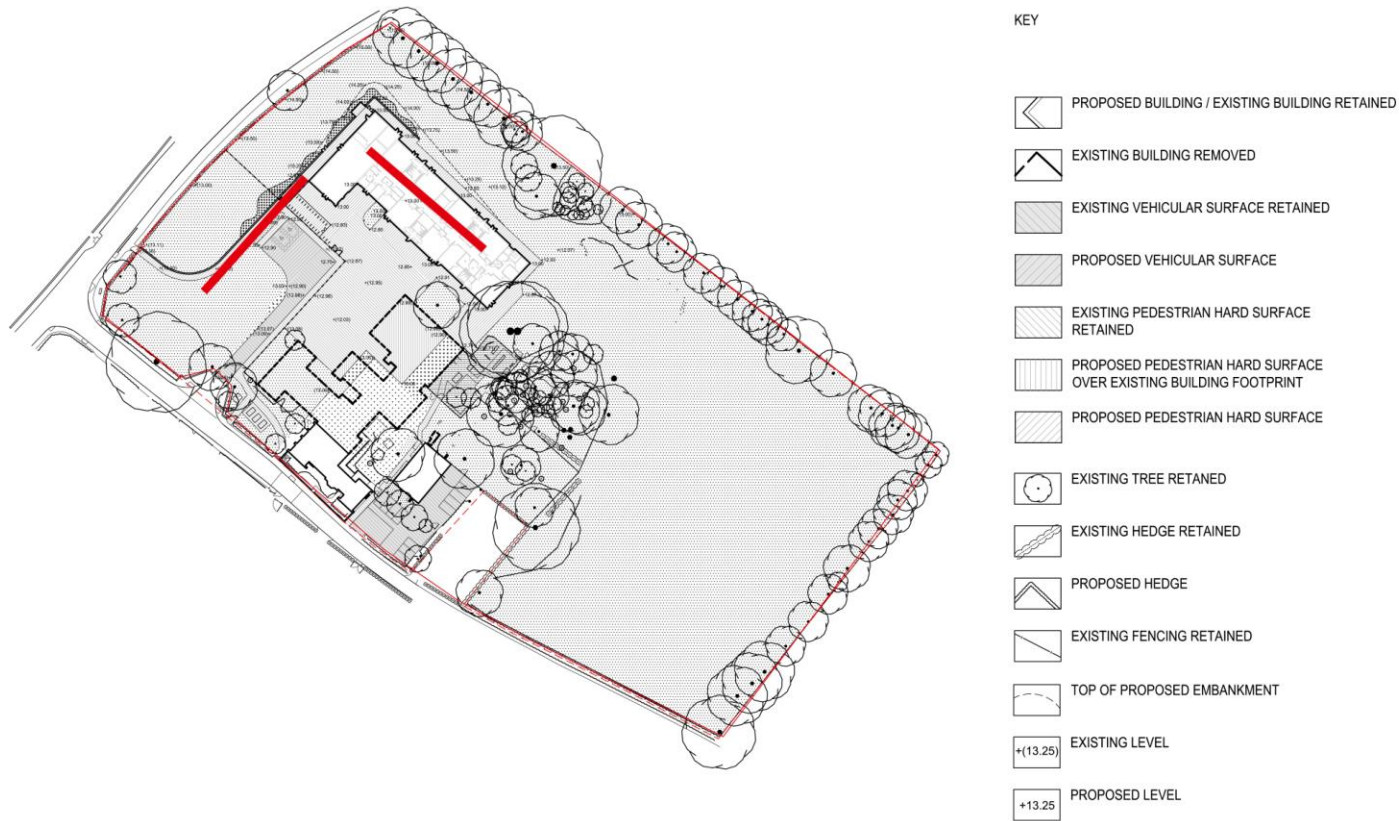
Lord Deramore's School, York. Proposed site layout with archaeological trenches (50m long) superimposed. (Plan BDP-04(9)-LP-005)

- 6.1 Fieldwork will be undertaken by a team from CfA. Two trenches each measuring 50m long by 1.6m wide located as shown on the attached plan, or as near as site conditions will allow. The fieldwork will be undertaken by a team of experienced field archaeologists over a period of approximately three working days, with a start date to be agreed.

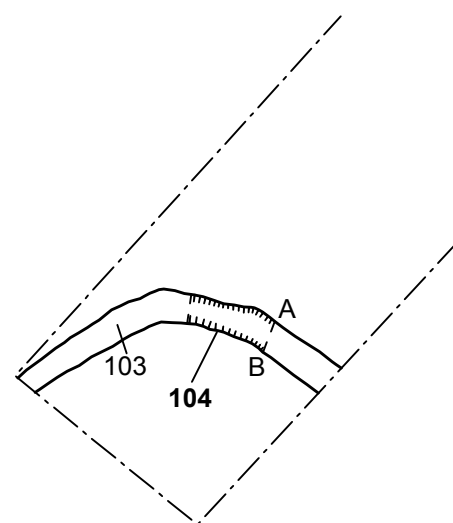
Fig. 2a Plan of 104, Trench 1

The natural geology in Trench 1 was recorded at a depth of 12.51m AOD. Cut through the natural at the south-western end of the trench was a small east/west orientated curvilinear gully (104, Figs. 2 and 4) measuring 0.24m in width by 0.18m in depth. No finds were recorded from this feature.

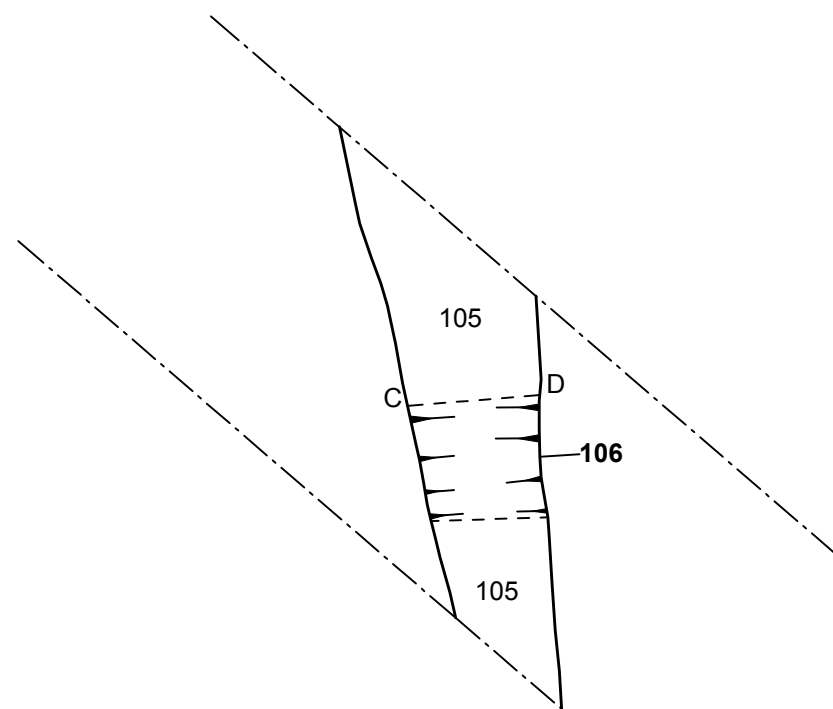
Fig. 2b Plan of 106, Trench 2

Two roughly north/south orientated Furrows were excavated within the trench (106 and 108). Located towards the centre of the trench, Furrow 106 (Fig. 2) measured 0.95m in width by 0.10m in depth and was filled by grey silty clay 105. To the south-east of 105 was Furrow 108 (Figs 2 and 6), a feature measuring 1.54m in width and 0.14m in depth and which was again filled by a grey silty clay (107). No finds were recovered from either of the features.

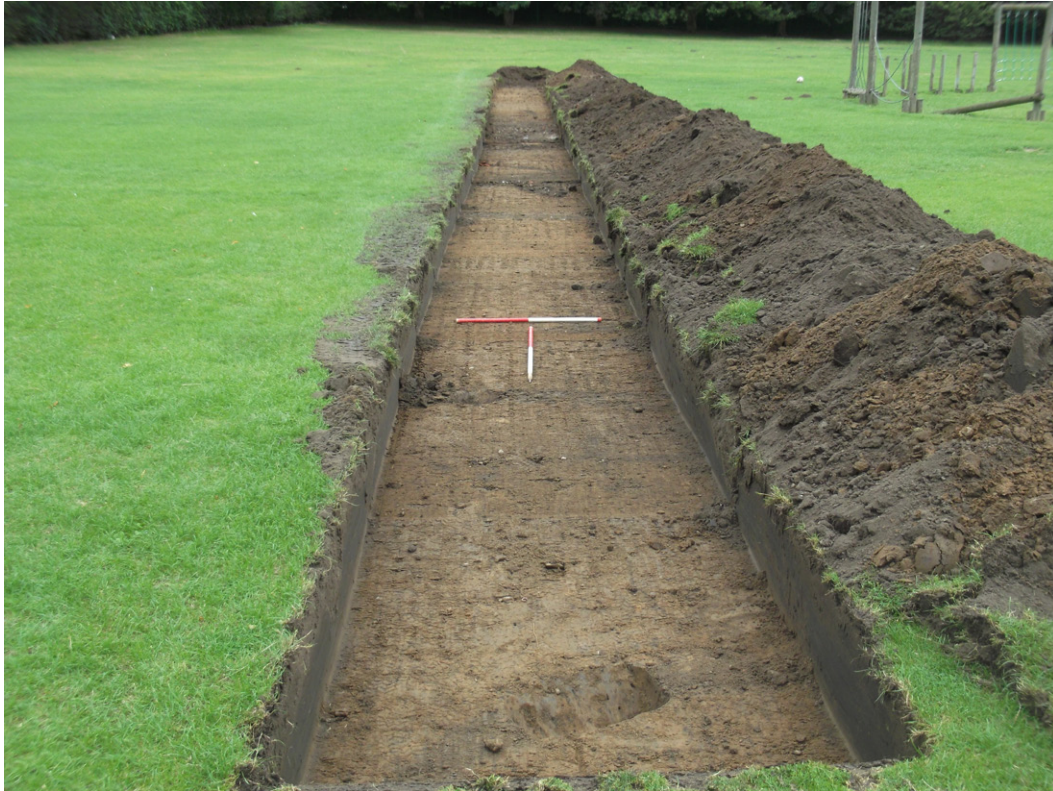
Fig.3 Trench 1 general shot, facing north-east

3.1 Trench 1 (Fig. 3)

The centre of the trench had been truncated by modern activity, with a large concrete cover/cap present within the trench and extending beyond the limit of the trench to the east. Three modern field drains were also identified.

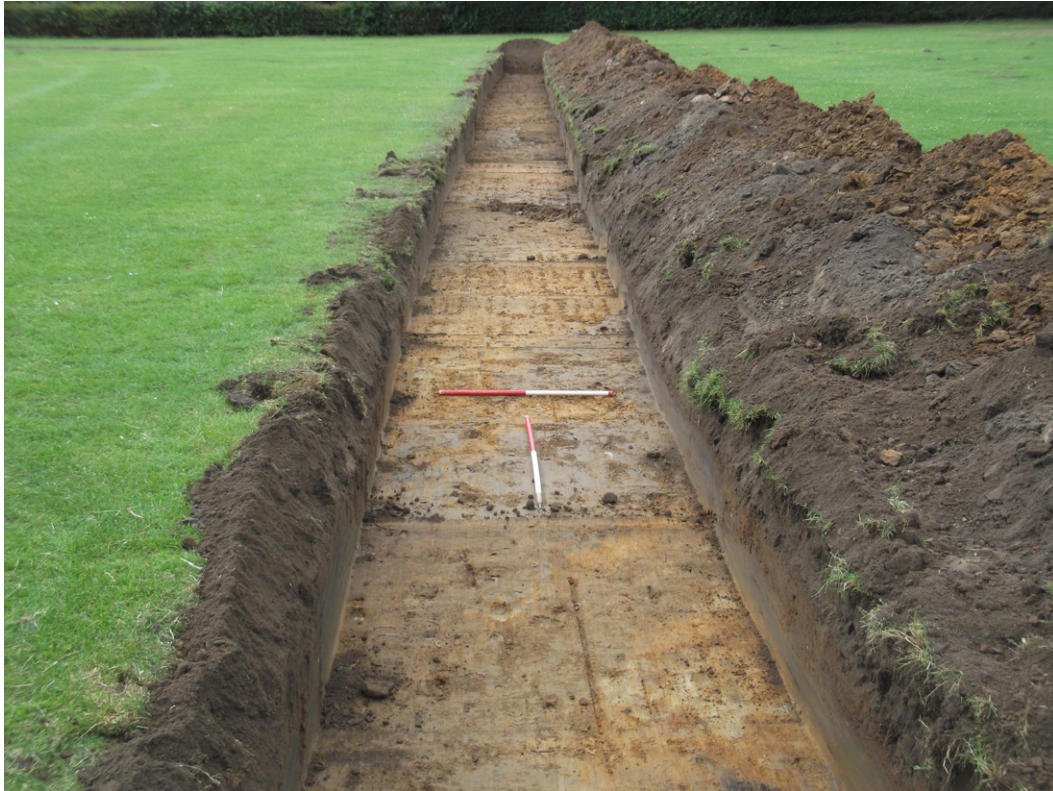
Fig.5 Trench 2 general shot, facing north-west

3.2 Trench 2 (Fig. 5)

The natural geology in Trench 2 was recorded at a depth of 12.5m AOD to the north-western end of the trench and at 12.1m AOD to the south-eastern end. Overlying the natural substrate was a layer of subsoil consisting of a light brown silty clay.

Two further similarly aligned, ephemeral features were noted within the trench and were recorded on the trench plan.
