Ardentraive Hydro Scheme Colintraive, Argyll & Bute

Archaeological Mitigation Works

Report No. 3400

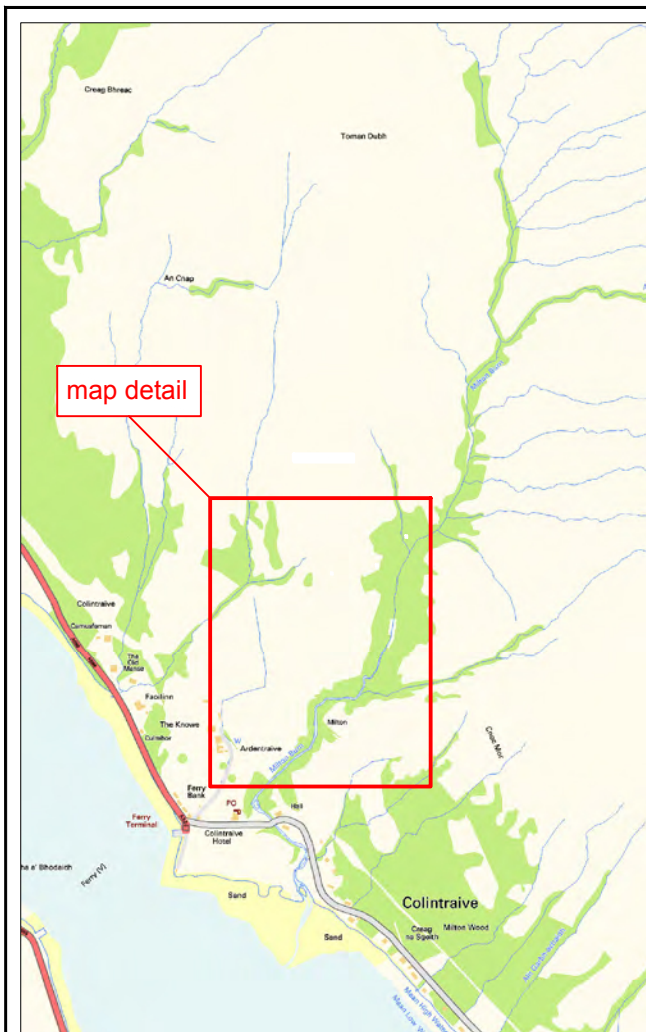
Fig. No: 1 Report No: 3400

Title:
 Location map and site plan

There were no archaeological features identified within the main watching brief area. A small area of rig-and furrow cultivation was identified adjacent to Site 8 and Site 9, but this lay just outwith the development area and was not affected by the programme of works (see Fig. 1 for location). Sections were recorded through Site 8 and Site 9 and the details are contained within the following paragraphs.

The Site 9 field bank (RCAHMS No. NS07NW 36) (Fig. 5) formed part of a large irregular enclosure which ran from the edge of the Milton Burn in a western direction before looping round and back to the Milton Burn at a location to the north-east of its starting point (Fig. 1). The south-eastern edge of the enclosure between the start and end points of Site 9 was formed by the steep natural escarpment dropping down towards the Milton Burn. The southern edge of this enclosure is depicted on the First Edition 6" Ordnance Survey map (1869), while the current map shows it extending as far as a small tributary watercourse, which enters the Milton Burn from the NNW. None of the maps consulted showed the enclosure in its entirety, but this is considered more likely to be a result of the standard of surveying in this remote upland area rather than a reflection of when it was constructed. The enclosure was breached twice by the penstock pipeline, once along its southern edge, and again along its north-eastern edge. Sections were recorded in both locations in which it was breached.

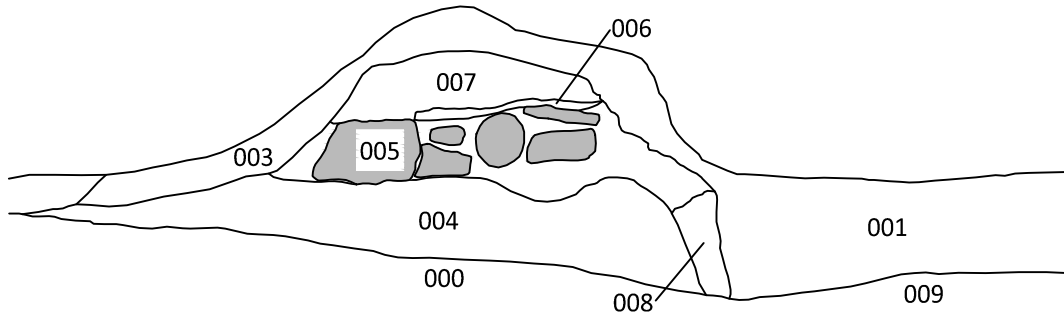
Fig.2 Site 9 SE-facing section

Where field bank Site 9 was cut for the penstock pipeline along its southern edge (Section 1) it measured 2.8m in width and was upstanding to a height of 1m (Fig. 2 and 6) Running parallel with the bank was a shallow ditch (**009**) with a width of 0.8m and a depth of 0.15m. The primary bank material consisted of compact beige clay (**004**). This was overlain by large stones set within a matrix of orange sandy-clay (**005**) and above this there was a layer of degraded turf (**006**) and a deposit of beige-orange sandy clay (**007**). The bank had then been capped with silty-peat topsoil material (**003**) (probably degraded turf/topsoil dug from the adjacent ditch).

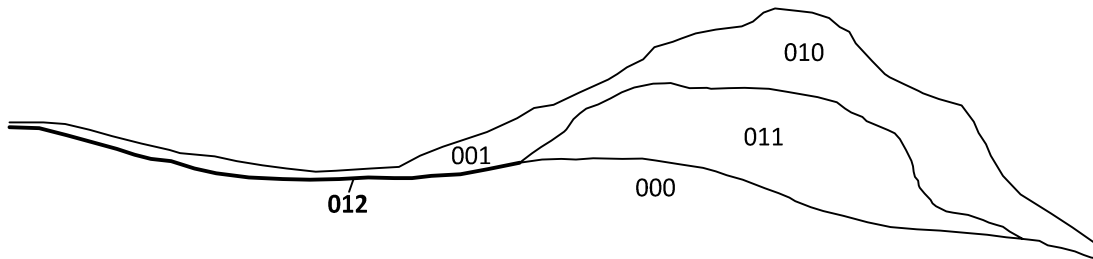
Fig.3 Site 9 S-facing section

Where field bank Site 9 was cut for the penstock pipeline along its north-eastern edge (Section 2) it measured 2.8m in width and was upstanding to a height of 0.8 (Fig. 3 and 7). Running parallel with the bank was a very shallow ditch with a width of 1.8m and a depth of 0.15m. The primary bank material (**011**) consisted of orange-brown sandy clay (redeposited natural) capped with brown silty-clay topsoil material (**010**) (probably degraded turf/topsoil dug from the adjacent ditch).

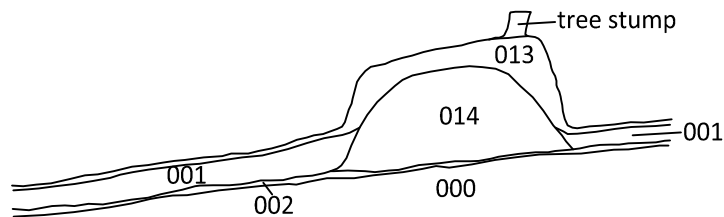
Fig.4 Site 8 SE-facing section

Site 8 consisted of a short length of WNW to ESE aligned field bank (Fig. 8), which ran for a distance of 20m from a tributary of the Milton Burn towards the Site 9 field boundary. Where a section was recorded through this feature it measured 0.9m wide by 0.46m high. The bank material (**014**) consisted of orange sand with patches of grey clay, which was capped with a thick layer of turf (**013**) (Fig. 4 and 9). This field bank may have been associated with an area of vestigial rig-and-furrow cultivation (Fig. 1), which was identified to the south of the bank just outwith the working area for the pipeline.

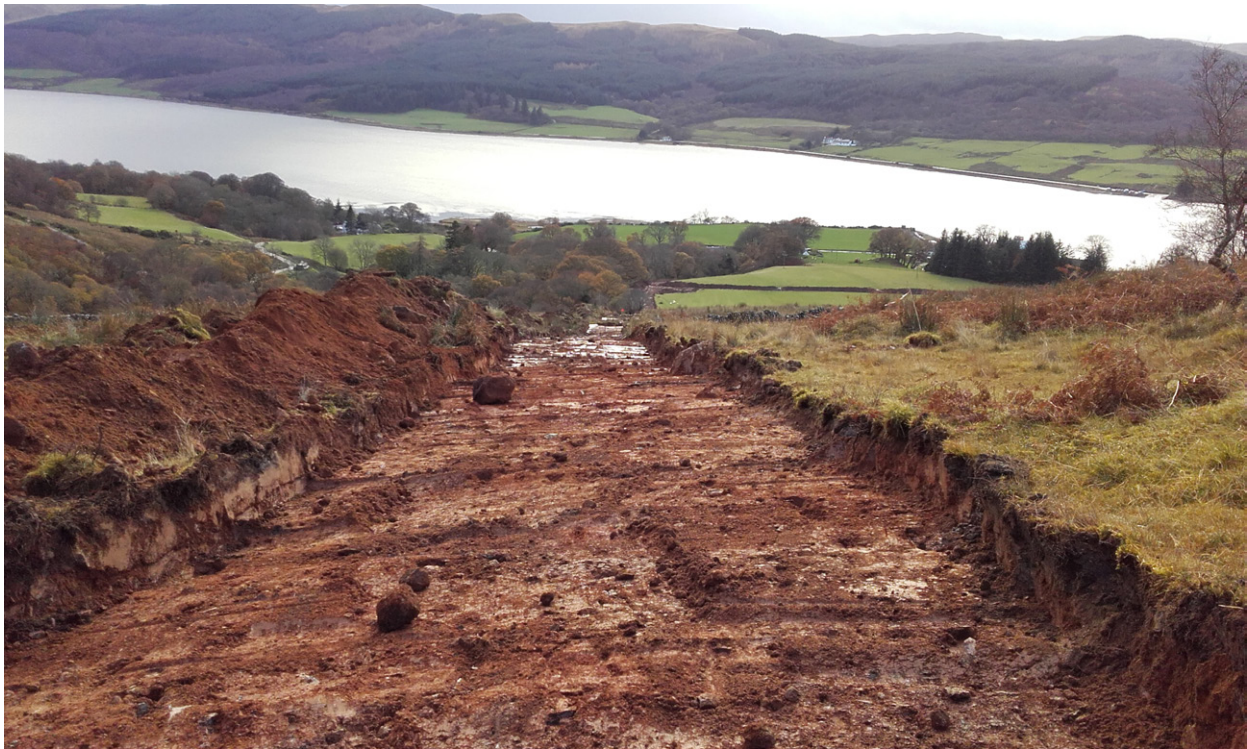
Fig. 10 General shot of main watching brief area (from the north-north-east)

The ground on which the main watching brief was undertaken sloped steeply upwards from south to north. On the lower ground adjacent to Ardentraive Farm, the ground had been extensively improved, while higher up the hill it had been partially improved for grazing (Fig. 10) with some evidence of drainage being present. Above the main watching brief area the ground consisted of rough moorland and birch forest, but vestigial traces of rig-and-furrow cultivation indicate that it had been utilized for agricultural purposes in the past.
