**Knutsford, Cheshire
Gas Main Works**

Archaeological Watching Brief

Report No. Y078/13

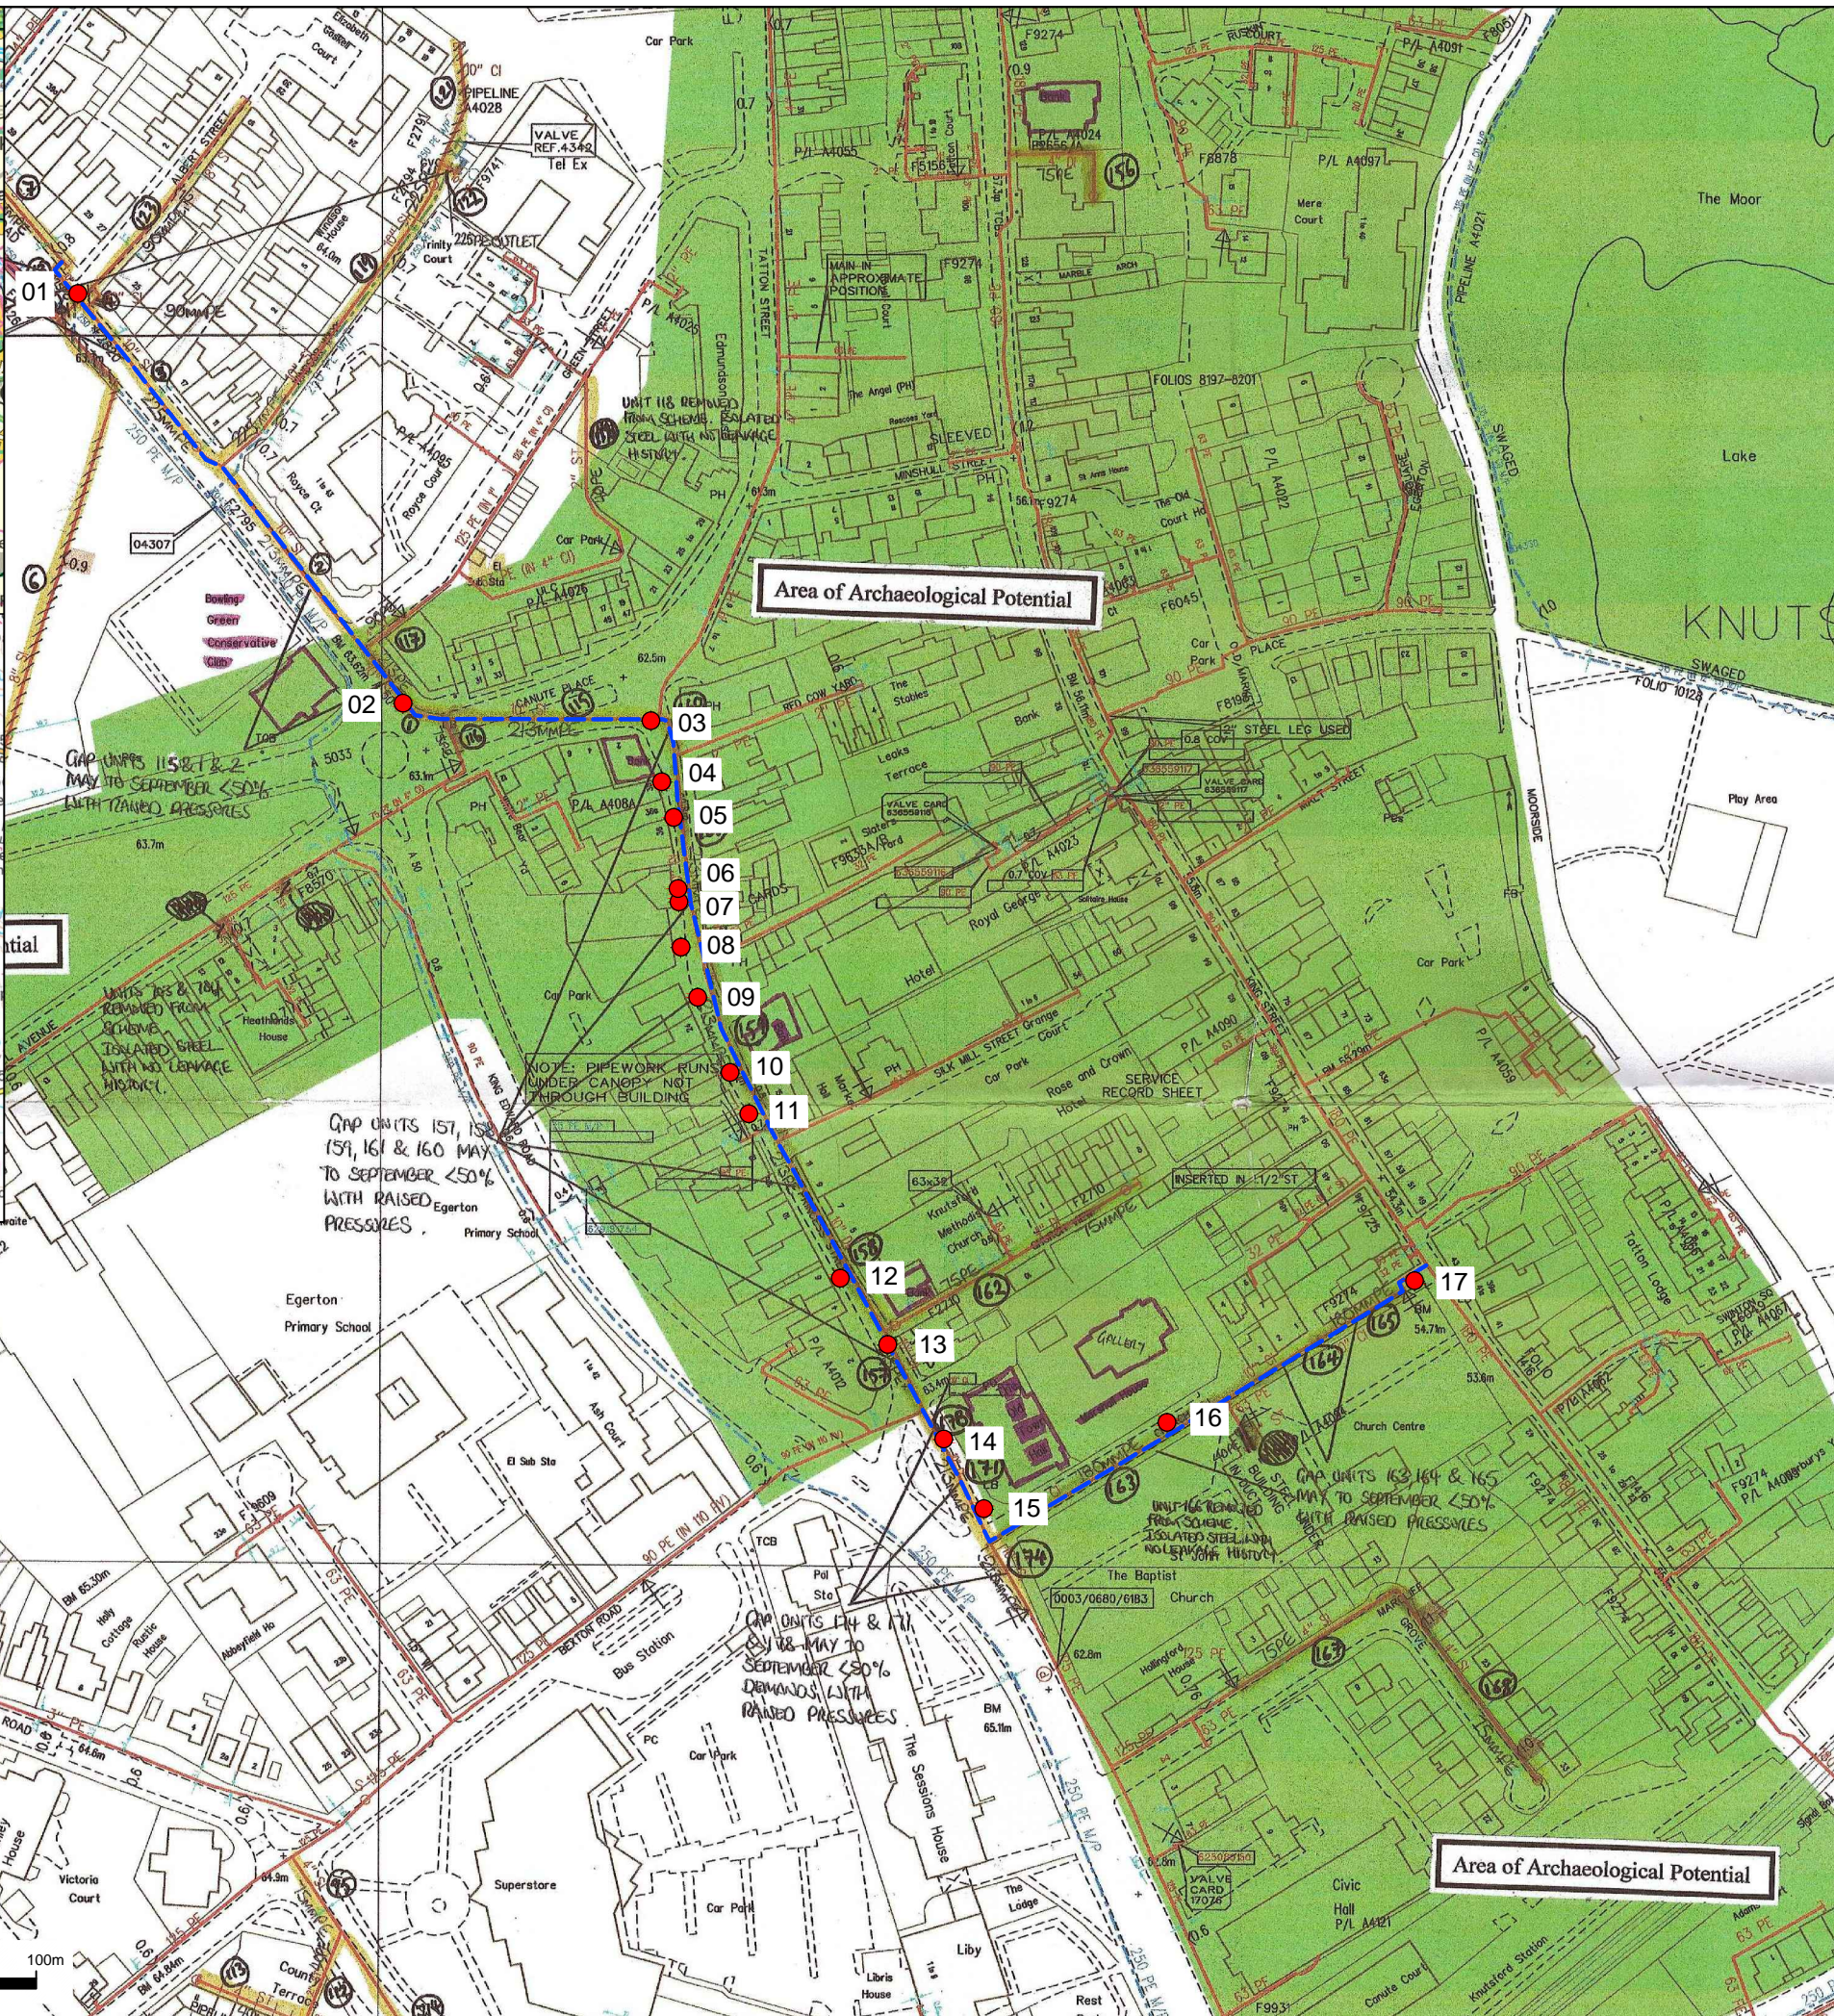
Fig. No: 1 Revision: A

The locations of the pits monitored are shown on Figure 1; photographs of pits form Plates 1-4. Excavation of the pits was almost entirely through the material redeposited during the construction of the original gas main (Plate 3); only rarely was natural soil encountered. No archaeological features were recorded and no pre-modern finds were recovered.

Title: Site and Pit locations

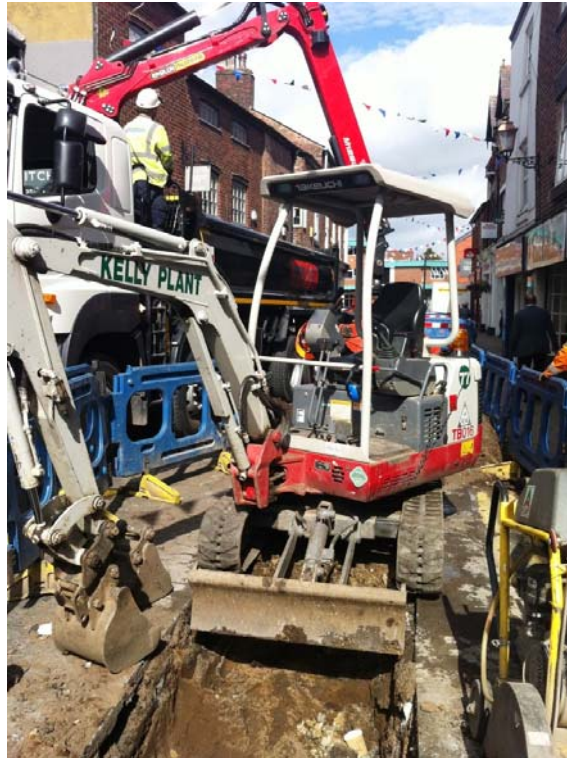
Pits were excavated by a mini-digger at intervals along the existing pipeline route (Plate 1); these were left open during the removal of the old pipe and the insertion of the new replacement pipe. The pits were monitored either during their excavation or inspected shortly afterwards. The pits were inspected for evidence of archaeological features and the resulting spoil was visually inspected for finds. Appropriate recording forms were completed and photographs were taken of each inspected pit.

Plate 1: Working shot during the excavation of Pit 07, looking north along Princess Street

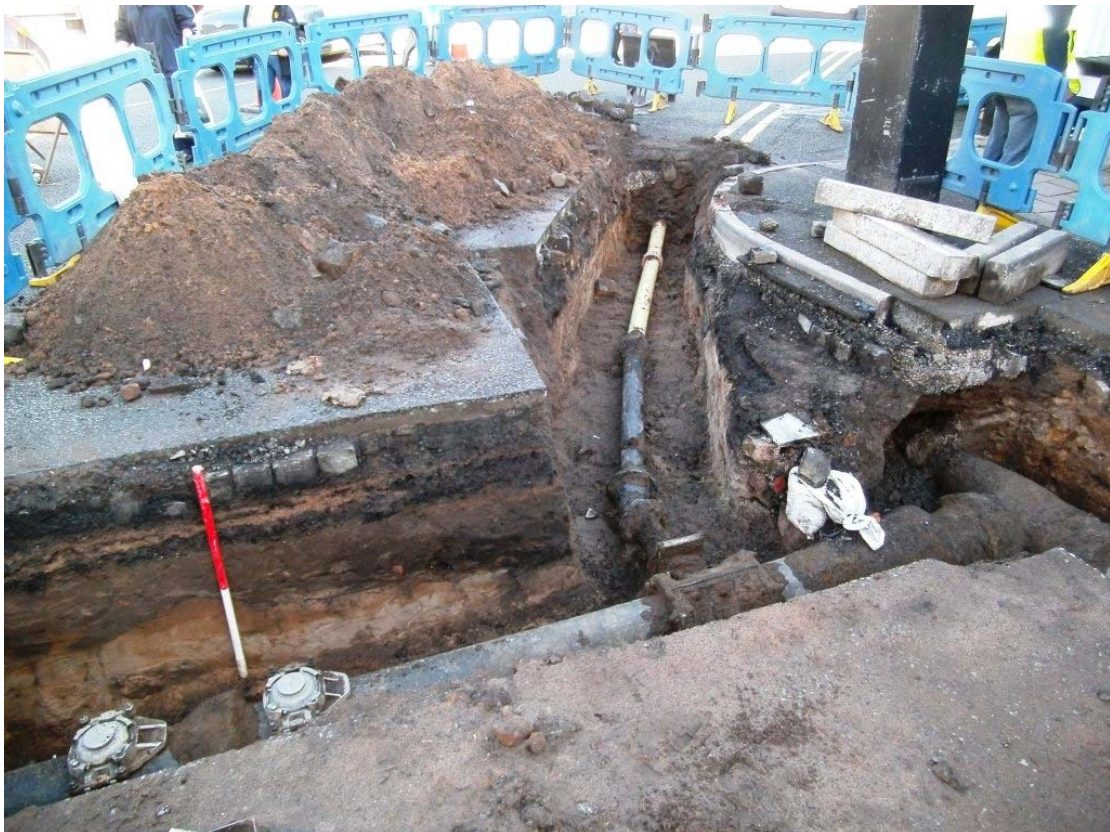
The depths of the pits varied from 0.75 - 0.80m along Princess Street to 0.20m at the junction of Church Hill and Kings Street. The pits were cut through tarmac and then builders stone / gravel stone and disturbed mixed redeposited clay or sand. Along part of Princess Street cobbles were recorded, probably dating to the late 19th or early 20th century. Most of the pits were fairly small measuring from 1m² to 2-3m in length by 1-1.5m wide, apart from Pit 03 on the corner of Canute Place and Princess Street (Plate 2).

As most of the pits were small and within the area disturbed by the cut for the original pipeline, there was little opportunity for the recording of the natural stratigraphy. The exception was in Pit 03. Stone setts (c. 0.15m x 0.14m) were recorded below the tarmac road surface, then a bedding layer of dark reddish-grey sand with some gravel over further bands of sand with lenses of grey gravel, then made ground of mixed dark grey sandy gravel, and cinders over cleaner though still redeposited orange-brown sand. Compact yellow to light orange natural sand was encountered at 0.70m below the ground level (Plate 2).

Plate 2: Pit 03 at the junction of Canute Place and Princess Street, looking north-west

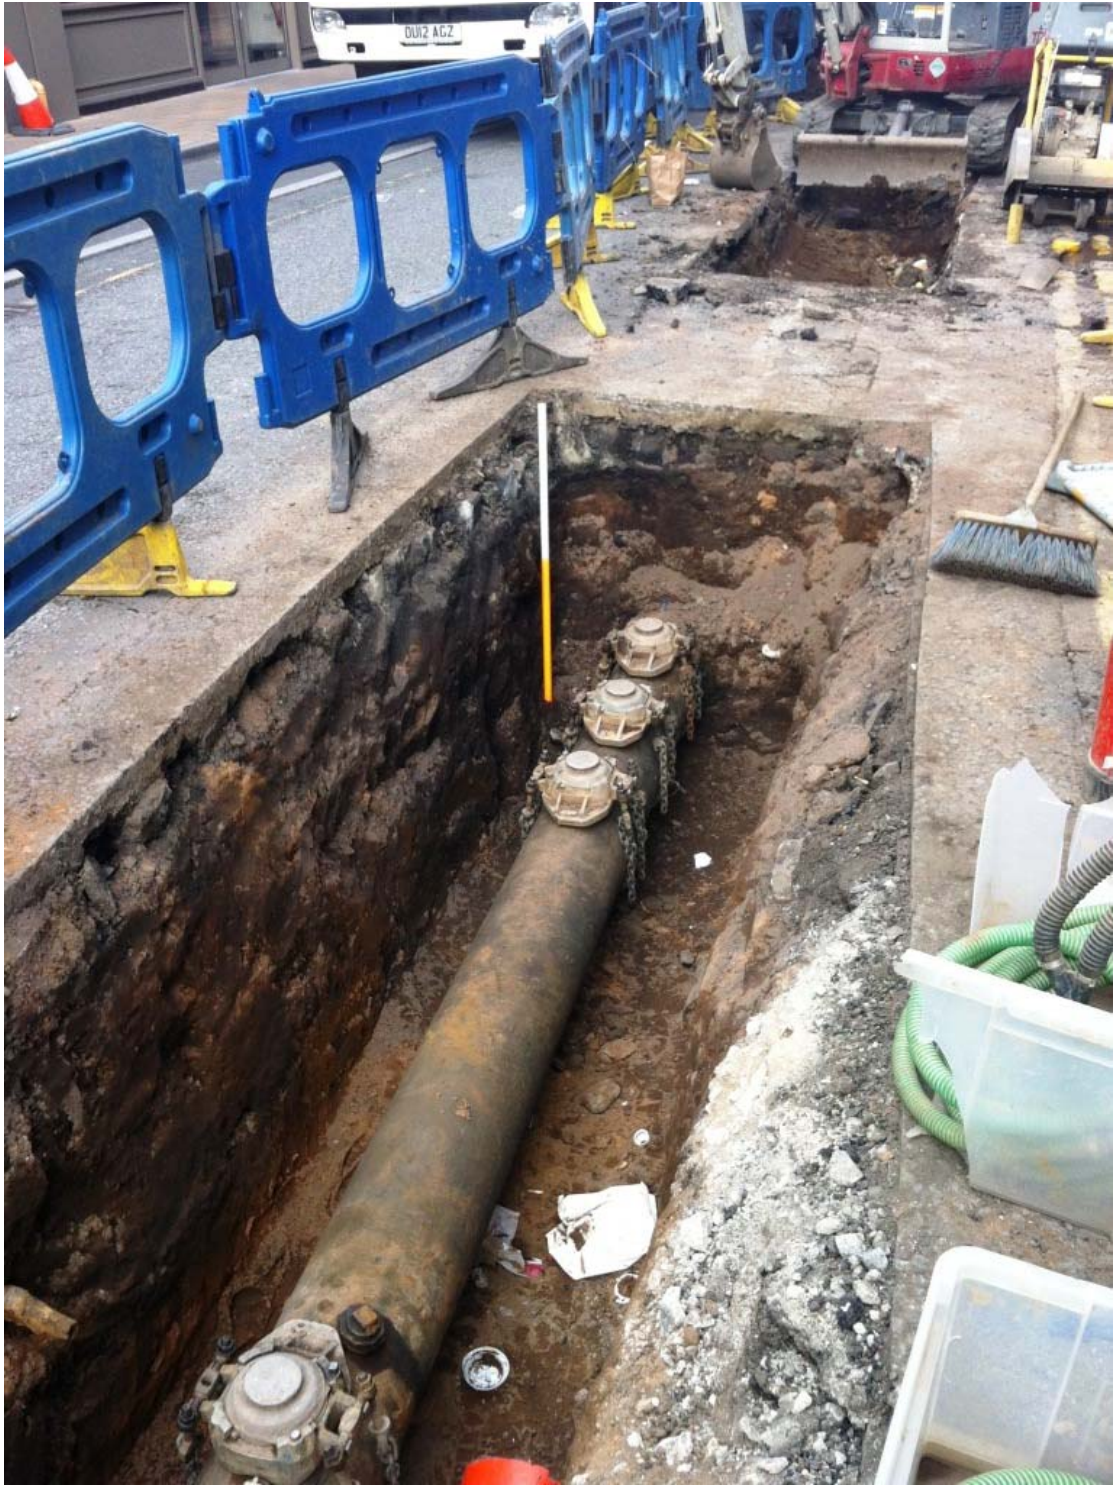
Plate 3: Pit 08 looking north

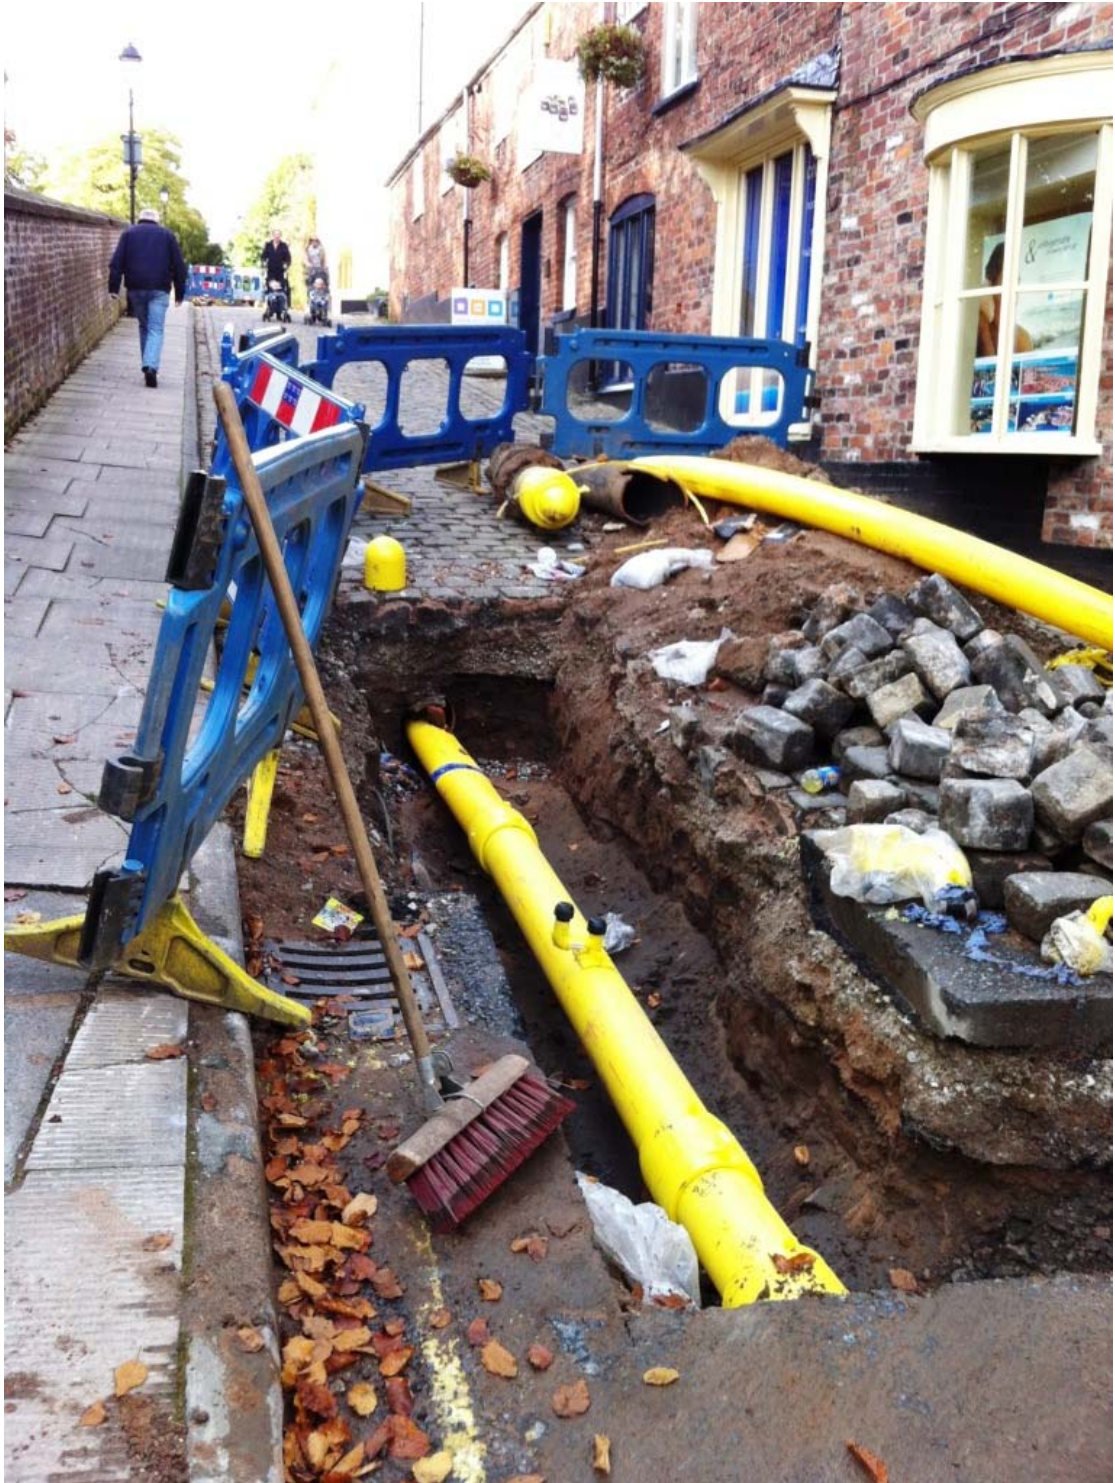
As the pipeline route continued down Church Hill the depth of the pipeline became much shallower and the pits did not penetrate beyond the cobbles, tarmac or underlying builders sand (Plate 4).

Plate 4: Pit 17 looking south-west
