**Scalesceugh Hall,  
Carleton, Carlisle,  
Cumbria**

**Archaeological Evaluation**

**Report No. Y218/16**

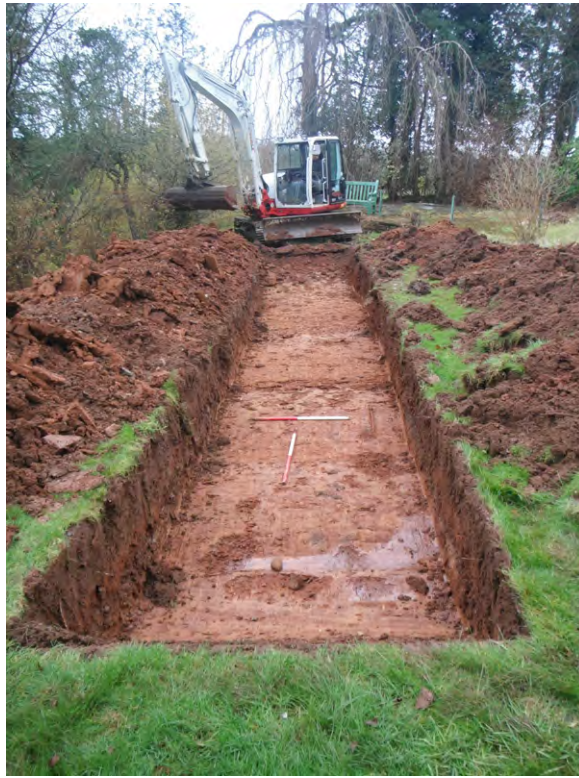
No.	Size (m)	Description
1	12.0 x 1.8	<p>The trench was orientated north-west/south-east and sloped downhill slightly from south-east to north-west (Fig. 2.1). The trench was located on a terraced area to the south-west of the existing house.</p> <p>Topsoil measured 0.30-0.35m in depth. Layers of made ground/leveling layers formed the rest of the trench stratigraphy (Fig. 2.2). Sealed by the topsoil was a layer of redeposited natural clay (101) 0.15-0.2m in depth which overlaid a layer of compacted stone and clay (102) 0.25-0.3m in thickness. Underlying this was the natural substrate for the trench, a red-pink firm clay.</p> <p>No archaeological features were recorded within the trench.</p>
2	9.0 x 1.8	<p>The trench was on a north-west/south-east orientation and formed a 'T' with Trench 3 at the north-western end of Trench 3 (Fig. 2.3). The trench was flat and waterlogged at time of excavation.</p> <p>Topsoil in the trench measured 0.25-0.30m in depth and directly overlay the natural substrate.</p> <p>Three relatively modern rough stone filled land drains were visible within the trench.</p> <p>No archaeological features were recorded within the trench.</p>

Fig. 2.1 Trench 1, general shot facing north-west

No archaeological features were recorded within the trenches excavated, and it appears likely that the site around Scalesceugh Hall has been heavily landscaped in the past. This landscaping, including the formation of terraced areas saw made ground being added to the area around Trench 1, and accounts for the layers of redeposited natural and layers of compacted stone recorded in this trench.

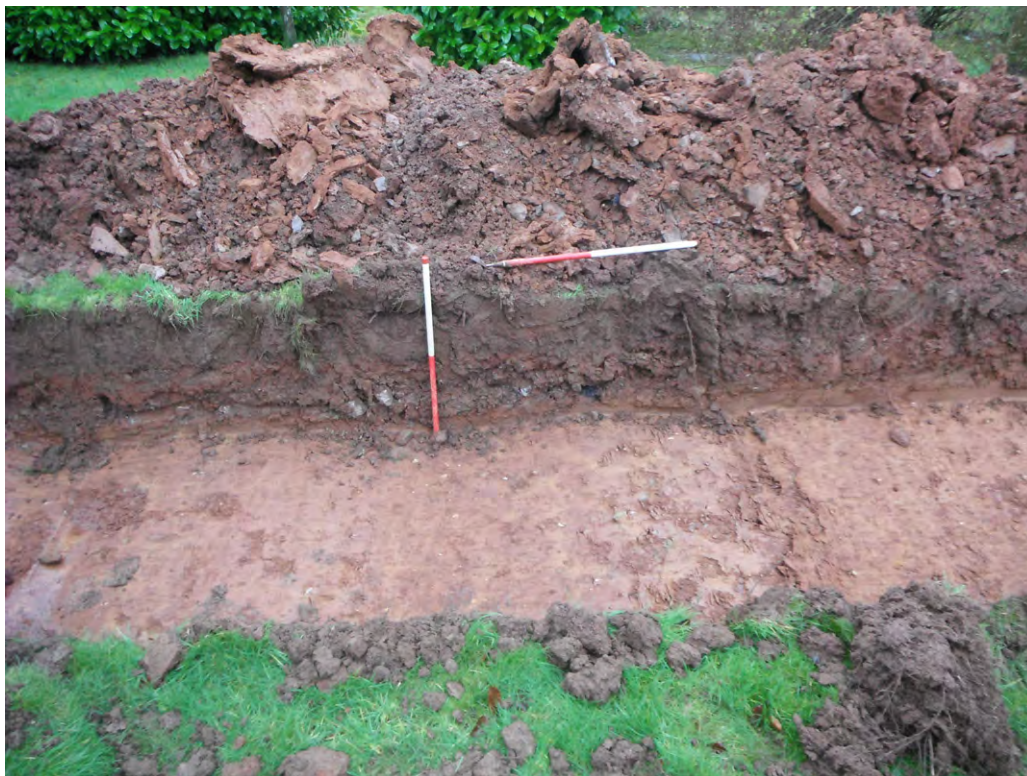
Topsoil on the site consisted of mid brown, silty clay (100) and varied in depth across the site from 0.25-0.35m. No obvious subsoils were recorded within the trenches, with extensive landscaping apparent across the site (see trench descriptions below). The natural substrate for the area consisted of a firm red-pink clay with some small stone inclusions (103).

Fig. 2.2 North-east-facing section of Trench 1

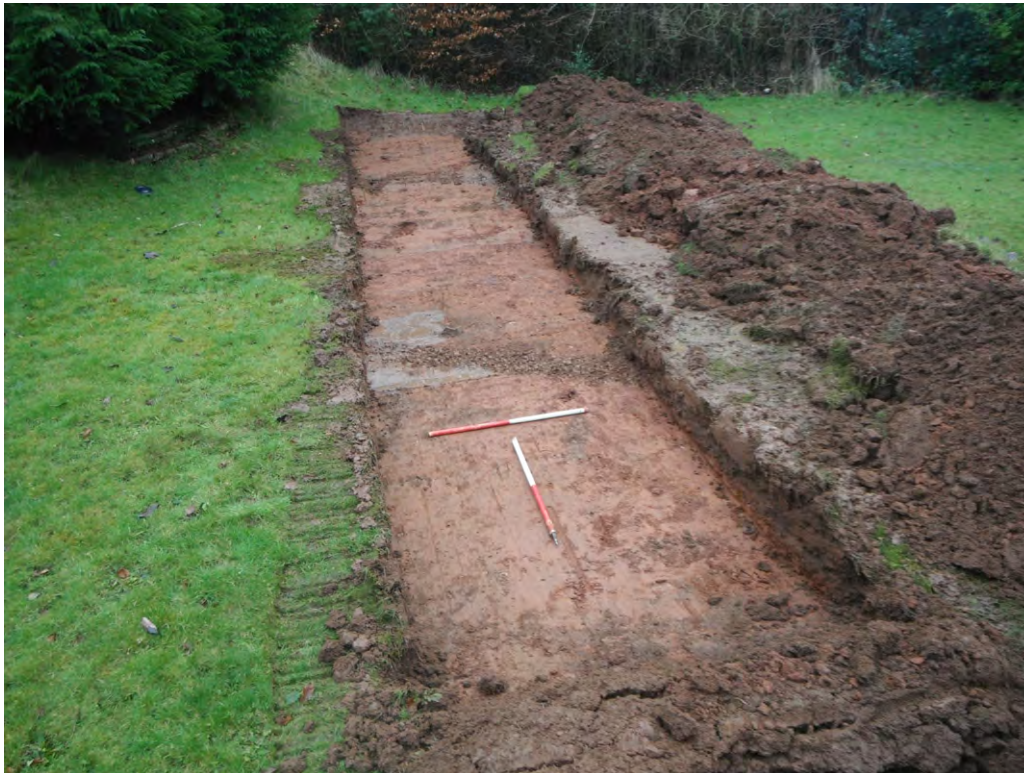
Fig. 2.3 Trench 2, general shot facing north-east

The area around Trenches 2 and 3 appeared to have been levelled flat during landscaping at some point in the past with the shallow layer of topsoil, and the absence of any subsoils suggesting material here had been removed, and most likely utilised in forming other terraced areas within the Hall's grounds. The stone land drains recorded here appeared modern and are likely a garden feature added to aid water drainage through the thick natural clays.

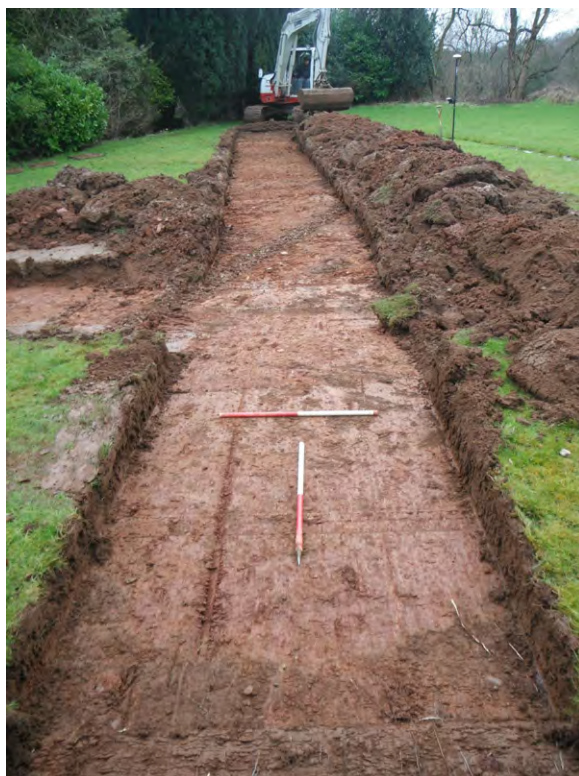
3	22.0 x 1.8	<p>The trench was orientated north/south and formed a 'T' with Trench 2 at its eastern edge (Fig. 2.4). The trench was flat, although the area was waterlogged at time of excavation.</p> <p>Topsoil in the trench measured 0.30m in depth and directly overlay the natural substrate.</p> <p>One rough stone land drain was recorded within the trench, a continuation of the same feature recorded within Trench 2.</p> <p>No archaeological features were recorded within the trench.</p>

Fig. 2.4 Trench 3, general shot facing south
