**85-87 South Bridge,
Edinburgh
Archaeological Building Survey**

Report No 3419

**85-87 South Bridge,
Edinburgh
Archaeological Building Survey

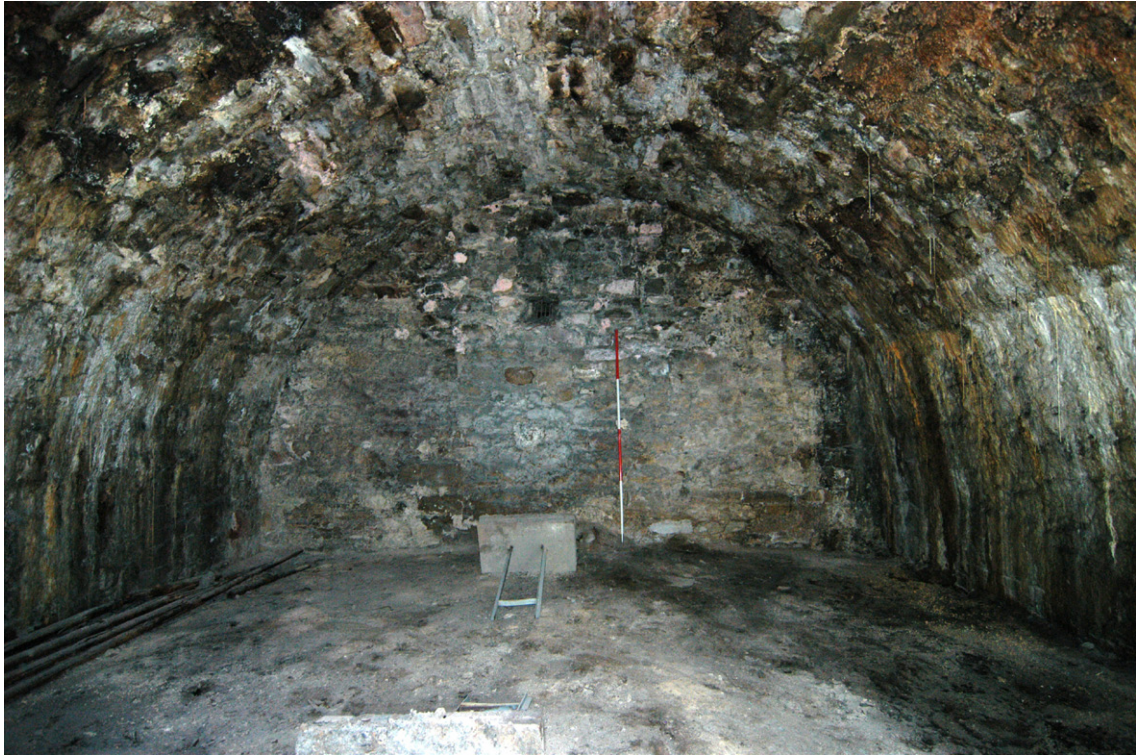
Vault 1 measured 6.9m long and 6m wide. The vault was 3.5m high and had been constructed using dressed blocks of sandstone bonded with lime mortar. The north and south-facing long walls were featureless and heavily encrusted with calcium carbonate as a result of the ingress of water through the lime-mortared joints. The only notable feature on the rear west-facing wall was a ventilation grille and traces of white-washed cement render (Fig 4).

Fig. 4 Interior of the Vault 1

The two vaults were part of a series of 19 that ran below Bridge Street and were constructed c.1790. The vaults that were surveyed are well preserved but both have suffered from the ingress of rain water resulting in a heavy concretion of calcium carbonate that has leached out of the mortar bonding the sandstone blocks. The vaults and the lower east-facing elevation of 85-87 South Bridge are not keyed in together showing that they are both mutually distinct. The large rectangular opening on the east-facing elevation shows that the vaults were accessible following the construction of the later core block of 85-87 South Bridge and were probably used for storage. Later the large rectangular opening was blocked up and a smaller door allowed access into Vault 1.

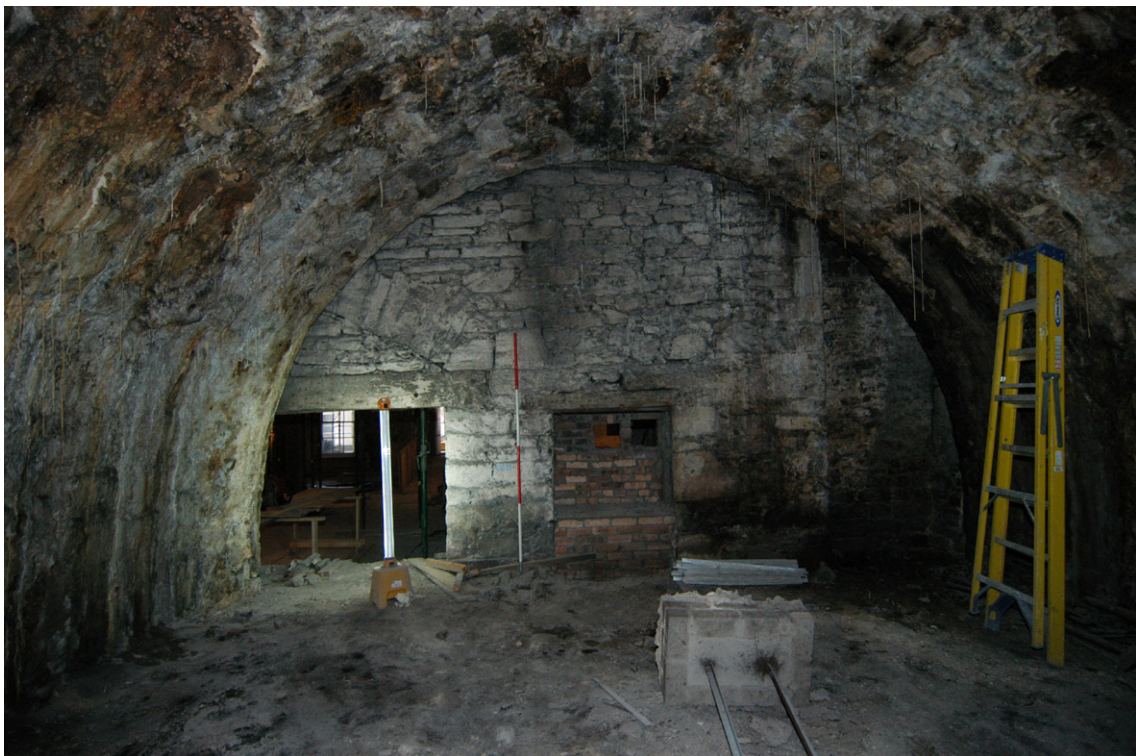
The east-facing wall (Fig 5) was built of coursed sandstone and was part of the lower core block of 85-87 South Bridge at Level 3. There was a gap of c.0.2m between the vault arch and the core block wall thus showing that both features were not keyed in together. At the centre of the elevation was a blocked doorway partly in-filled with 20th century brickwork. On the left-hand side of the blocked doorway was a large rectangular opening surmounted by a large composite timber lintel. A stone relieving arch was situated above it. The rectangular opening measured 4.4m long and 1.5m high and appears to have served as the main entrance into the vaults and probably contemporary with the aforementioned brick-blocked doorway. The floor of the vault was compacted rubble.

Fig. 5 Vault 1 interior east-facing wall with a central blocked doorway and part of a larger opening with a segmented relieving arch

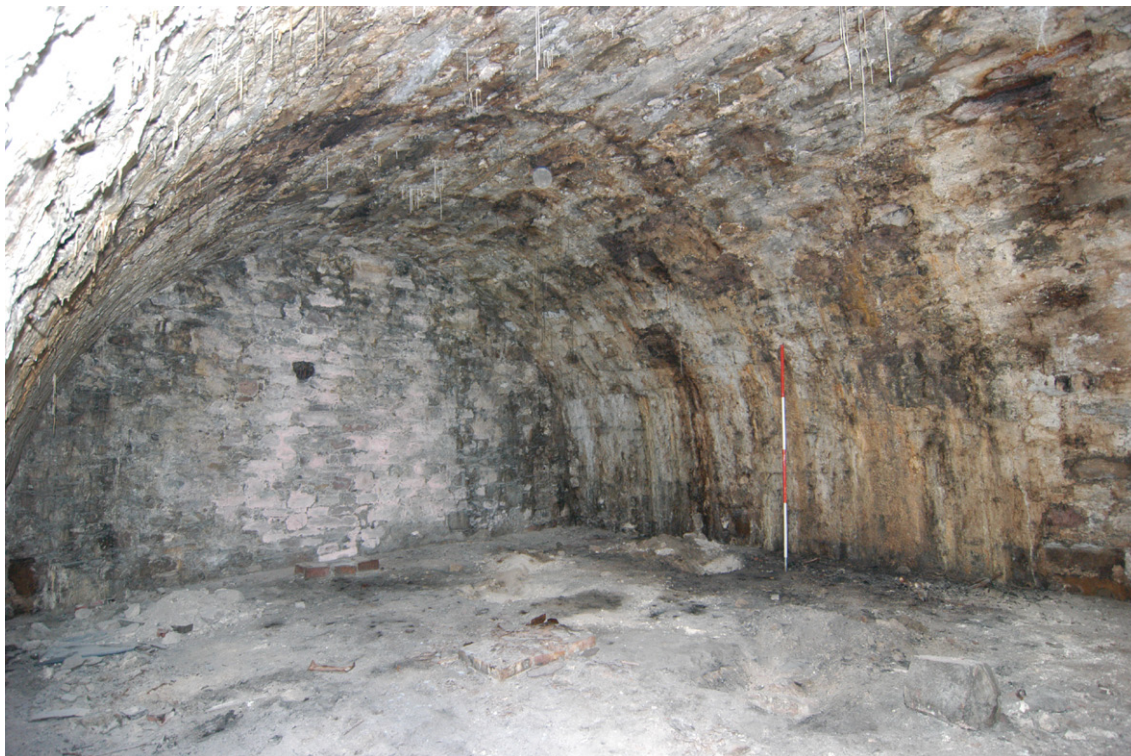
Vault 2 measured 6.7m long, 6.1m wide and 3.4m high (Fig 6). The north, south and west-facing walls were the same as those described above. The east-facing wall was a continuation of the external Level 3 core block wall with the aforementioned large rectangular opening with its relieving arch above (Fig 7). A similar gap c.0.2m wide

Fig. 6 Interior of the Vault 2

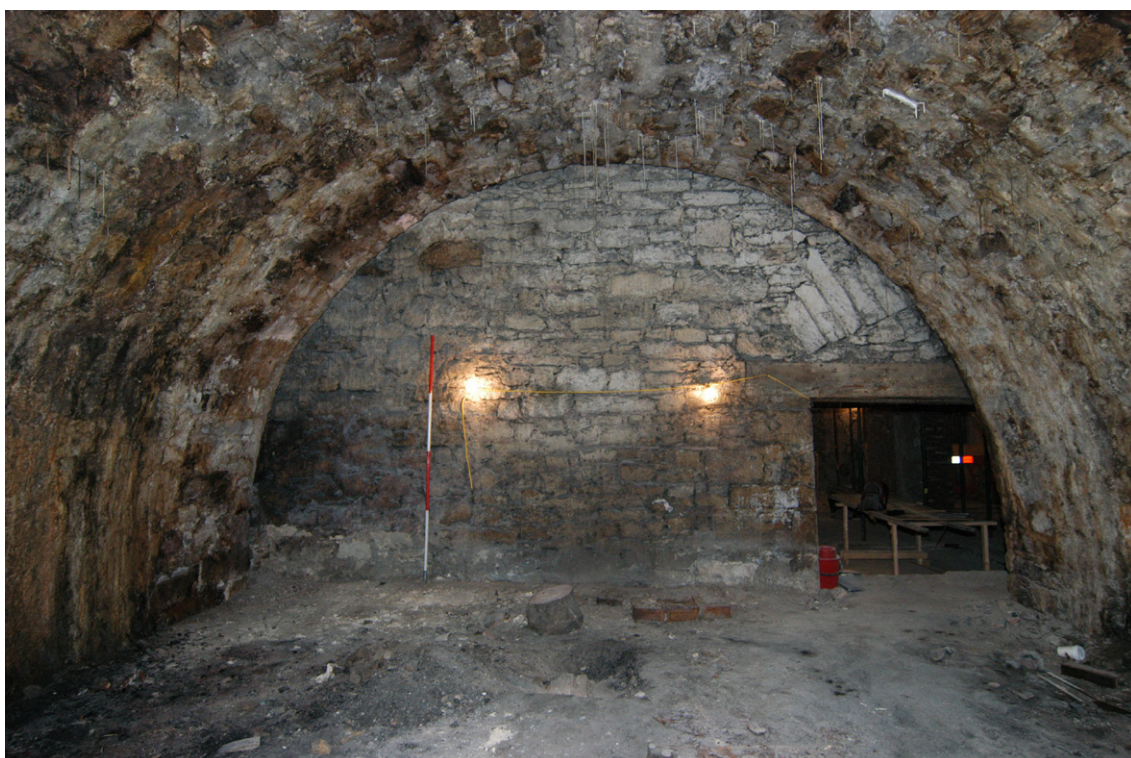
was present between the vault arch and the east-facing wall of the core-block elevation. The wall separating the two vaults was 1.5m thick at floor level (Fig 8).

Fig. 7 Interior east-facing elevation of Vault 2 showing part of the larger opening with a segmented relieving arch

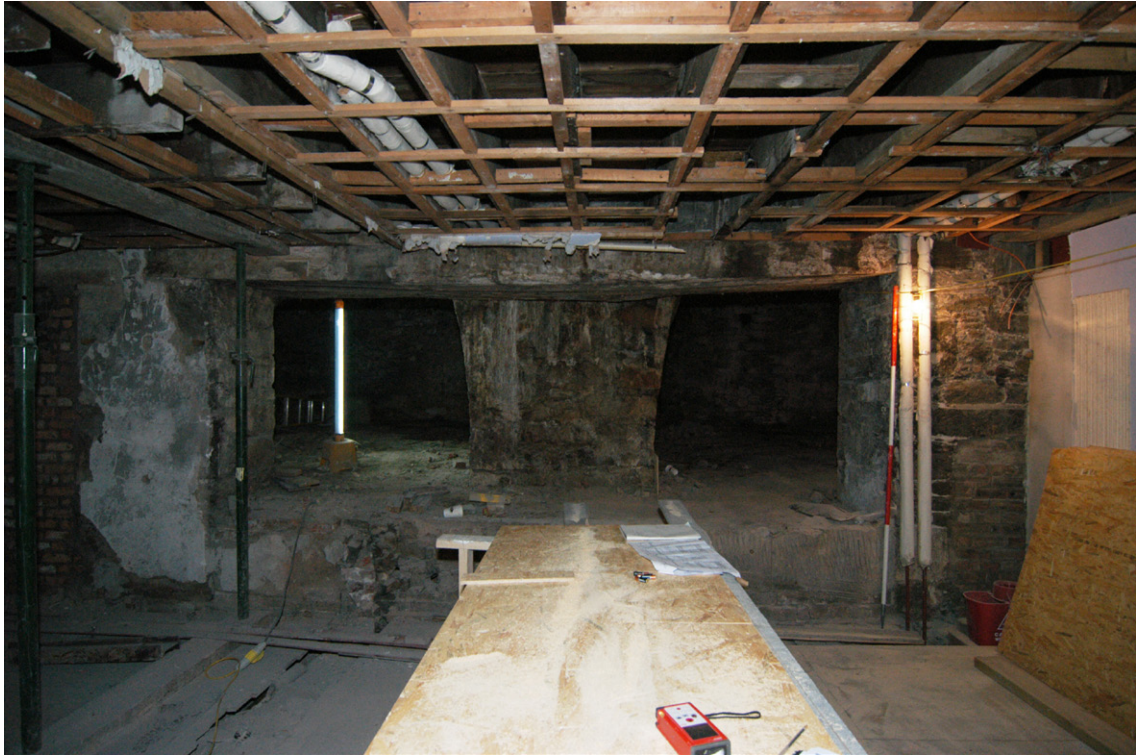
Fig. 8 Looking into Vaults 1 and 2 from within the main block of 85-87 South Bridge

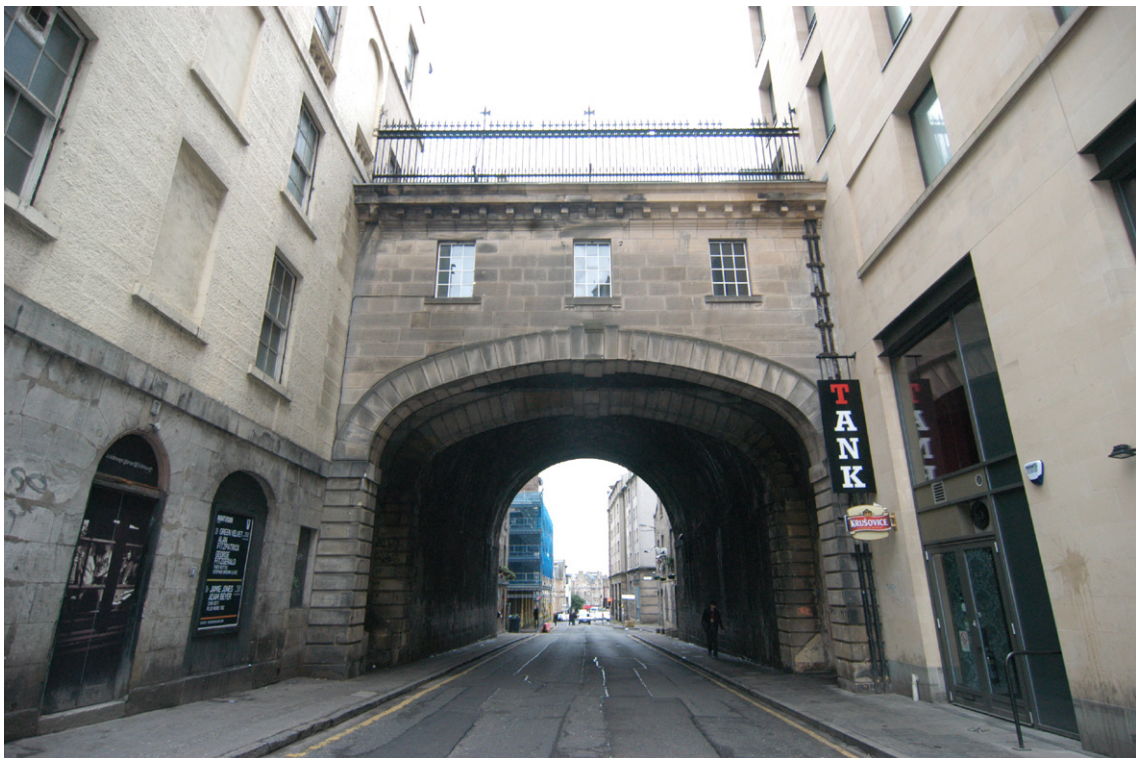
The Link Bridge west-facing elevation consisted of a segmented elliptical arch with three ashlar-built square-headed windows surmounted by a dental cornice. Wrought iron railings flanked the pedestrian footpath that ran above the Link Bridge roof. The double segmented archway could be seen from the Cowgate street level. The Link Bridge arches contrasted with the barrel vaulted roof line of the 18th century South Bridge.

Fig. 9 Exterior west-facing elevation of the Link Bridge

The exterior of the Link Bridge is of detailed ashlar construction and its arches contrasts sharply with the earlier late 18th century barrel-vaulted South Bridge. The Link Bridge was built c. 1929-30 and its interior is in keeping with the Art-Deco style with its use of marble mouldings and wall panelling. The link bridge was used as a

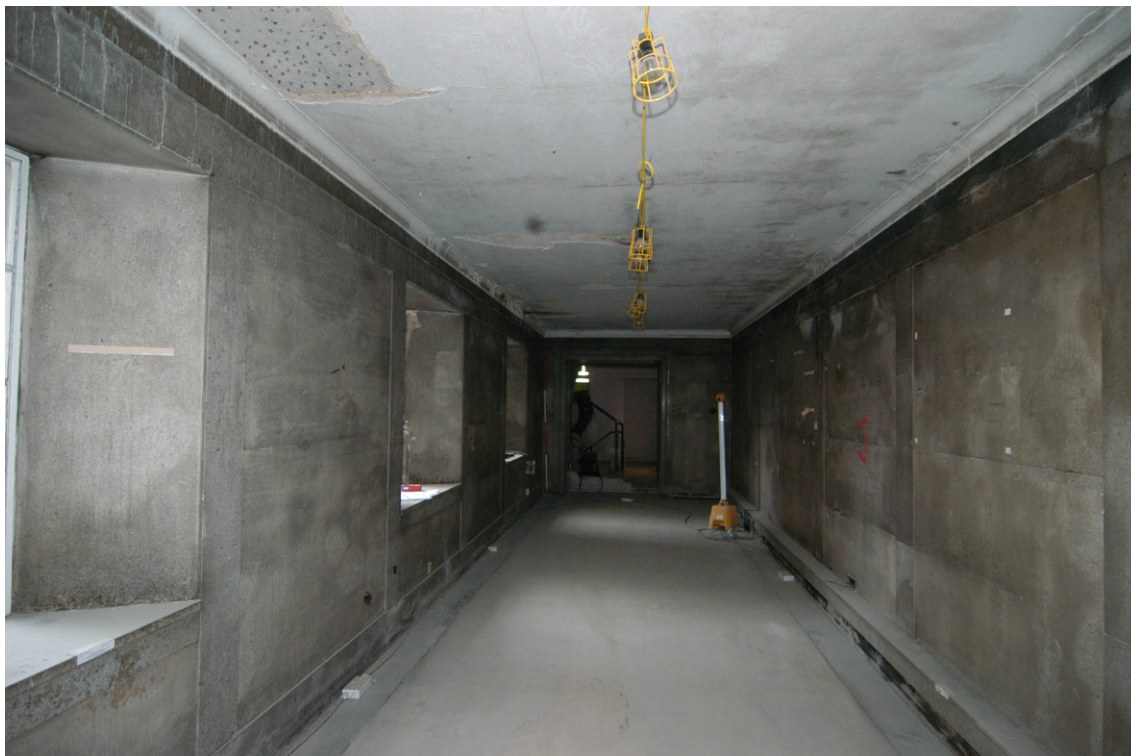
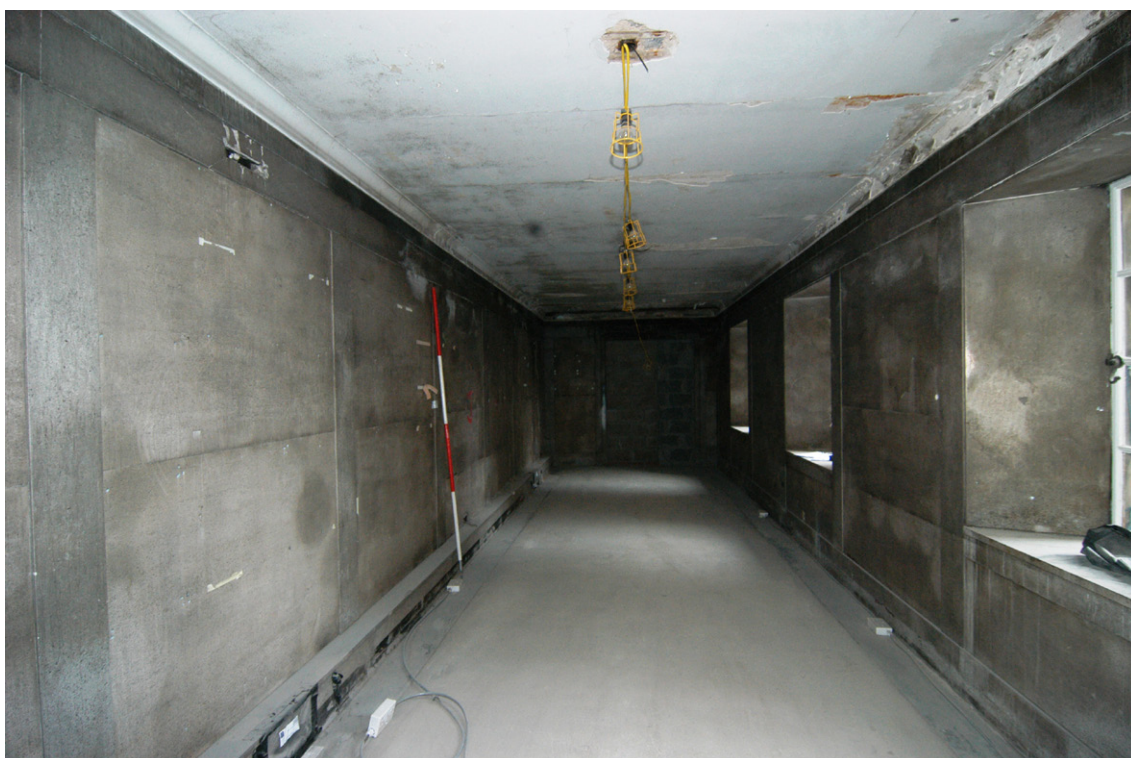
The interior of the Link Bridge measured 10.2m long, 2.8m wide and 2.6m high (Fig 10-11). The entrance doors were situated at the north and south end of the bridge. The latter entrance was blocked. The walls were lined with a grey marble with black flecks. The west wall (east-facing elevation) contained three windows with splayed reveals that were 0.5m deep. The northern-most window contained its original ornate 1930s window latch (Fig 12), the other two were broken. At the north and south ends of the bridge the door surrounds were a grey marble with bead-mouldings (Figs 13-14).

The floor and ceiling were concrete; the latter was severely eroded at the south end revealing its steel frame.

Fig. 10 Interior of the Link Bridge facing north

Fig. 11 Interior of the Link Bridge facing south

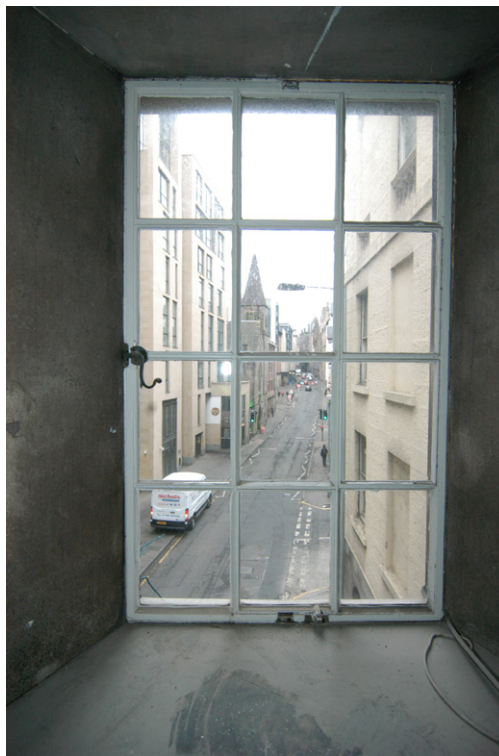
Fig. 12 Northernmost window with original window latch

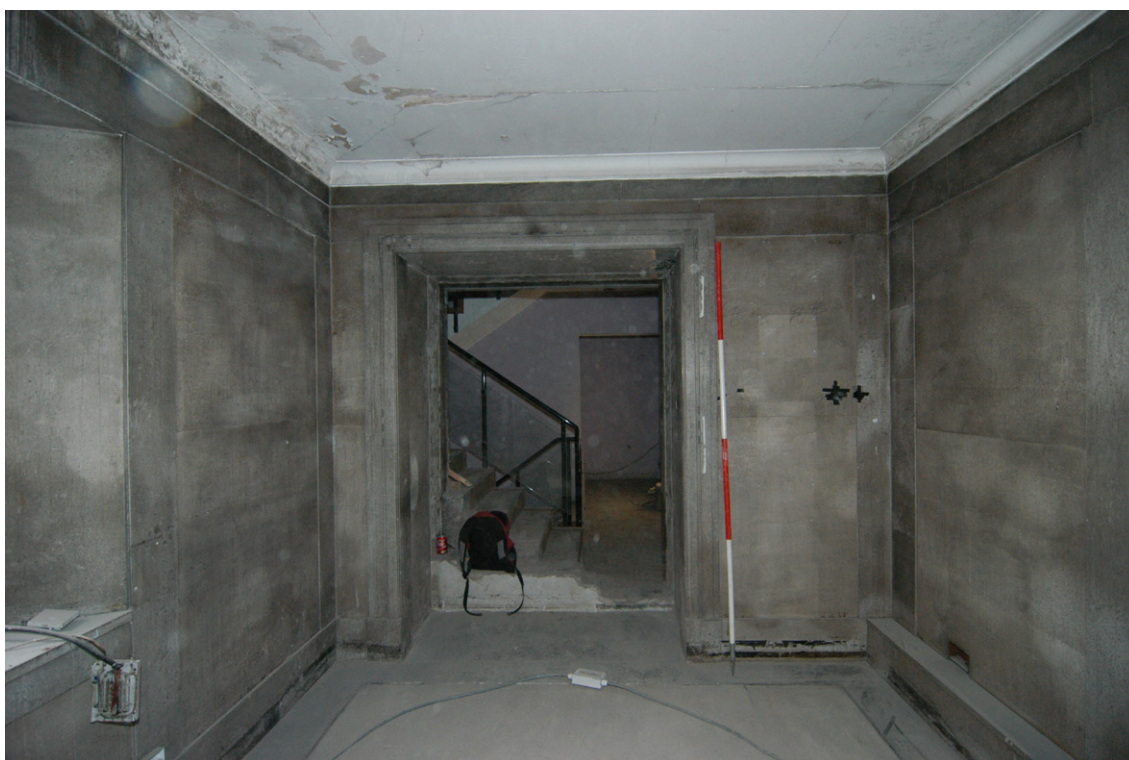
Fig. 13 Moulded door surround on the north entrance

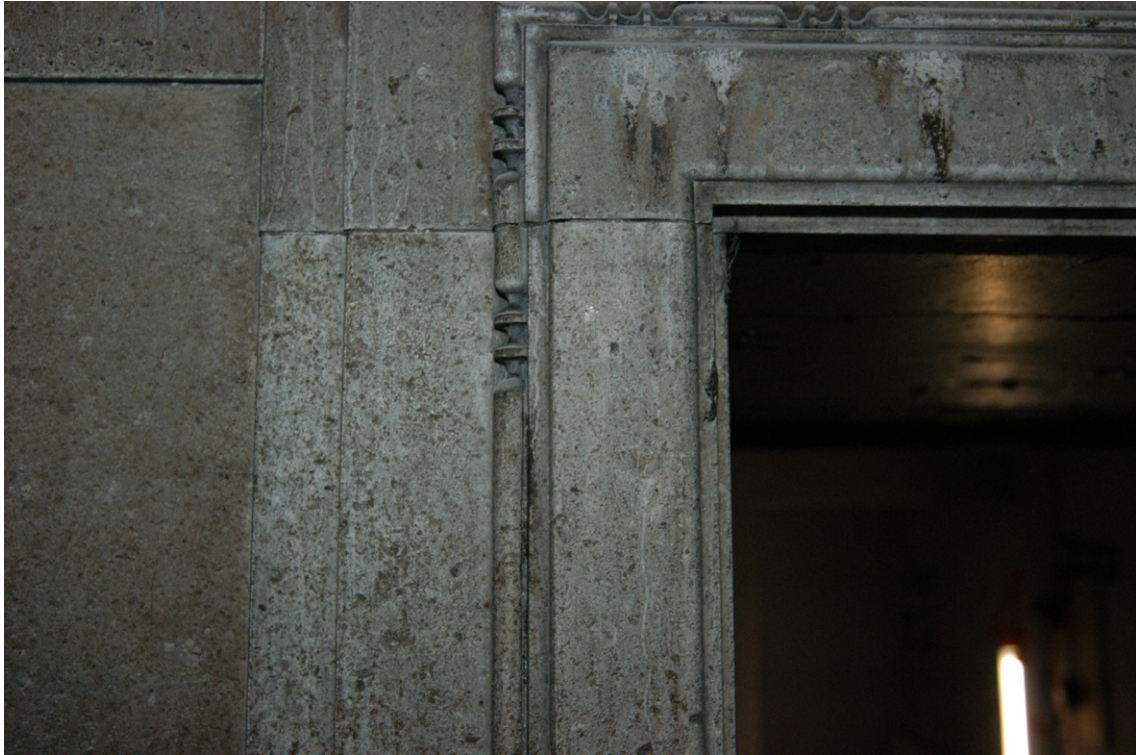
Fig. 14 Detail of the bead-moulding around the marble door frame
