**85-87 South Bridge,
Edinburgh
Archaeological Watching Brief**

Report No 3383

Author	Ewan MacNeilage MA (Hons)
Illustrator	Shelly Werner BA MPhil PhD MCifA
Editor	Bruce Glendinning BSc PG Dip MCifA
Commissioned by	Mr Joe Crolla
Date issued	January 2016
Version	1
Grid Ref	NT 25958 73496

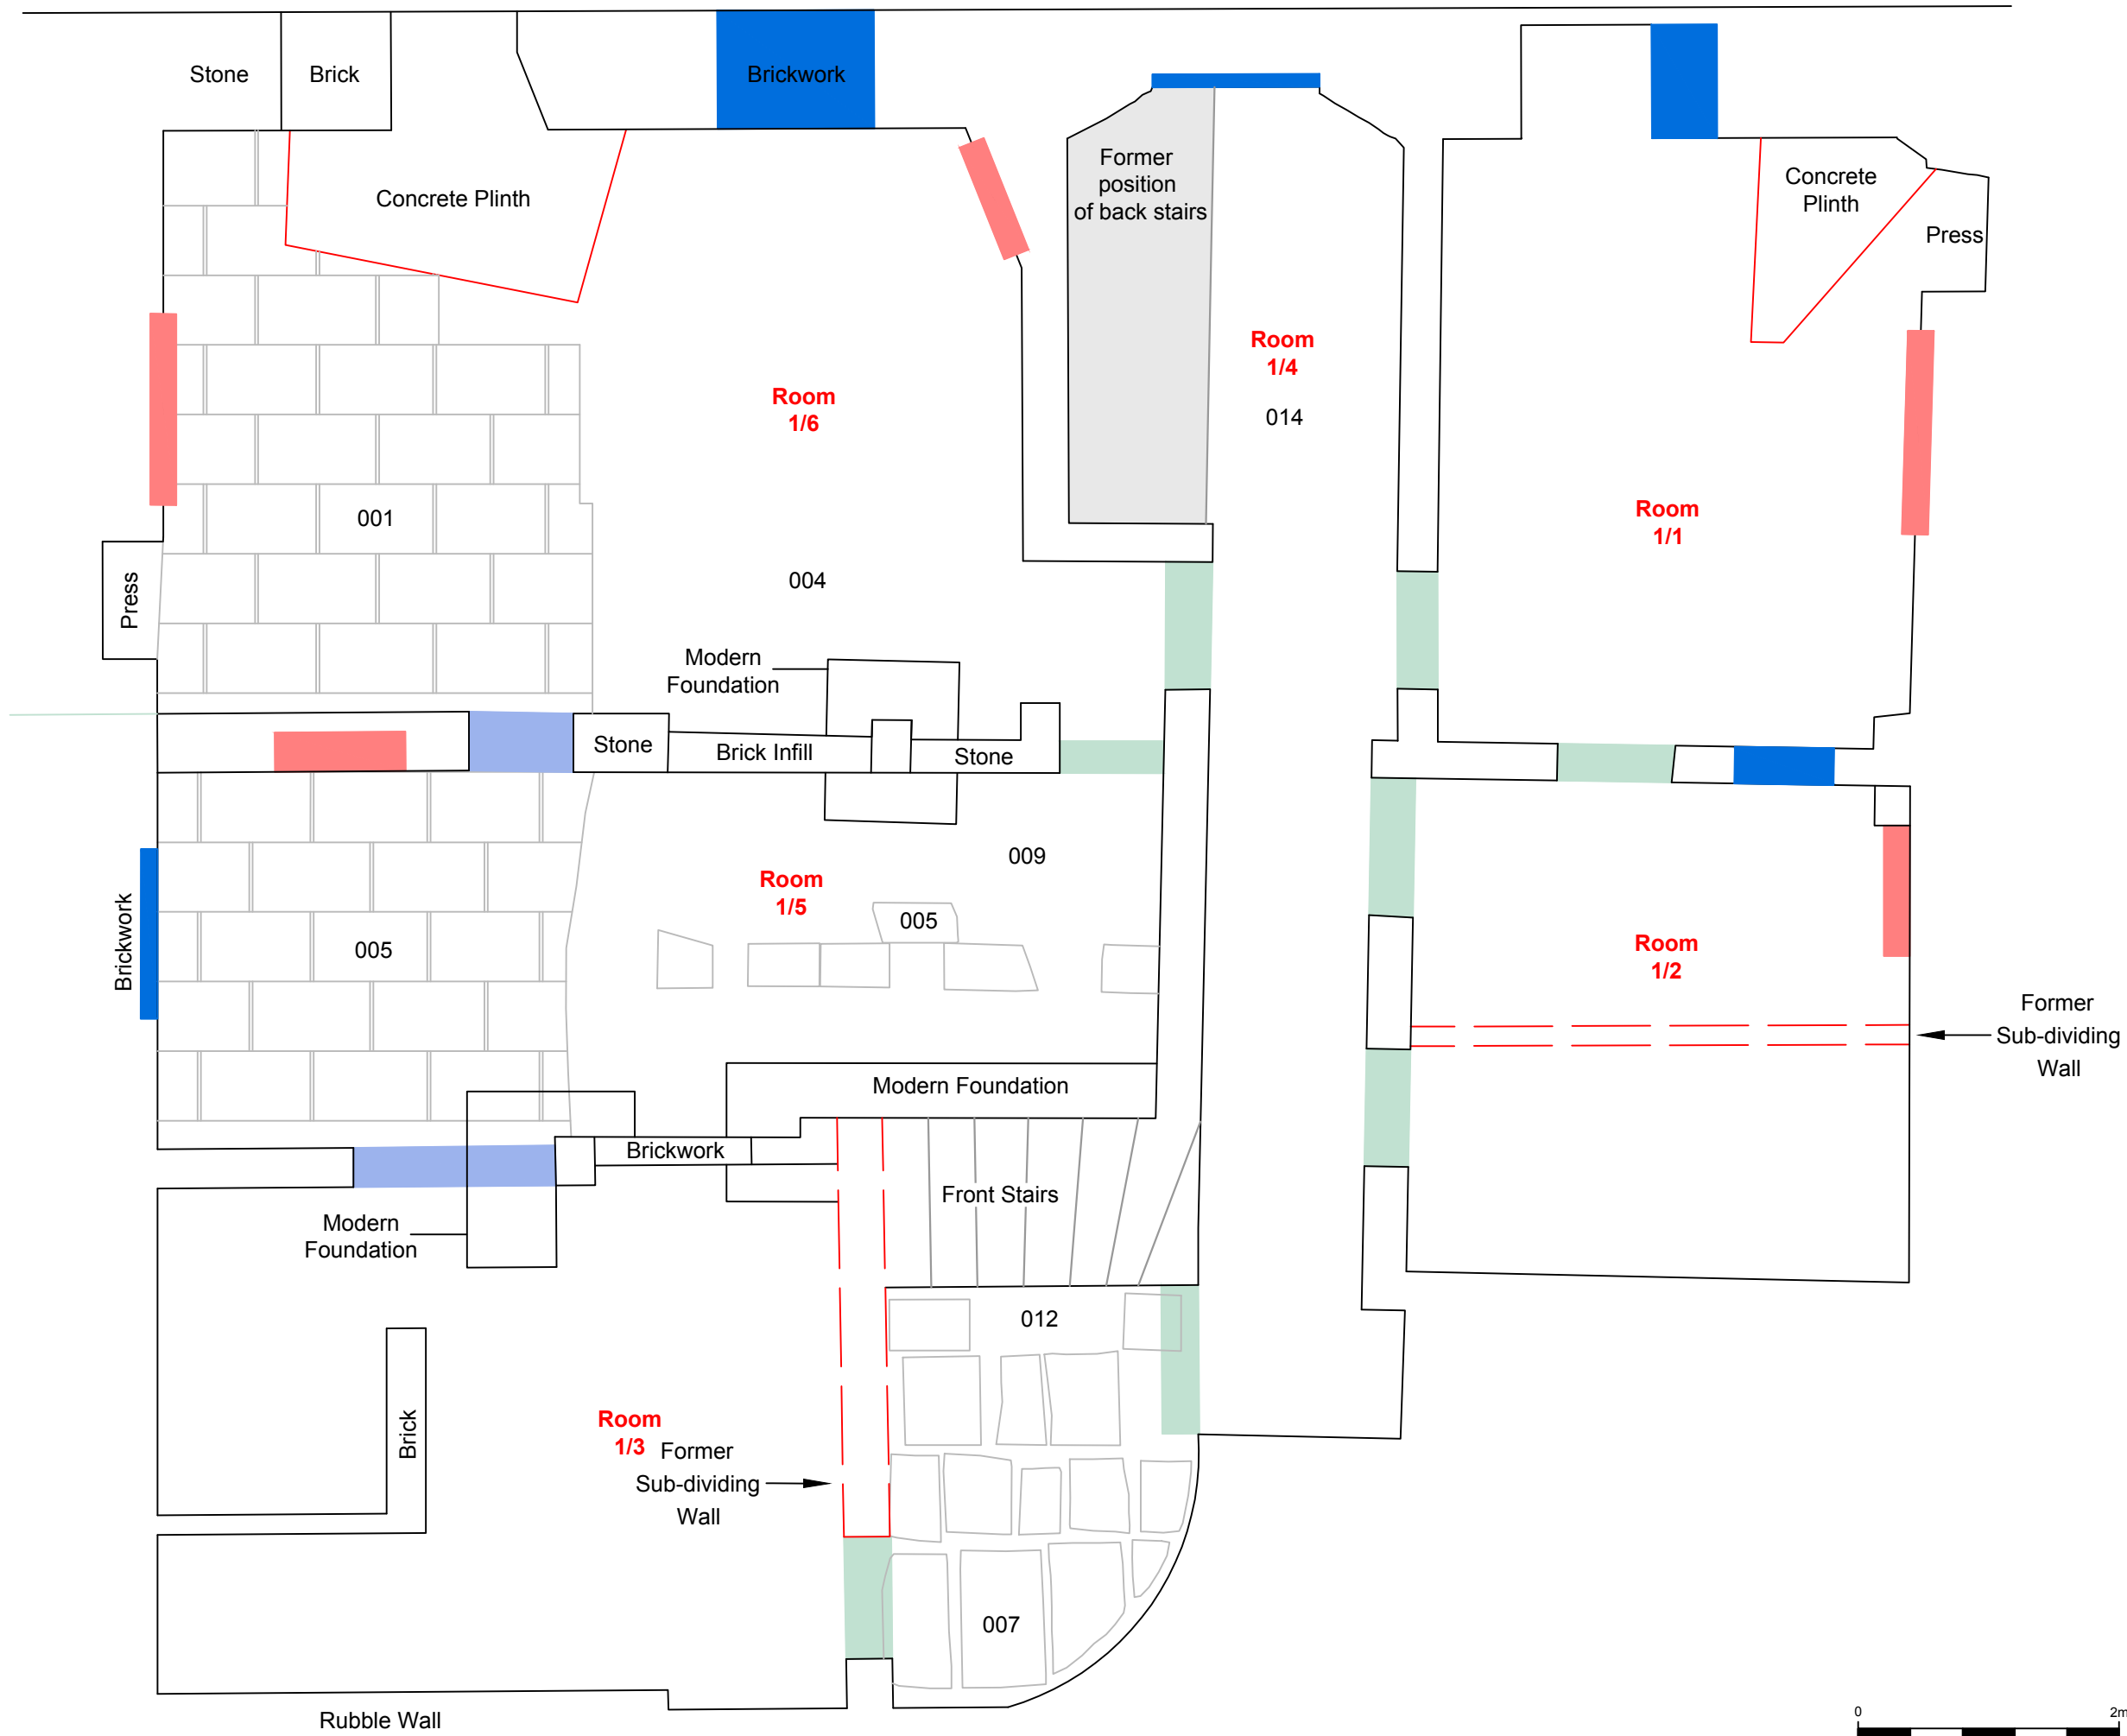
Fig. No: 1 Report No: 3383

The interior layout of the basement is described and six rooms were each assigned a unique number 1/1 to 1/6 (Fig 1) as per the building appraisal (Cressey 2015). The following table provides the dimensions, floor covering and proposed former use of each room identified in the basement.

Title:
Floor plan of basement level showing room numbers

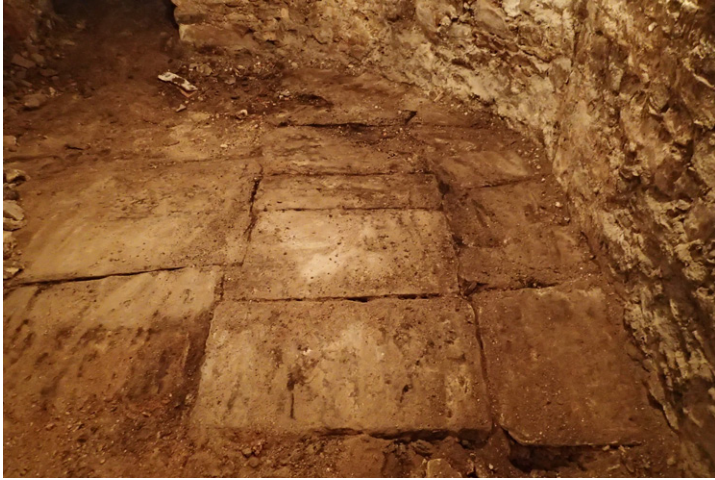
A flagstone floor (**007**) (Fig. 2) was present in the northern half of this room. The sandstone flags were square or rectangular and measured up to 1m in length by 0.8m in width. Underlying this was a deposit of dark brown mixed sands with ash and rubble inclusions (**012**). This deposit measured 0.3m in depth. Underlying this was a deposit of mid brown/black clayey sand containing orange and black mottling (**013**). This deposit was excavated for 0.1m of depth before formation level was reached. No artefacts of significance were identified and these deposits appeared to be simple levelling deposits.

Fig. 2 - Flagstone floor in Room 1/3

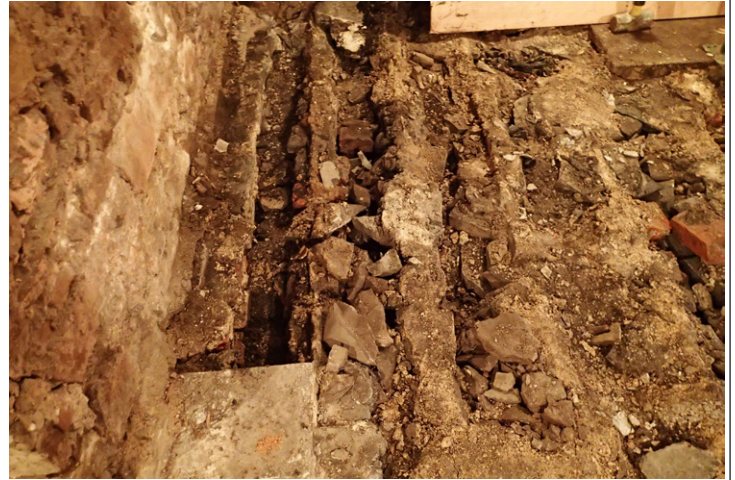
The southern part of Room 1/5 was covered with a flagstone floor (**005**) although a section of this was also observed in the north side of the room. Later construction, including the insertion of the steel work in the 1930's, looks to have caused its destruction elsewhere. Below the flagstone flooring rough mortar bonded rubble, and in places brick, walls (**006**) (Fig. 3) supported the flagstone floor. These were spaced

about 0.2m apart and the gaps between the walls were filled with loose sandstone fragments, earth and broken brick rubble. These walls were set onto a deposit of rubble (009). This deposit overlay a deposit of midden material (010), comprising greyish black silty clay. Oyster shells and coal fragments were common inclusions. Two or three fragments of animal bone and one horn core fragment was observed, however no dateable finds were recovered.

Fig. 3 - Mortered walls and rubble supporting flagstone floor in Room 1/5

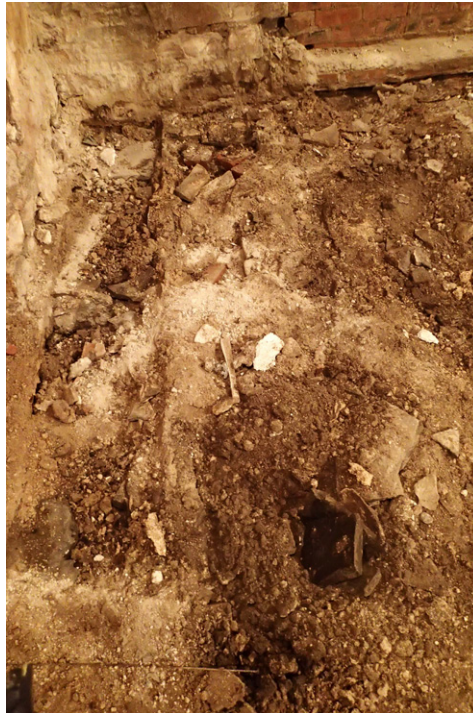
The southern half of the room was covered with a flagstone floor (001). Below the flagstone flooring rough mortar bonded rubble walls (002) (Fig. 4) supported the flagstone floor. These were spaced about 0.2m apart and the gaps between the walls were filled with loose sandstone fragments, earth and broken brick rubble. These walls were overlying a deposit of rubble, soil, mortar and ash (003), which did not extend into the northern half of the room where the flagstones were not present. Below this was a deposit of red/orangey brown mottled clay (008), with occasional sandstone and ash inclusions. The excavations ceased 0.1m into this layer as formation level was achieved.

Fig. 4 - Mortered walls and rubble supporting flagstone floor in Room 1/6
