**Halkshill Hydro Scheme
Largs, North Ayrshire**

Archaeological Watching Brief

Report No. 3403

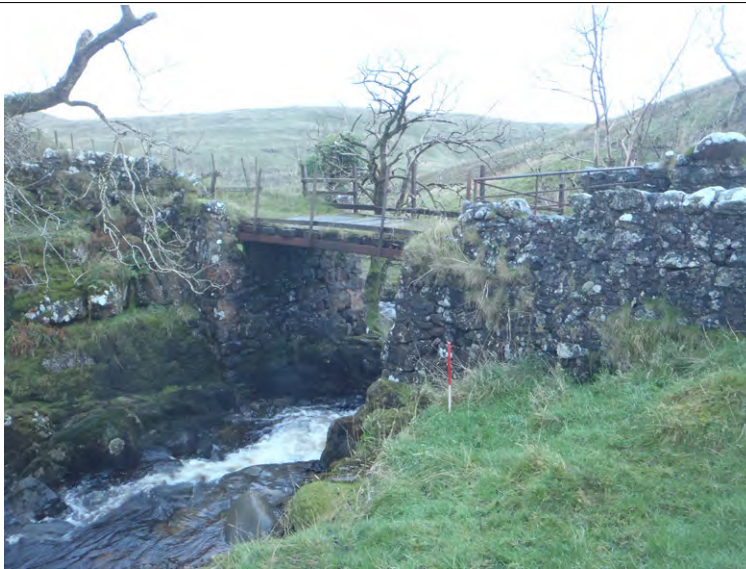
Greeto Bridge consists of abutments of drystone construction with mortar reinforcing in places (Fig. 3-4). Some later brick repairs are apparent within the western abutment. The abutments are 4.1m wide with the deck roughly 3.6m above the river below. The bridge deck is made of iron beams surfaced with wooden slats and is 2.7m wide; the remains of a hand rail are present as upright iron posts with the remains of wooden rails in places. There is no evidence of any arched stonework indicating an earlier stone span.

Fig. 3 - Greeto Bridge (Site 3) looking south-west

The original structure of the bridge, including the stone abutments and the wood and metal deck and railings, will remain in situ below the new bridge.

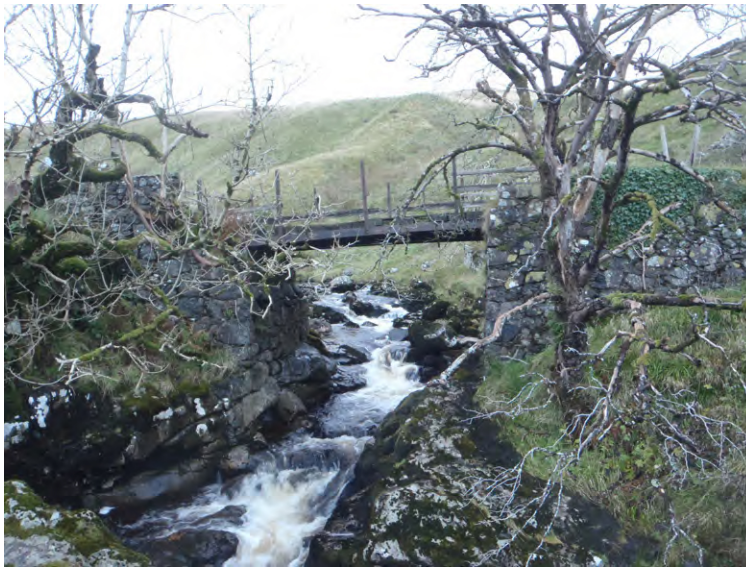
Fig. 4 - Greeto Bridge looking south-east

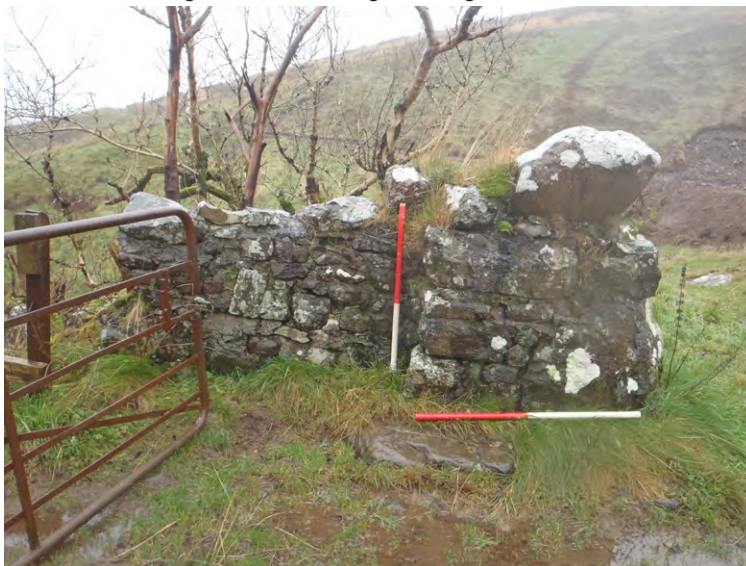
Site 4 was a section of rough lime mortar bonded masonry incorporated into a drystone wall located on the south-west side of the bridge (Fig. 5). The date and function of the bonded masonry is unclear. It measured 2m in length by 1.5m in height. The wall was demolished under watching brief conditions as part of the new bridge works.

Fig. 5 - Site 4

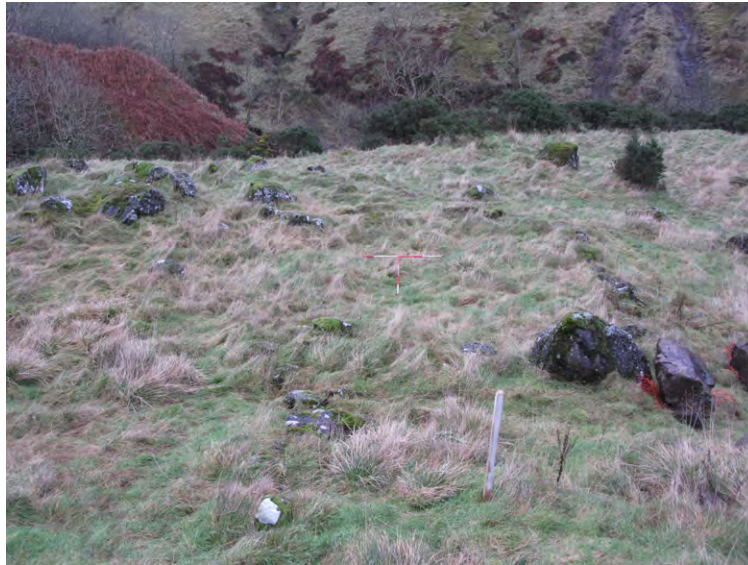
visible as low, grass-covered banks with stones and boulders visible, with possible entrances in the NE and SE corners (Fig. 6-7). It measured 10m by 9.5m (NW-SE) at its widest, enclosing an area measuring 7.5m by 5.8m. It appeared to utilise large boulders, likely from rock-falls, within its circuit.

Fig. 6 - Pre-excavation photo of enclosure (Site 30)

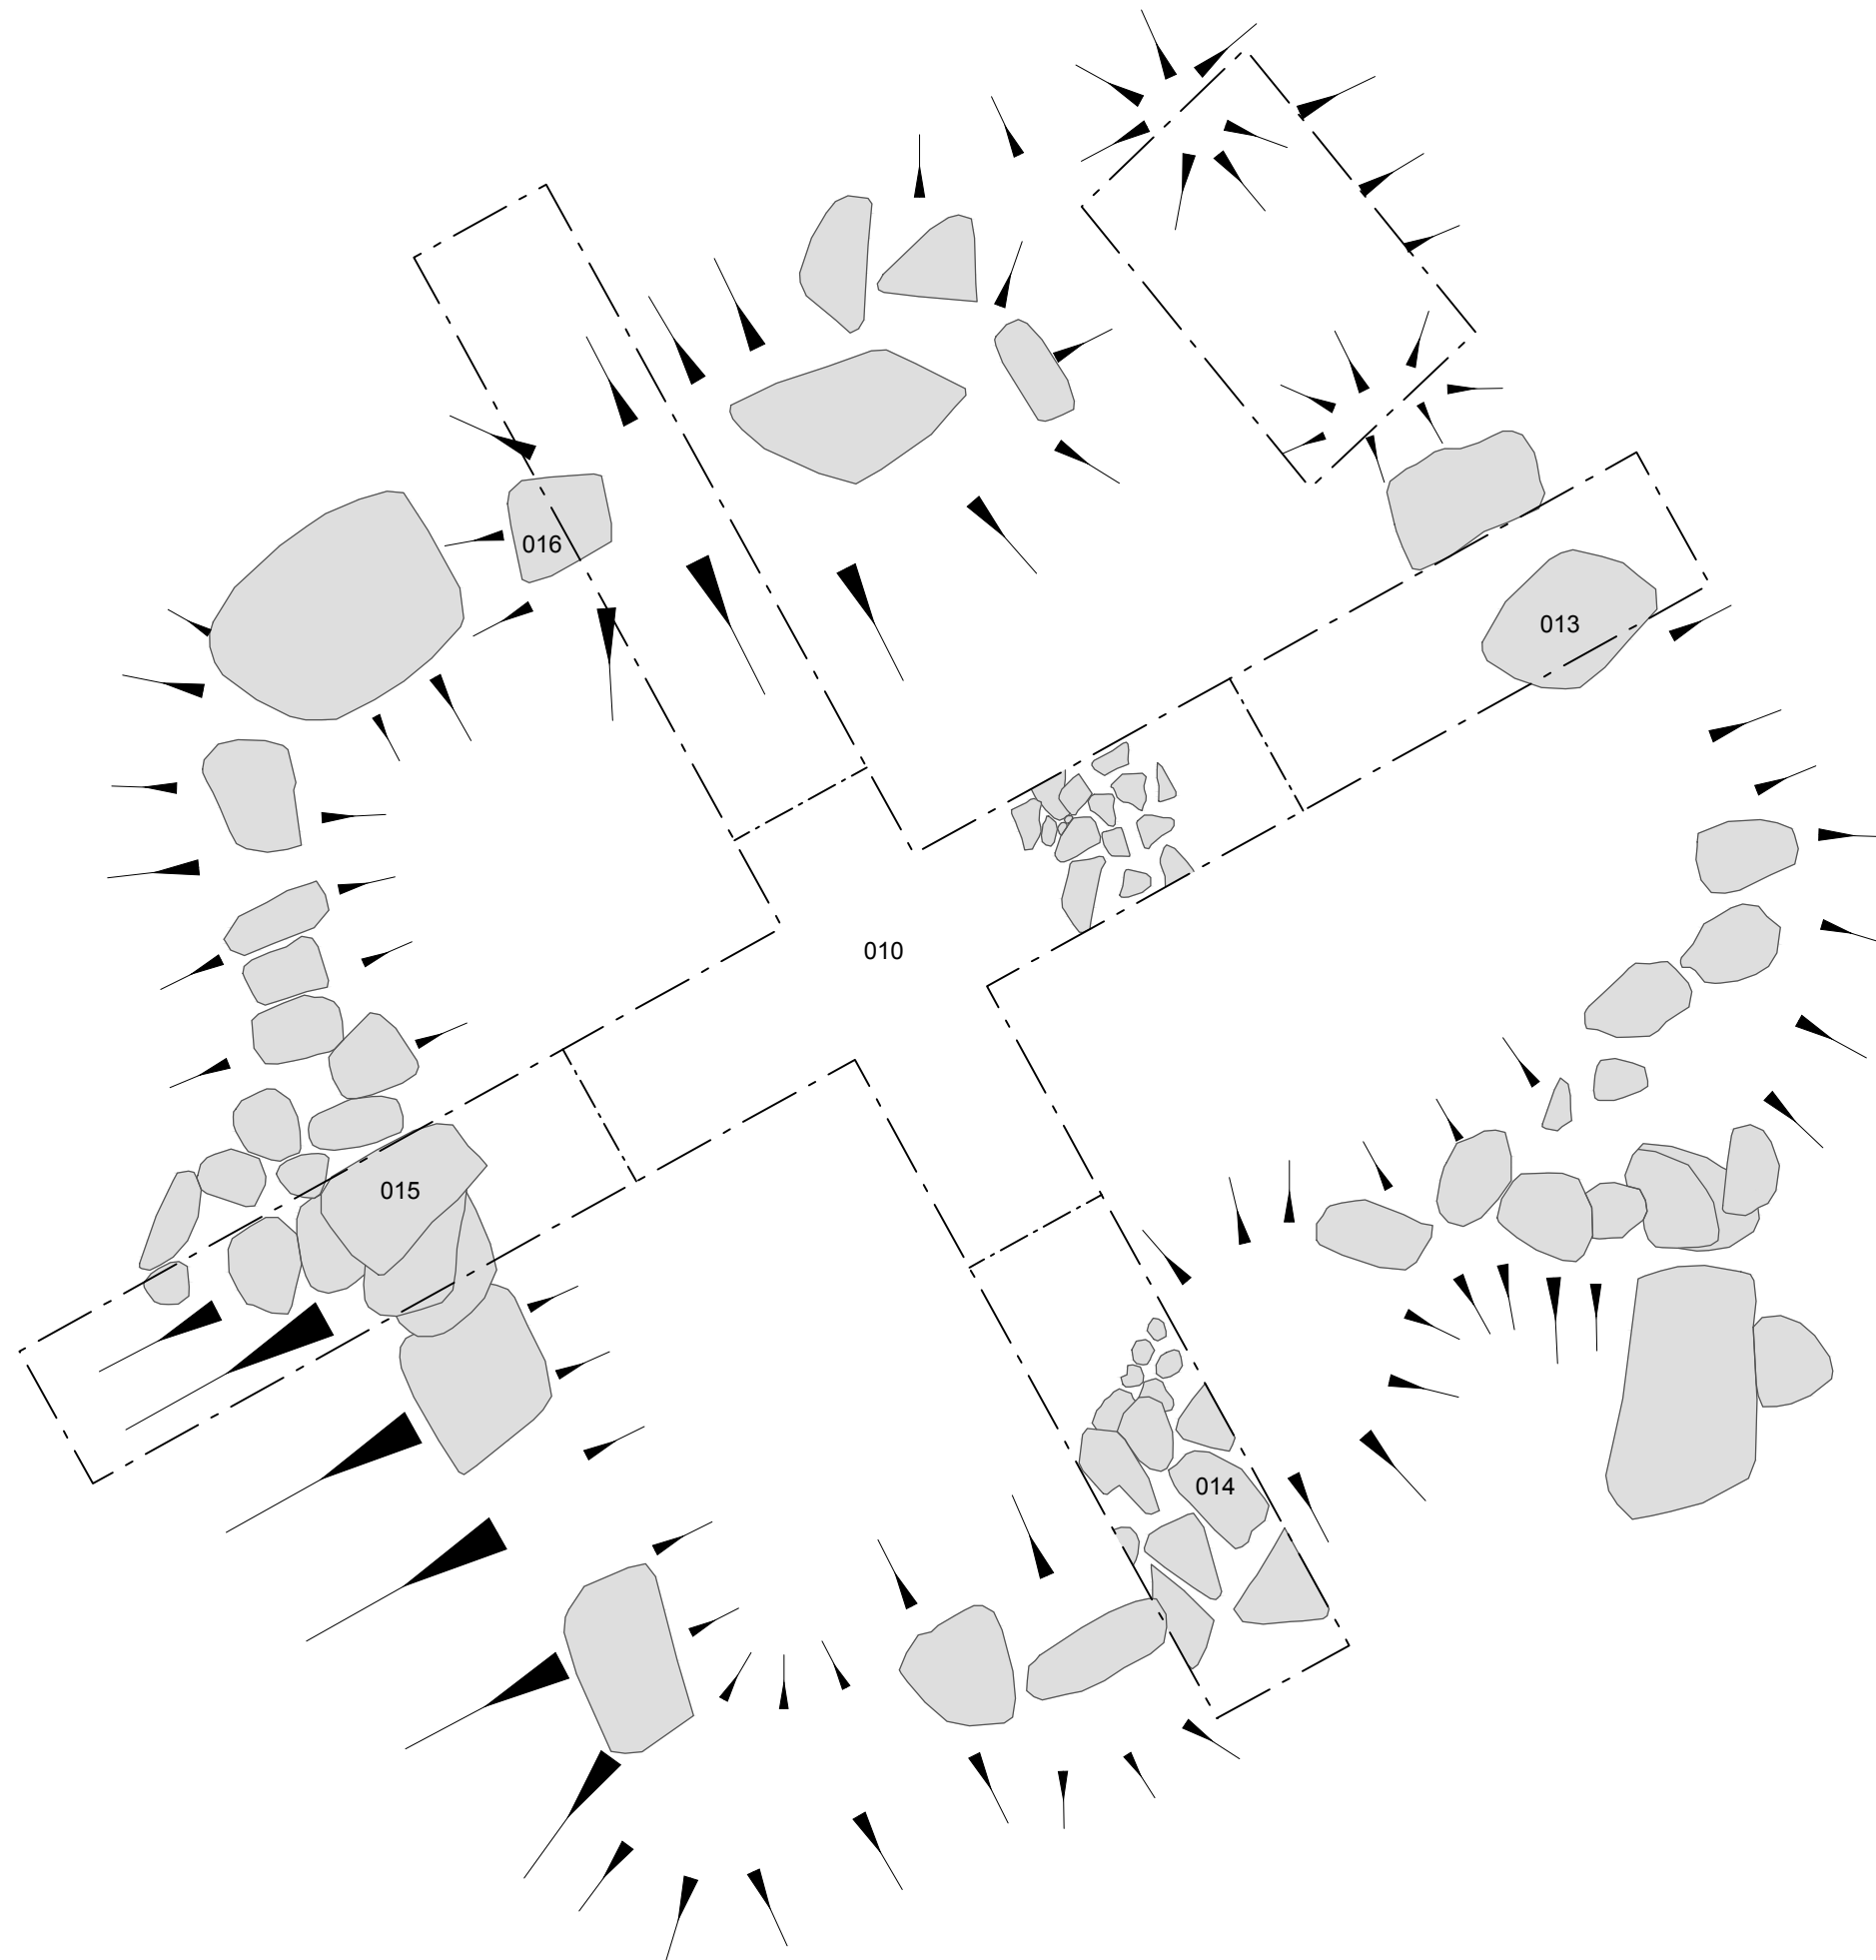
Report.No: 3403	Fig. No: 7
---------------------------	----------------------

Two 1m wide trenches were hand excavated across the enclosure forming a cross (Fig. 7, 11). The two trenches were aligned north-west by south-east and transversely. Each trench was initially excavated as two slots across the opposing walls, which were then joined to form a continuous trench. Therefore, Slots 1 and 3 formed the north-east by south-west trench and Slots 2 and 4 formed the north-west by south-east trench. A fifth slot (Slot 5) investigated a possible north-eastern entrance.

Title:
**Plan of sub-rectangular enclosure
 (Site 30)**

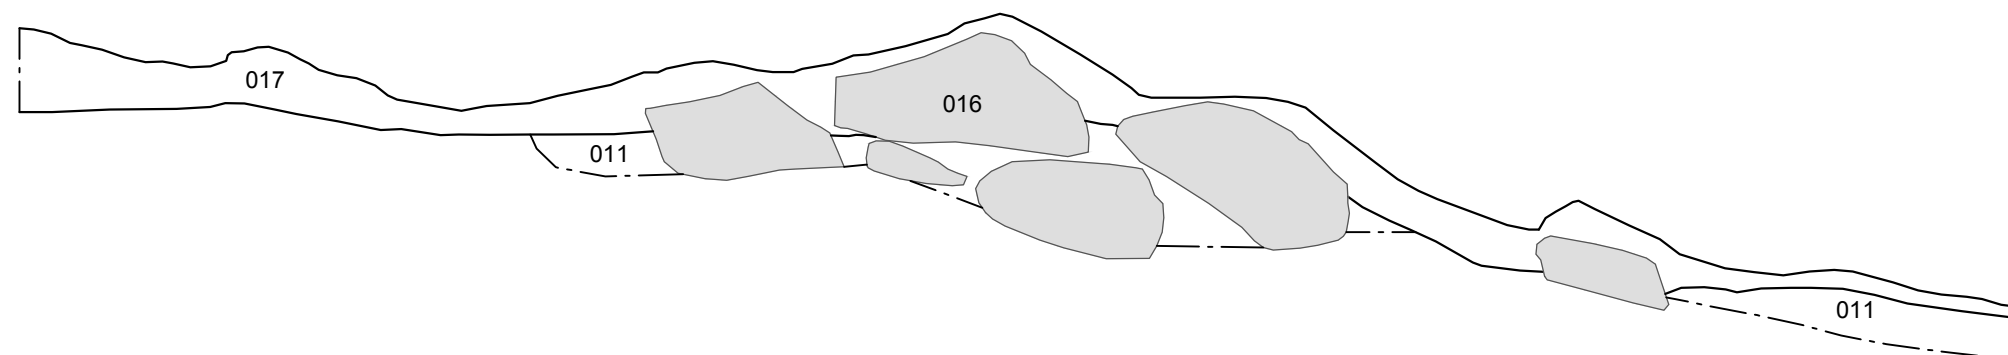
The walls (**013-016**) were constructed from medium to large rounded and sub-angular boulders which were overlying a reddish-brown/grey sandy silt (**011**) with no discernible foundation trenches (Figs. 8-9, 12). The walls ranged in width from 1.0m to 1.6m and survived to heights ranging from 0.4m to 0.5m.

The walls of the structure were built on top of **011**, a deposit of shattered angular stone/scree likely deposited through movement of loose material from the steep slopes above, and **010**, a dark brown silty clay subsoil. The structure was covered with topsoil and turf (**017**).

Fig. 8 - South-west-facing section through Wall (016)

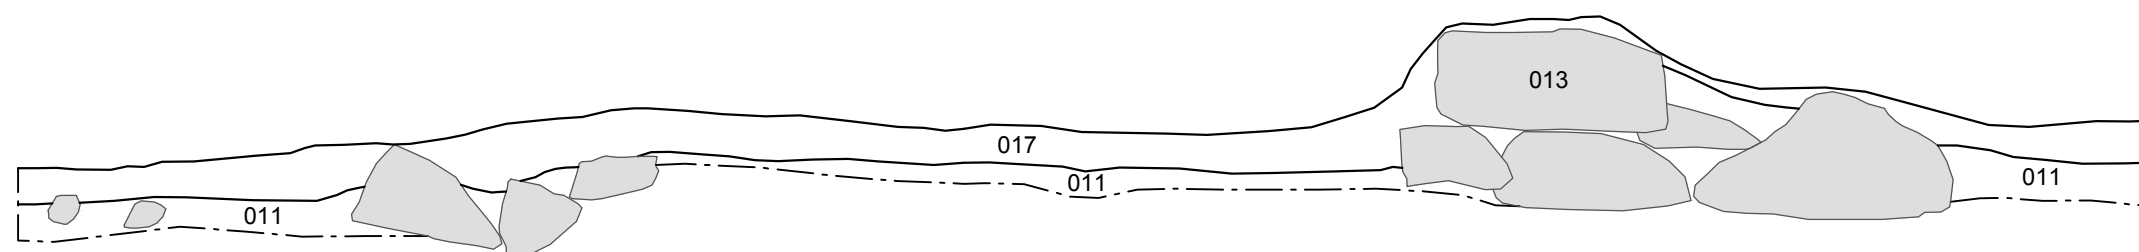
Fig. 9 - South-east-facing section through Wall (013)

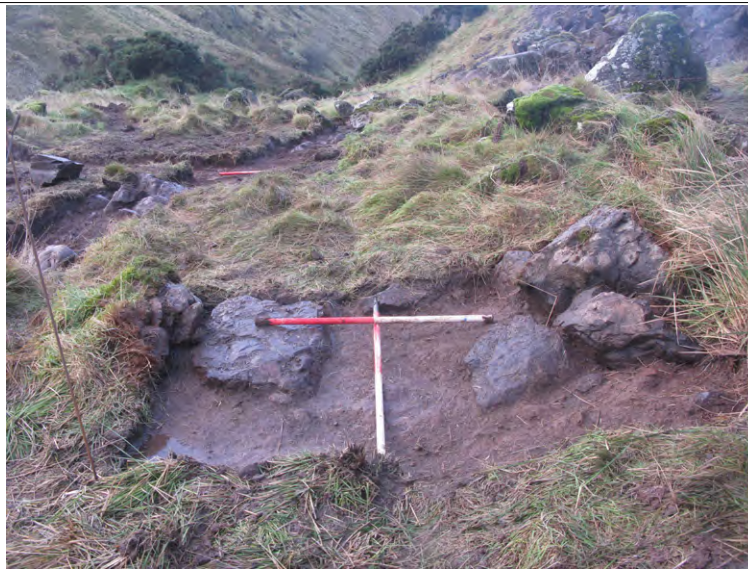
A possible north-west entrance was identified in Slot 5 (Fig. 10) which measured approximately 0.8m wide. A trench was also placed to investigate a possible entrance on the north-east but it turned out to just be a lower spread of stones beneath the turf. No internal features were identified within the trenches.

Fig. 10 - Possible north-west entrance of enclosure (Site 30)

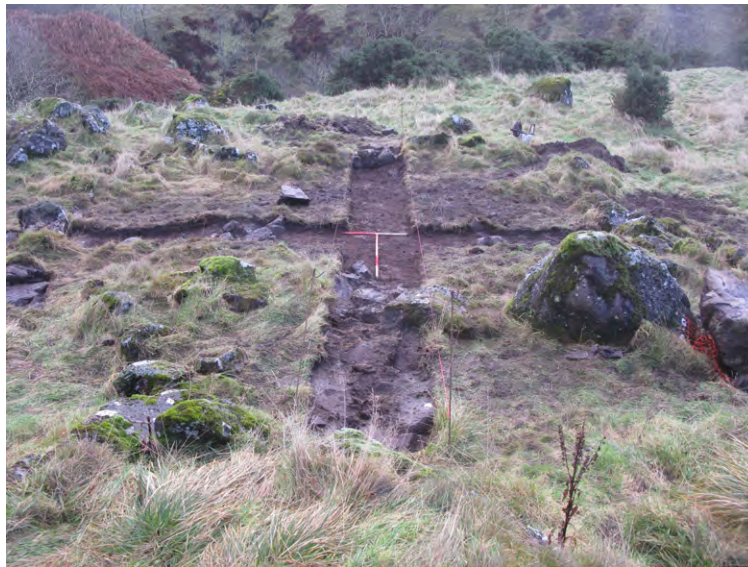
Fig. 11 - Site 30, view of excavated trenches from NW

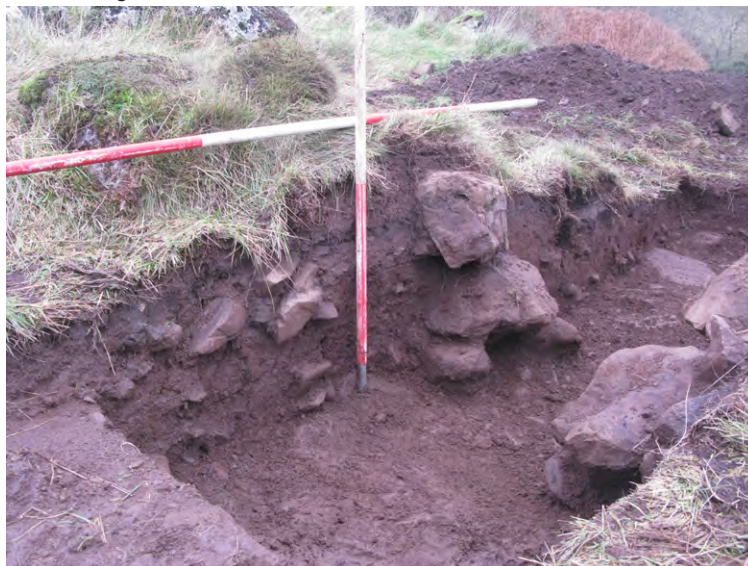
Fig. 12 - Site 30, wall 014 SW-facing section

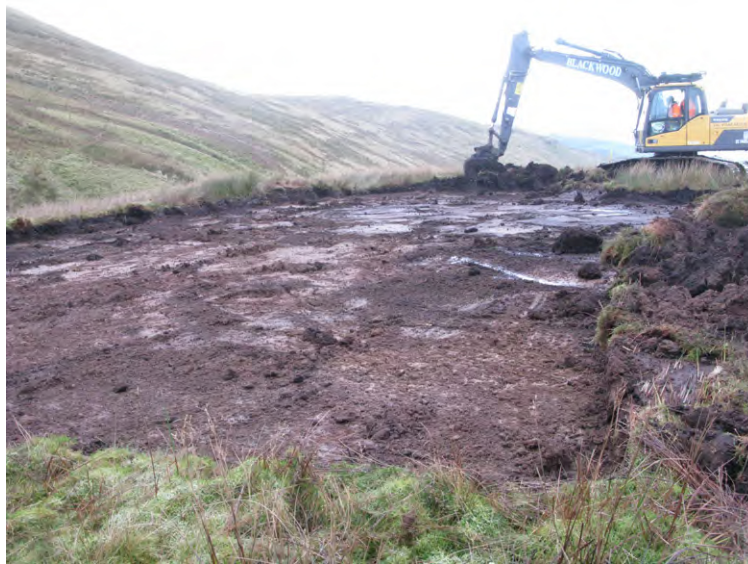
Topsoil was generally thin (up to 0.4m) in the steeper areas around the Greeto/Gogo Waters, with some areas of peat (up to 1m) on the moorland, over yellow-brown clay natural which contained frequent stones and bedrock outcrops.

Fig. 13 - View of soil stripping for penstock along Greeto Water

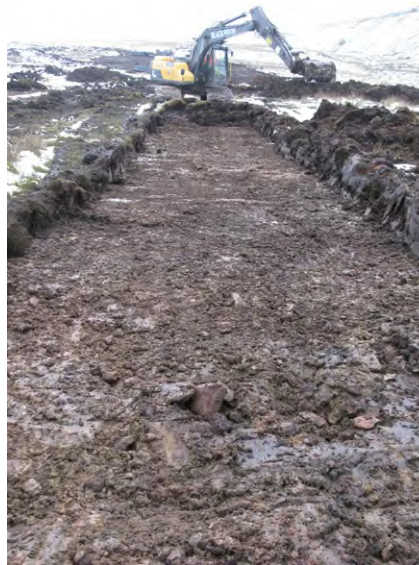
The watching brief areas are shown on Fig. 1. Areas monitored included access roads from Blairpark to Rye Plantation, a borrow pit at Paton's Hill, a borrow pit near Greeto Bridge, ground breaking works to either side of Greeto Bridge (Fig. 15), access roads along the Greeto Water to Packman's Knowe and to the outfall on the Greeto Water (Fig. 13), and access roads between Greeto Bridge and Paton's Hill (Fig. 14).

Fig. 14 - View of soil stripping for penstock east of Greeto Water

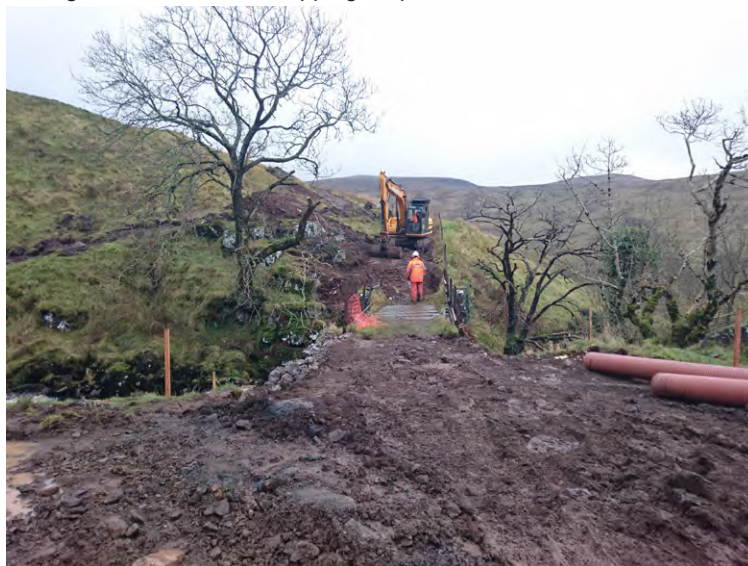
Fig. 15 - Excavation work adjacent to Greeto Bridge
