Land at Oswestry Water Treatment Works Oswestry Shropshire

Archaeological Watching Brief

Report No. Y233/16

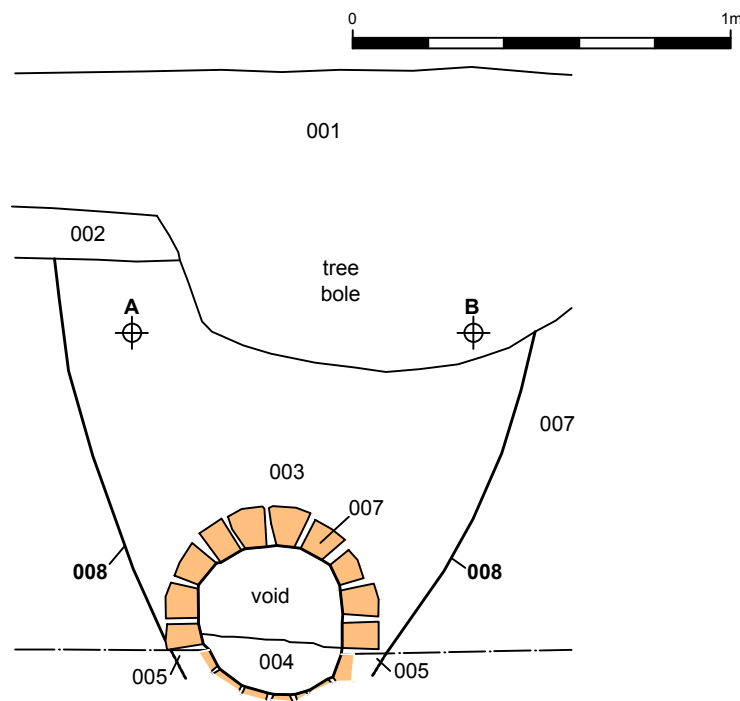
Fig 3a SE-facing section through culvert 007

Two brick culverts were identified to the south-west of the Floc-Sed Tank (Figs. 3, 4, 9 and 10) near the western corner of the woodland that covers the Llanforda-isaf farmstead. Culvert 007 was exposed to a length of 7.5m (Figs. 3 and 9), and continued west into the woodland. Where protected by the woodland, the culvert survived to a height of 0.46m, and a width of 0.66m. The majority of the culvert within the boundary of the Water Treatment Works had been subject to truncation by previous ground works and the insertion of cables and services. The culvert had silted up with a deposit 0.15m in depth containing post-medieval and modern material including glass and metal. The remains of at least one small mammal, thought to be a rodent were identified, though this is likely to have been post-depositional.

| Context no. | Fill of | Length (m) | Width (m) | Depth(m) | Type | Description |
|---|---|---|---|---|---|---|
| 007 | 008 | >7.5 | 0.66 | >0.46 | Brick Culvert | Brick culvert with semi-circular with vaulted roof and curved base forming a squashed/weighted circle. Bricks are unfrosted man-made, tapered to fit the curve of the circle, therefore asymmetrical, becoming more symmetrical towards the central keystone. They were stamped with the word 'DRAIN', one was retained as a sample. Survives in full towards the woodland and Llandford-isaf, and heavily truncated within the grounds of the Water Treatment Works due to landscaping and the insertion of cables and services. |

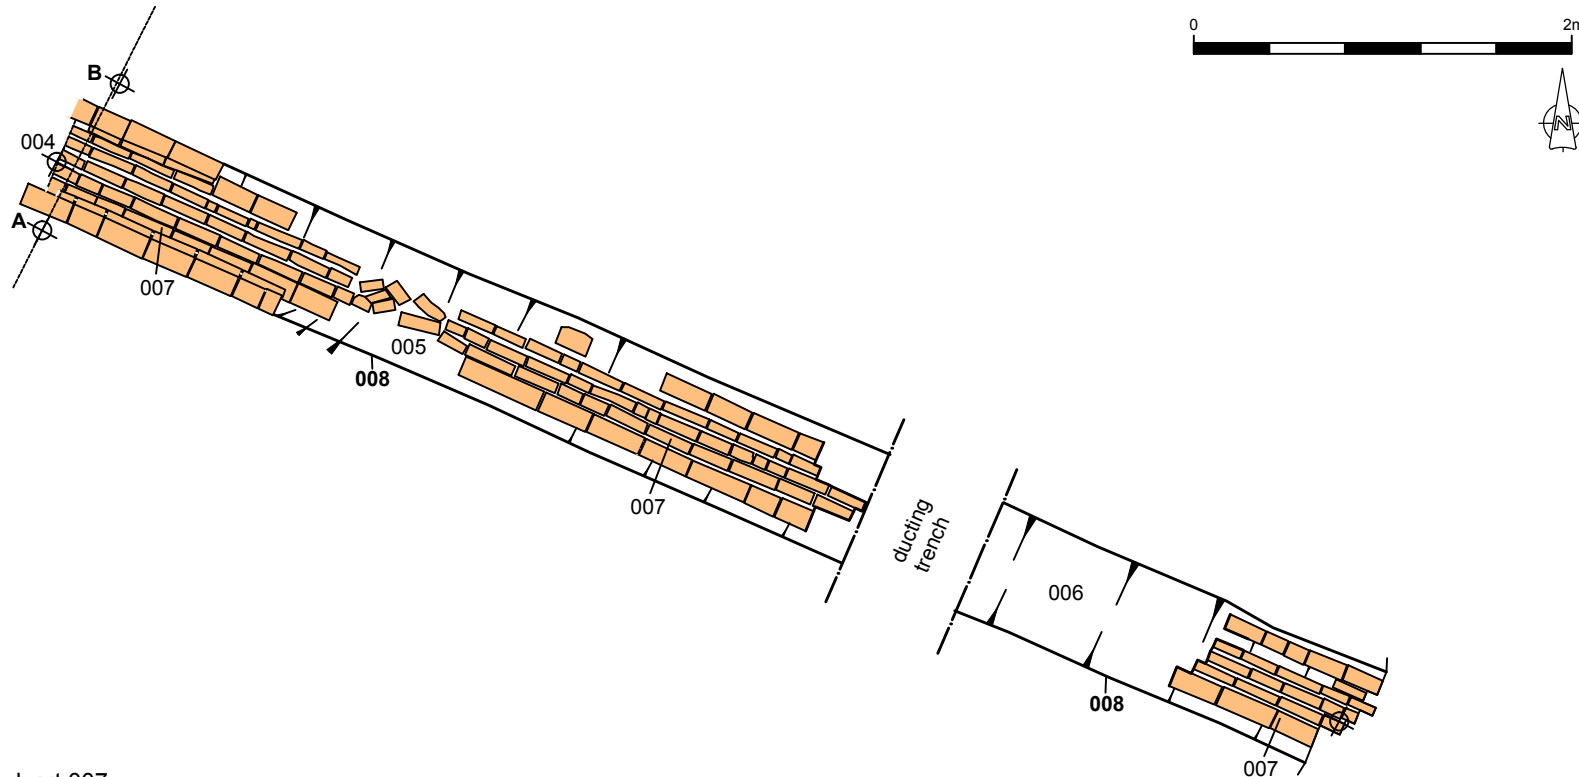
Fig 3b Plan of culvert 007

| Context no. | Fill of | Length (m) | Width (m) | Depth(m) | Type | Description |
|---|---|---|---|---|---|---|
| 008 | | >7.5 | 0.66 | >0.46 | Cut for Culvert 007 | Linear cut with concave base, orientated east to west. Sides are unclear due to formation or construction processes. Cut for the construction of the culvert 007. |

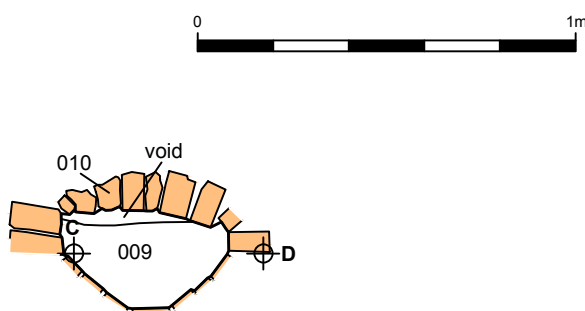
Fig 4a W-facing section through culvert 010

Culvert 010 was exposed to a length of 6m (Fig. 4 and 10), and was aligned from east to south-west with a north-west corner. It cut through the subsoil creating an internal depth of 0.37m and had fully silted up, with this silt breaching the brickwork of the culvert itself and containing fragments of the culvert fabric. The culvert had been subject to truncation due to landscaping works within the boundary of the Water Treatment Works.

| 010 | 011 | >6 | 0.7 | 0.37 | Brick Culvert | Brick culvert with an arched, vaulted roof, made up of seven rows of possible standard 9" brick, with the 4th row from the north and the 1st row from the south being narrower. All brickwork was on edge with a cement-like mortar bonding and gaps on the external arch were infilled with slate. The sides were made of four courses each and sloped to form a smooth V-shape, from a flat base made up of one row of brick. Only a small section survived as the rest had been heavily truncated by landscaping or dislodged by bioturbation. |

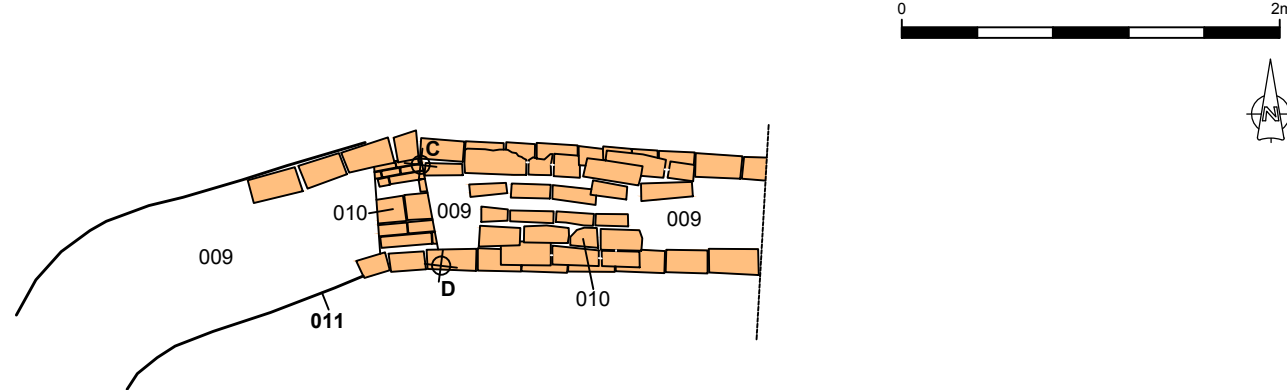
Fig 4b Plan of culvert 010

| 011 | | >6 | 0.7 | 0.37 | Cut for Culvert 010 | Curvilinear cut with moderately sloped sides and flat base, orientated from east to south-west with a north-west corner. Heavily disturbed by landscaping for the Water Treatment Works and bioturbation. Cut into the subsoil, seems to lead from the Llandford-isaf farmstead. |

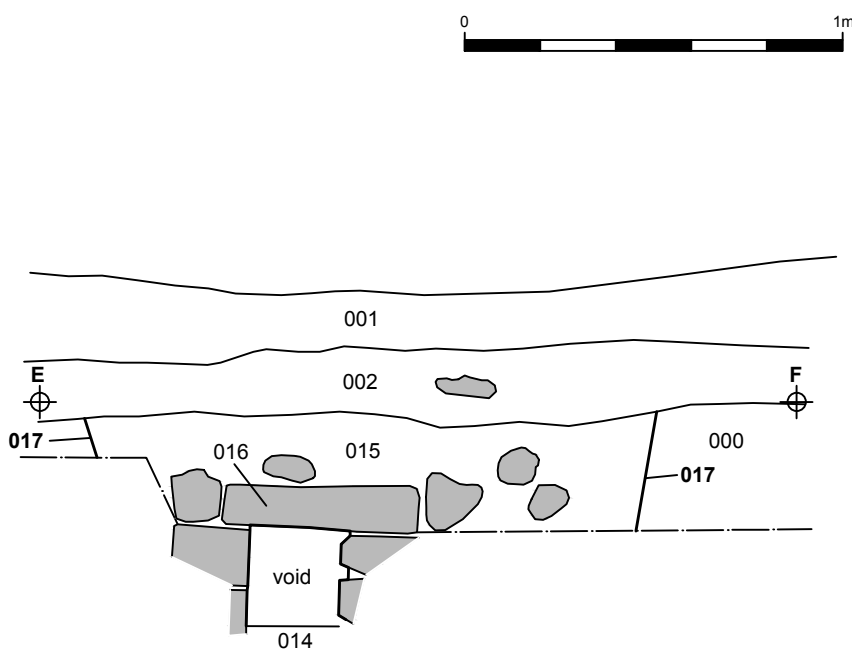
Fig 5a SW-facing section through culvert 016

Stone culvert (016) was identified in the cable trench along the access road from the car park (Fig. 5). A 1.4m² test pit was excavated across its length to aid identification as the excavation of the cable trench had released a build up of water caused by the removal of one of several clay plugs (015) along its length. The culvert was only part exposed and largely covered in wet clay. It consisted of two rows of stone, set 0.24m apart, which were two courses in height (0.28m) and which were capped with roughly shaped stone, with smaller stones used to fill in the gaps. The culvert was on the same orientation -south-west to north-east - as the outlet for Pond 2 (Hunt 2014).

| 016 | 017 | >1.4 | 1.4 | >0.38 | Stone Culvert | Stone culvert orientated south-west to north-east formed of two rows of shaped stone set 0.24m apart, which were two courses deep at 0.28m, and a layer of roughly shaped capping stones with additional smaller stones to fill in the gaps. No bonding material, and not built to be seen, appears to line up with Site 2 (Hunt 2014). |

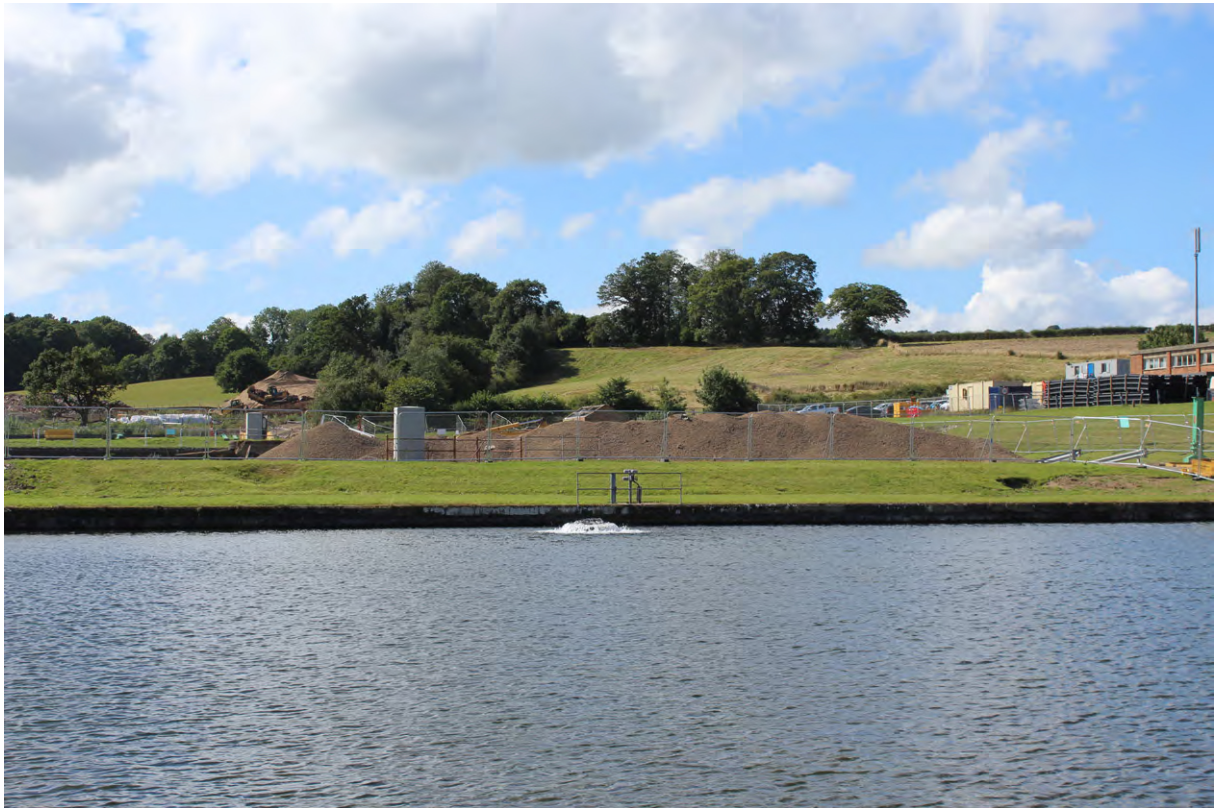
Fig. 6 The Vyrnwy Aqueduct, as viewed from the Filter Beds of Oswestry Water Treatment Works

identified outside the development boundary (Appendix 3), this assessment identified the upstanding remains, and possible below ground remains of the Llanforda-isaf farmstead, and two ponds in the fields and woodland to the west of the Water Treatment Works, dating from at least the 19th century (Fig. 2; Appendix 3). The Vyrnwy Aqueduct (SMR 21491) was not identified in the walkover survey, but subsequently identified during the watching brief through further inspection of the landscape (Fig. 6).

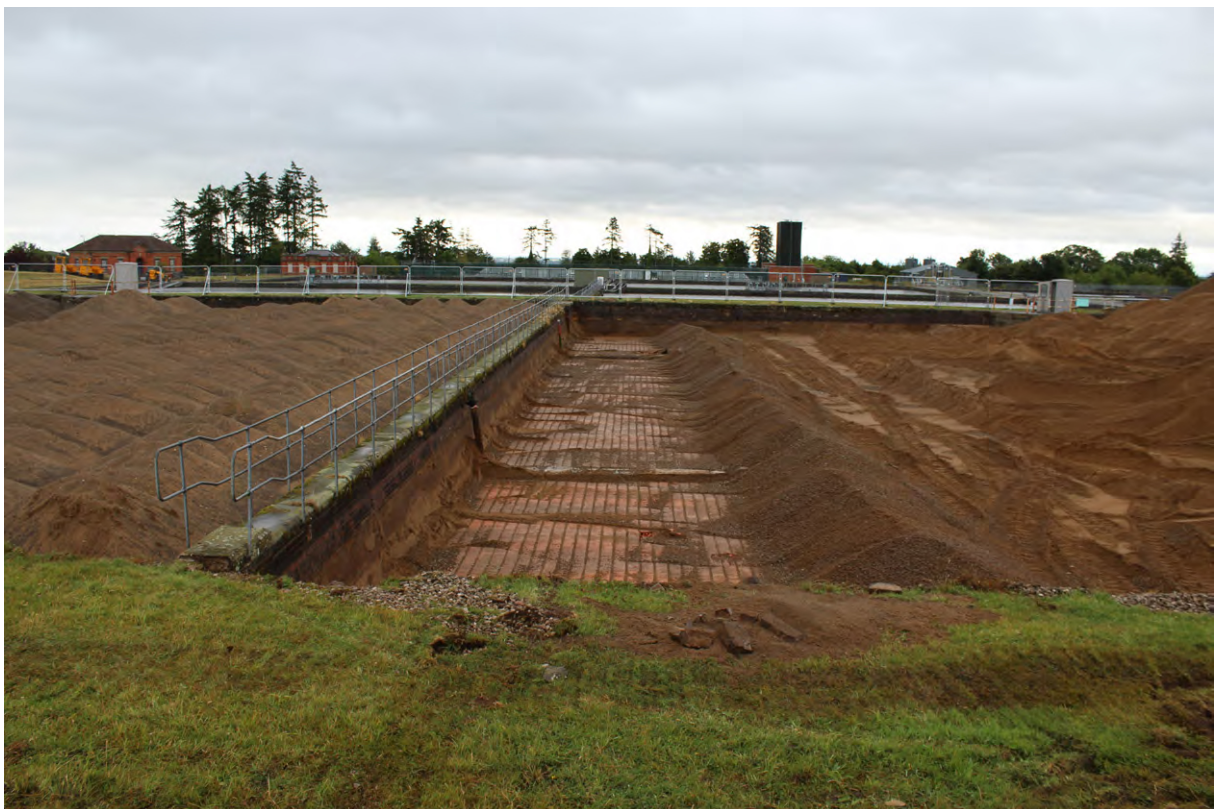
Fig. 7 Example of the stratigraphy of the Filter Beds

An initial inspection, monitoring and photographic record was undertaken during the demolition of Filter Beds 1-4. The demolition revealed the construction of the high quality Late Victorian Filter Beds and how layers of clean sand over perforated tile filtered water into the next set of beds via large cast iron pipes (Fig. 7). It also showed how the underlying ground which the filter beds had been cut into, was made up of a combination of redeposited/disturbed natural or made-ground.

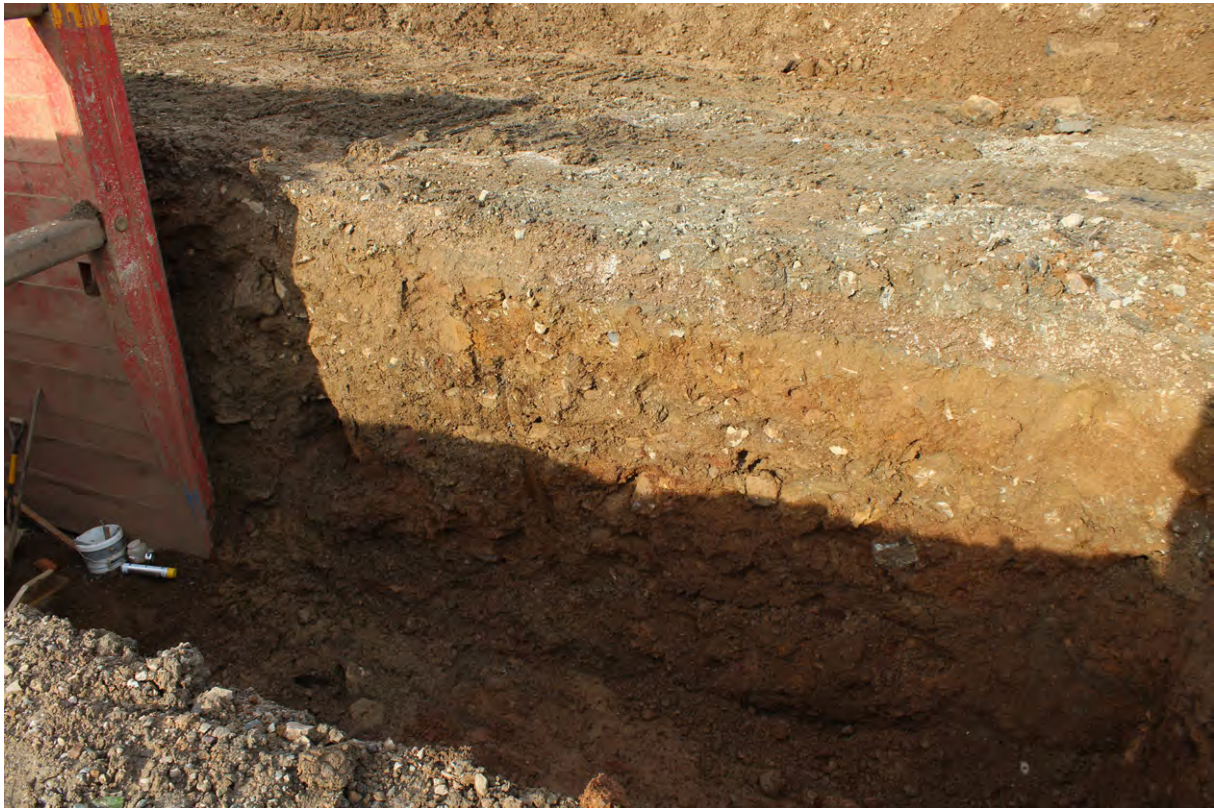
Fig. 8 Stratigraphic profile of the process pipework diversion

The full length of the pipe diversion for the Floc-Sed Tank was monitored to establish the nature of the stratigraphic profile. The trench was 3m wide and varied between 2.5m and 3m in depth. The upper sections of the trench, with a minimum depth of

0.5m, were made up of redeposited blue clay and made-ground overlying the Devensian-Diamicton Till (Fig. 8). Disturbances in this stratigraphy could be seen where the existing pipework was present. A brick culvert was identified during clean up within the vicinity of the pipework trench (007; see below).
