**Proposed Agricultural Building
Auldhouseburn Farm
Muirkirk, Cumnock
East Ayrshire**

Archaeological Survey

Report No. 3458

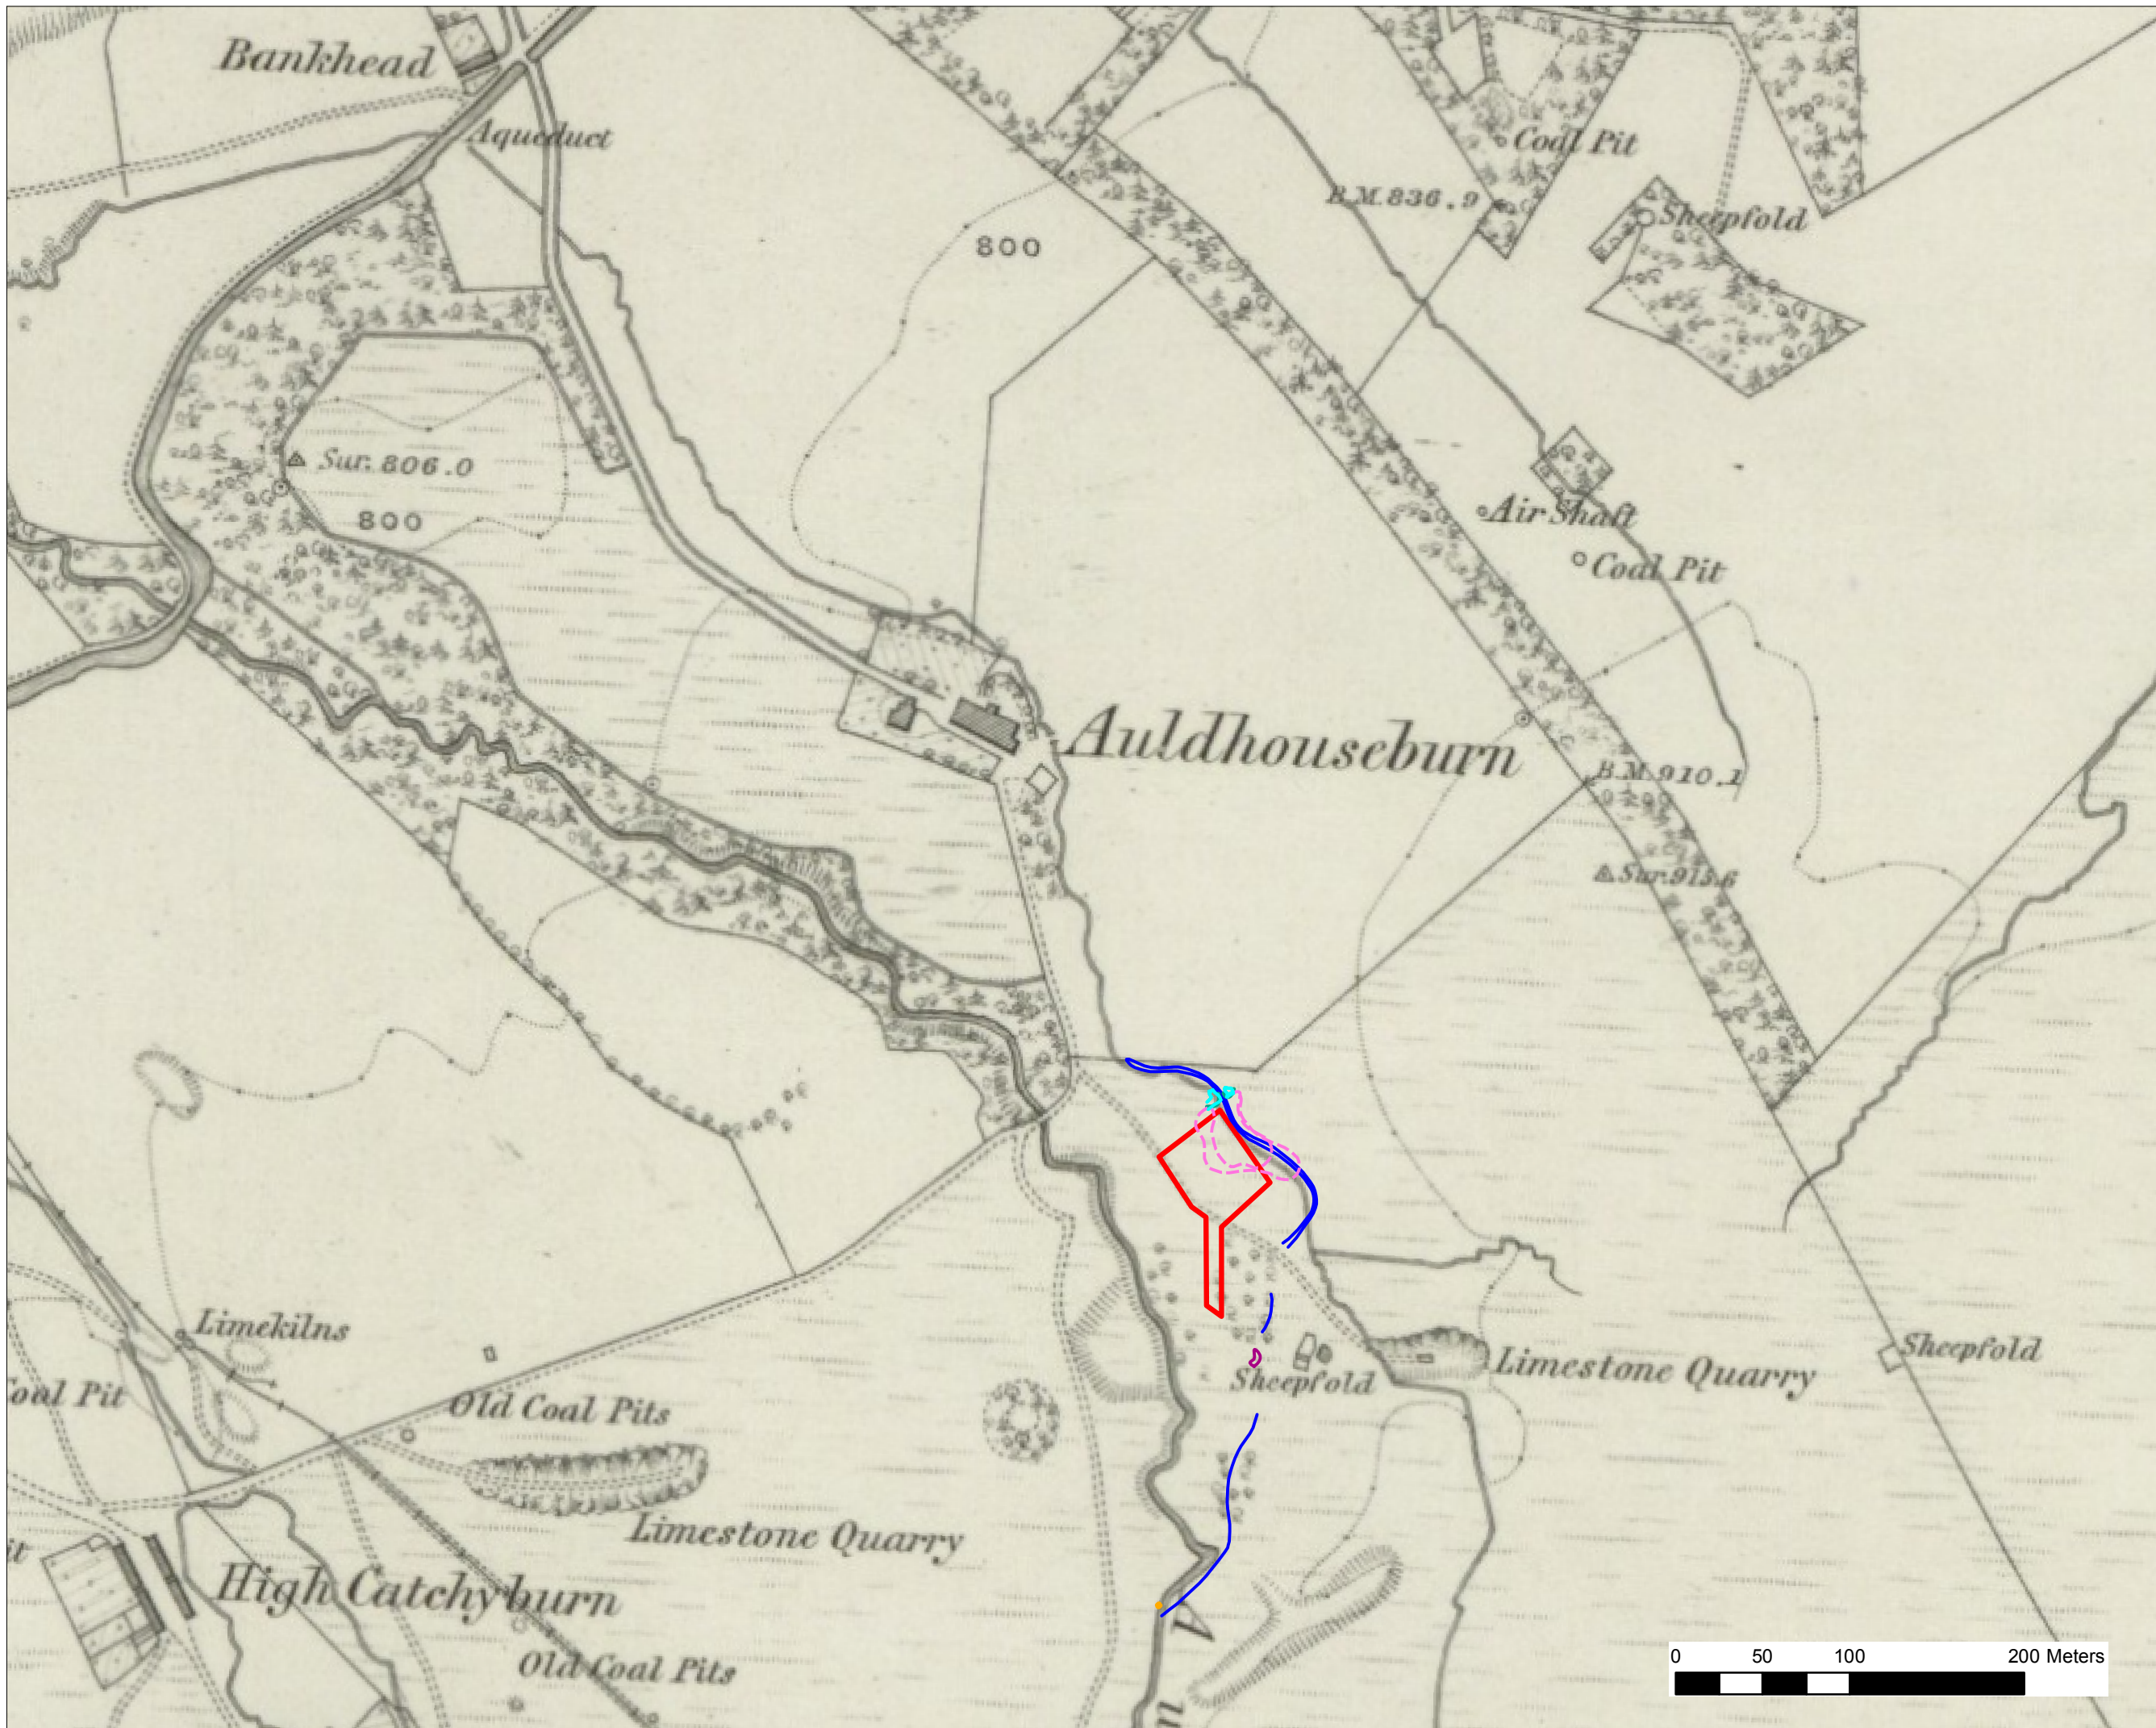
Report No: 3458	Fig. No: 3
--------------------	---------------

Title:
 Extract from 1860 Ordnance Survey map

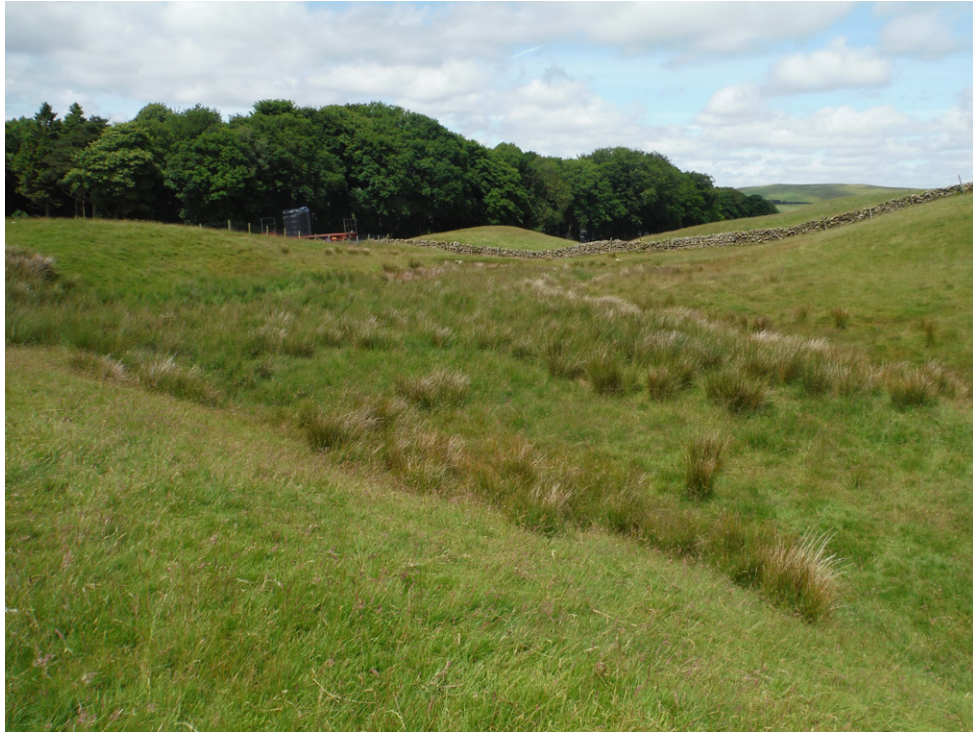
The pond (Fig. 4) had completely dried up and just consisted of an area of rushes set within a natural gully. There was no evidence that this was a cut feature, but appears to have been created by constructing the dam and then diverting water from the Auldhouse Burn into it. Evidence from the First Edition Ordnance Survey map indicates that there used to be a natural watercourse running through the gully, but this had been diverted when a reservoir and water treatment plant was constructed to the south-east of the proposed development area in the second half of the 19th century. It was not possible to determine an exact size for the pond, as it would presumably have varied considerably depending on how much water was in it.

Fig. 4 - Location of dried up pond

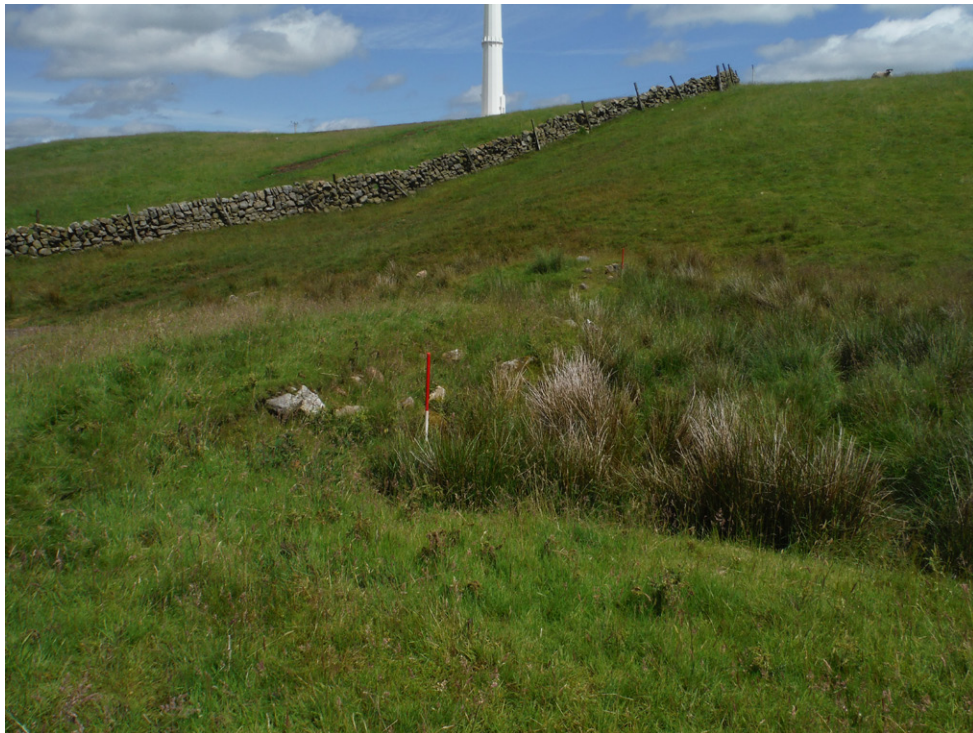
The dam consisted of earth banks with surviving traces of a stone face constructed along the south-east side against the edge of the pool (Fig. 5). It is unclear if the banks were largely man-made or if they were predominantly part of the natural topography. The dam had been constructed in two lengths with a gap in the middle for the outlet channel where the sluice would have been located. On the eastern side, the dam measured 5m in length and had a surviving length of well constructed facing wall (Fig. 6) measuring 2.4m long by 0.6m wide and surviving to a height of 0.6m. This had been constructed from rough-dressed quarried stone. On the western side, the dam measured 8m in length and survived to a height of c.0.6m. There was no surviving facing on this side, with just a few random stones within the earth bank being in

Fig. 5 - General shot of dam

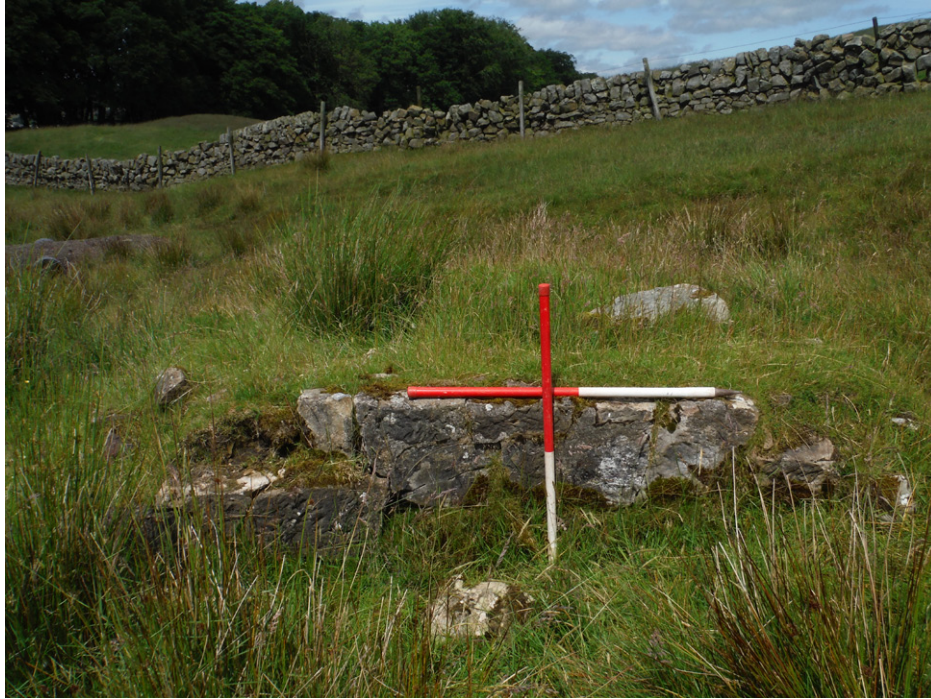
Fig. 6 - Stone facing on dam

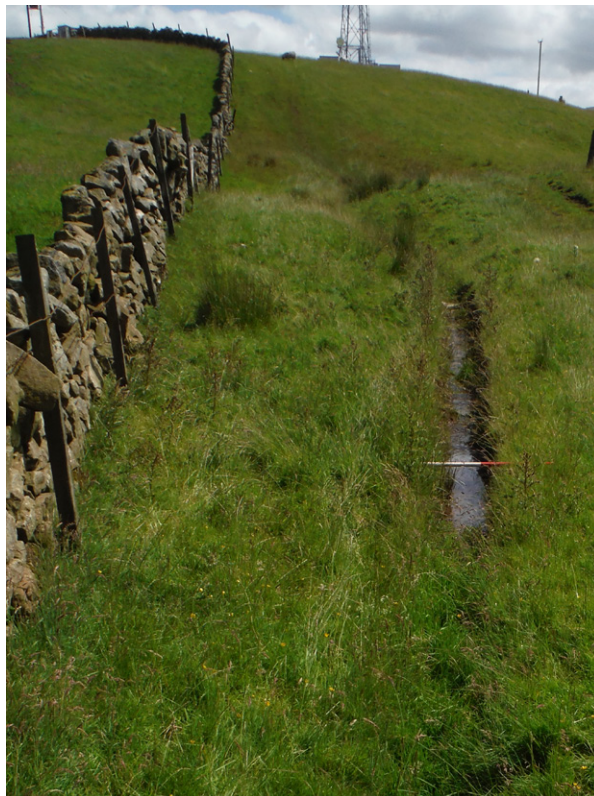
The outlet channel (Fig. 7) ran from the dam in a north-westerly direction, disappearing underground at the edge of the existing farm track. It had a width of 0.6m and a depth of 0.4m, and had been partially lined with half-section concrete piping. Evidence from the 1896 Ordnance Survey map suggests that it initially ran to Auldhouseburn Farm where it may have driven a threshing mill and then continued to Auldhouseburn Coal Pit.

Fig. 7 - Outlet channel

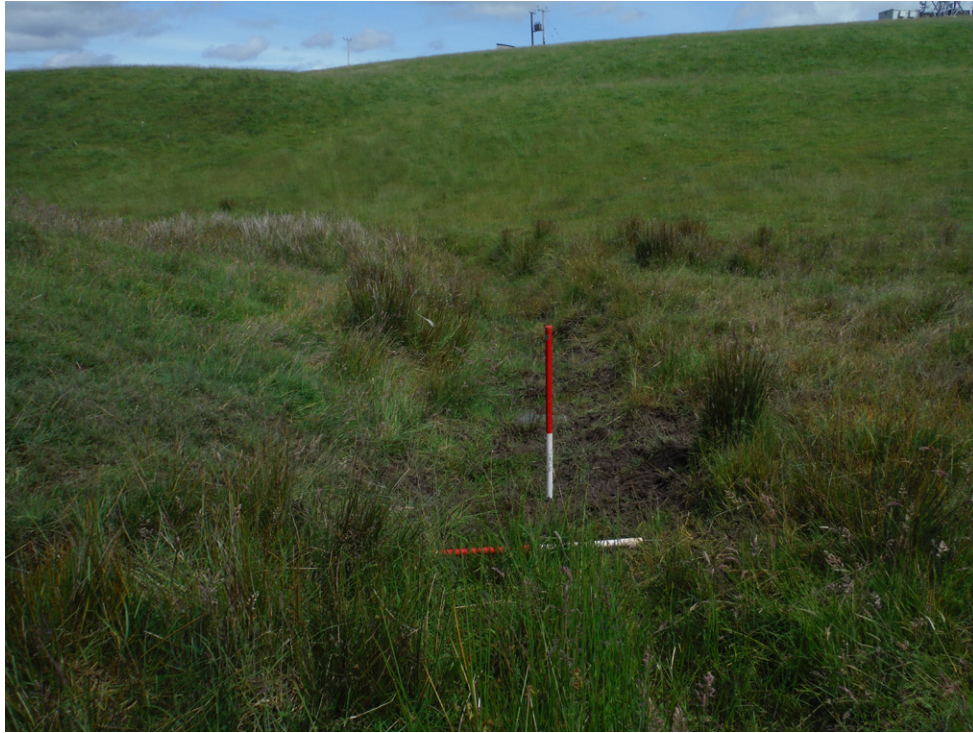
The inlet channel (Fig. 8) ran from Auldhouse Burn to the pond, continuing along the base of the pond to the dam. It was largely silted up with a grassy base and generally had a width of 1.3m and a depth of 0.3m. At the start of the inlet channel there was a stone built weir (Fig. 9) across the Auldhouse Burn and part way along there was an earth and wood aqueduct (Fig. 10) carrying a large diameter pipe across deep former quarry workings. The weir and the aqueduct were situated well outwith the proposed development area. The inlet, weir and aqueduct are shown on the 1896 OS map.

Fig. 8 - Inlet channel

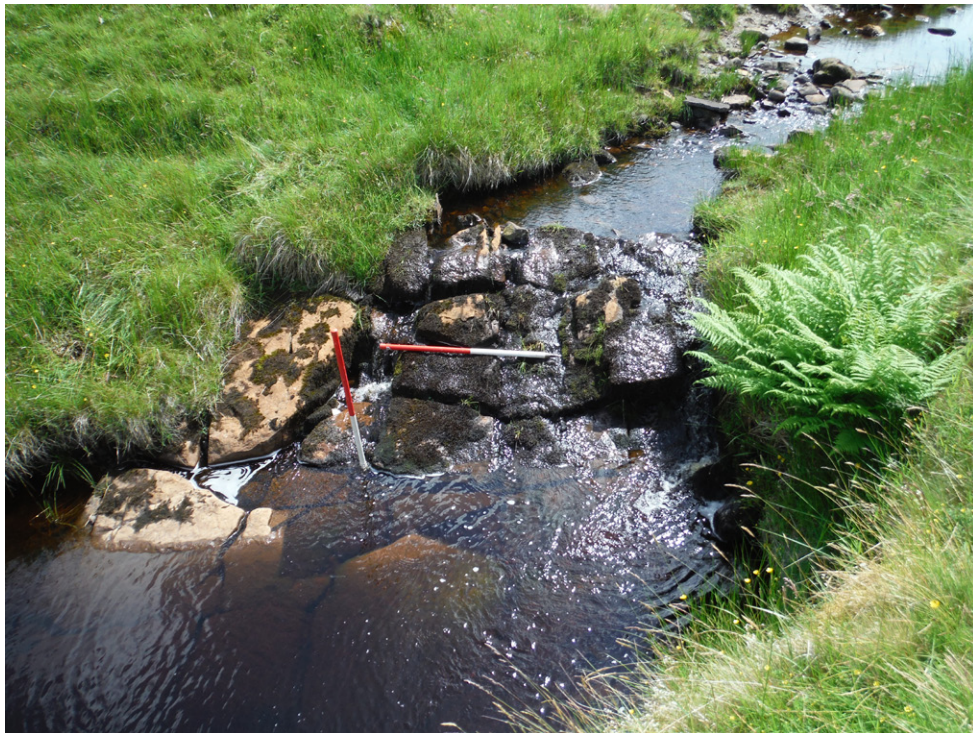
Fig. 9 - Weir in Auldhouse Burn

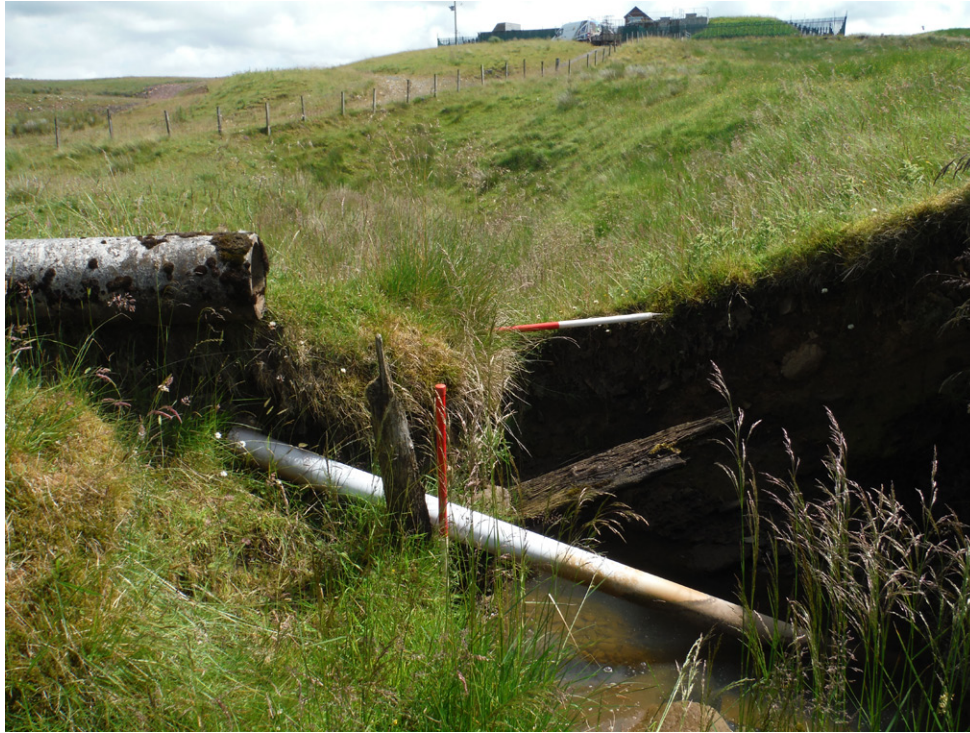
Fig. 10 - Aqueduct carrying inlet channel
