**Andershaw Wind Farm, South Lanarkshire**

**Post-felling Survey**

**Report No. 3319**

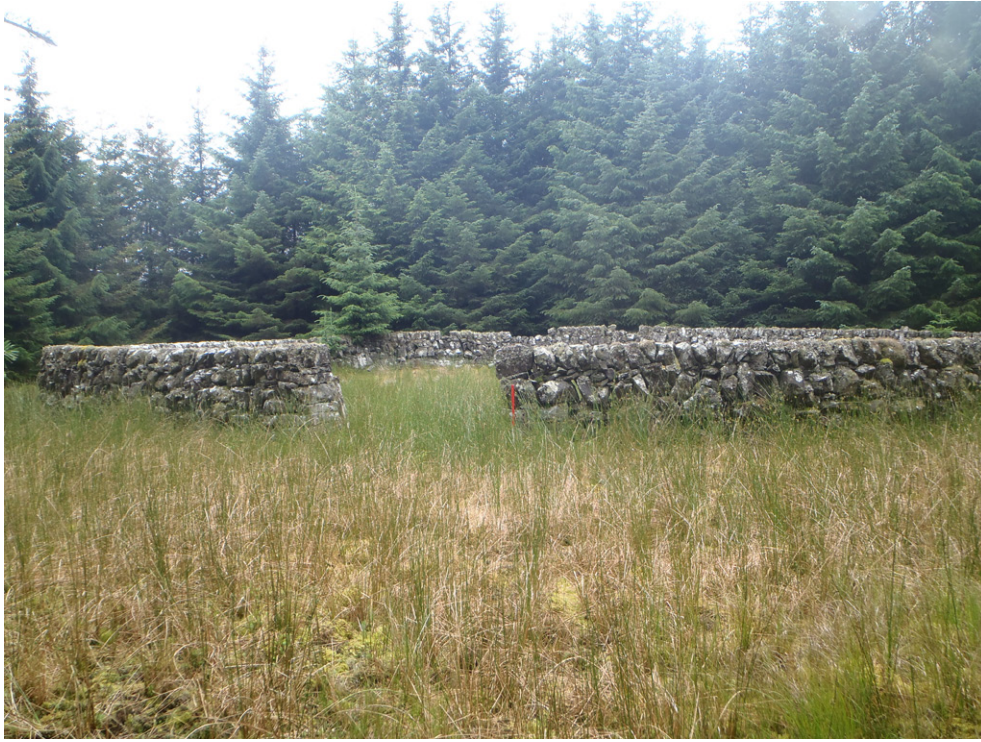
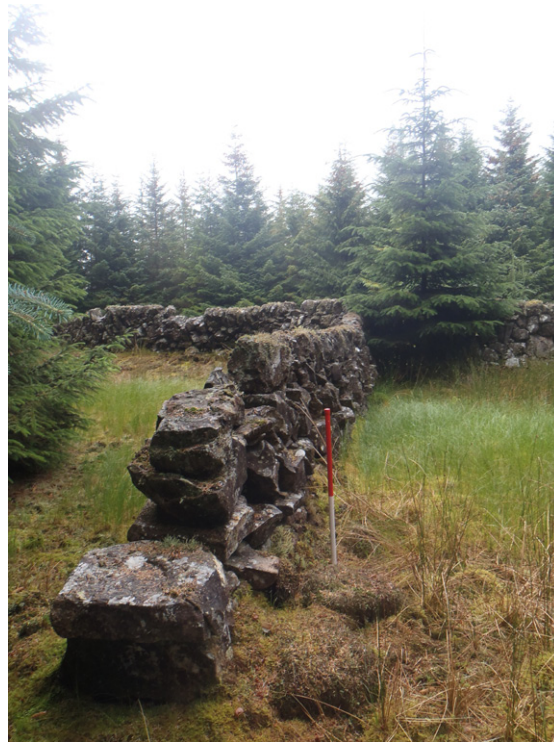
Site no	Easting	Northing	Baseline condition
<b>22686</b>	284667	625707	The remains of a well-preserved dry-stone sheepfold stand in a forest clearing c. 25m north-east from an existing forest track. The sheepfold is roughly oval in plan and measures 19m by 17m with walls 1.5m high. Two walls run from the north-west and south-west corners of the sheepfold for c.8m and c.5m, respectively. An entrance, c.3m wide, is present in the north-east arc of the sheepfold (Figures 2 and 3).
<b>Entec 6</b>	283387	624985	A large quarry is located c. 30 m north of the Glespin to Crawfordjohn public road, adjacent to an existing forest track. The quarry measures c.65m by 30m and is 2m deep. It is partially grass-covered although a large amount of stone debris is visible at its base.
<b>Entec 8</b>	284180	624603	A bedrock ridge is aligned west-north-west by east-south-east c.100 m north-east of the Glespin to Crawfordjohn public road. At least four quarries have been cut into the bedrock ridge, ranging in size from 10m by 8m to 70m by 18m and up to 3m deep.

Fig. 2 Sheepfold **22686** taken from the east

Fig. 3 Sheepfold **22686** taken from the south-east

Sites **13296**, **22686**, **Entec 11** and **cfa100-102** were marked-off with canes and bunting. Where possible a 10m stand-off buffer from the edge of the upstanding remains was included within the demarcated areas. Durable fencing will be placed around each of the sites by the Infrastructure Contractor prior to construction works commencing. No further work is recommended in relation to these sites.

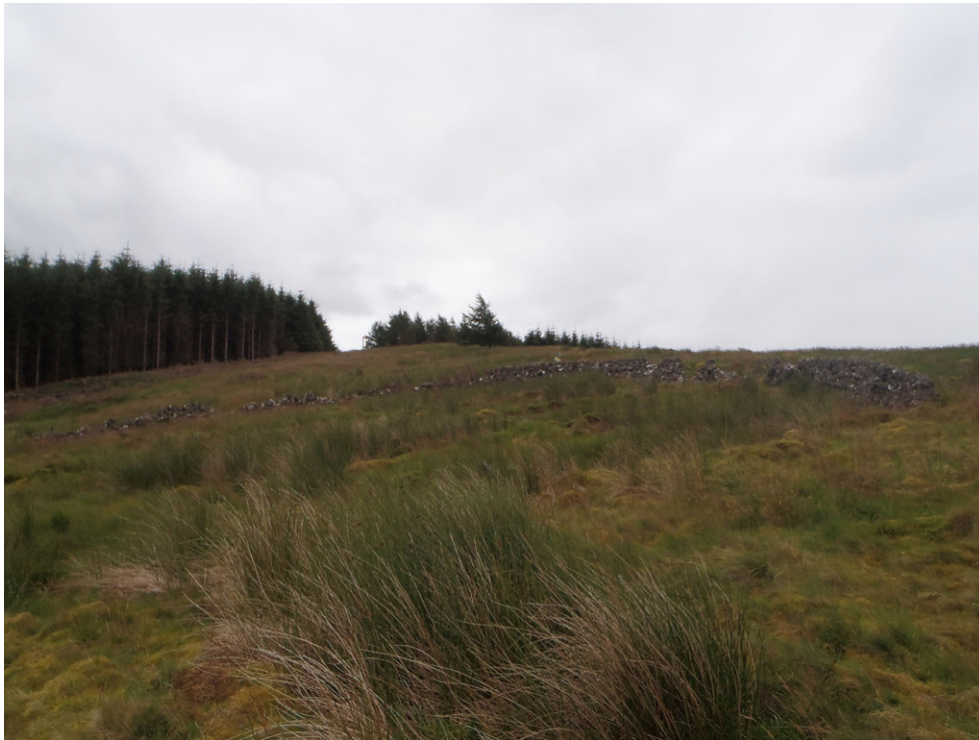
<b>Entec 11</b>	284313	624583	The remains of a well-preserved dry-stone sheep shelter stand on a north-west facing slope, just south-east of a former quarry. The sheep shelter is roughly horse-shoe shaped, open to the north-west and measures 30m at its widest part. The remains of a small square, dry-stone structure, which abuts the sheep shelter on its south-east side, measures c.1m by 1m (internally) with walls 0.5m high. The exact function of this structure is not known, but it may be a possible lambing pen or small shepherd's shelter (Figures 4 and 5).
<b>cfa100</b>	285158	625353	The tumbled remains of a dry-stone building survive at the base of a small quarry <b>cfa102</b> . The building is rectangular in plan and measures c.2.5m by 2m and up to 0.4m high. The

Fig. 4 Sheep shelter **Entec 11** taken from the north-west

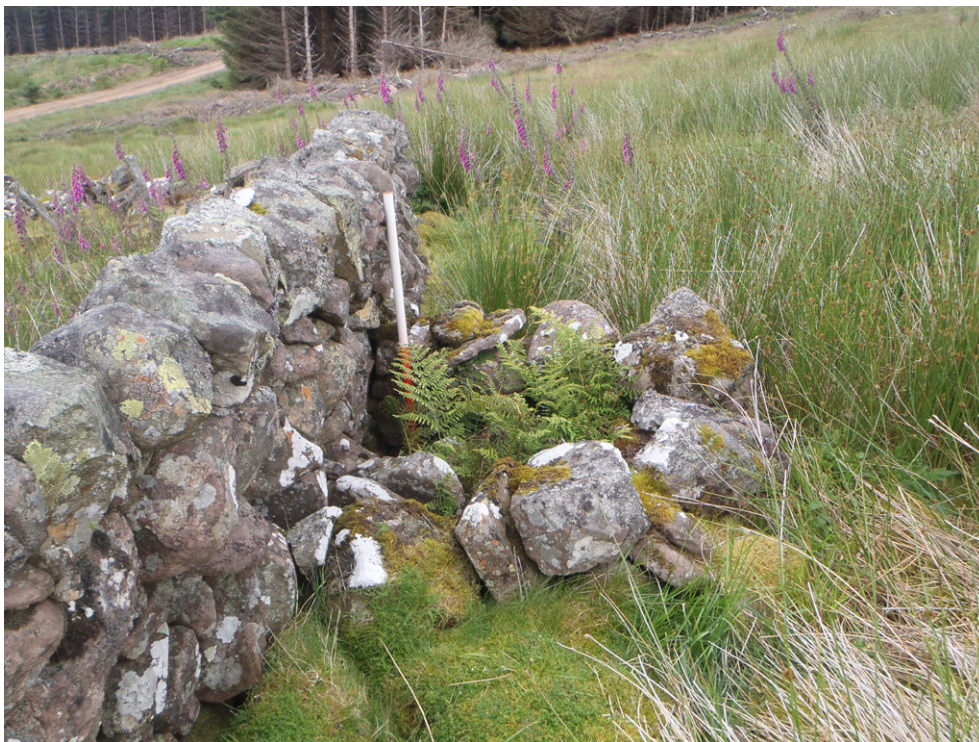
Fig. 5 Small shelter abutting south-east side of sheep shelter **Entec 11**, taken from the south-west

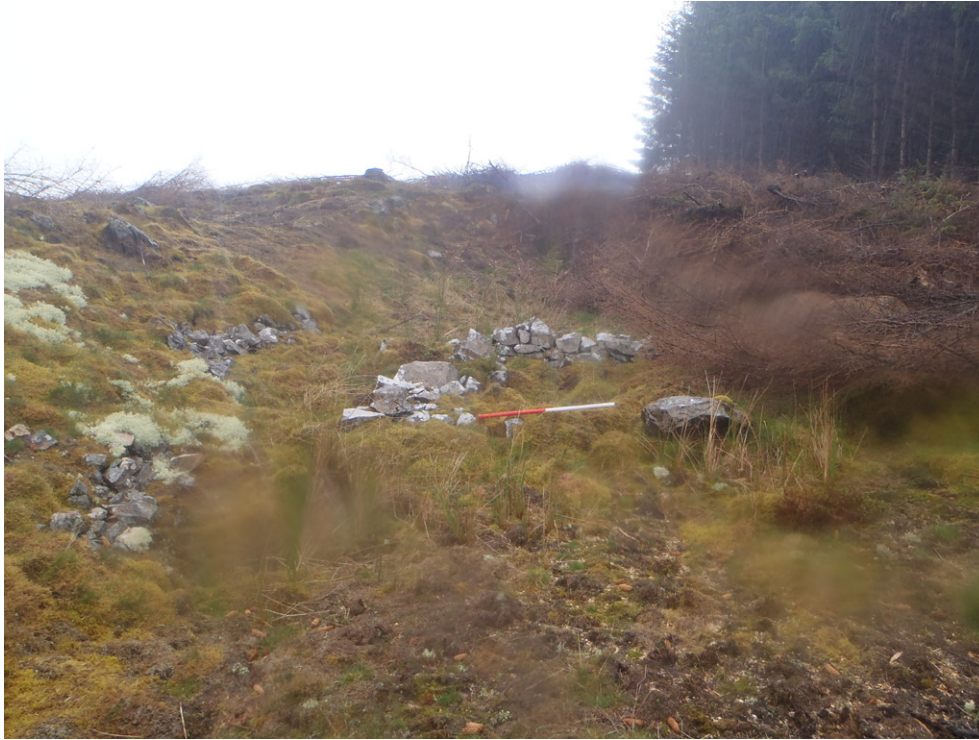
structure is partially covered in moss and turf and no internal features or an entrance are visible. Its function is unknown, although it may have been a small shelter for the quarry workers (Figure 6).
<b>cfa101</b>	285141	625353	A small roughly oval quarry cut into the edge of a bedrock knoll. The quarry measures 6m by 5m and is c.1.5m deep. It is partially water-filled.
<b>cfa102</b>	285158	625359	A possible quarried bedrock edge is c.22m long and 1.5m high. The quarried edge is largely covered in moss, but tumbled stone is visible at its base.

Fig. 6 Building **cfa100** taken from the west

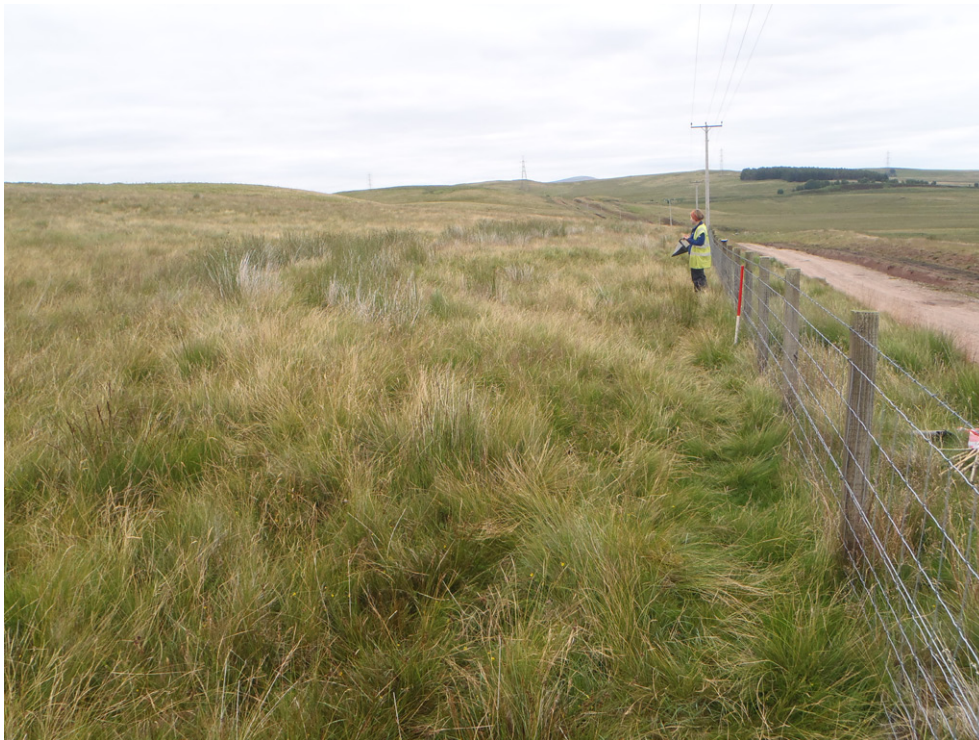
The remains of the enclosure were identified on a gentle slope, on the edge of an improved pasture field, just north of the former conveyor road at NGR: 285744 626980. The conveyor road has been cut into the natural slope of the hill down to a maximum depth of between 1.5m and 2m and much of the enclosure was evidently destroyed during road construction; only its north-western arc now survives (Figures 7-11). The enclosure remains are crossed by a modern post- and wire-fence and a trident electric overhead power line runs passed the eastern side of the enclosure remains.

Fig. 7 Enclosure **13296** taken from the south-west

No construction works are necessary along the northern edge of the former Glentaggart Mine conveyor road as part of the upgrading works to form the access to the proposed Wind Farm. Therefore, the surviving upstanding remains of the enclosure **13296** will not be affected. Taking this into account, it was agreed with WoSAS that no further mitigation would be required in relation to this site.

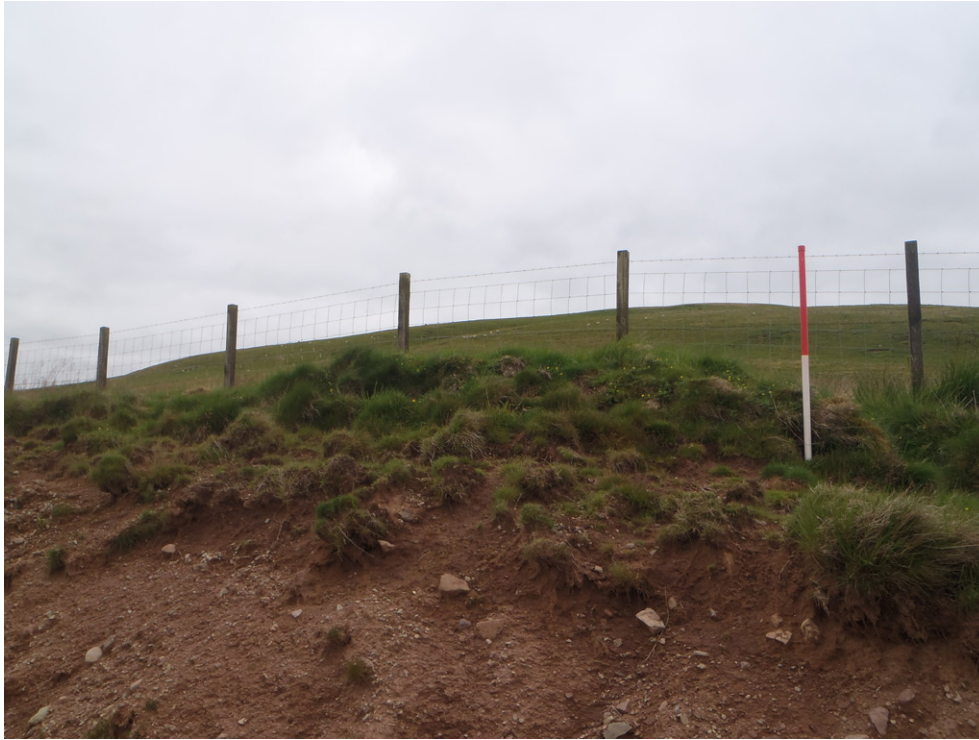
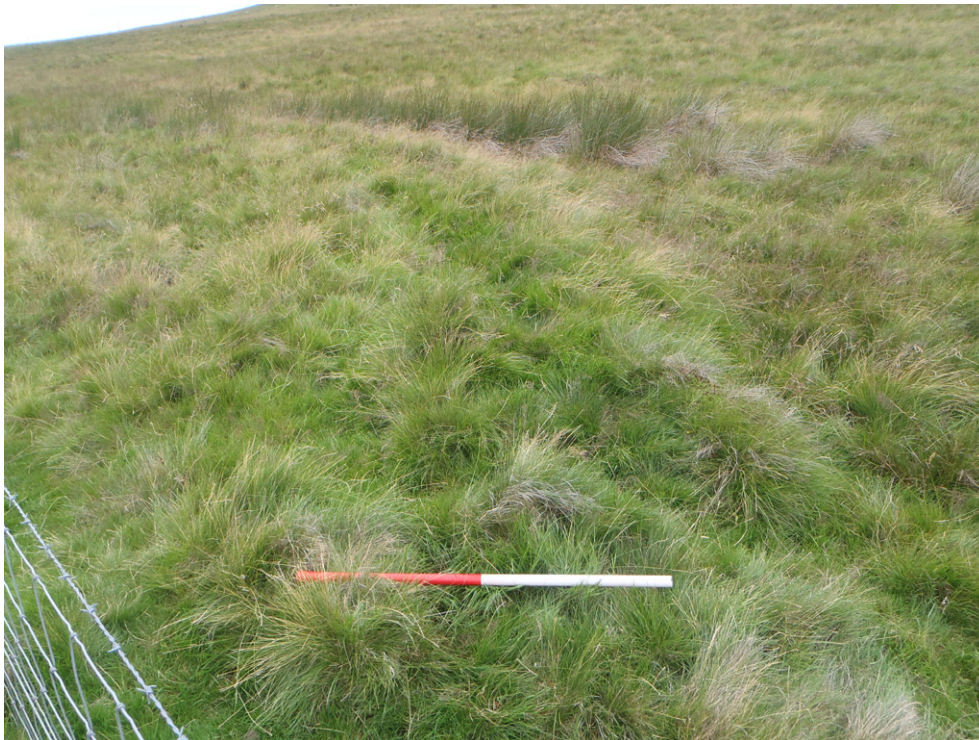
The surviving portion of the enclosure bank is 3m-4m wide and 0.4m high (Figures 8 and 9). There are no obvious stones within the bank, but the faint outline of what may be the remnants of a groove, as recorded by Ward (1992), are visible partially running along the centre of the bank. A possible ditch, which runs around the enclosure is visible on the surface as a depressions c. 0.5m-1m wide and 0.2m-0.3m deep (Figure 10). The ditch is filled with dense grass and reeds and was difficult to define, and it seems probable that excavation would reveal it to be both broader and deeper.

Fig. 8 Enclosure 13296, section through bank taken from the south-east

Fig. 9 Enclosure 13296, enclosure bank taken from the east-south-east

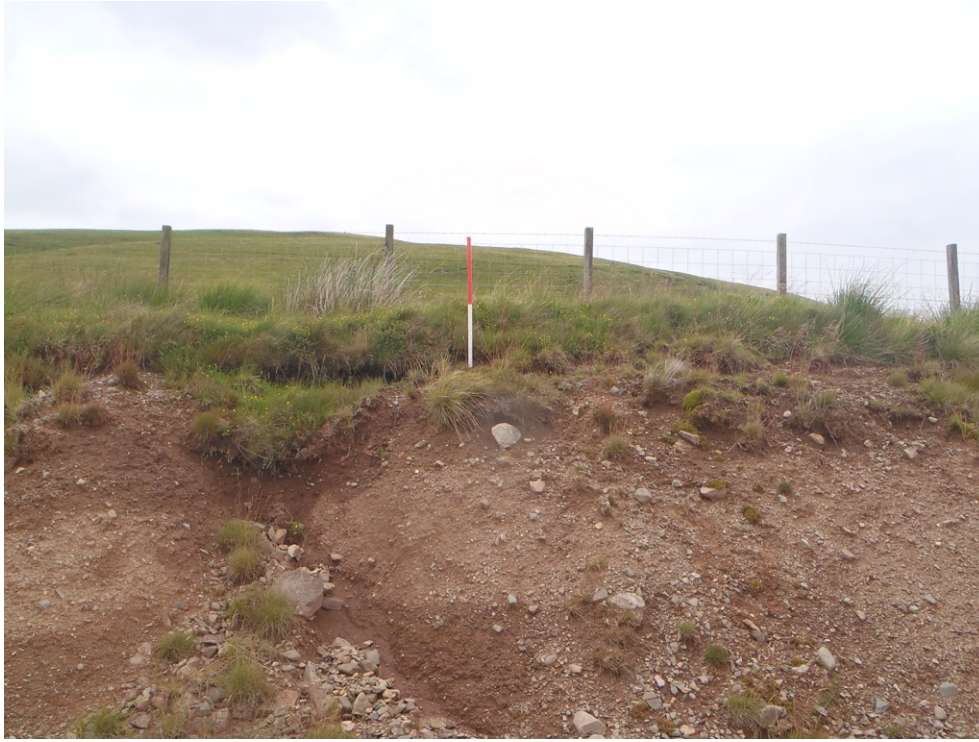
Fig. 10 Enclosure **13296**, section through enclosure bank and possible ditch taken from the south-east

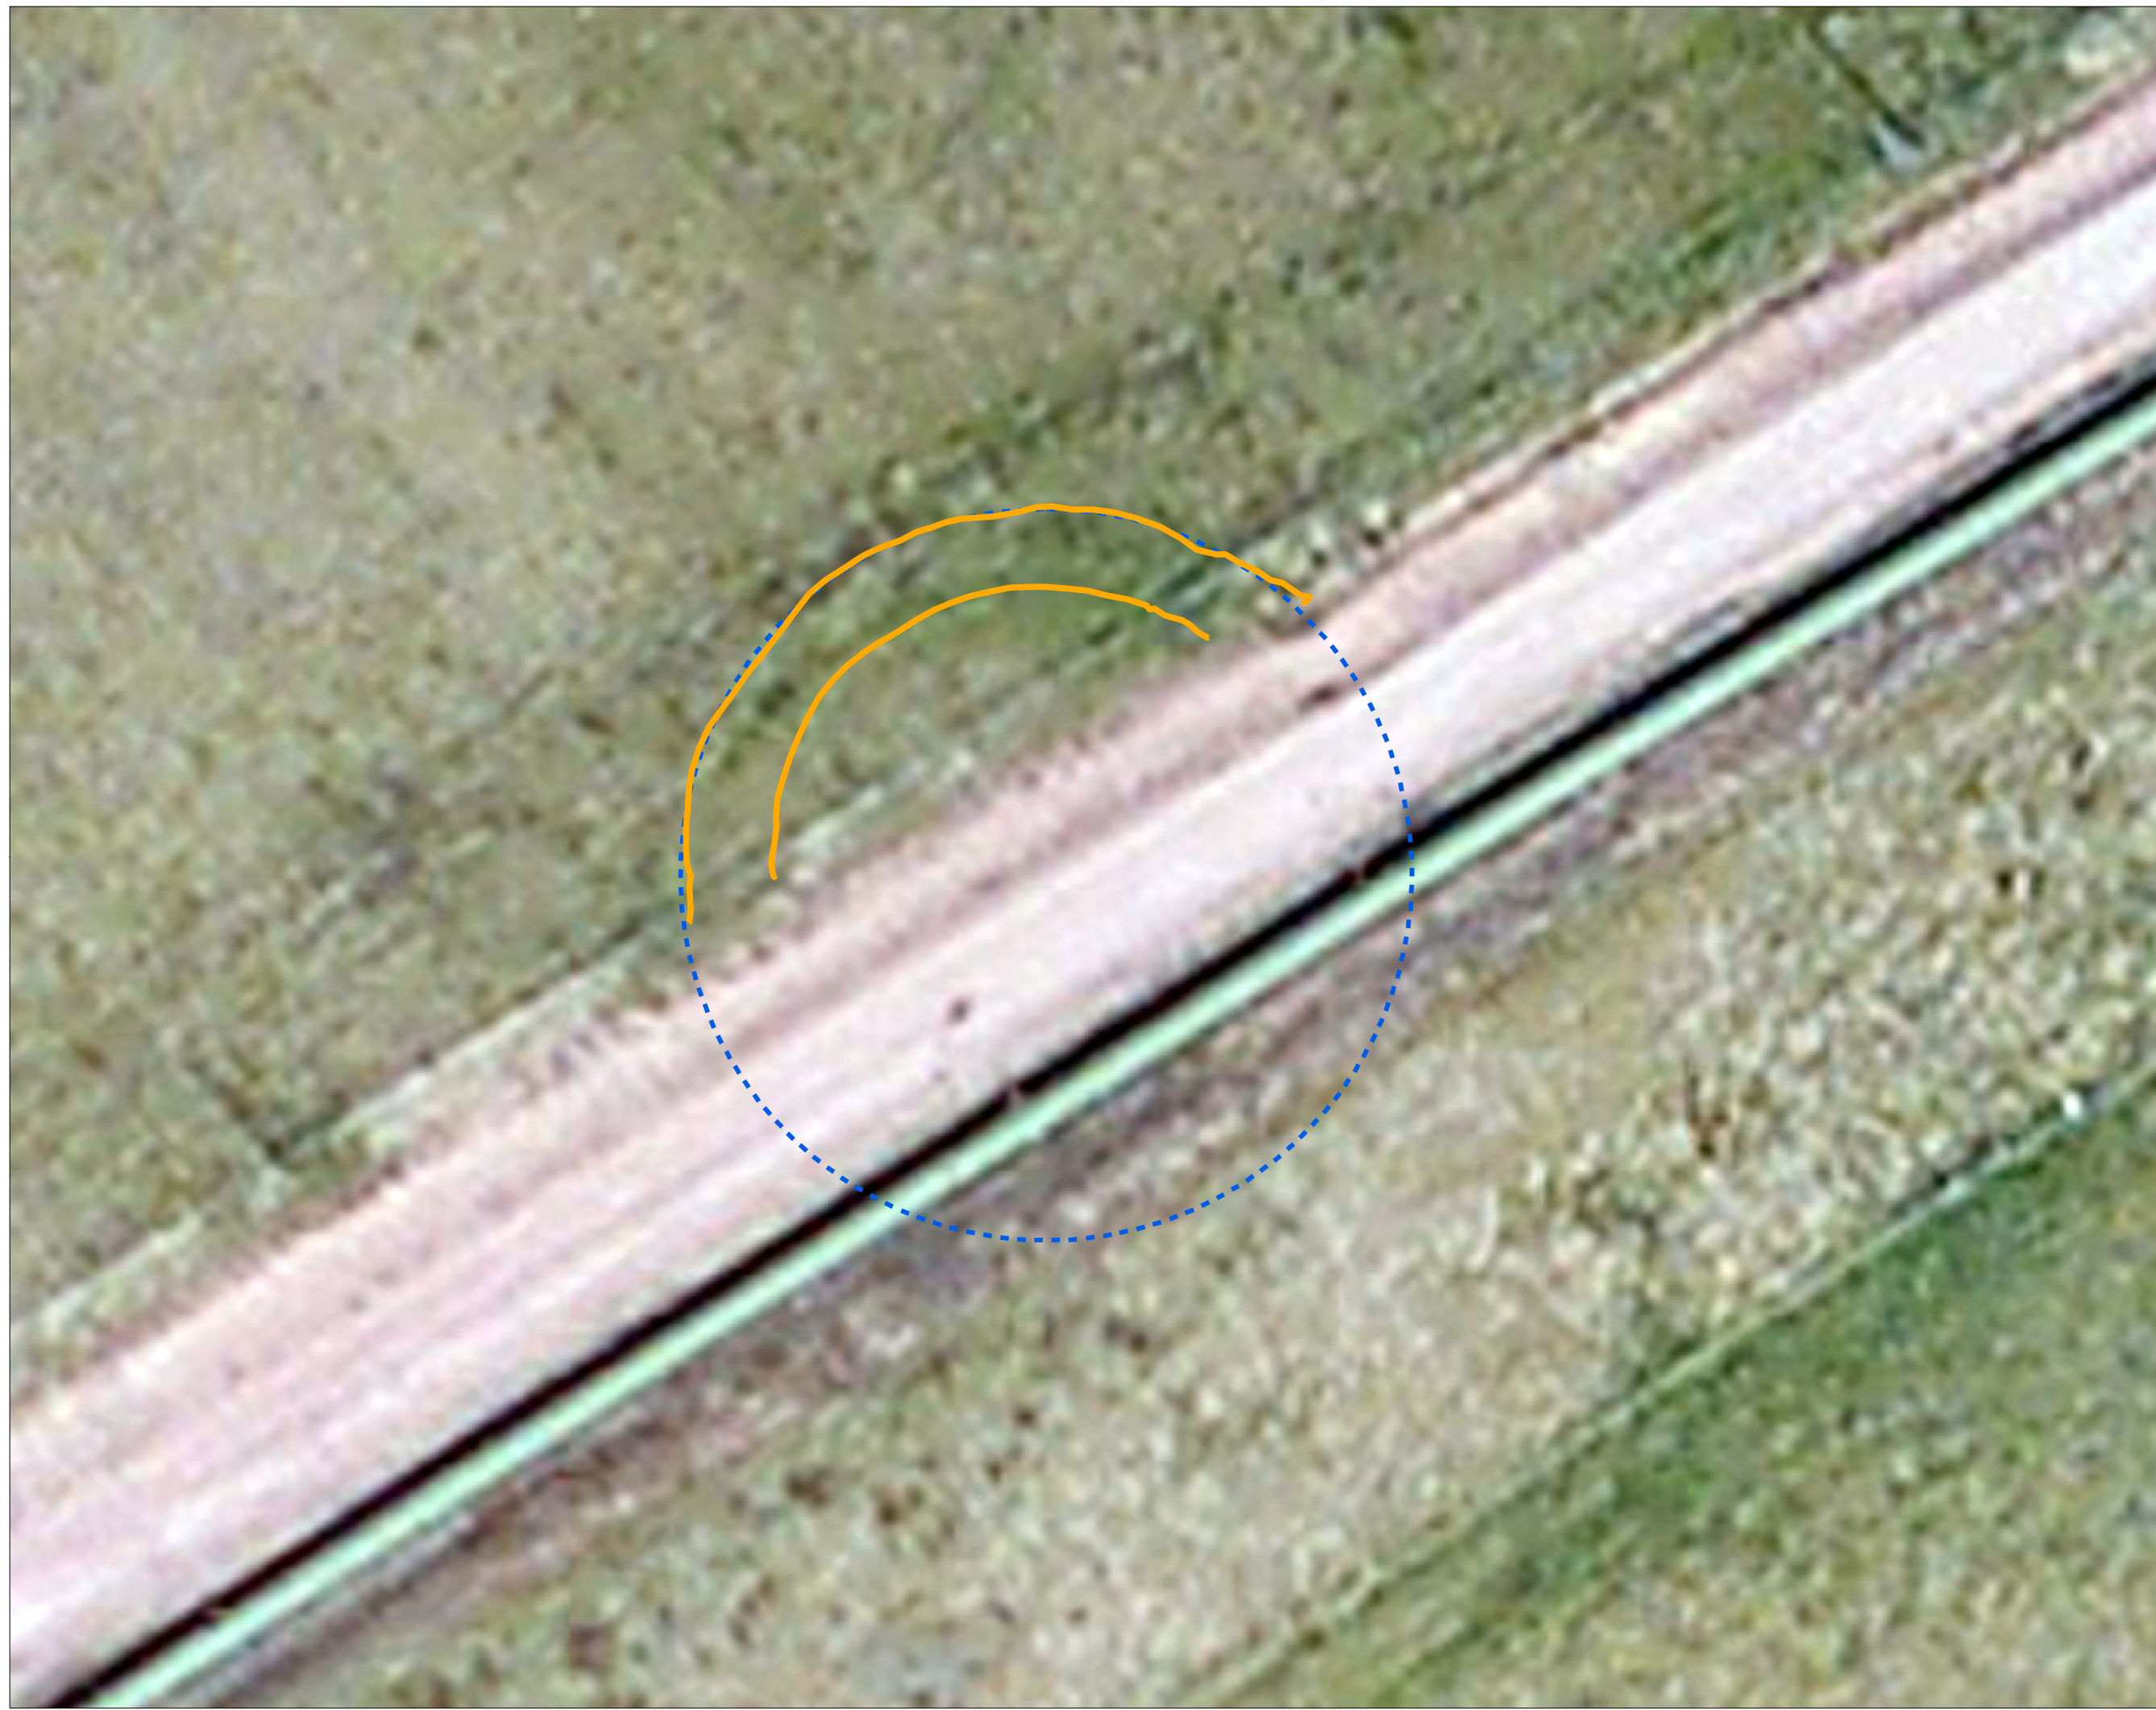
Fig. No:	11	Report No:	3319
----------	----	------------	------

Little survives of the interior of the enclosure, it having been largely removed by the construction of the former conveyor road. What does survive is grass-covered, and no internal features were visible.

No upstanding remains of the enclosure were visible on the southern side of the conveyor road. This side of the conveyor road has been disturbed both during the construction of the conveyor route, which ran along the southern edge of the road, and during the removal of the conveyor itself following the closure of Glentaggart Mine (Figure 11). It is, therefore, considered that it is unlikely that any buried remains of the enclosure survive on the southern side of the conveyor road.

Title:  
**Plan of Enclosure 13296**  
 over arial photograph
