**Merchiston Castle School,  
294 Colinton Road,  
Proposed 2G Hockey Pitch**

**Archaeological Evaluation**

**Report No. 3326**

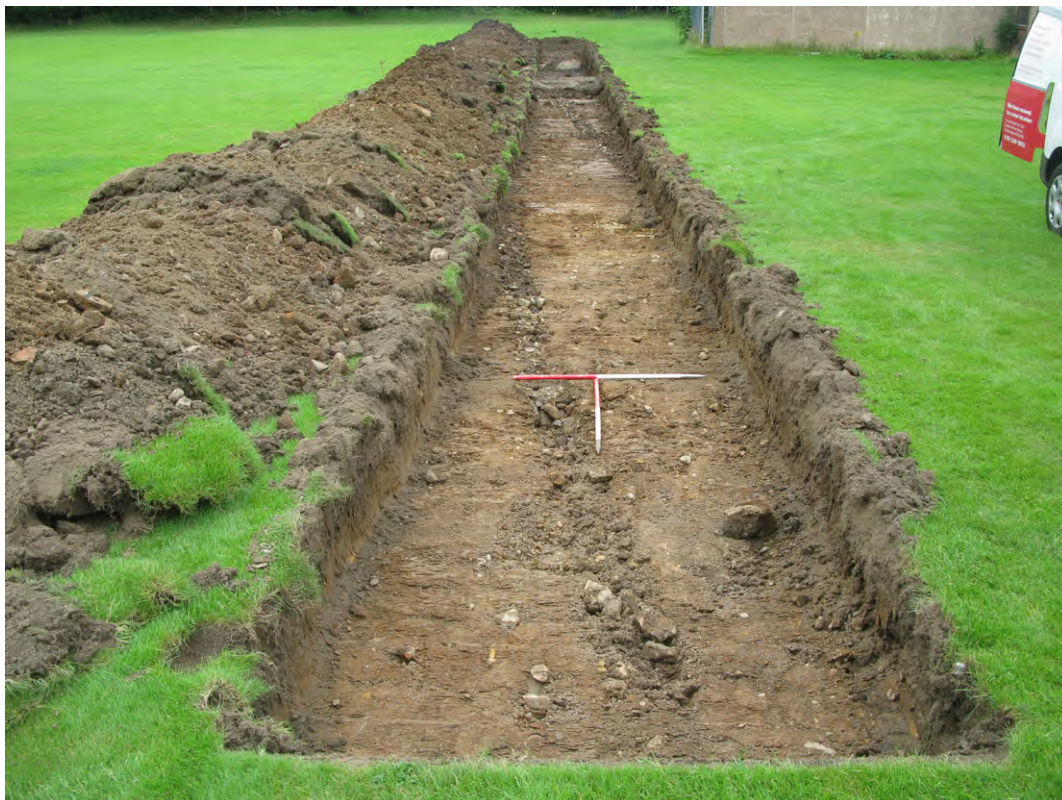
Fig. 2 Trench 1 post-excavation

*Trench 1 (1.8m by 40m; Fig. 2)* ran in northwest to southeast orientation. Topsoil (**001**), c.0.6m deep overlay 0.2m to 0.3m of orangey brown silty clay subsoil (**002**) which in turn overlay orangey brown sandy clay natural (**003**). A substantial stone drain bisected the trench in a roughly northeast to southwest orientation. The cut of the drain [**005**] was V-shaped in section (Fig.3) and formed of stone slabs (**004**) with horizontal capping slabs on top. The drain passage had been filled in with grey silt (**006**). Four rubble-filled field drains were also present in the trench; two aligned northeast to southwest and two aligned west-northwest to east-southeast. No other archaeological remains were discovered.

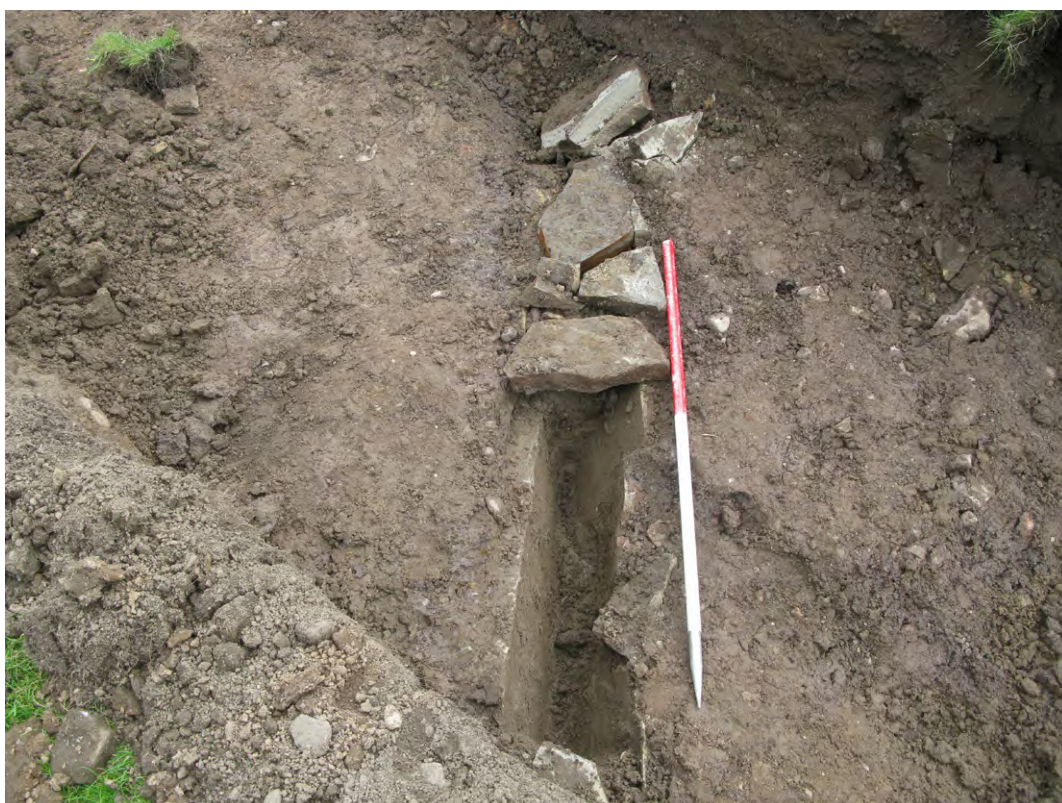
Fig. 3 Stone box drain in Trench 1, post-excavation

It is likely that the box drains discovered are the remains of a drainage system for now demolished buildings within the school grounds, or the school building itself, with the horseshoe and rubble drains representing land drainage in order to improve the quality of the grassed areas of the school grounds.

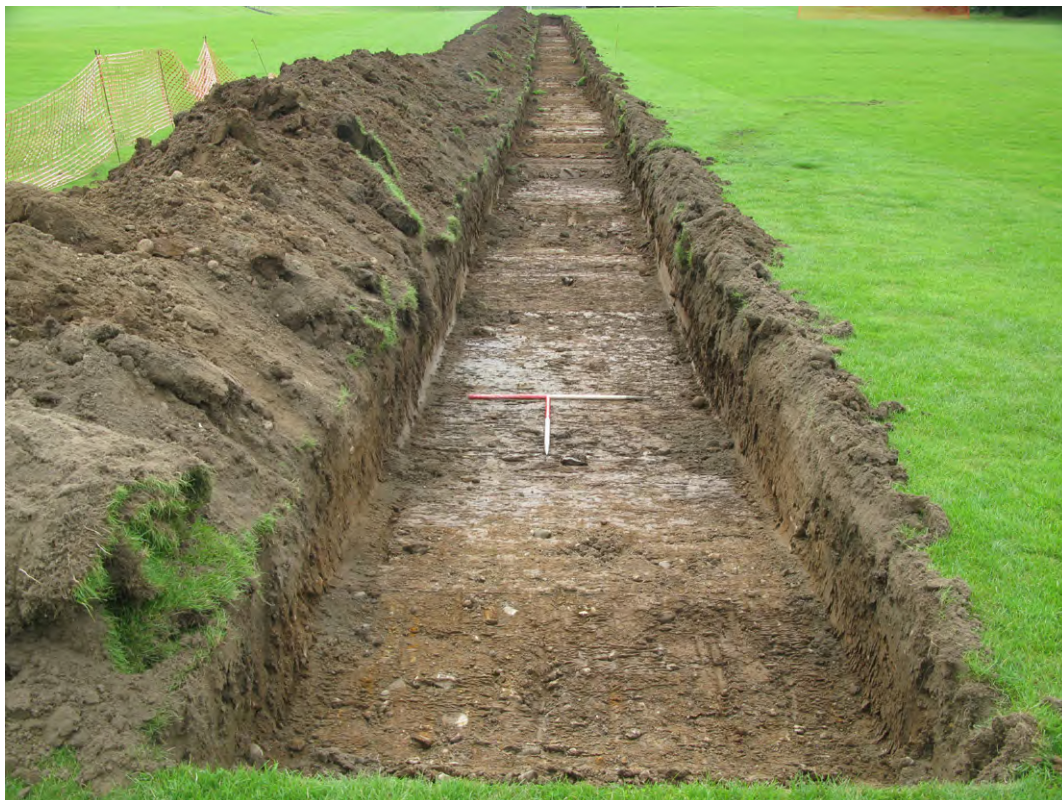
Fig. 4 Trench 2 post-excavation

*Trench 2 (1.8m by 80m; Fig. 4)* ran in a northeast to southwest orientation. The trench was excavated through 0.6m of topsoil (001) at the southwest end, which increased to 0.75m at the northeast end. Topsoil (001) overlay 0.3m to 0.45m of subsoil (002) which overlay natural (003). Seven rubble-filled field drains and two ceramic horse-shoe field drains were discovered. No other archaeological remains were found.

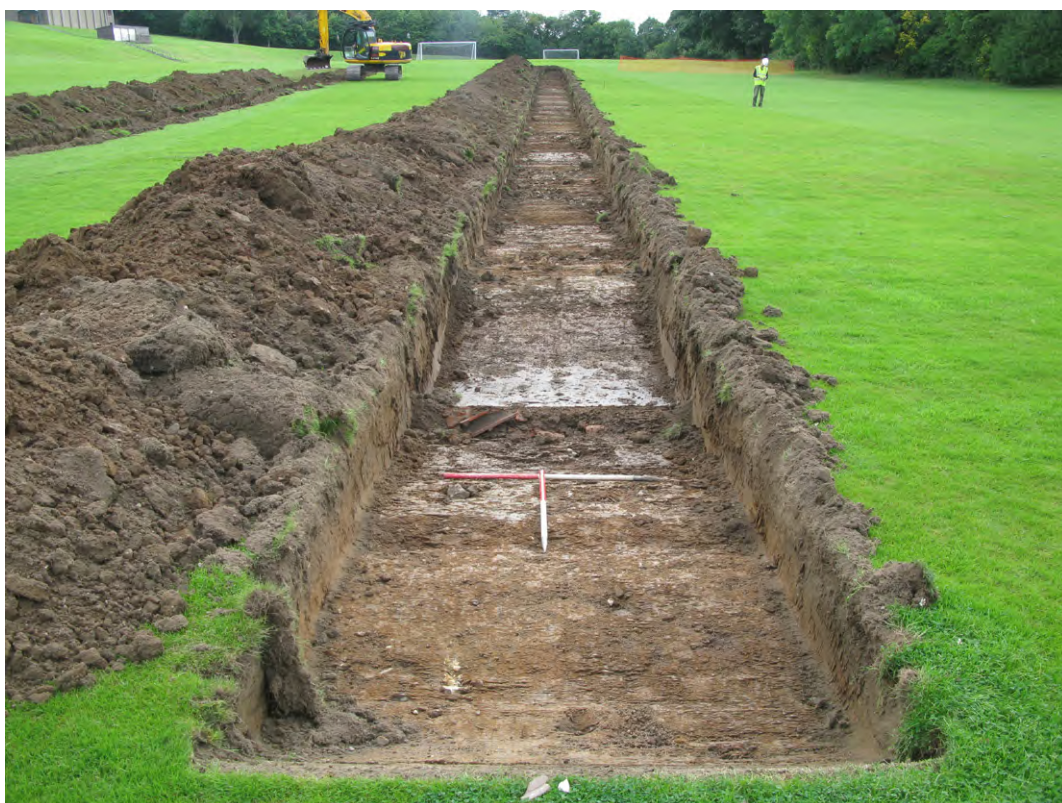
Fig. 5 Trench 3 post-excavation

*Trench 3 (1.8m by 78m; Fig. 5)* ran in a northeast to southwest orientation. Topsoil (001), 0.3m deep, overlay 0.1m to 0.5m of subsoil (002) which overlay natural (003). Seven rubble filled field drains and one ceramic horse-shoe field drain were discovered. No other significant archaeological remains were found.

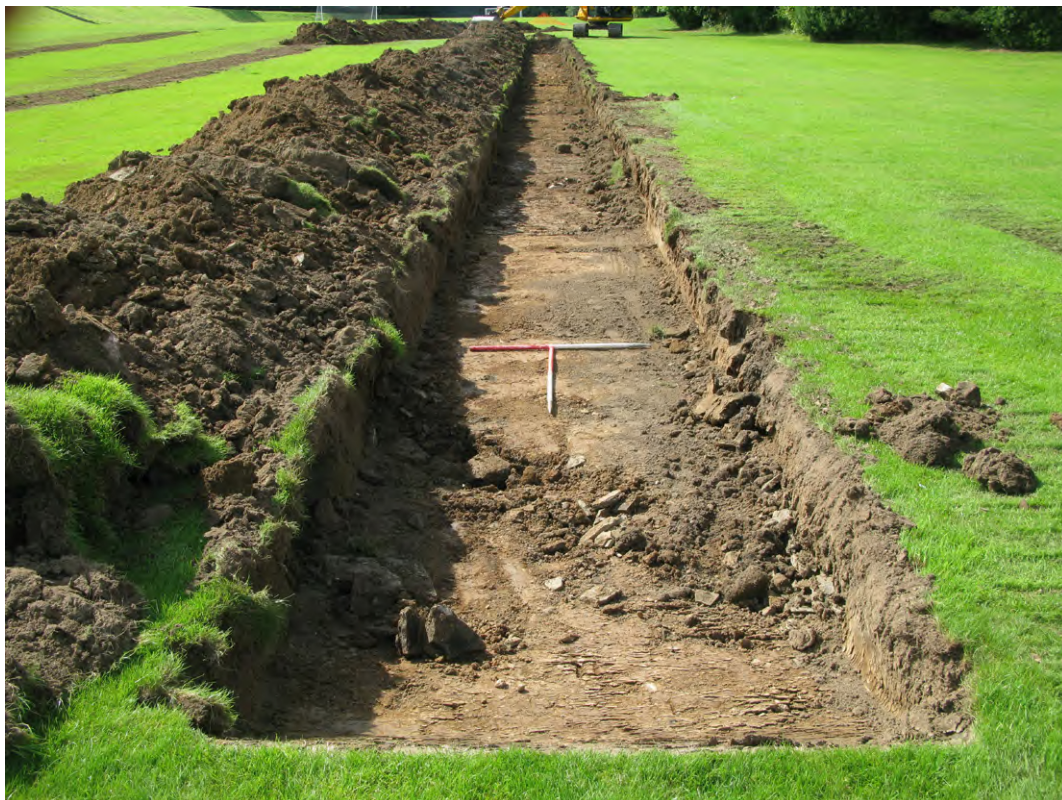
Fig. 6 Trench 4 post-excavation

*Trench 4 (1.8m by 60m; Fig. 6)* ran in a northeast to southwest orientation. Topsoil (001), 0.3m deep, overlay 0.2m to 0.3m of subsoil (002) which overlay natural (003). Two rubble filled field drains and seven ceramic horse-shoe field drains were discovered as well as a poorly preserved and irregularly constructed stone box drain. No other archaeological remains were found.

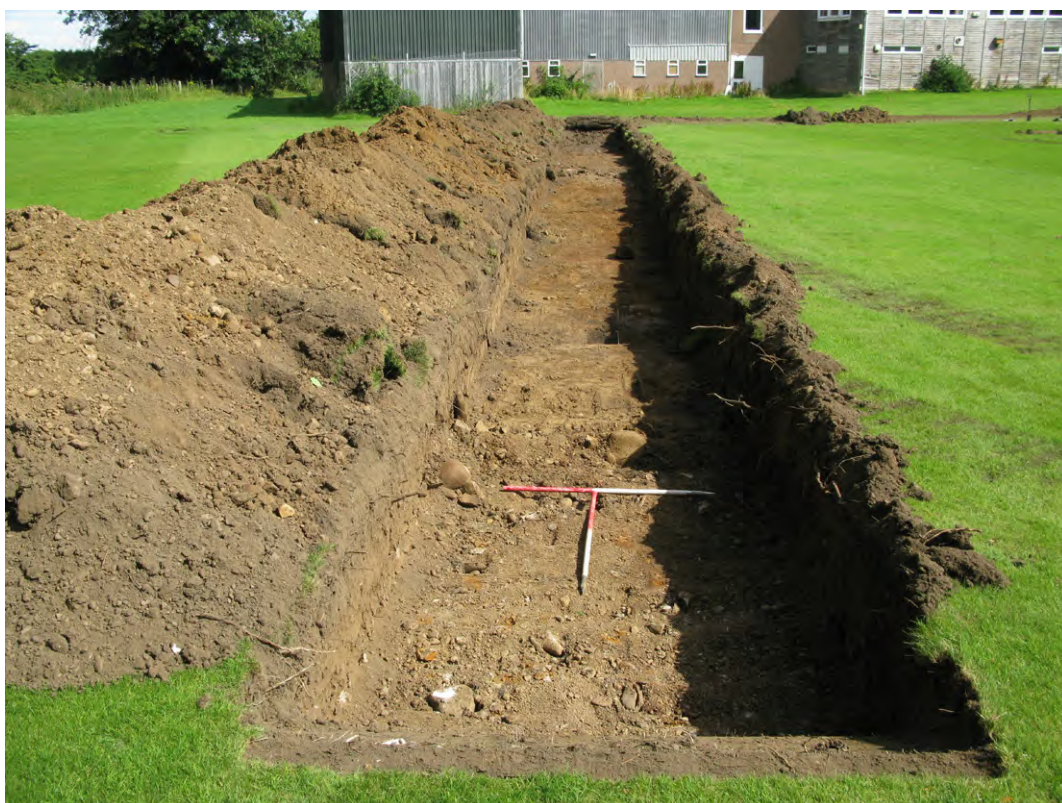
Fig. 7 Trench 5 post-excavation

*Trench 5 (1.8m by 36m; Fig. 7)* ran in an east to west orientation. Topsoil (001), 0.3m deep, overlay 0.3m to 0.4m of subsoil (002) which overlay natural (003). One stone box drain aligned north-northwest to south-southeast was discovered, in a poorer state of preservation than drain (004) in Trench 1. No other archaeological remains were found.

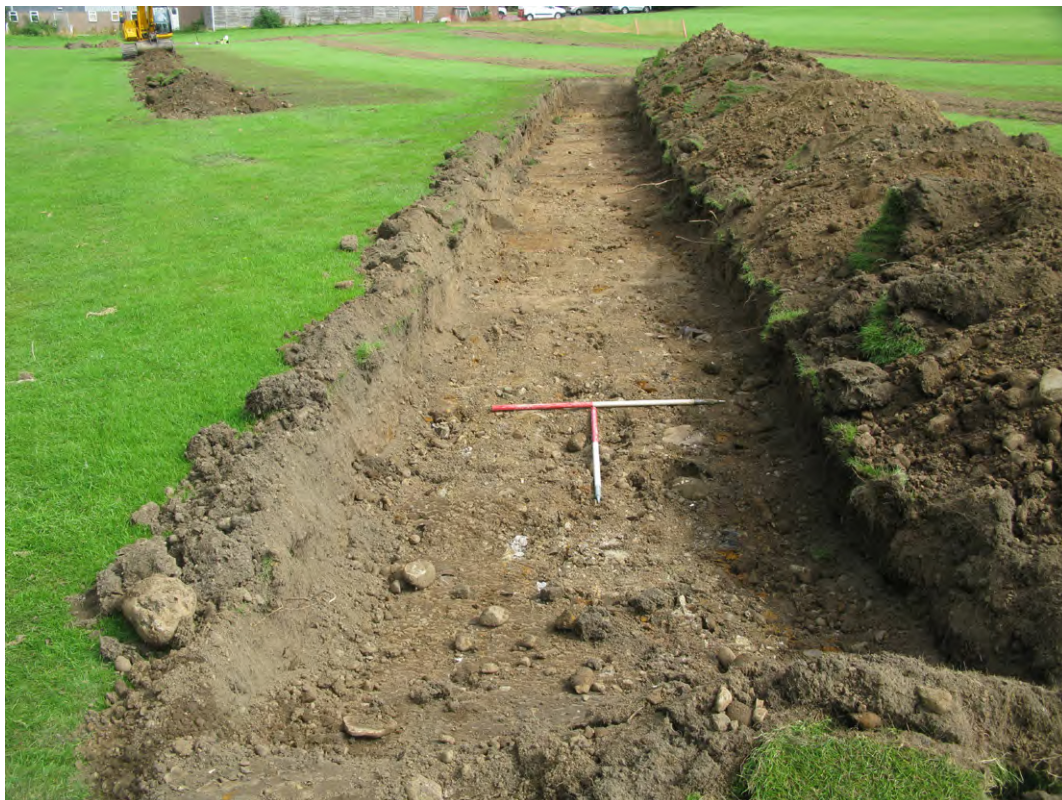
Fig. 8 Trench 6 post-excavation

*Trench 6 (1.8m by 26m; Fig. 8)* ran in an east to west orientation. Topsoil (001), 0.3m deep, overlay 0.1m to 0.5m of subsoil (002) which overlay natural (003). One ceramic horse-shoe field drain was discovered. No other archaeological remains were found.

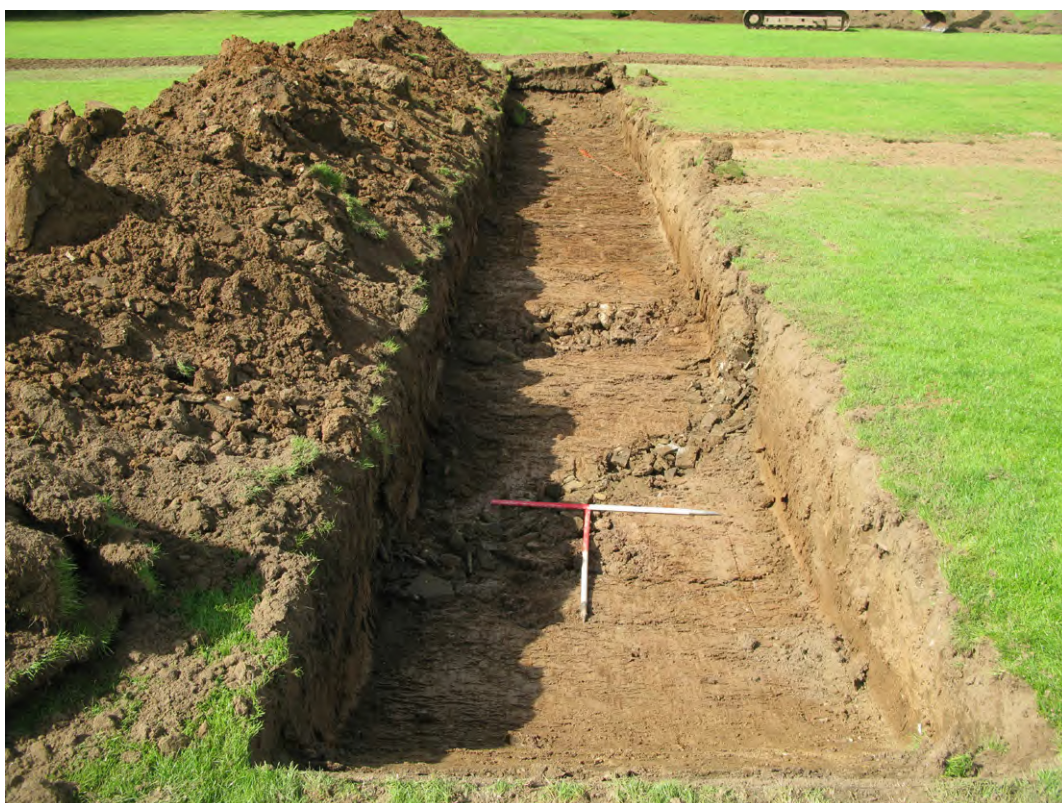
Fig. 9 Trench 7 post-excavation

*Trench 7 (1.8m by 17m; Fig. 9)* ran in a southeast to northwest orientation. Topsoil (001), 0.3m deep, overlay 0.4m to 0.5m of subsoil (002) which overlay natural (003). One ceramic horse-shoe field drain, one rubble filled field drain, and the possible remains of a damaged stone box drain were discovered. No other archaeological remains were found.
