**Calderwood
East Calder, West Lothian
Archaeological Evaluation (Phase 2)
Report No. 3483**

Authors	Magnus Kirby MA FSA Scot ACIfA
Illustrator	Graeme Carruthers MA MCIfA
Editor	Bruce Glendinning MA PgDip MCIfA
Commissioned by	Stirling Property Partnership
Date issued	September 2016
Version	1
Oasis No.	cfaarch1-262815
Planning Application No	0524/P/09
Grid Ref	NT 089 686

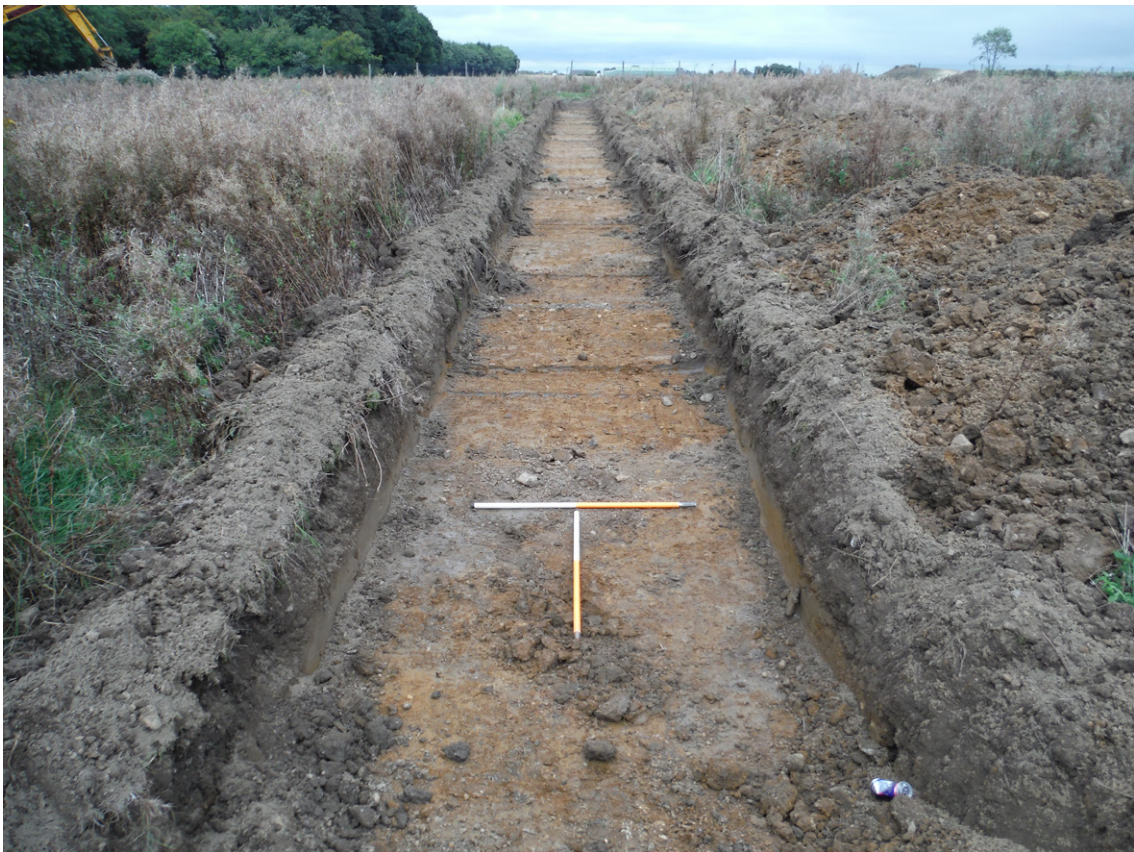
Fig. 4: Trench 23 from SW

23	48 x 2	0.4m	2 rubble drains, 1 shale drain, and 1 ceramic drain
