## **Bonnington Road Lane, Edinburgh Historic Building Survey**

**Report No 3480**

Author	Michael Cressey, BA MSc PhD MCIfA FSA Scot
Illustrator	Graeme Carruthers MA MCIfA
Editor	Bruce Glendinning BSc PG Dip MCIfA
Commissioned by	Miller Homes
Date issued	September 2016
Version	1
Grid Ref	NT 2616 7596
Oasis Ref	cfaarcha1-263903

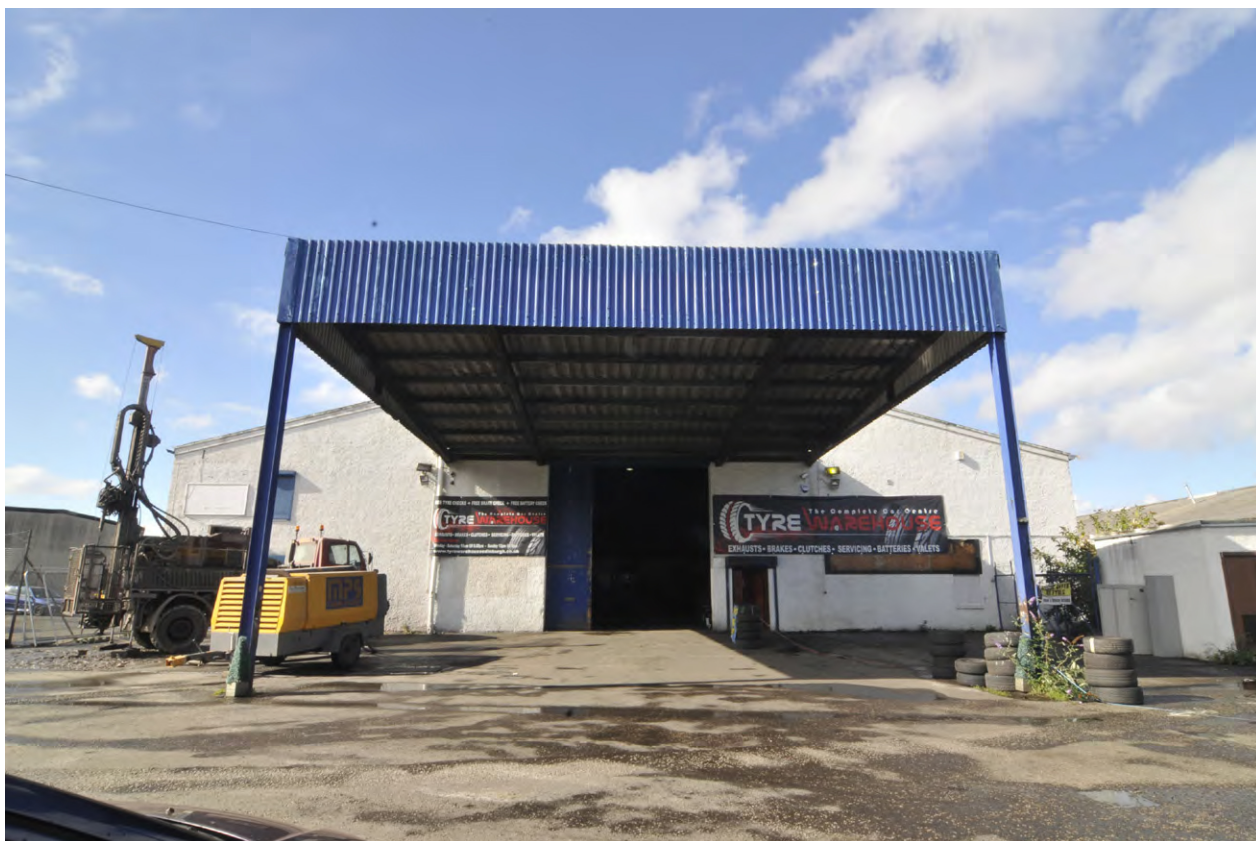
Fig. 3 Building A, external south-facing gable

The external south-facing elevation measured 30m wide and was a gable wall covered with whitewashed pebble dash render. Occupying the centre of the elevation was a pair of large wooden sliding doors. On the west side of the elevation was a sliding door leading to a mezzanine floor. On the east side of the elevation was a single roller door. Extending off the elevation was a large steel-framed canopy (Building B described below).

Extending of the south-facing elevation was Building B a large steel-framed canopy measuring 11.9m x 11.9m and supported on two steel I-beams. The roof and fascia was clad with corrugated steel sheeting.

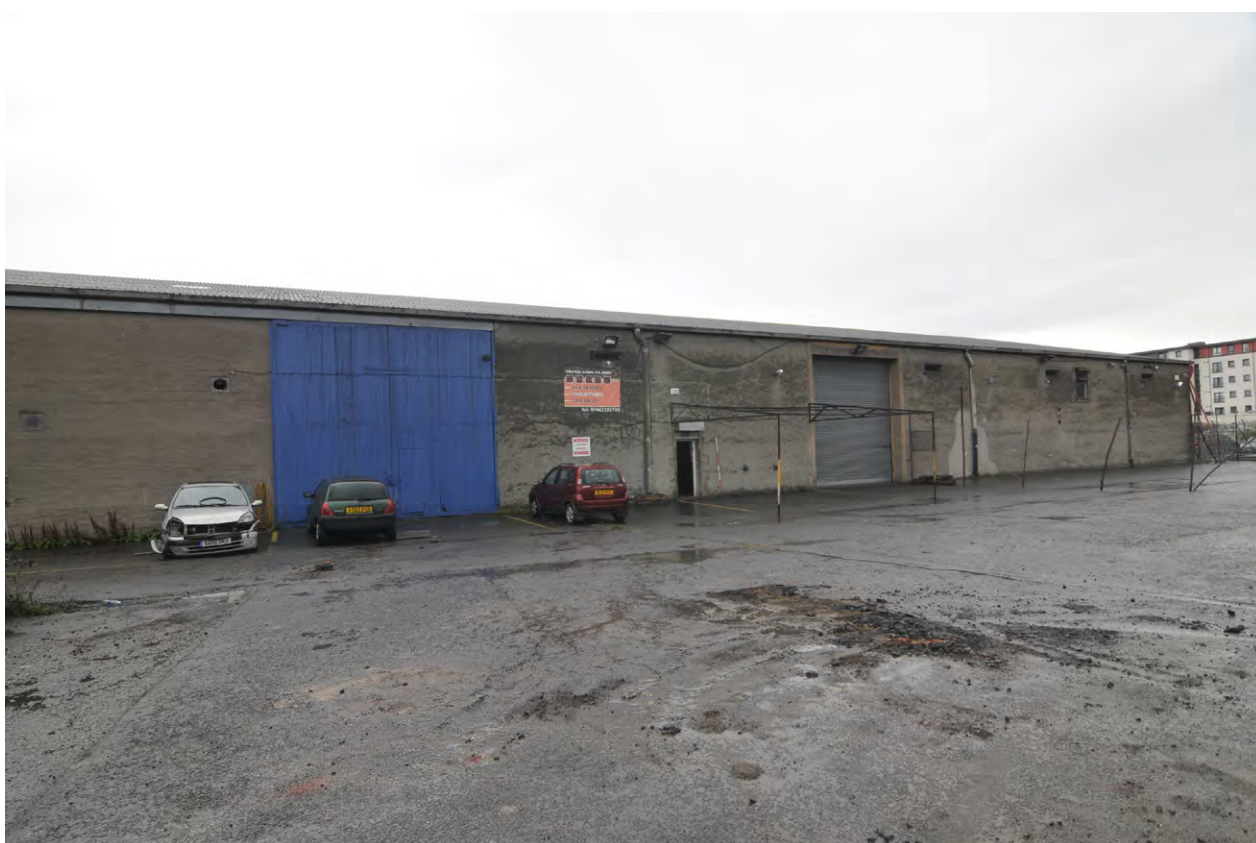
Fig. 4 Building A, external south-facing elevation

The external west-facing elevation was 59m long and contained a large double-leaved sliding doorway and a large steel roller door. In between these two entrances was a single door to Unit 2. On the south side of the steel roller door the elevation contained a series of vents and a shuttered window opening.

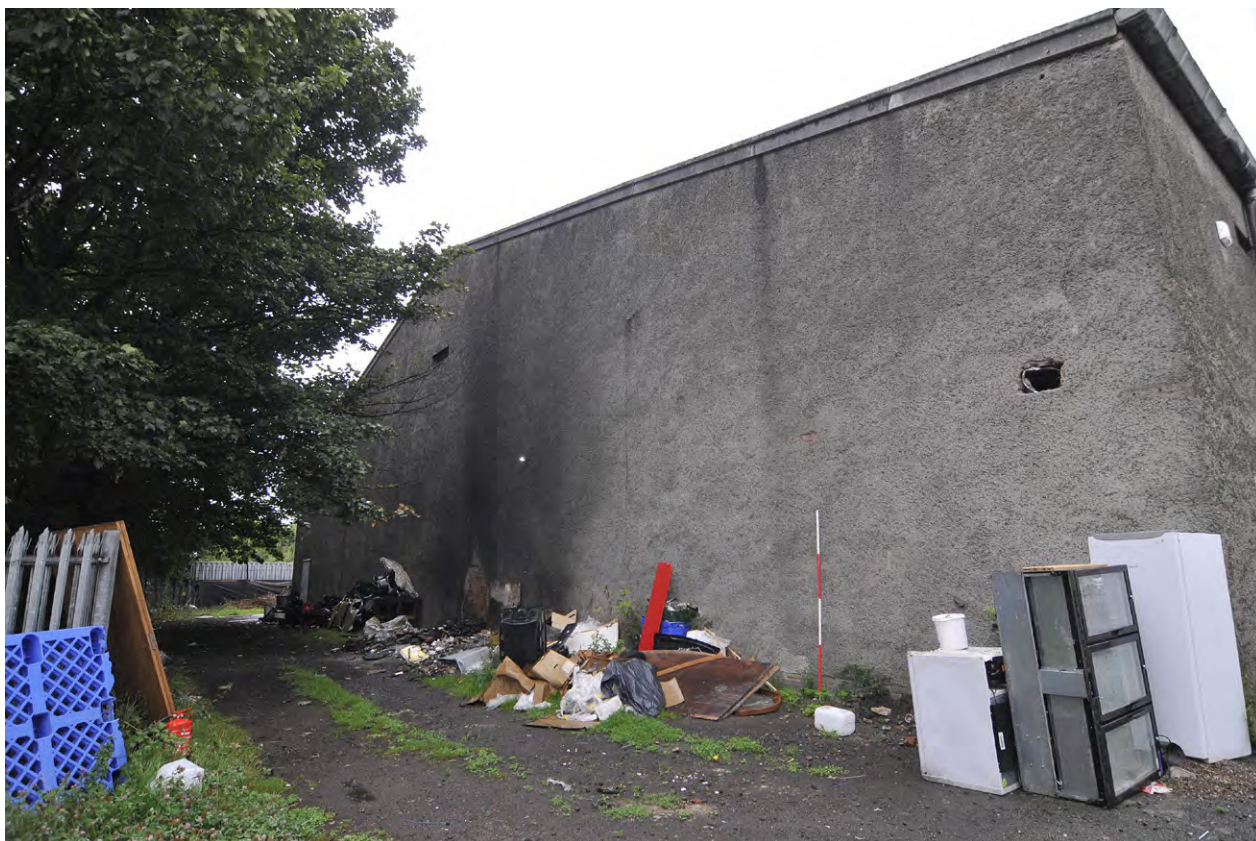
Fig. 5 Building A, external north-facing gable

The external north-facing gable was 30m wide and contained a shuttered doorway on its east side. The rest of the gable was featureless and covered with pebble-dash render.

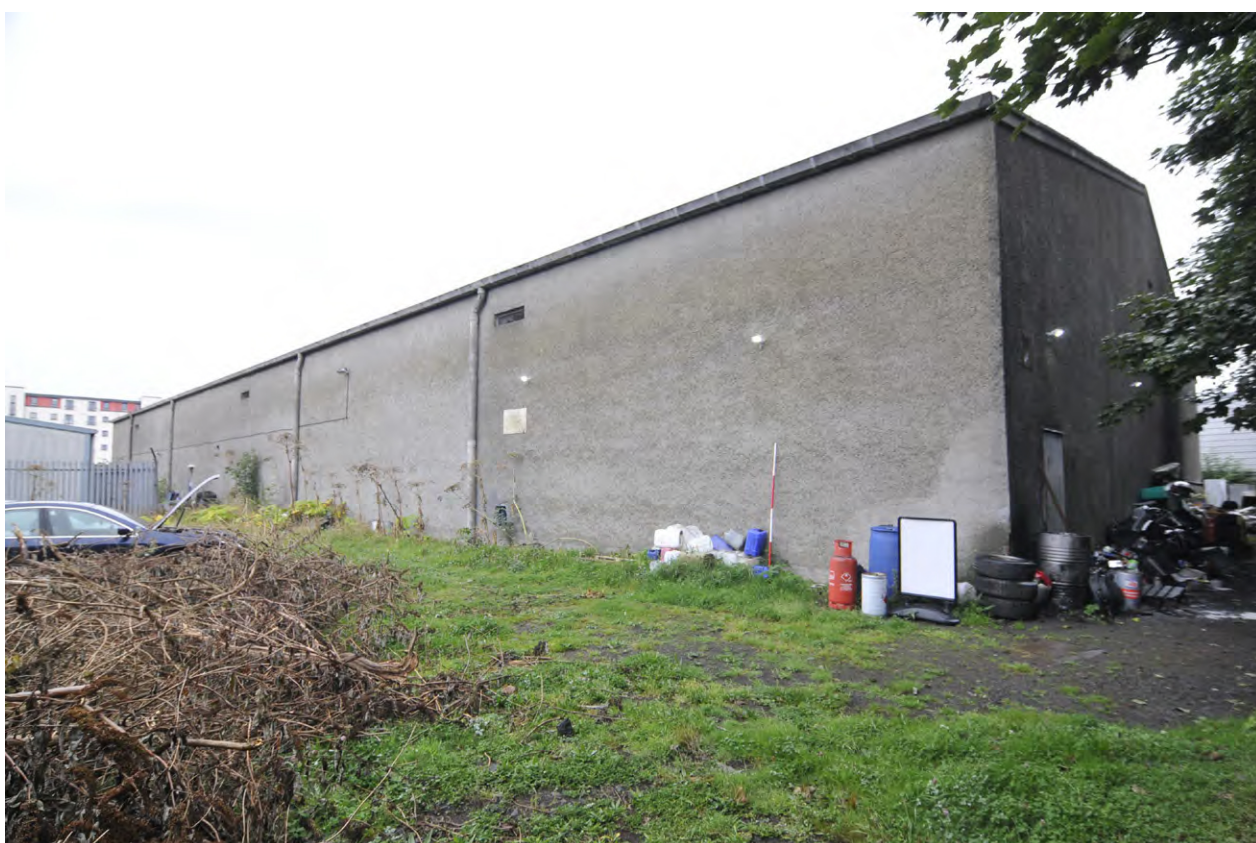
Fig. 6 Building A, external east-facing elevation

The external east-facing elevation was 59m long and contained three rectangular vents towards its eaves. The rest of the wall was featureless and covered with pebble-dash render.

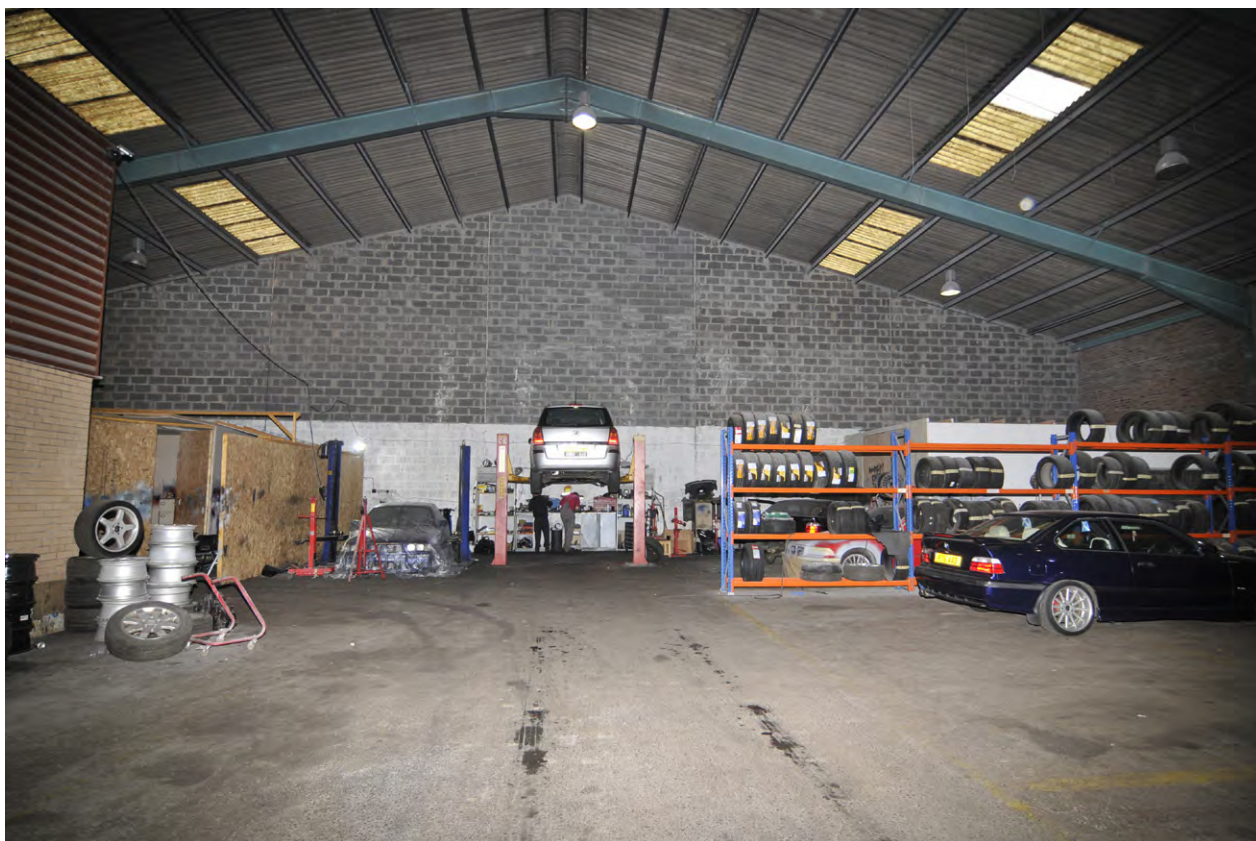
Fig. 7 Building A, Unit 1, interior south-facing elevation

The north wall was constructed of mono-block and was whitewashed to a height of about 5m. Two timber built spray booths had been built against the wall.

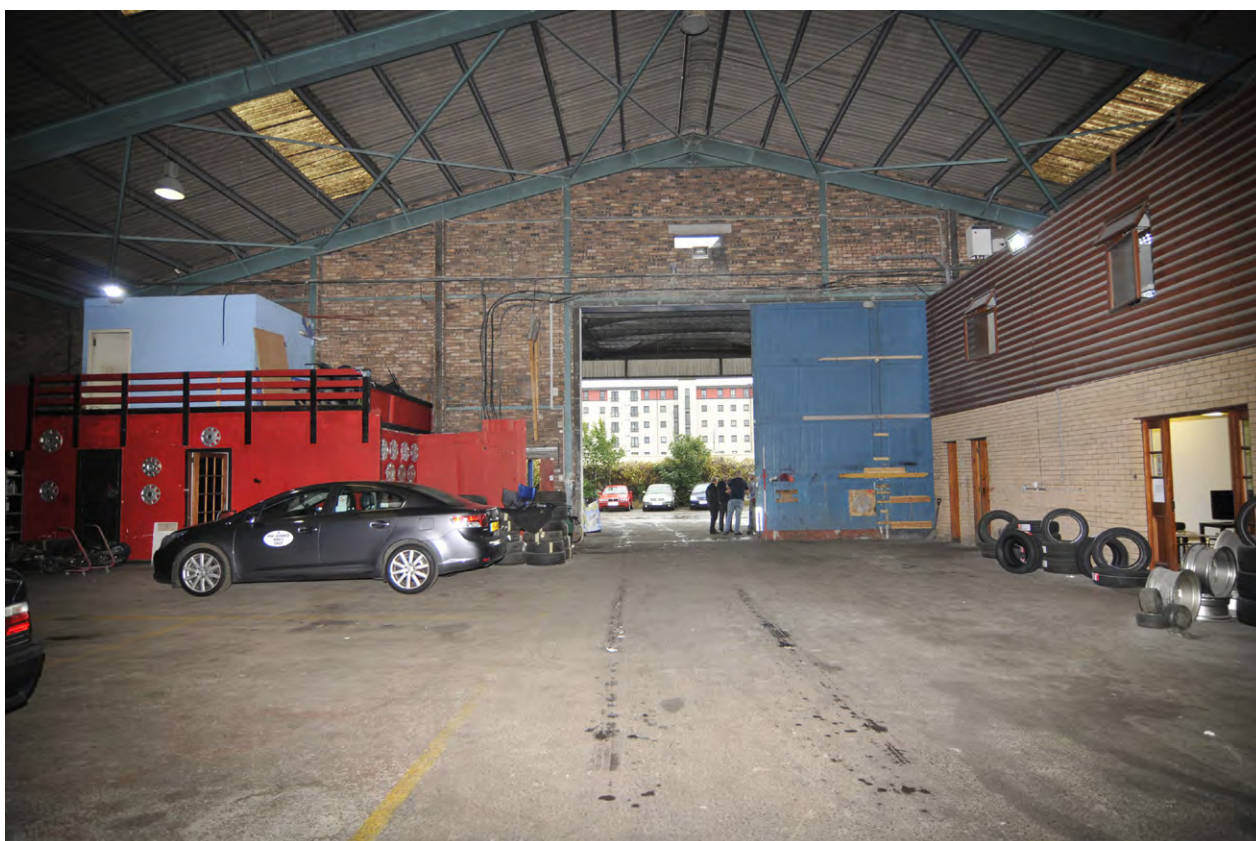
Fig. 8 Building A, interior north-facing elevation

The south wall comprised the main gable and entrance to the garage and was brick-built within a steel frame. On the left-hand side (facing) was a timber-built storage shed with a mezzanine above with blue-painted walls. On the right-hand side of the large door was the aforementioned garage and waiting room.

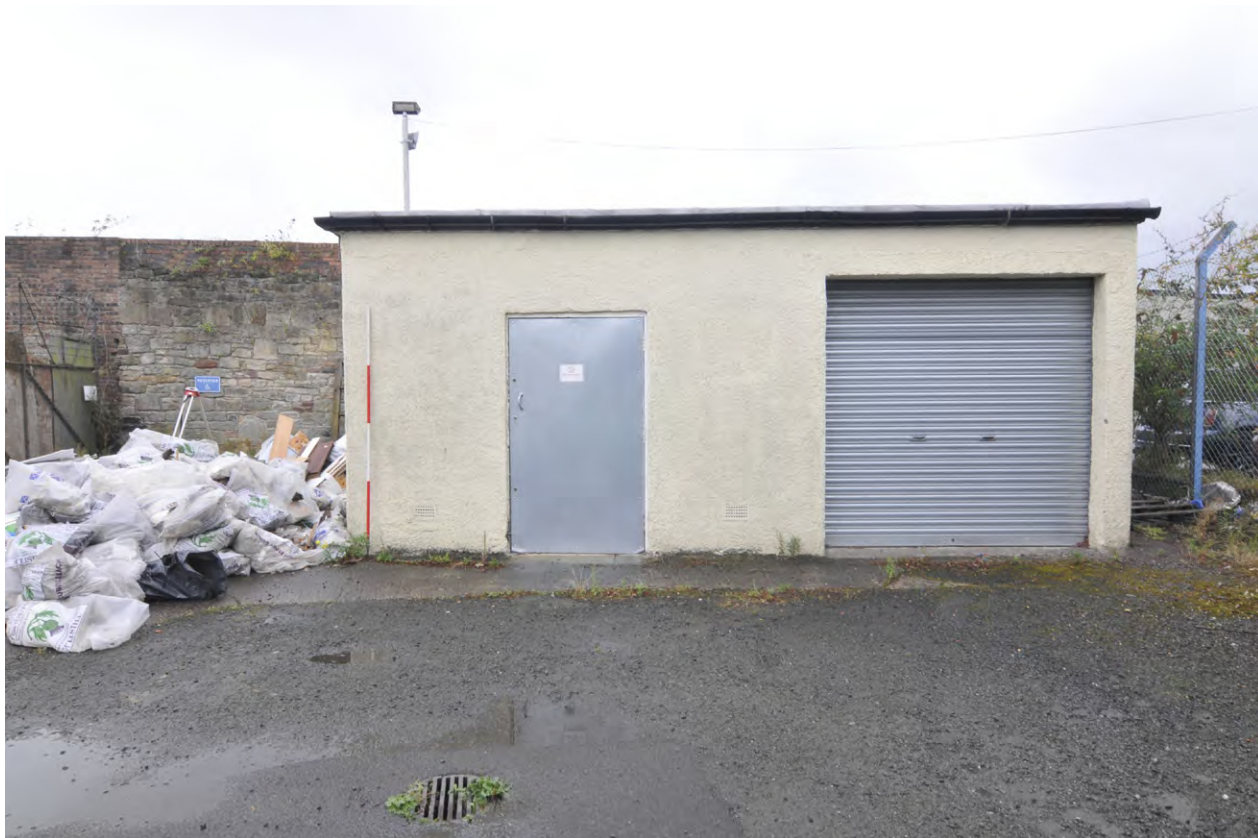
Fig. 9 Building C, double garage

There was no access to the interior of this building. Building C comprised a brick-built double garage (6m x 6m) with a single steel-plated door and a steel roller shutter door on its east-facing elevation. All four external walls were cement harled and featureless. The roof was flat.

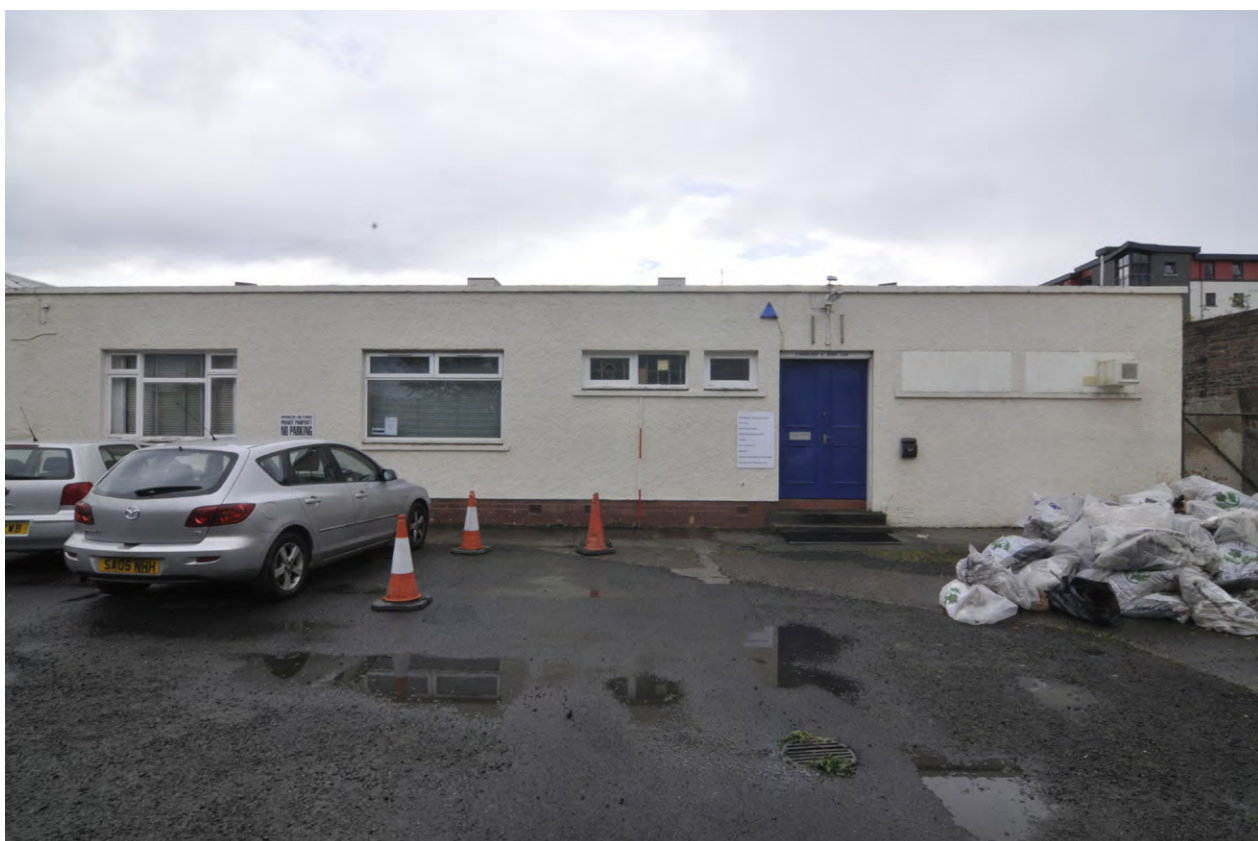
Fig. 10 Building D, external north-facing elevation

The business centre/recording studio was situated at the west end of a large rectangular block. Its main elevation faced northwards and contained its two main doorways and four windows, one set of which was boarded.

The west (gable) wall contained four boarded-up windows and two small toilet windows. The rear south wall contained three wooden casement windows, one of which was boarded-up and an off-centre door. Three small windows were present on the right-hand side of the door. The building had a flat roof.

All the walls were harled but at the base of the elevations approximately six courses of exposed brick work was visible. This appeared fairly modern and may have been installed recently as part of a damp course.

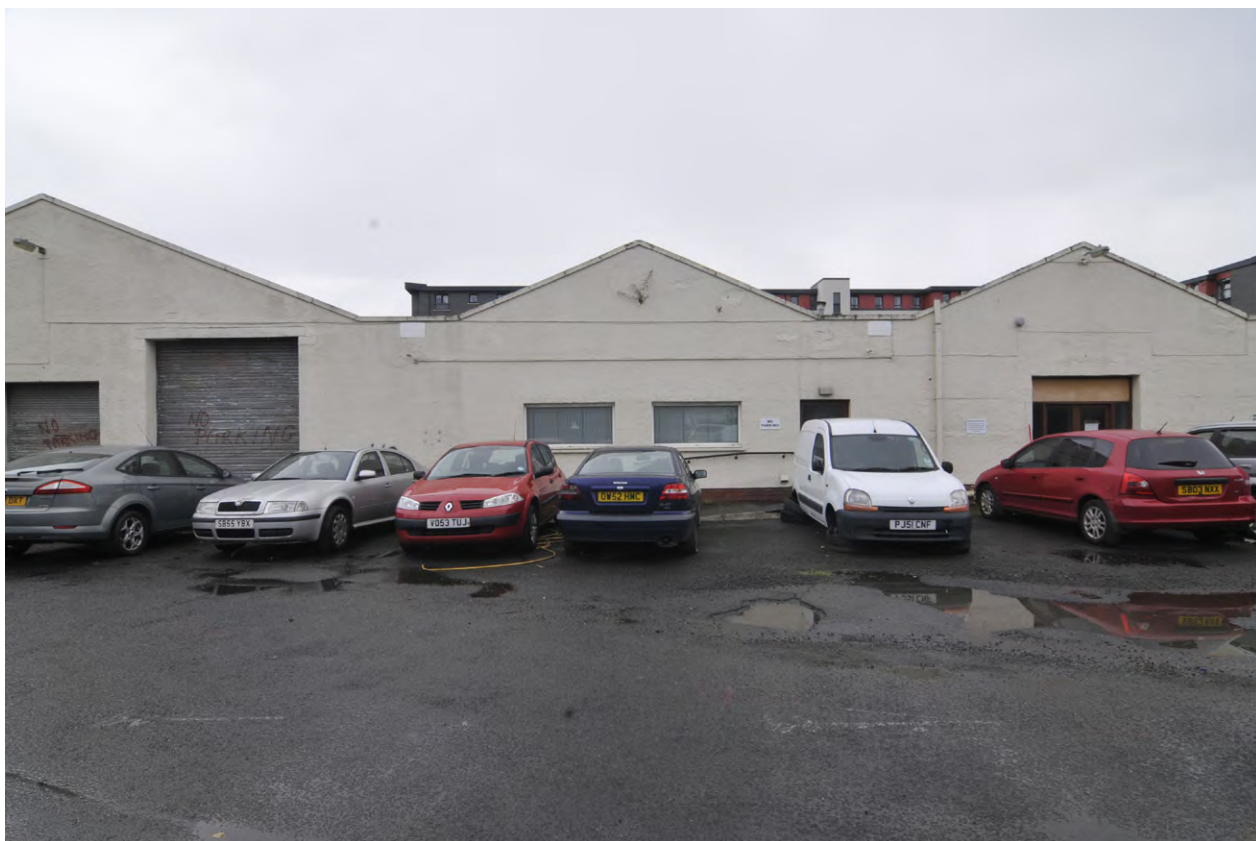
Fig. 11 Building E, external north-facing elevation

The frontage was on its north-facing elevation. Its main entrance was within one of the two pitched gables that were present. The other gable contained two large rectangular windows and a doorway. Apart from a black-painted door at each end of the elevation the elevation was otherwise featureless. Concrete coping stones were present on each of the M-shaped gables and the roofs were clad with steel sheeting. There was no access to the interior of the building but it comprised a collection of modern offices and therefore was of no historical interest.

All the walls were harled but at the base of the elevations approximately six courses of exposed brick work was visible. This appeared fairly modern and may have been installed recently as part of a damp course.

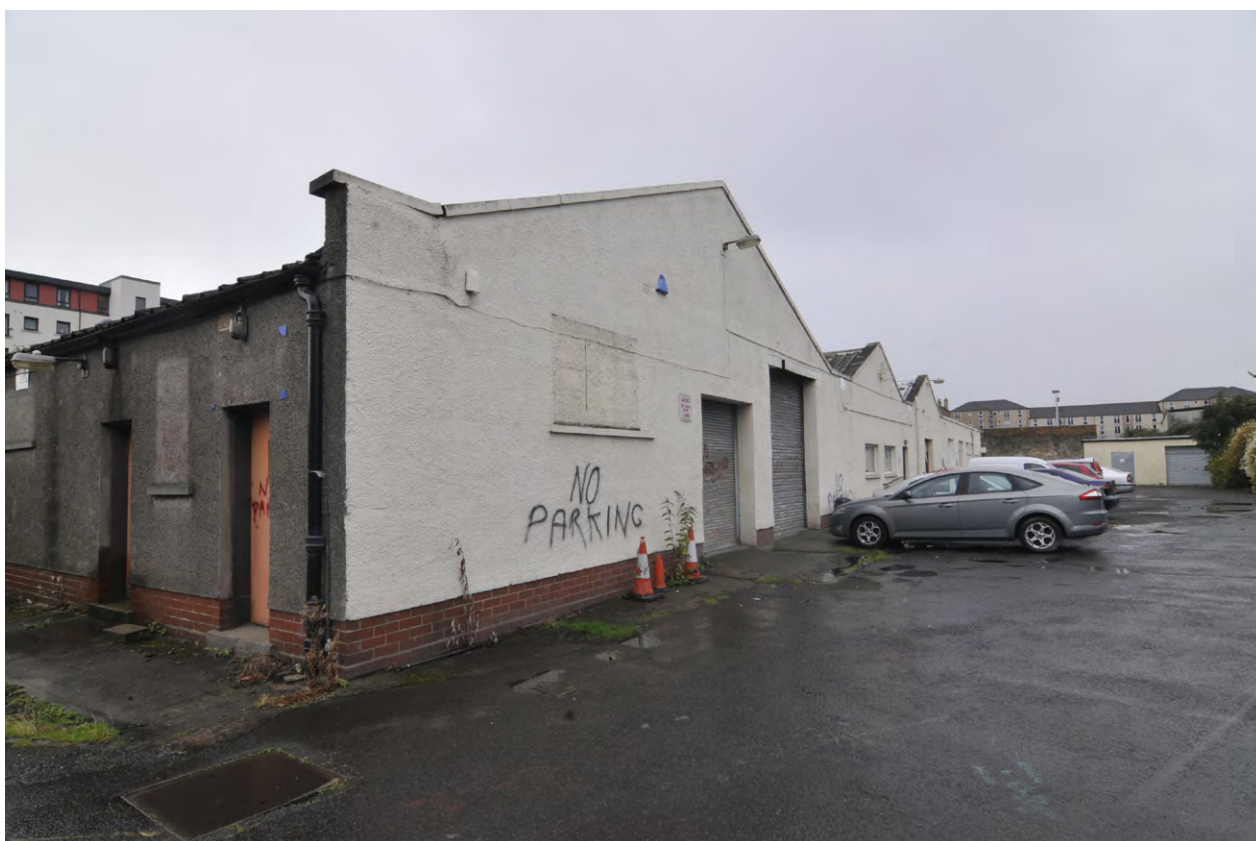
Fig. 12 Building F, external north-facing elevation

The front of Building F (north-facing elevation) had a single pitched gable containing two steel roller doors and a blocked up window. The walls were harled but at the base of the elevations approximately six courses of exposed brick work was visible. The east-facing elevation contained six blocked-up windows and two plain orange-painted doors at the north end. The rear south-facing elevation had a pitched gable with a large sliding door below it. To the right of the sliding door was a smaller double-leafed door. The pebble-dashed walls surrounding the doorways were featureless. Interestingly the wall was deliberately angled off-line with the main wall of Building E in order to respect the position of a railway line shown on the historical maps.

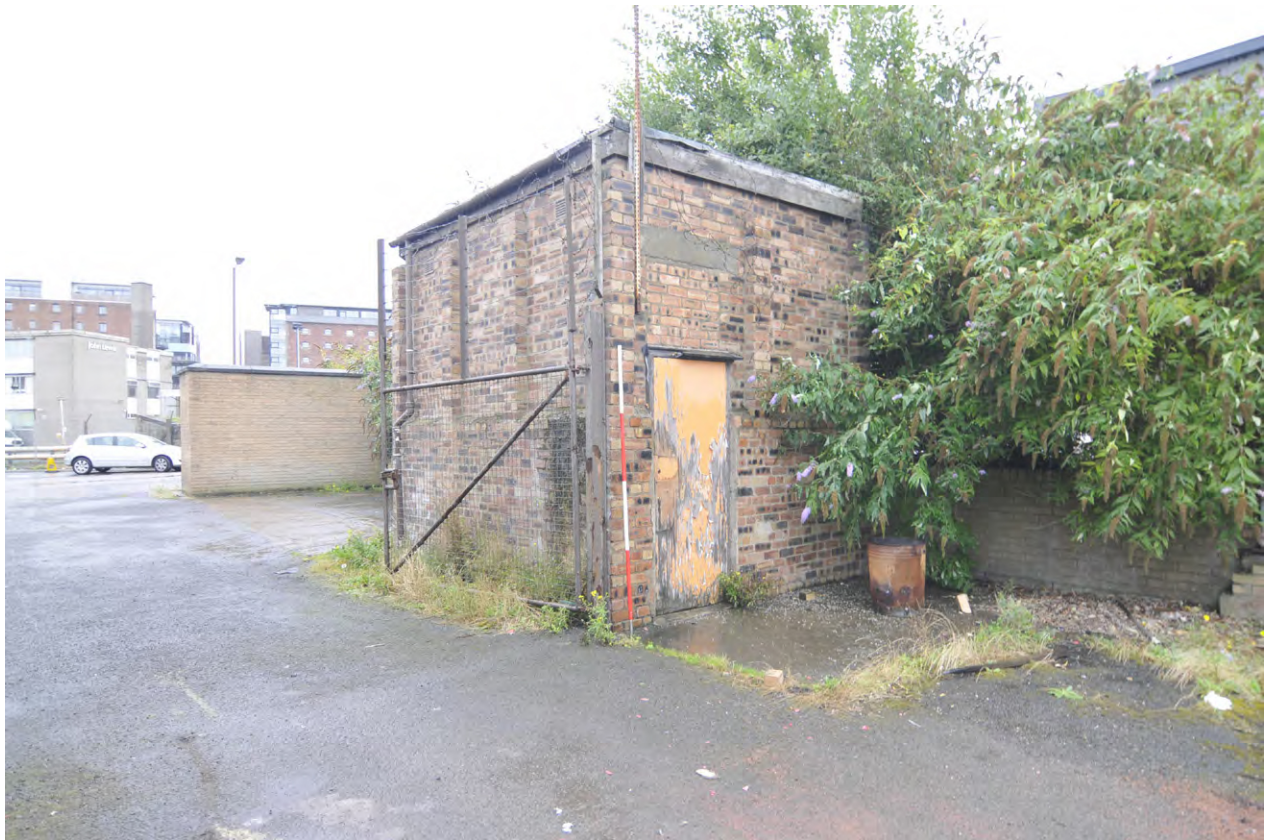
Fig. 13 Building H, external north and west-facing elevations

Building H was situated to the rear of the East Coast Garage and was a chemical store for the garage. This small brick-built structure measured 4m x 3m and had a plain wooden door on its west-facing elevation. The north and east-facing elevations had a standard brick wall at its base which was surmounted by single-skin wall with narrow buttresses. A timber fascia board was present below the flat roof.

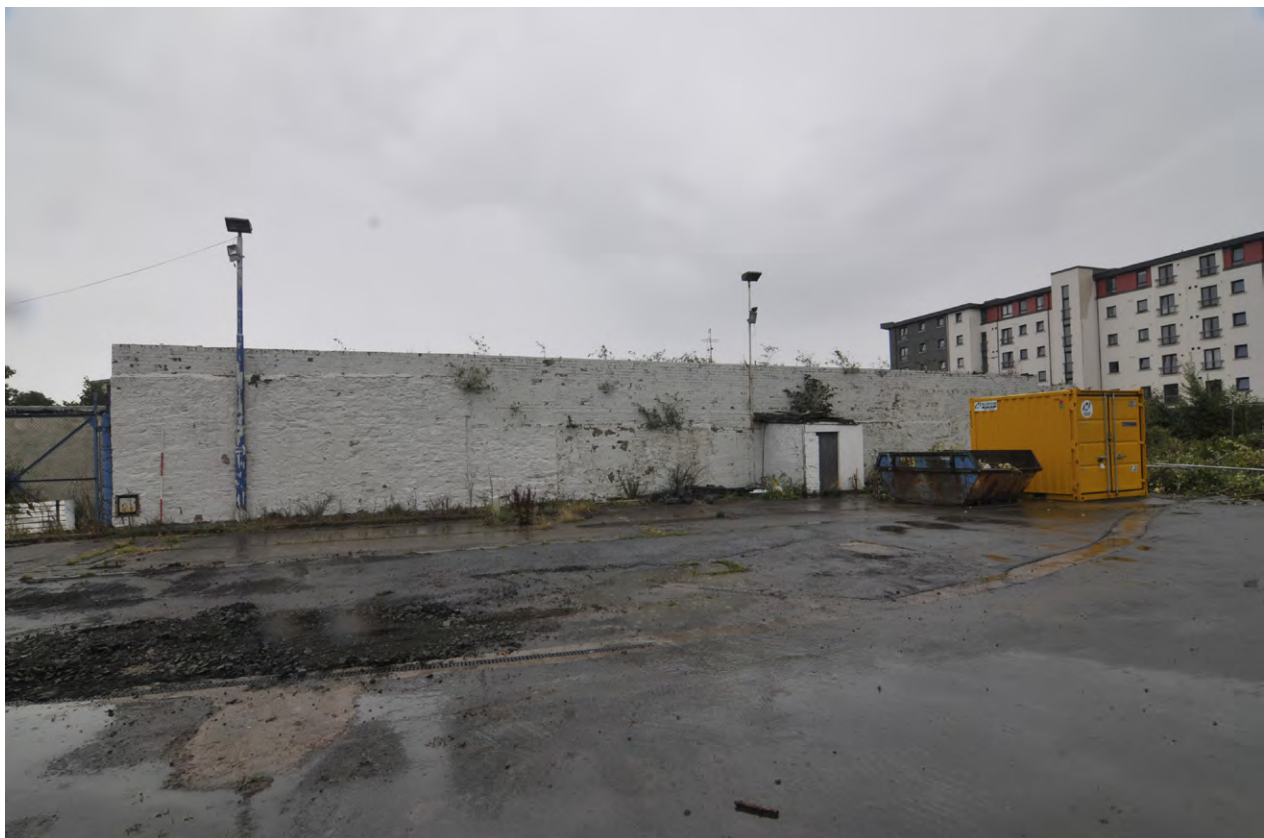
Fig. 14 Wall I, general view of the west-facing elevations

The upstanding wall was situated at the west end of Building D and was free standing and comprised both random rubble and several phases of brickwork. Both sides of the wall were recorded.

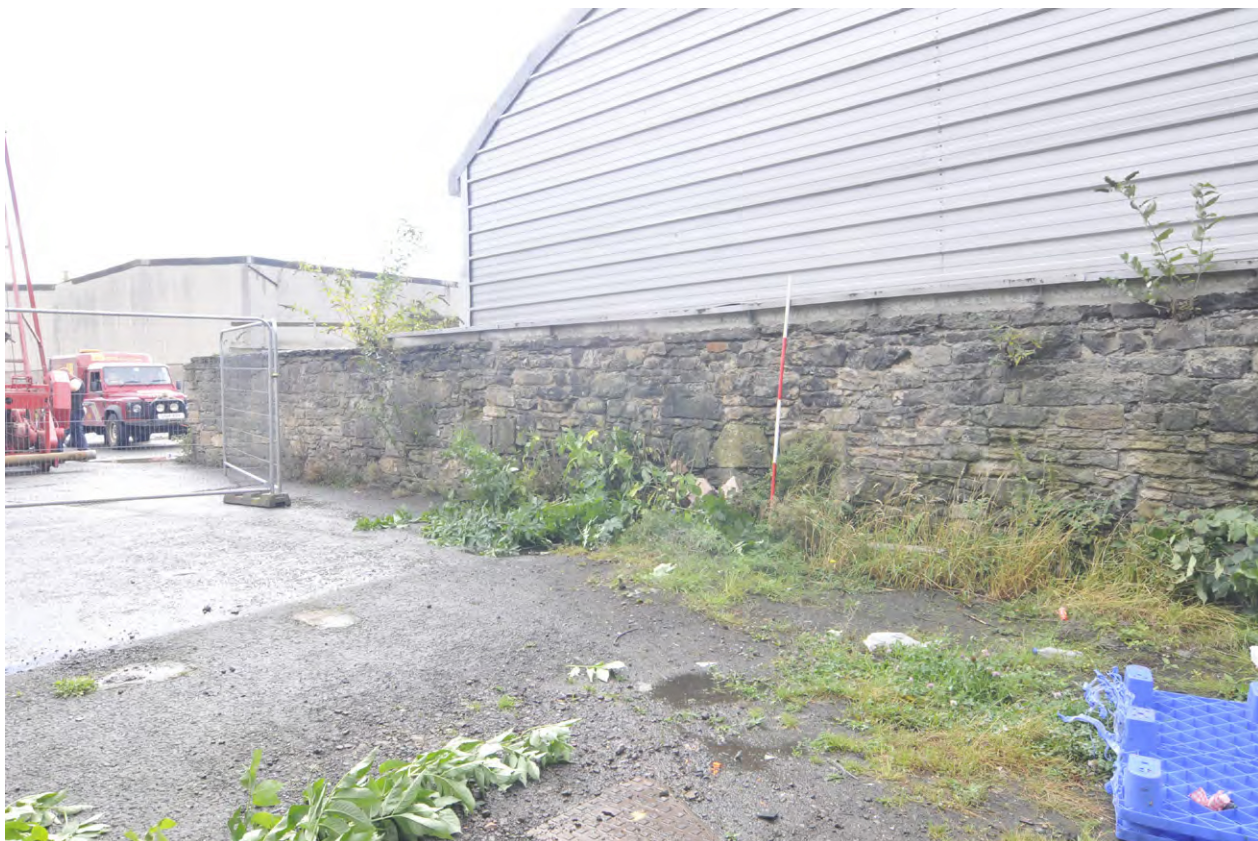
Fig. 17 Wall 2, east-facing elevation

Situated at the north-west end of the proposed redevelopment boundary was a length of wall running north to south for a distance of about 30m (Fig 17). The wall stood to a height of about 1.6m and was 0.5m wide with a double skin construction. The wall was faced with snecked sandstone on its east-facing elevation and contained no blocked features. Only part of the west-facing elevation was visible and this had been painted in the past confirming it as the interior of a building. The gable wall of a large modern steel-clad building was keyed into the wall head.

Wall 2 was probably the remains of a stone-built gable wall associated with an Iron Works that stood just outside the proposed redevelopment boundary.

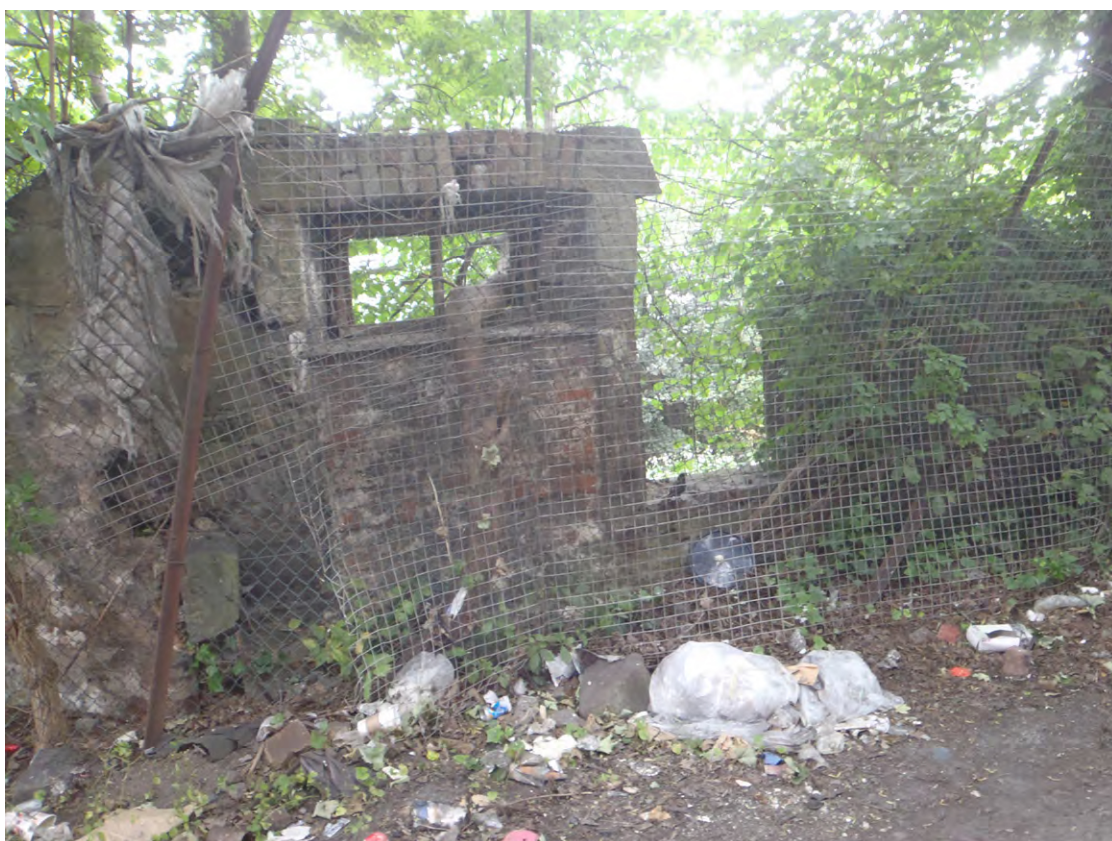
Fig. 18 Wall 3, part of the south-facing elevation

Wall 3 was situated on the northern boundary of the proposed development area and was very overgrown by vegetation. The wall was c.15m long and stood to a height of c. 3m. It comprised a mixture of brick and stonework and contained the remains of a large window opening. Adjacent to this opening was another large opening that had been partially blocked to accommodate a smaller window with a brick relieving arch.

Wall 3 represents the upstanding remains of a rubble-built side wall of a rectangular building shown on the 1877 Second Edition Ordnance Survey map.
