# Land to the East of East Suffolk Road, Edinburgh

**Archaeological Evaluation**

Report No. 3485

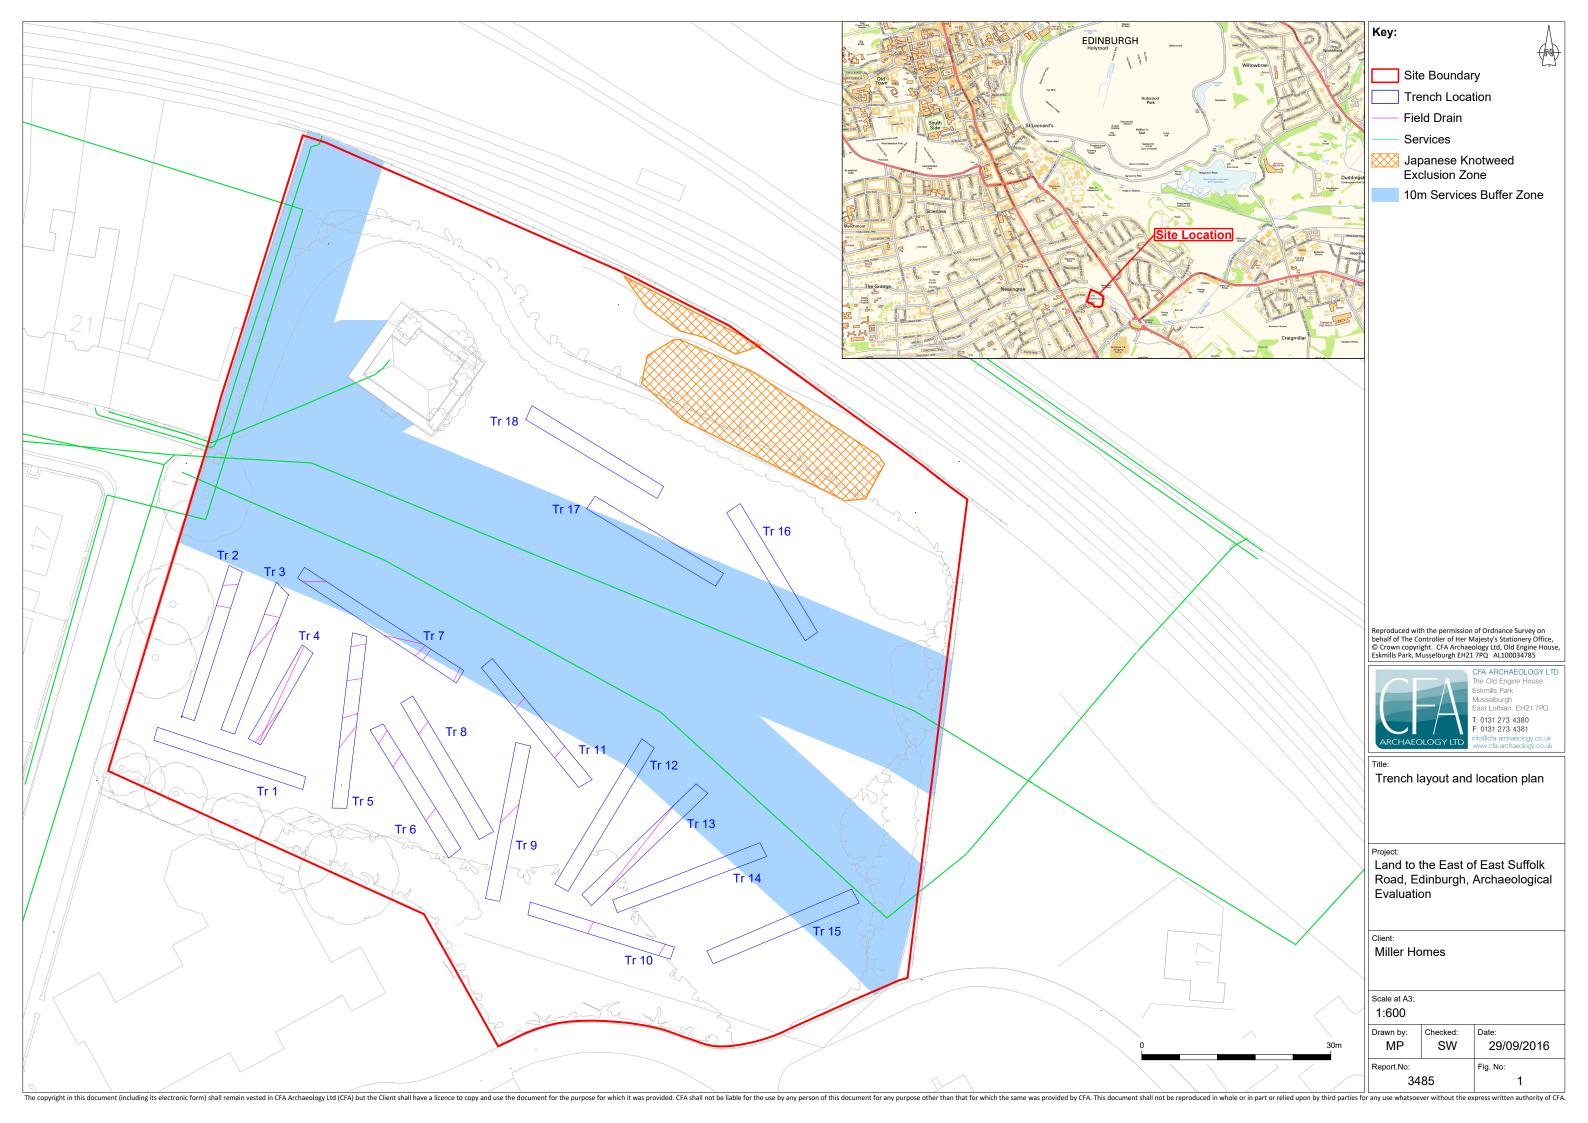
This report presents the results of an archaeological evaluation carried out by CFA Archaeology Ltd (CFA) in September 2016 ahead of a proposed housing development on land to the east of East Suffolk Road, Edinburgh (NGR: NT 27178 71459) (Fig. 1). The work was commissioned by Miller Homes.

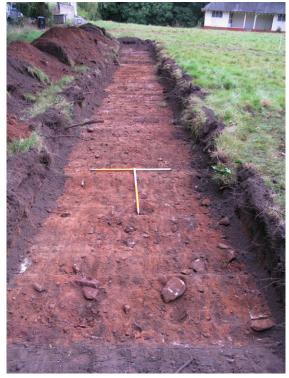
Fig. 2 - Post-excavation shot of Trench 2

The natural (000) across the site mostly consisted of reddish to orange-brown sandy silt changing to more sandy clay towards the north of the site (Figs. 2-4). The natural was not identified in Trench 16-18 as extremely deep deposits of re-deposited made ground were encountered down to a depth of at least 3.8m as recorded in Trench 16. It was clear in the section of Trench 16 that the natural land formation sloped extremely sharply (c.45°) in a northerly direction down towards the Pow Burn (Fig. 5).
