The Garage, Reeds Lane, Wigton Historic Building Survey

Report No 3495

Author	Michael Cressey, BA MSc PhD MCIfA FSA Scot
Illustrator	Graeme Carruthers MA MCIfA
Editor	Bruce Glendinning BSc PG Dip MCIfA
Commissioned by	Mr & Mrs Saunderson
Date issued	November 2016
Version	2
Grid Ref	NY 25684 48479
Oasis Ref No.	cfaarcha1-267505

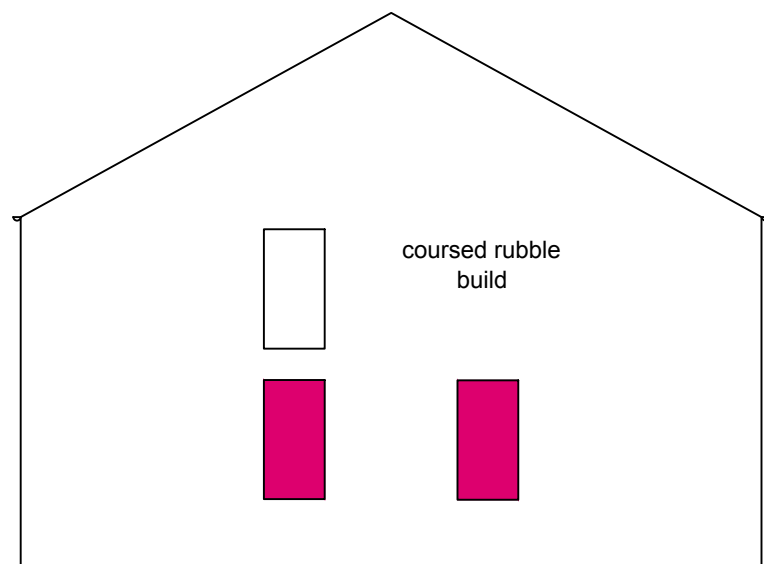
Fig. 3a South-facing elevation

The south-facing rear gable wall was constructed of coursed sandstone blocks and had the remains of backing plaster present on its eastern half. The aforementioned sash-and-case present on the opposite side of the wall had been inserted into ashlar margins that were raised. Below the window was the blocking work for the rectangular window (described above) and a second blocked window adjacent (Fig. 18). Both windows had sandstone lintels and the blocking work within the former window openings was random rubble.

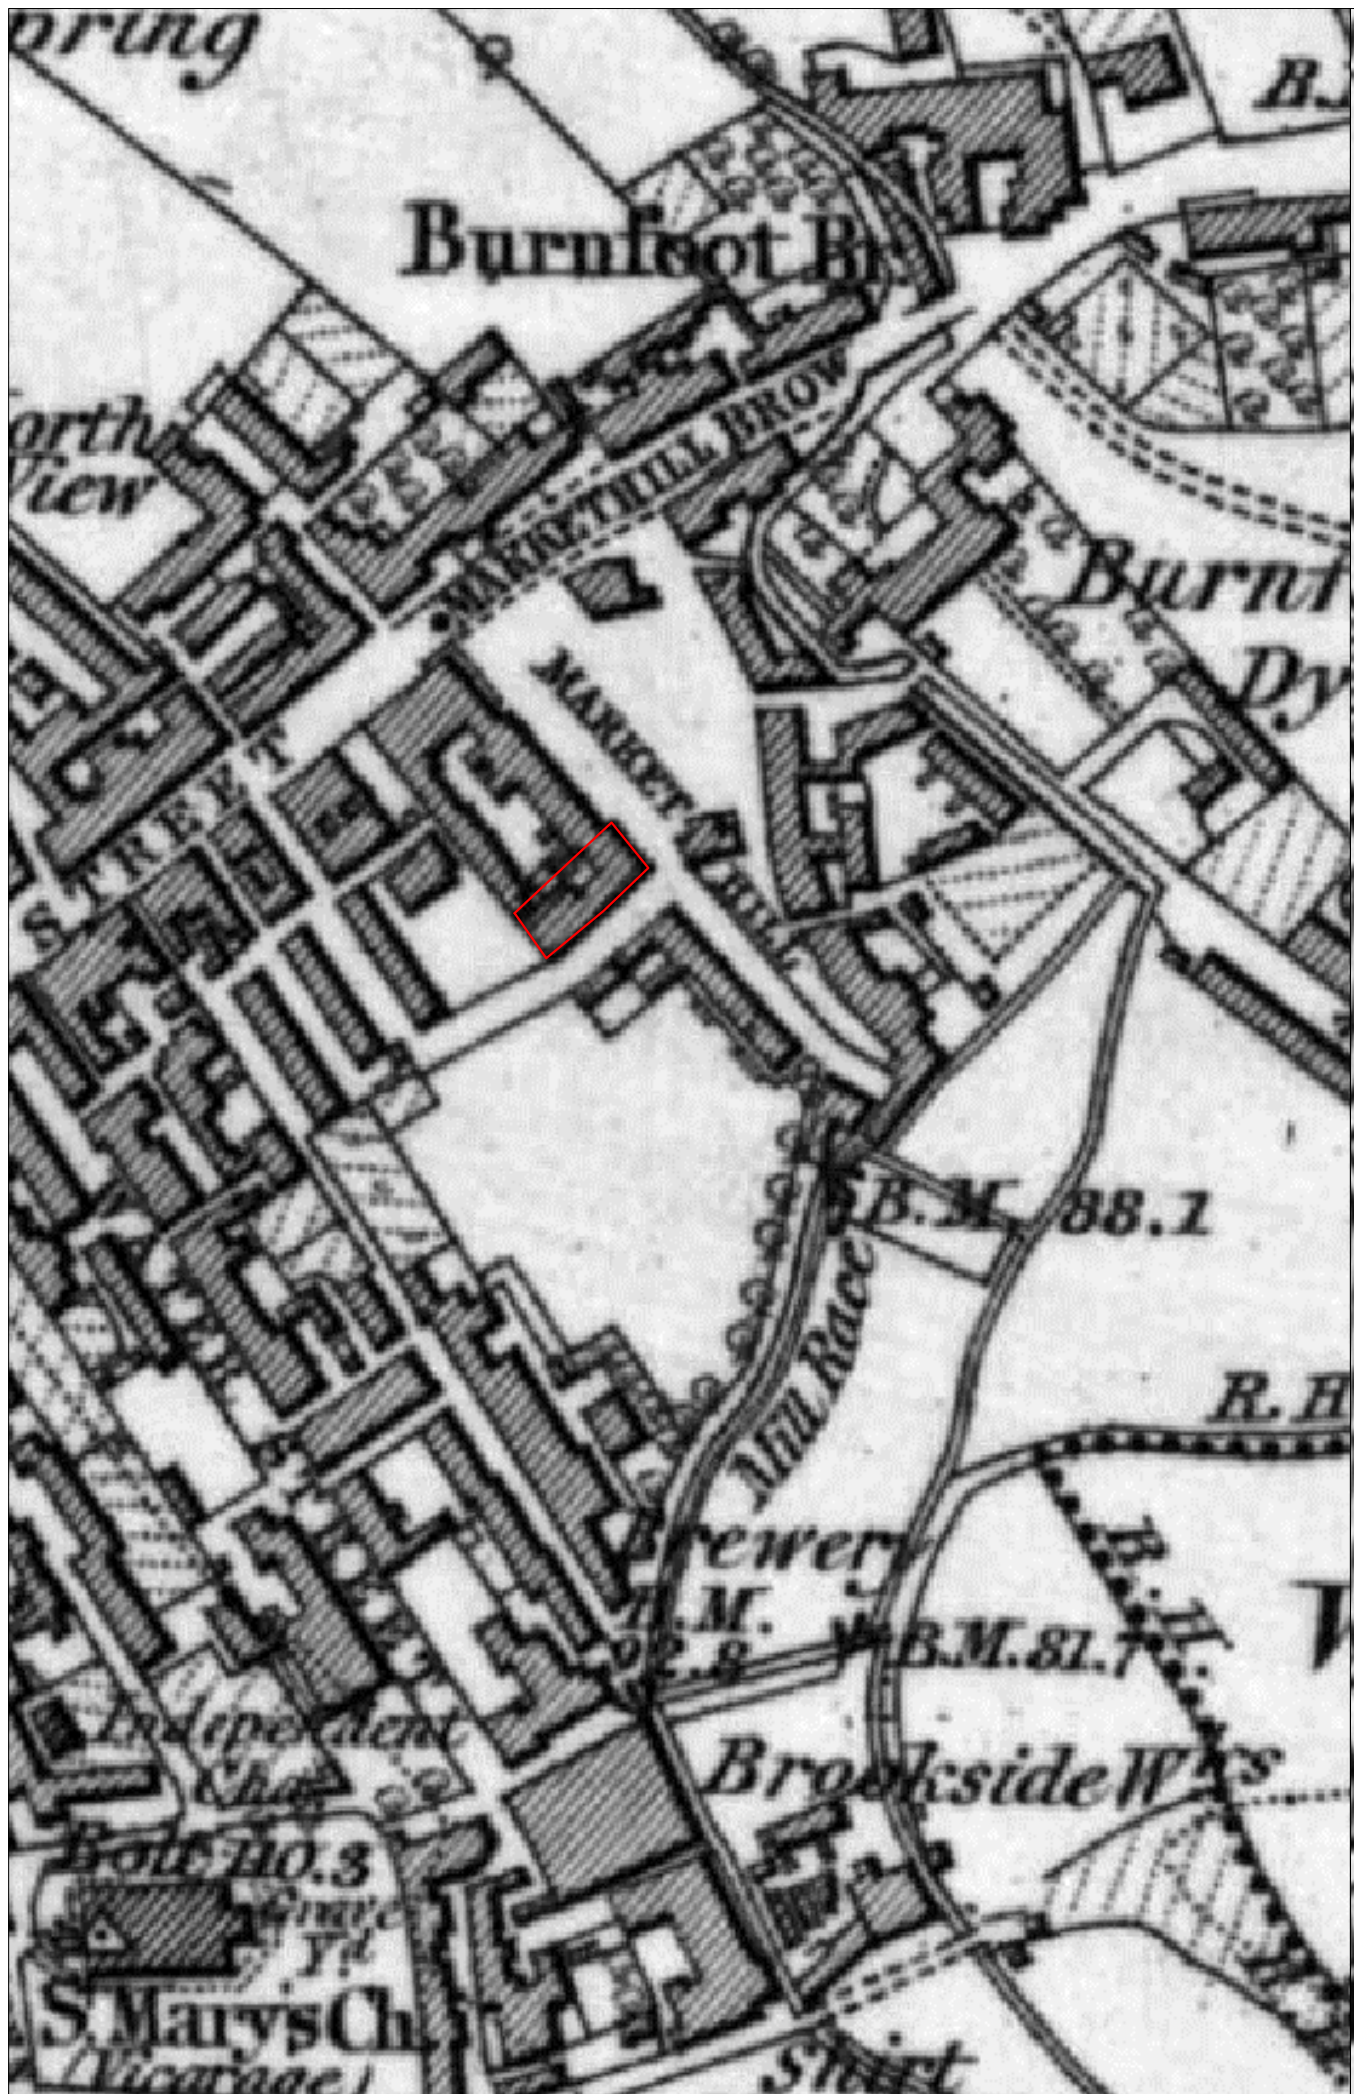
Fig. 4a 1868 First Edition Ordnance Survey Map

The 1868 Ordnance Survey map (Fig. 4a) does not name the chapel and only shows the position of a series of buildings in block layout form. The 1901 Second Edition Ordnance Survey map (Fig. 4b) shows an L-shaped building sharing the same position as the surveyed building. It has been emboldened and labelled as *School*. Subsequent Ordnance Survey maps show the same detail up until c.1952.

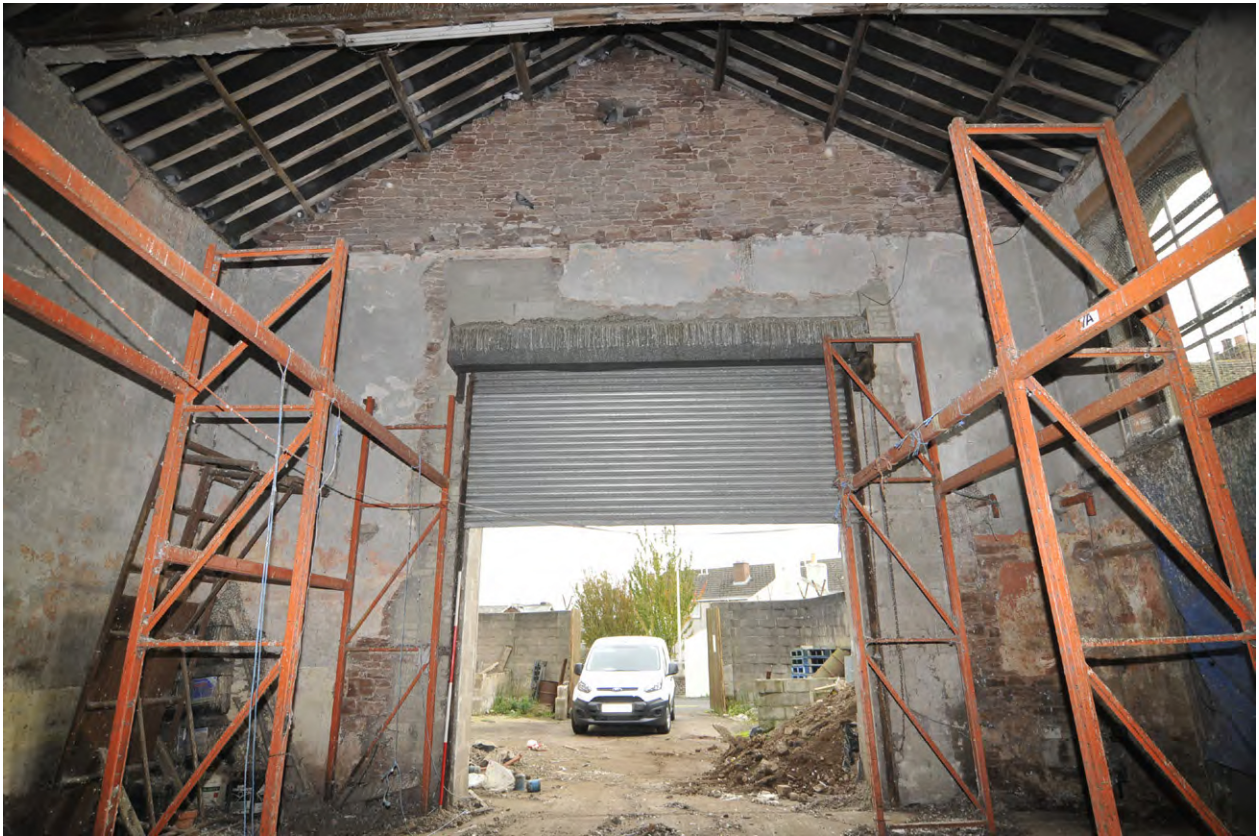
The internal south-facing gable was constructed of blocks of coursed sandstone. This was visible towards the apex of the gable and both on the left and right hand side of a large roller door that measured 3.5m wide. Most of the elevation had been rendered with grey-painted plaster. About 1m above the roller door mechanism was a line of small sockets marking the position for batons that once supported a lath-and-plaster ceiling.

Fig. 5 Room 1, internal south-facing gable wall and roller shutter door

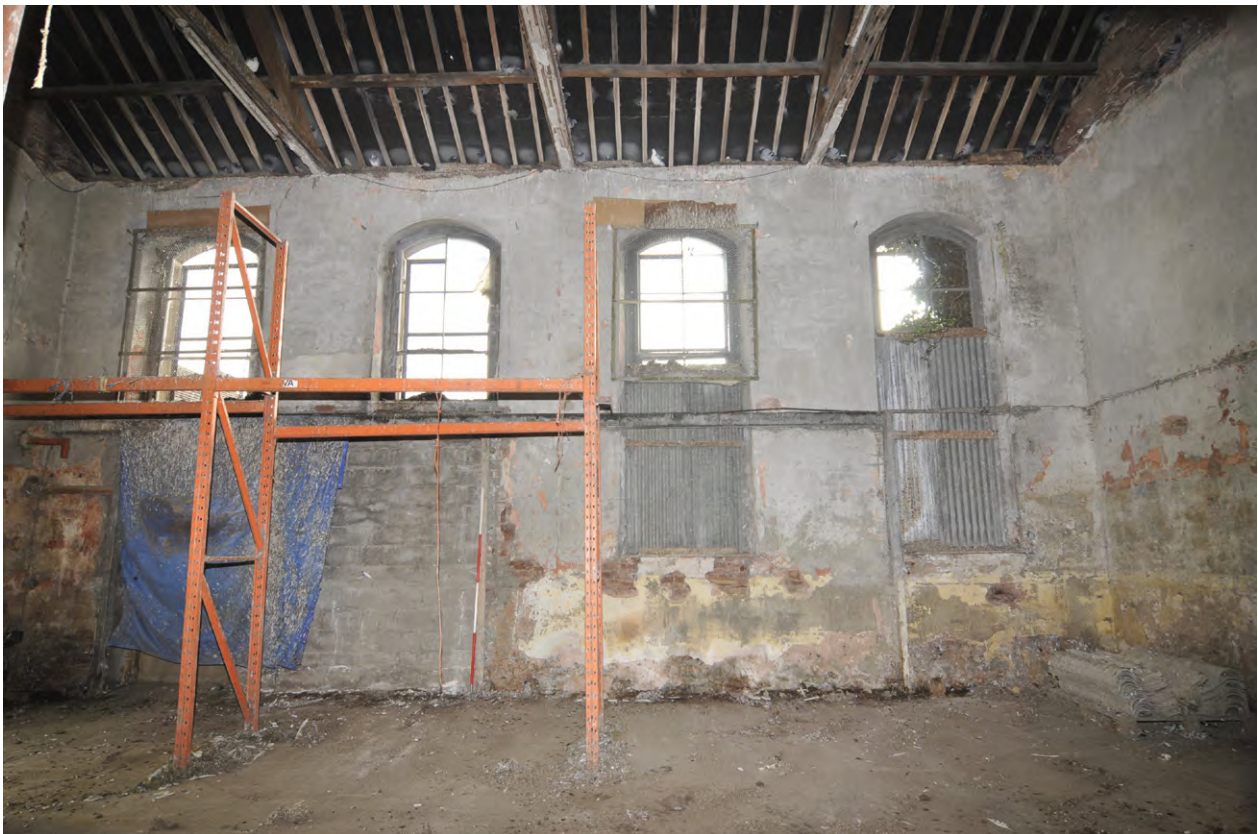
The internal west-facing elevation (eastern side wall) was constructed of coursed sandstone blocks and had been lined with grey-painted plaster. The plaster had been painted yellow to about dado height (1m). Four arched windows were present. Two windows were complete and were part-boarded up with corrugated sheeting, behind which the wooden window frames could still be seen. The two at the north end (left-hand side facing) had been reduced in height to accommodate a large blocked vehicular opening that was about 3m wide. A doorway was present on the north side (left-hand side facing) of the former blocked vehicular opening.

The archaeological evidence shows that Room 1 had two round-headed windows looking westwards (Fig. 6). One window was blocked when Room 2 was added, the second window faced into the narrow alley between the external west-facing elevation

Fig. 6 Room 1, internal west-facing elevation (side wall) with round-headed windows

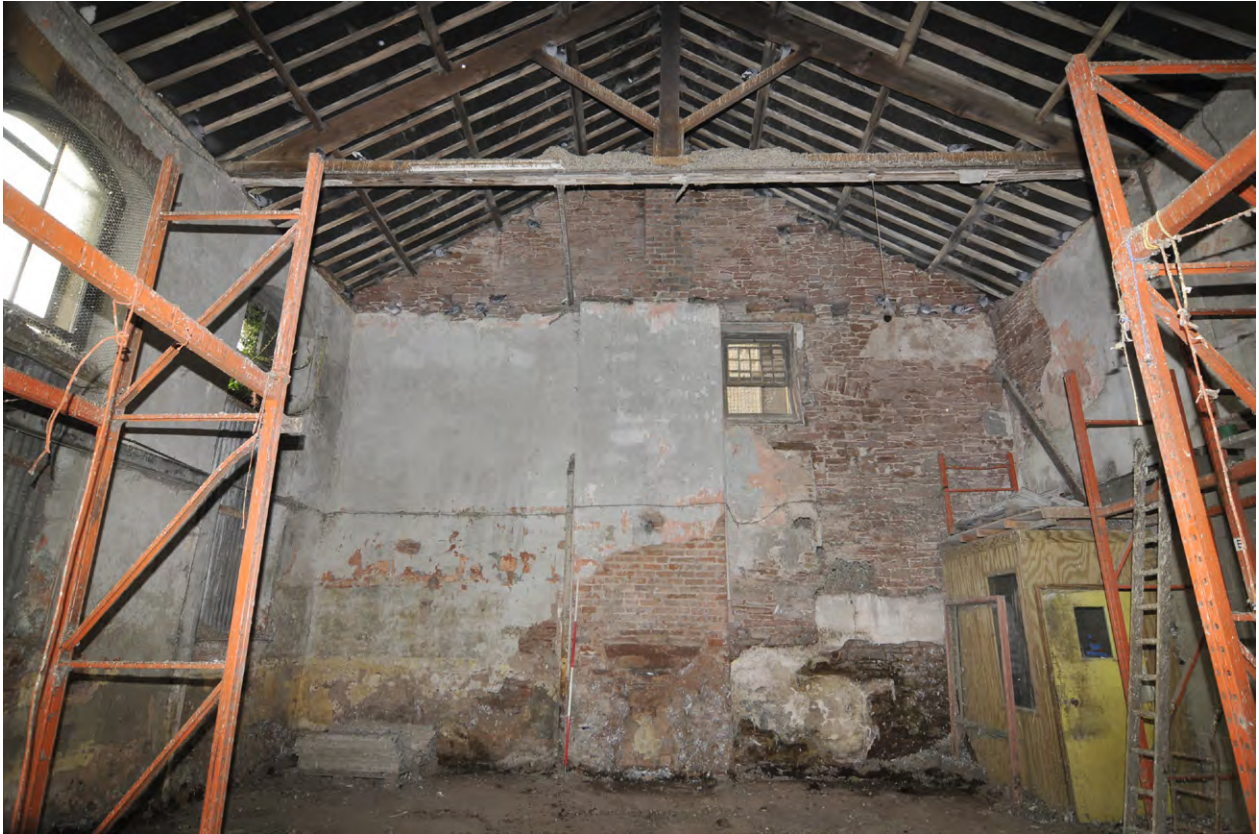
The internal north-facing elevation (south gable wall) was divided into two parts by a brick-built chimney breast laid in stretcher-bonded brickwork (Fig. 7). At the base of the chimney breast was a small blocked fireplace. The fireplace had a single sandstone lintel and had been blocked with brickwork (Fig. 8). The wall on the east side of the chimney breast and a large portion of the chimney breast itself had been lined with grey-painted plaster.

On the west-side (right-hand side facing) of the chimney breast was a small sash-and-case window (formerly 15 over 15) set within flush reveals. To the right of the window some of the sandstone had been laid end on but these did not form a relieving arch as there were no blocked openings below it (Fig. 8). Below the window was a line of sockets marking the position of a possible gallery floor.

Fig. 7 Room 1, internal north-facing elevation (gable wall)

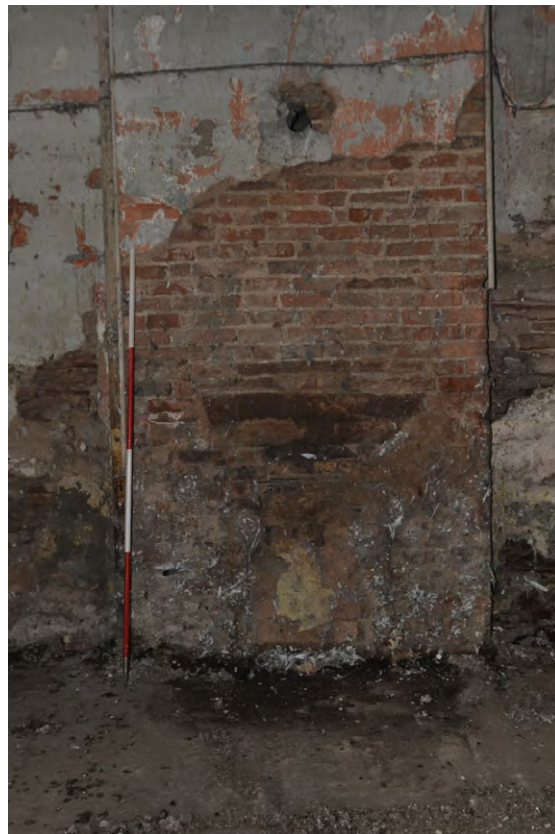
Fig. 8 Room 1, internal north-facing gable, blocked fireplace

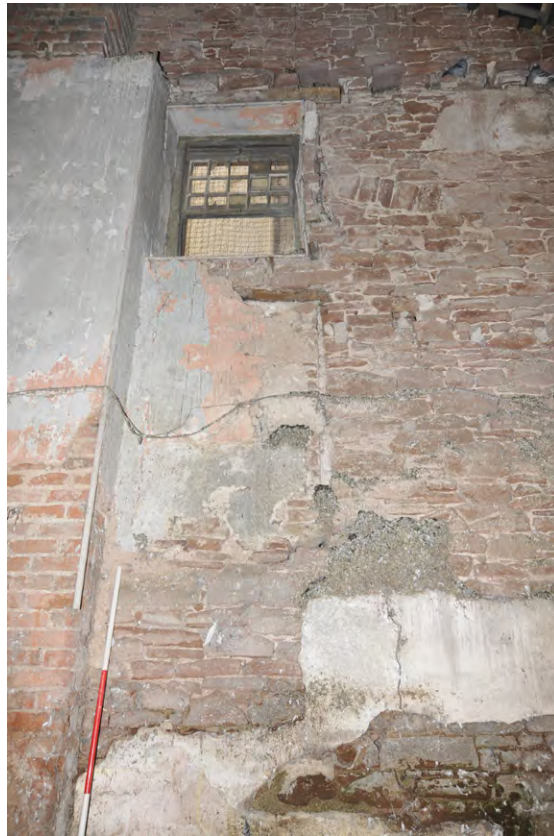
Below the window was an earlier rectangular blocked window measuring 1.6m x 1.1m. The window had a wooden lintel and the blocking was demarcated by a risband joint. The blocking work was covered with pink and grey painted plaster. The rest of the elevation was bare sandstone and contained a horizontal line of sockets marking the position of a former lath-and-plaster ceiling.

Fig. 9 Room 1, internal north-facing gable with small window and a blocked window below

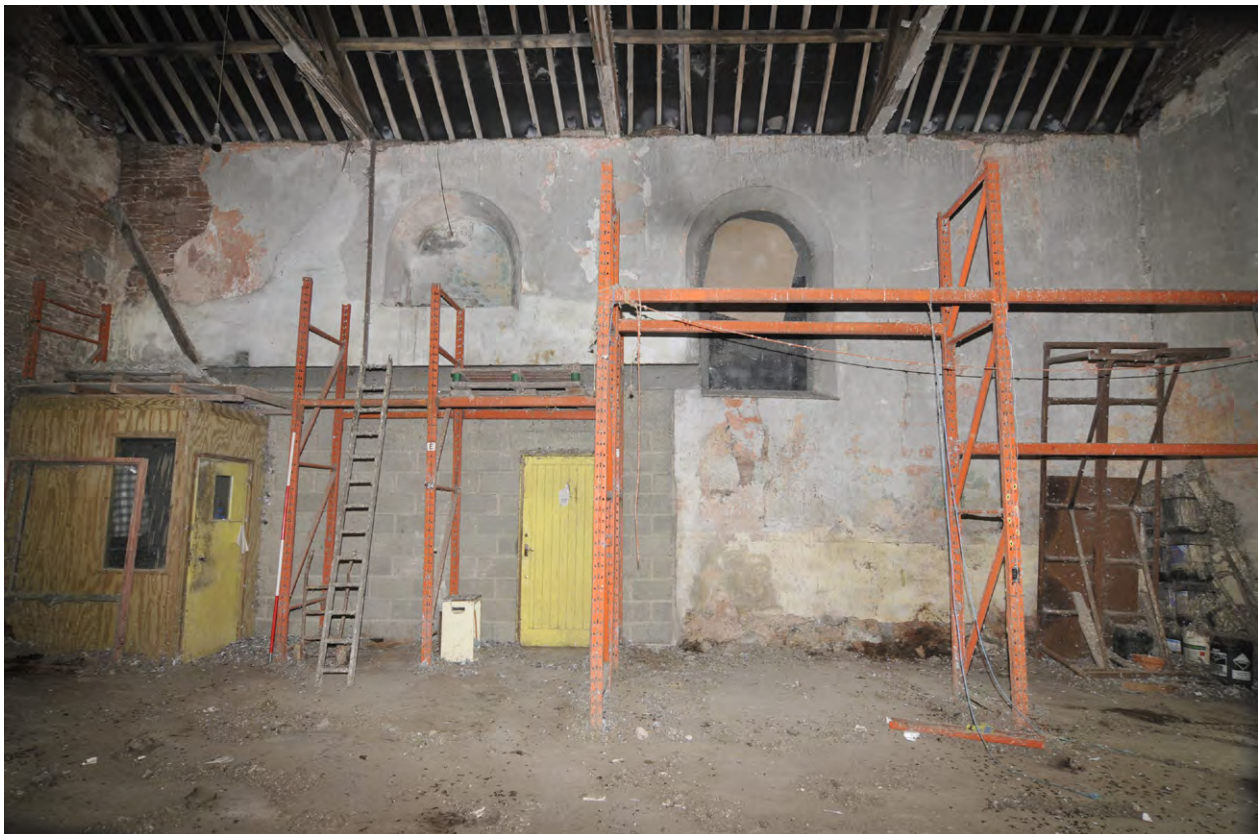
The west side wall (east-facing elevation) was for the most part covered with grey-painted plaster over coursed sandstone. The principal features included the remains of two blocked round-headed windows that occupied the centre of the elevation. The southernmost window had been reduced by about a half, whereas the one on the north side was complete and covered by a board and chicken wire. Both windows had splayed reveals. A large I-beam had been inserted on the southern half of the elevation to form a large bay opening. This was then later blocked up and a yellow plank-built door inserted. At the south-west corner of the elevation was a small timber-built cash booth measuring about 1.2m wide and 2.1m high.

Fig. 10 Room 1, internal east-facing elevation with two blocked round-headed windows

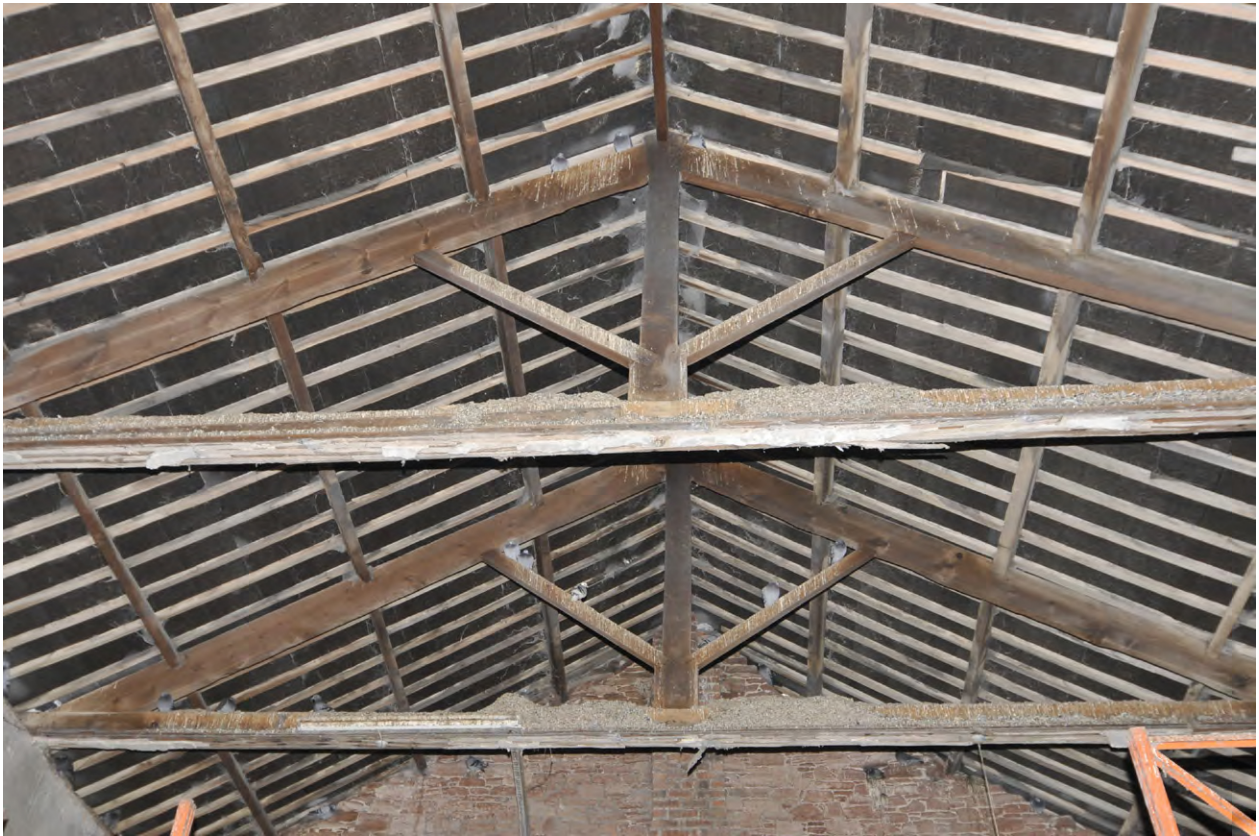
The roof was covered with grey concrete tiles supported on softwood king-post trusses with through purlins (Fig. 11). The braces had been fixed to the king posts with mortise joints. The purlins carried the roof batons and black roofing felt was

exposed. The common rafters had lath-and-plaster fixed to their underside. The floor was concrete.

The king-post trusses show evidence for the presence of a lath-and-plaster ceiling. This was probably taken down when a new roof was added sometime in the late 20th century. Two 19th century windows situated on the south gable were later replaced by a sash-and-case window at a higher level above what may have been a small gallery. The chimney breast may also be a feature that was added later when the chapel was converted to a school.

Fig. 11 Room 1, king-post roof trusses

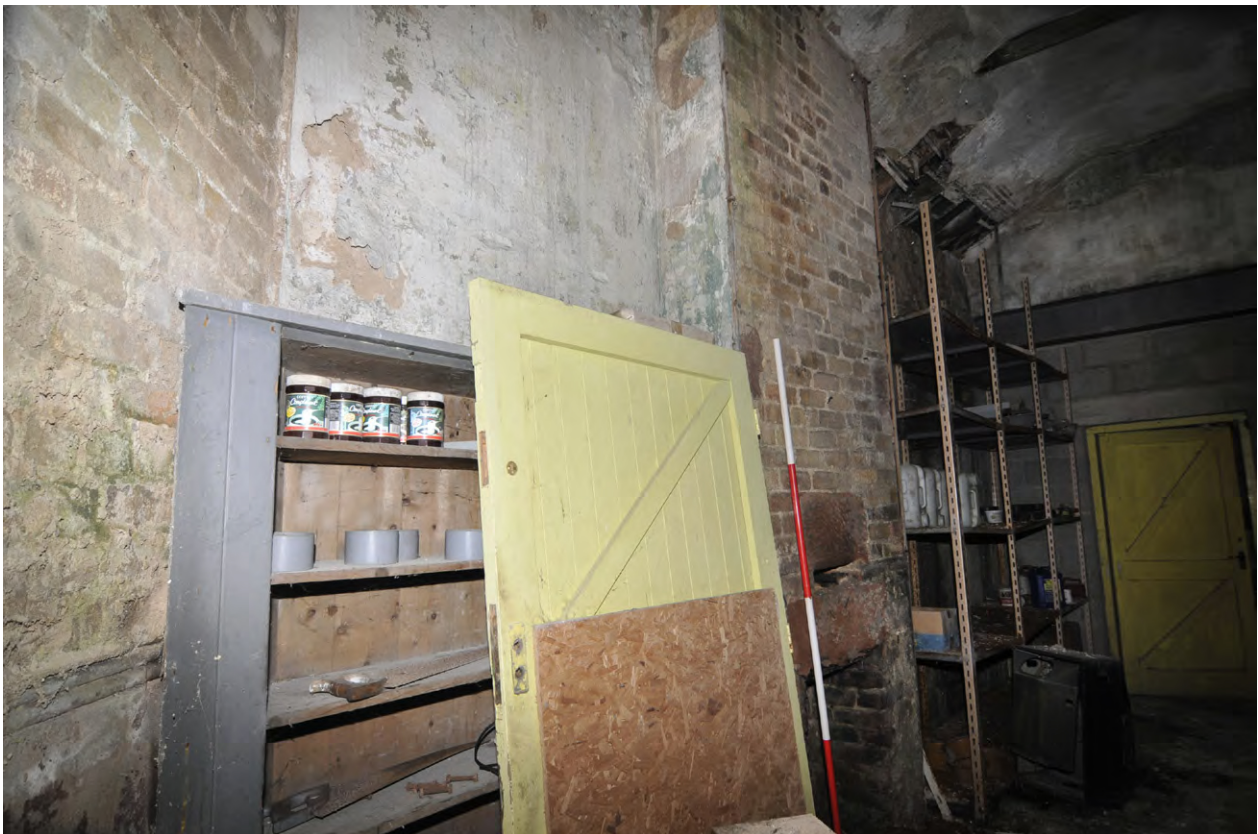
The north wall was brick-built with traces of whitewashed plaster. At the centre of the wall was a brick-built chimney breast laid in stretcher bond. The walls on either side of the chimney breast were largely hidden behind a storage cupboard and Dexian shelving. A fireplace at the base of the chimney breast measured about 0.6m x 0.6m and was surmounted by two sandstone lintels.

Fig. 12 Room 2, south-facing elevation with fireplace

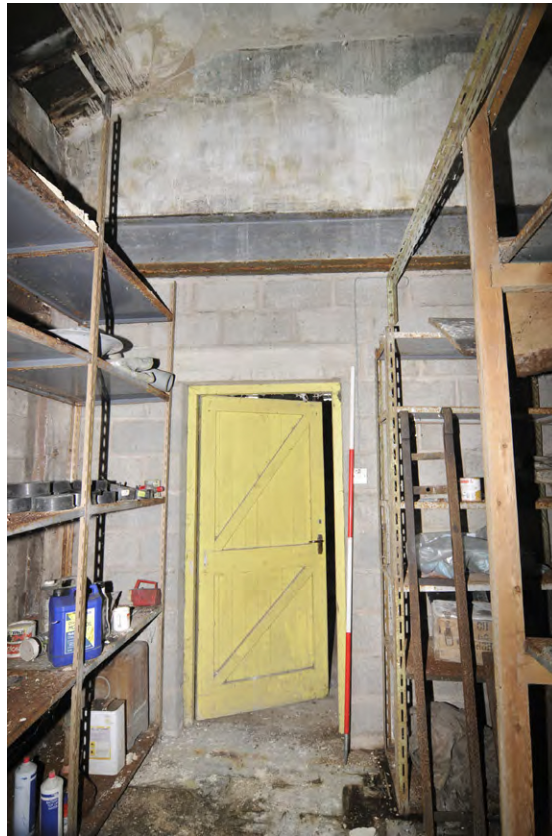
The east wall was largely hidden behind a series of wooden storage racks. The wall was built of concrete mono-blocks above which was a steel I-beam, a feature that was visible on the other side of the wall. A yellow plank-built door had been inserted on the left-hand side of the wall (facing). The wall above the beam was covered with grey-painted plaster.

Fig. 13 Room 2, west-facing elevation with inserted plank-built door

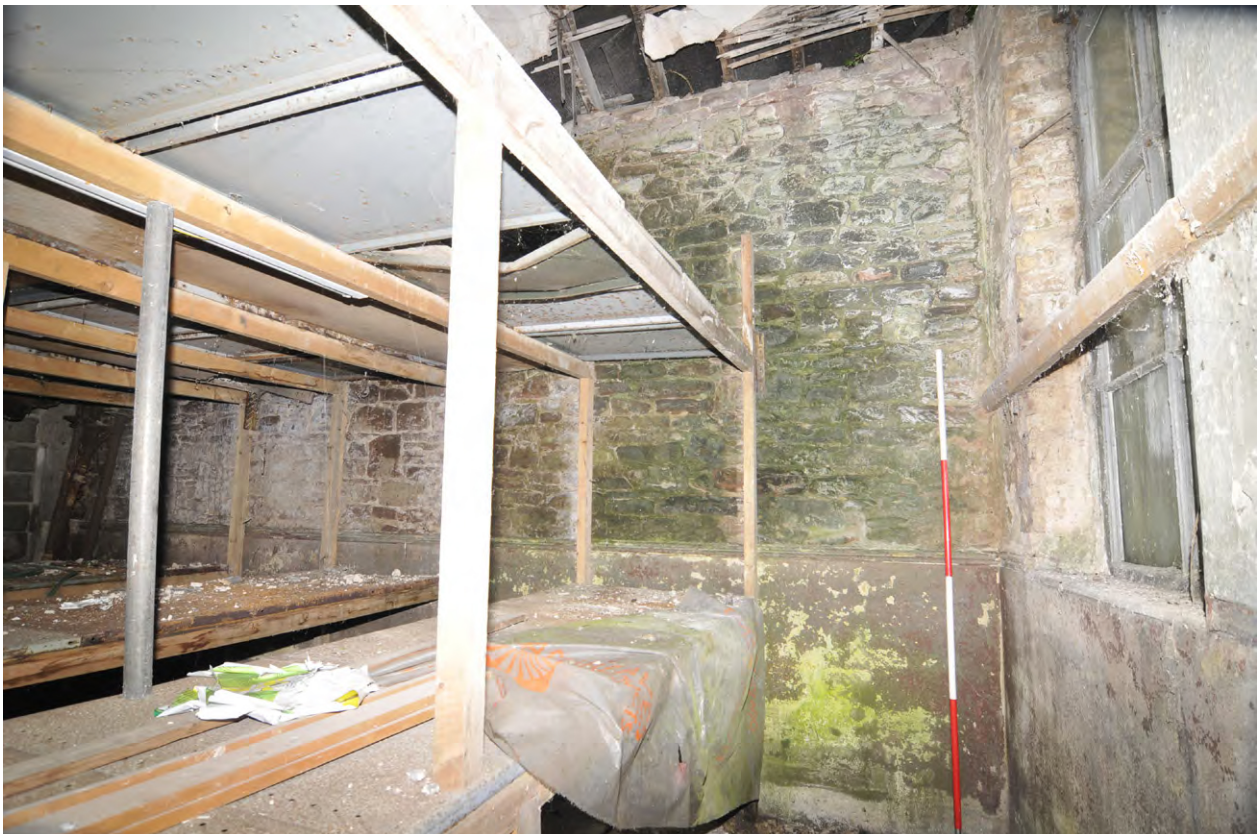
The south wall was constructed of coursed sandstone rubble and had been rendered with cement to dado height (c.1m). Remnants of yellow paint were still present on the cement. The wall was otherwise featureless.

Fig. 14 Room 2, north-facing elevation, rubble-built wall

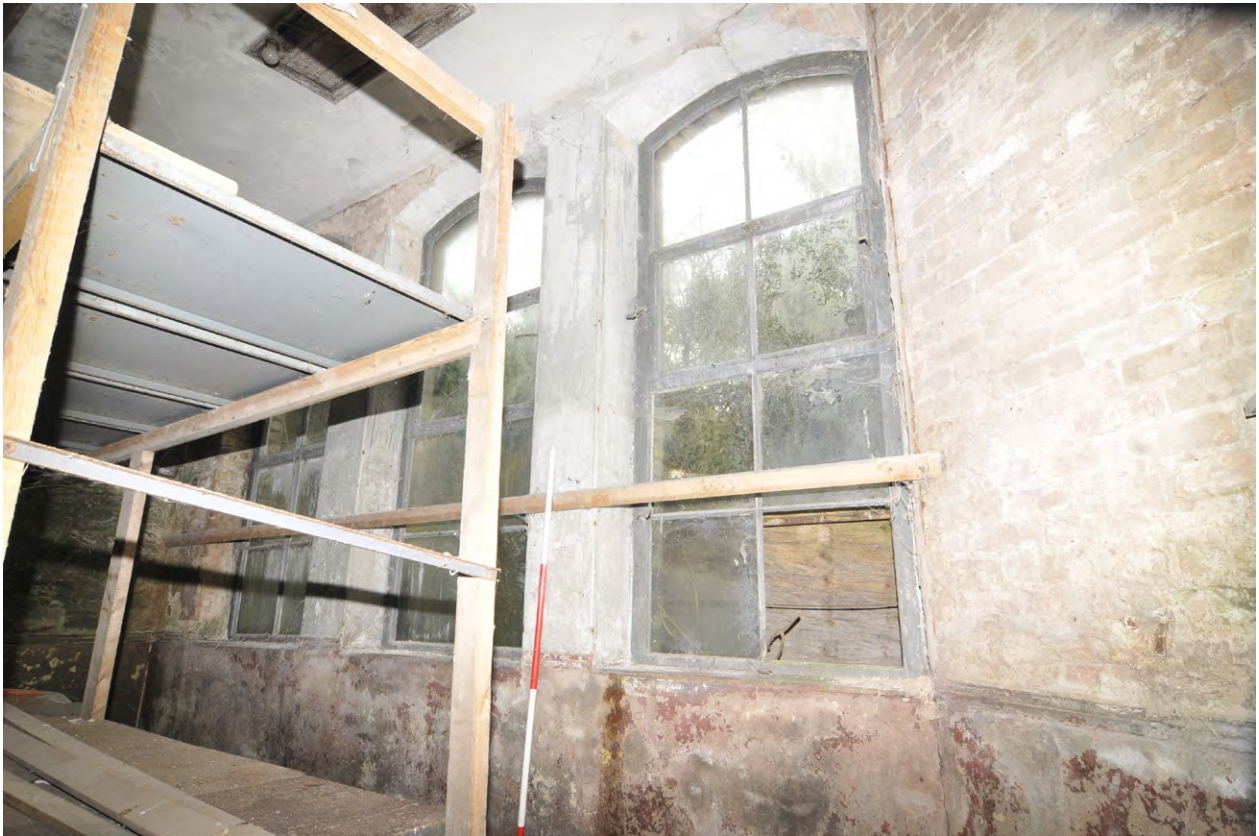
The west wall had three round-headed windows with eight panes and grey-painted frames (Fig. 15). The windows were set within a brick-built wall. Below the windows the wall had been rendered and had been painted red.

This small former classroom was well lit by three tall round-headed windows on its west wall (Fig. 15). The ceiling was combed and the room had a small fireplace, probably for a small coke-fired stove on its north wall. The main access appears to have been through a blocked doorway situated at the end of the alley between the external west-facing wall of the chapel (Room 1) and an adjoining property.

Fig. 15 Room 2, east-facing elevation with round-headed windows

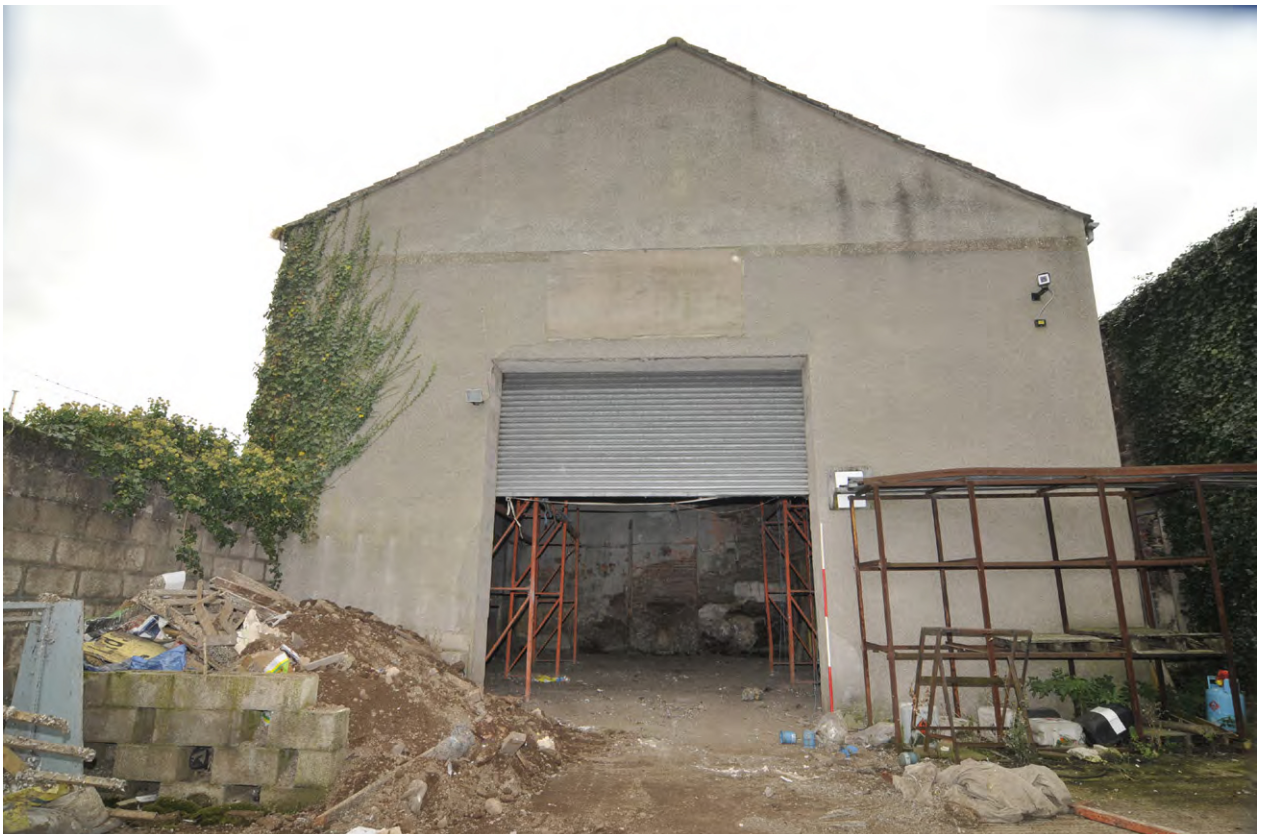
The north-facing gable wall contained the aforementioned roller shutter door and was flanked by walls covered in wet-dash render. The rectangular scar where a builders merchant sign once hung could still be seen above the doorway.

Fig. 16 Exterior north-facing gable wall

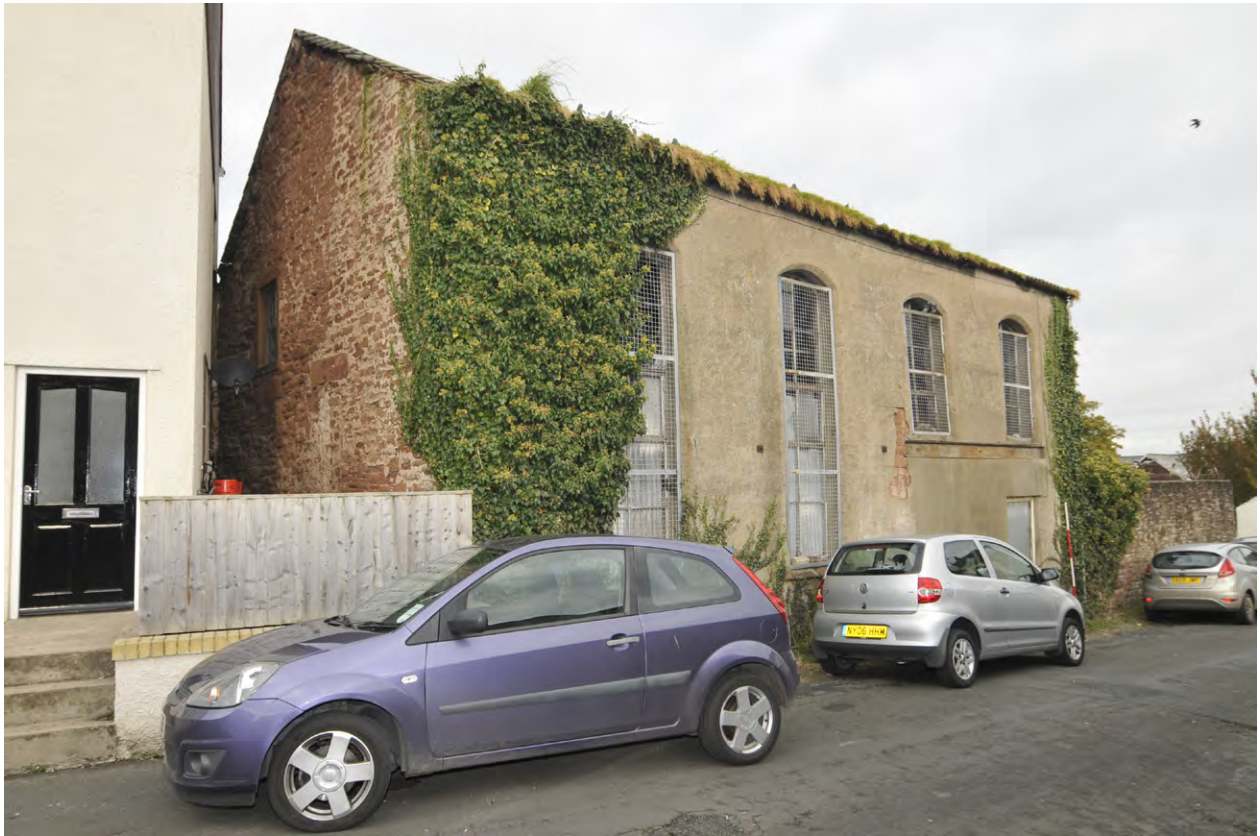
The east-facing side wall fronts onto Reeds Lane and was constructed of coursed sandstone blocks then rendered with pebble-dash render. The fenestration comprised two tall roundhead windows and two short windows. The former survived to their full height (c.4m) and still had their window-frames present behind a security grill. The latter windows had been reduced by half to accommodate a steel I-beam that was inserted to make a large vehicular opening. This was later blocked and a plank-built door inserted. The door had been covered with metal sheeting for security.

Fig. 17 Exterior east-facing side wall with fenestration

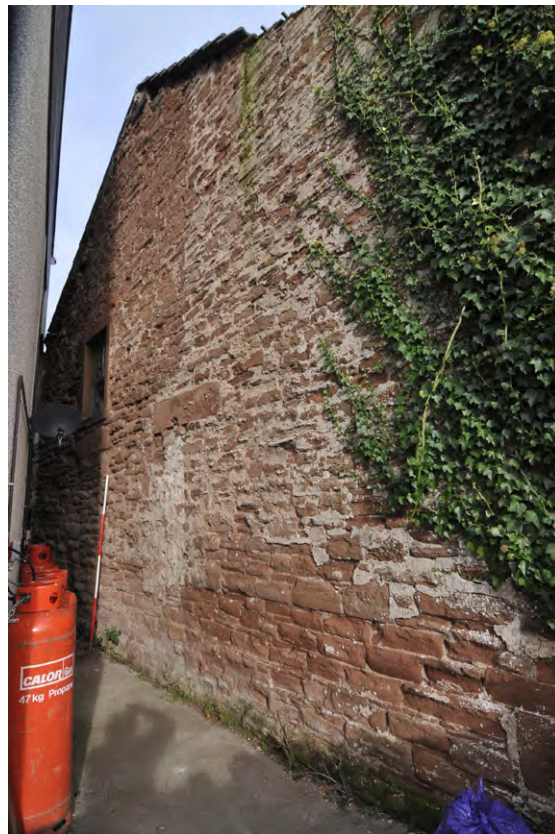
Fig. 18 Exterior south-facing gable wall

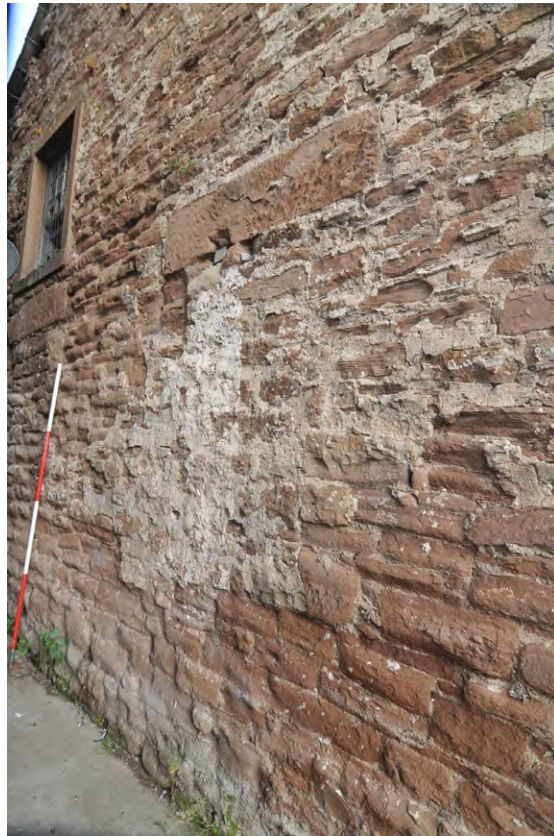
Fig. 19 Exterior south-facing gable wall, blocked windows

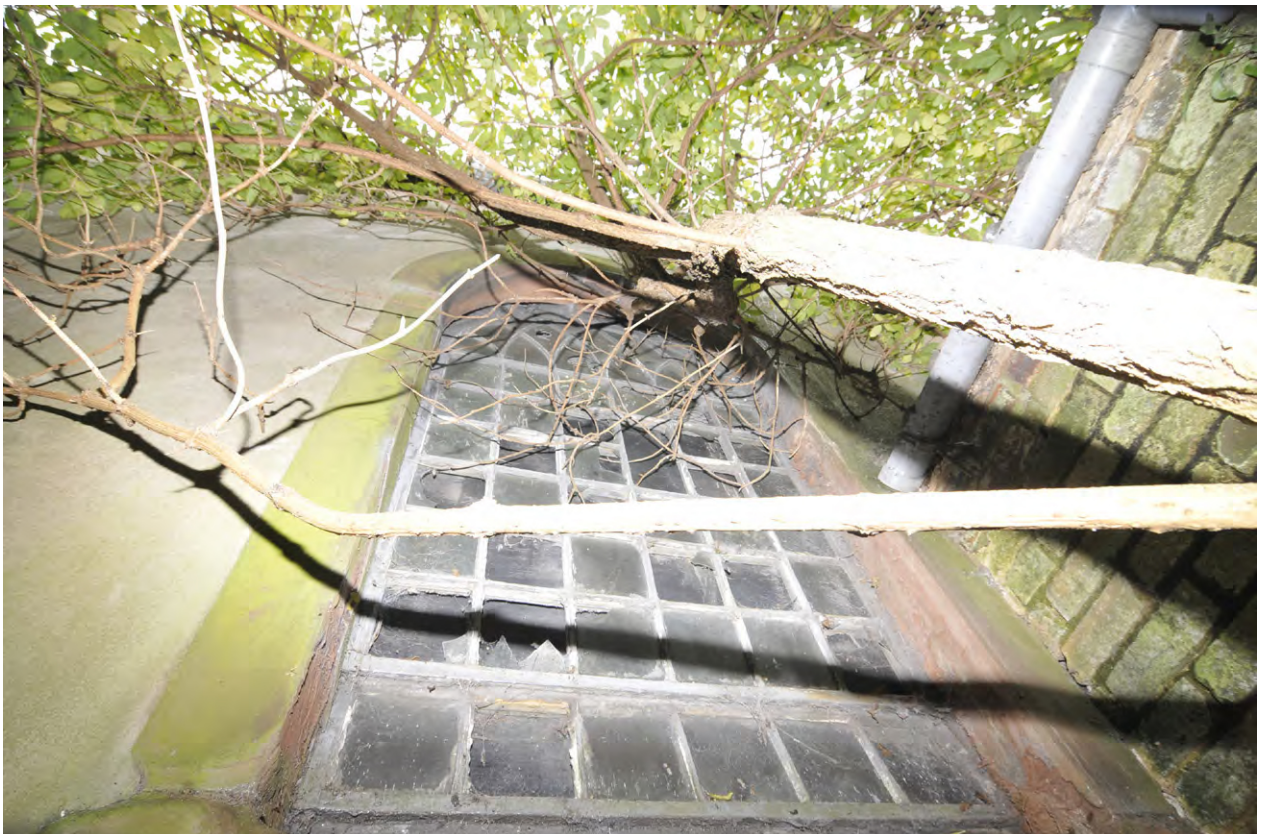
The west-facing elevation was partly visible within a small passage formed by a gap between the former chapel and a neighbouring property. The elevation was rendered with a grey cement throughout. Situated towards the end of the passage was a single round-headed window complete with its window frame that comprised lancet estragles at the top and square panes at the base (Fig. 20). This window corresponds with the complete blocked window seen on the internal east-facing elevation. The window is a typical chapel window.

and an adjoining property. Here an original 19th century window with tracery was still extant (Fig. 20).

Fig. 20 Exterior west-facing wall with an original 19th century chapel window

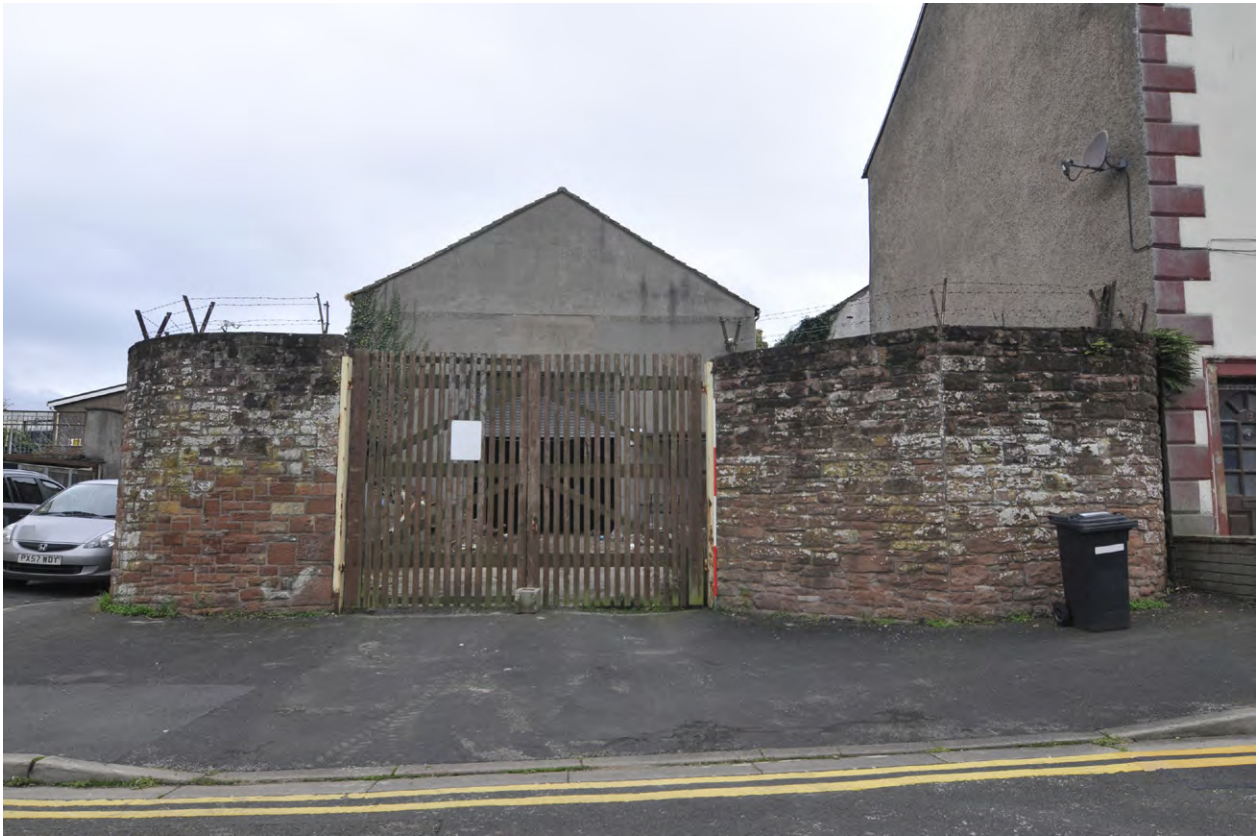
The boundary walls fronting onto Reeds Lane and Market Hill were constructed of concrete mono blocks and faced with snecked sandstone blocks. The walls were built in the late 1970s or early 1980s when the site became a builders merchants.

Fig. 21 Boundary walls and gate on the north side of the former chapel
