**Access Road Retaining Wall,
Rosslyn Castle,
Midlothian.
Archaeological Watching Brief.**

Report No. 3502

Author	Ian Suddaby MA, MCIfA
Illustrator	Marta Perlińska BA, MA
Editor	Bruce Glendinning BSc PG Dip MCIfA
Commissioned by	Limerich Ltd
Date issued	December 2016
Version	1
Oasis No.	cfaarcha1-268405
Planning Application No	N/A
Grid Ref	NT 27495 62834

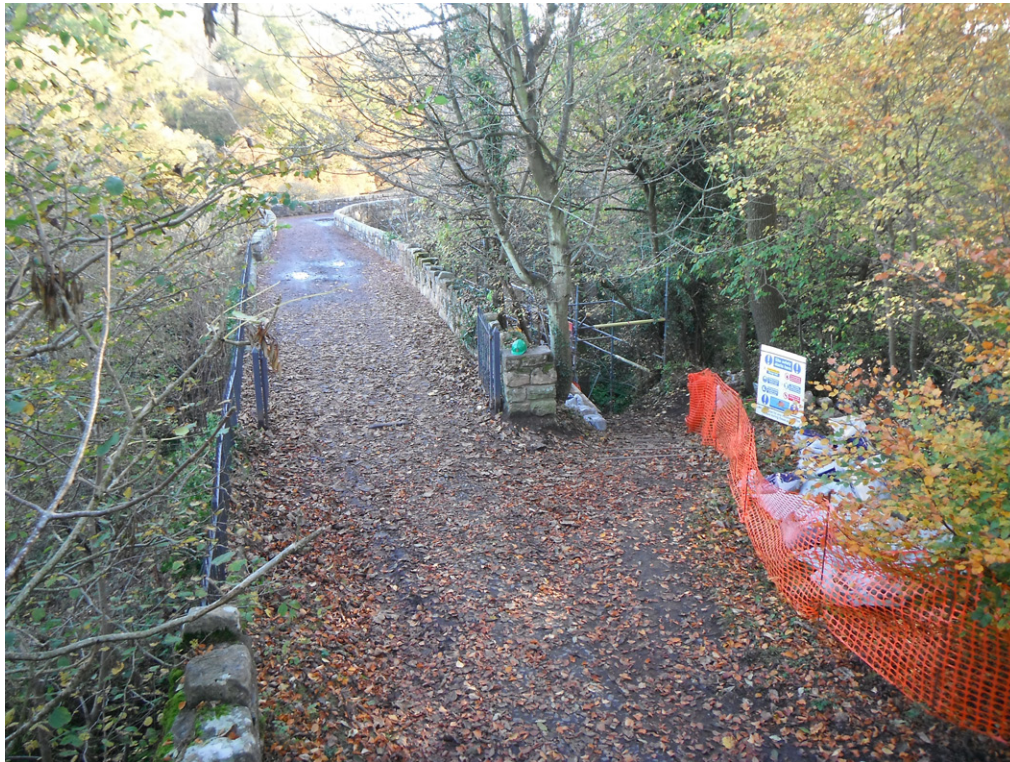
Fig. 2 - View from the north of the retaining wall location and the access over to the castle

The track leading from Rosslyn Chapel to Rosslyn Castle ran south through the wooded Rosslyn Glen and an embankment lead onto the bridge across to the castle (Figs. 1-2). The track to the castle had a concrete foundation at this point and was flanked by cement-bonded stone parapet walls. Below the level of the concrete track foundation, both sides of the embankment had retaining walls. In 2006 it was noticed that tree roots and erosion associated with a public path on the western side had caused damage to the structure of the wall. A large block of masonry had been undermined and had become detached from the remainder of the wall (Fig. 3). This was in danger of collapsing onto the path below. Scaffolding was erected to prevent further damage.

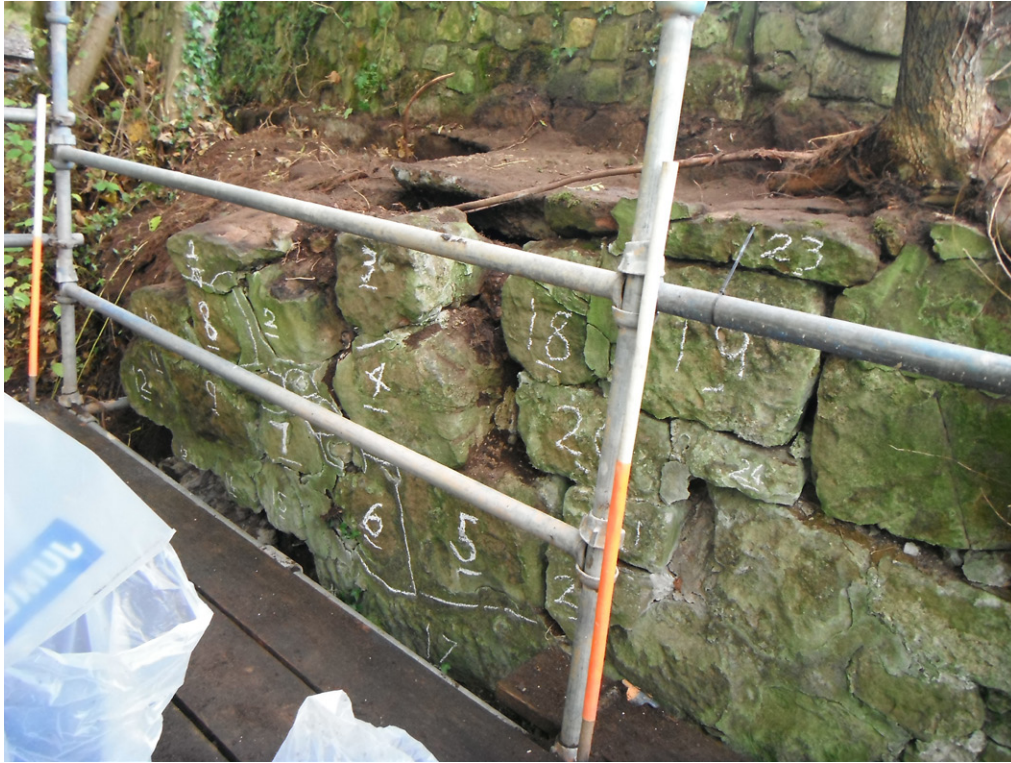
Fig. 4 - Numbering of the stones in the detached portion (006) of the retaining wall

Soil and vegetation were removed from the upper surface of the retaining wall (**005**, **006**) and the concrete foundation (**003**) for the track and parapet wall (**002**). The stone work contractors sketched, numbered and photographed the stones in the retaining wall so they could be reinstated in their original position in the wall (Fig. 4).

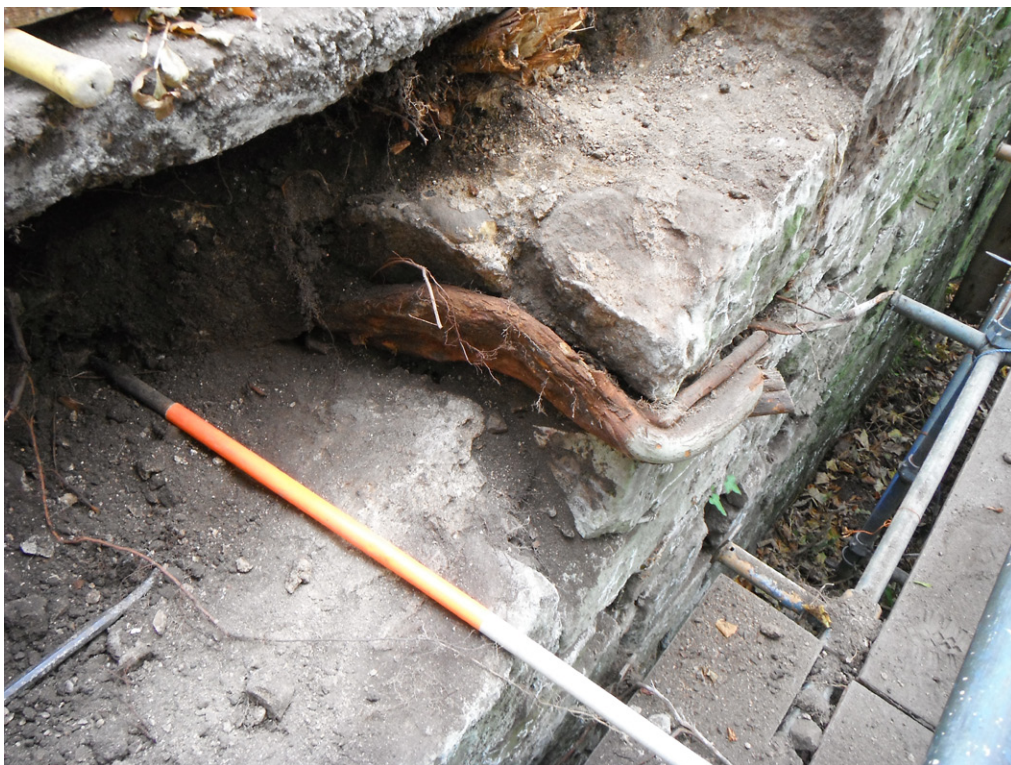
It was noted that tree roots had penetrated the wall in several places to the south of the detached portion of wall and that the original lime mortar was degrading. The wall had previously been repointed with ordinary Portland Cement which was also cracking.

Fig. 5 - Tree roots (007) growing through the wall

The recent cement pointing (**004**) was removed. The detached portion of the wall (**006**) was dismantled and the stones stored. The rest of the retaining wall (**005**) was assessed and the portion that was affected by roots (Fig. 5) was also dismantled and the stones stored. In total, a length of 4.2m was dismantled. Two sections through the

A new foundation trench was created slightly to the east of the previous foundation. Two trees were cut down and the stumps dug out by hand so that their roots did not affect the new trench. The ledge on which the new wall was be founded was 0.8m wide and around 2m long. Beyond this to the south, the new wall was constructed on the foundations of the old one.

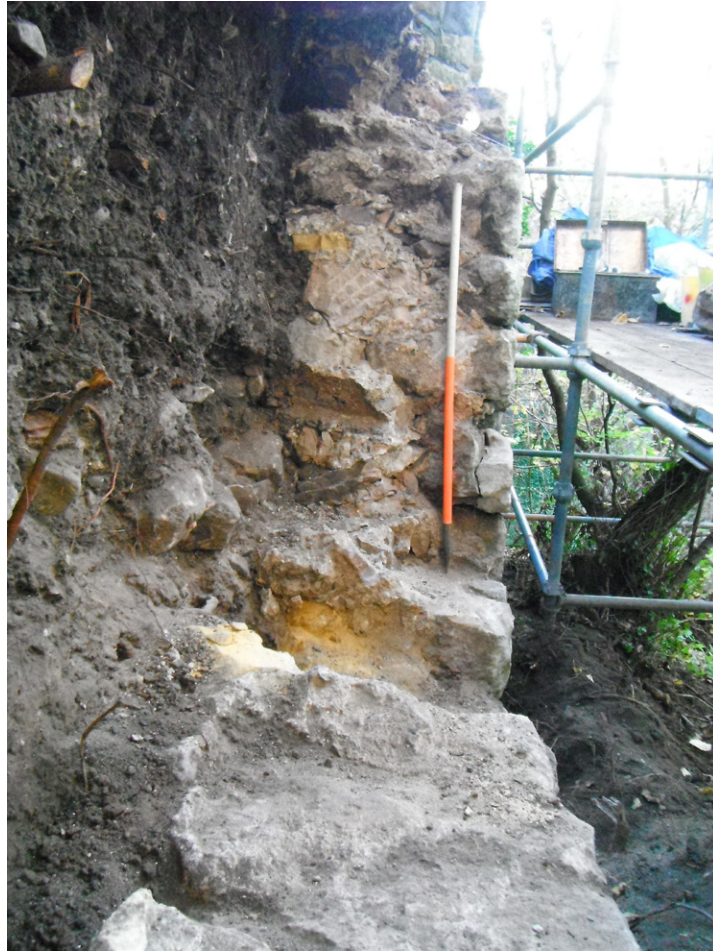
wall were recorded, the one further to the south is shown in Fig. 6. This revealed that the wall was 0.7m wide. Most of the large stones were dressed to some extent. Several of the stones were reused carved architectural pieces. Examples of arched lintels, springers and ashlar blocks were identified.

Fig. 6 - North facing section through the retaining wall (005)

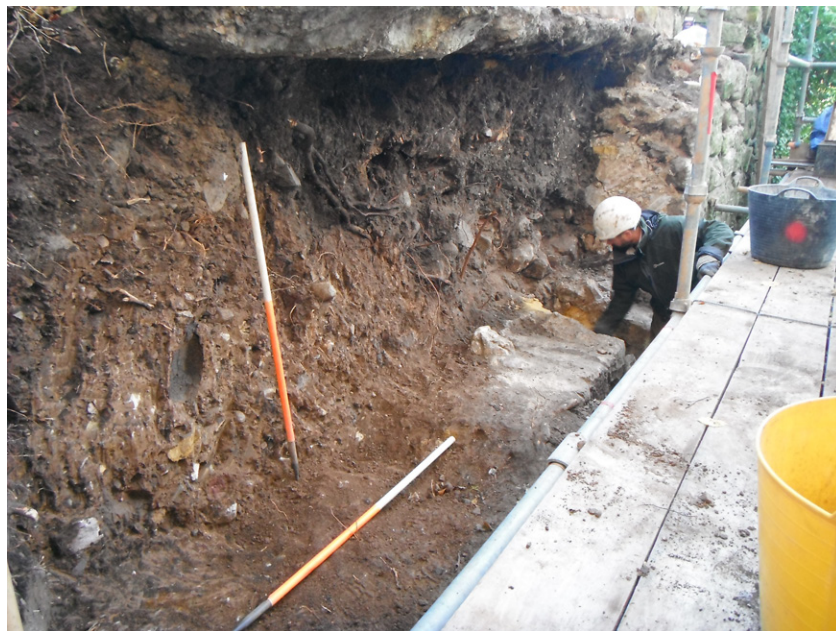
Deposits behind the wall (Figs. 7-8) consisted of an upper layer of dry grey-brown soil, stones and stone chips (**009**). This had a depth of up to 0.85m. Layer **009** overlay a deposit of dry pinkish-grey gritty silt (**011**) with numerous cobbles, fragments of lime mortar, coal and occasional bones. This overlay a very compact deposit of brownish-orange clayey silt, dipping to the south, with a few, mostly small stones (**008/010**). All of these deposits were heavily permeated with roots. The foundation trench (**012**) for wall **005/006** cut through layer **008/010**. The other deposits behind the wall appeared to be infilled behind the wall after it had been built.

Fig. 7 - Oblique view of the deposits (008-011) behind the retaining wall
