St Andrews Cathedral and Priory and adjacent Ecclesiastical remains Index No.13322

Archaeological Watching Brief on Geotechnical Site Investigation works

Report No. 3473

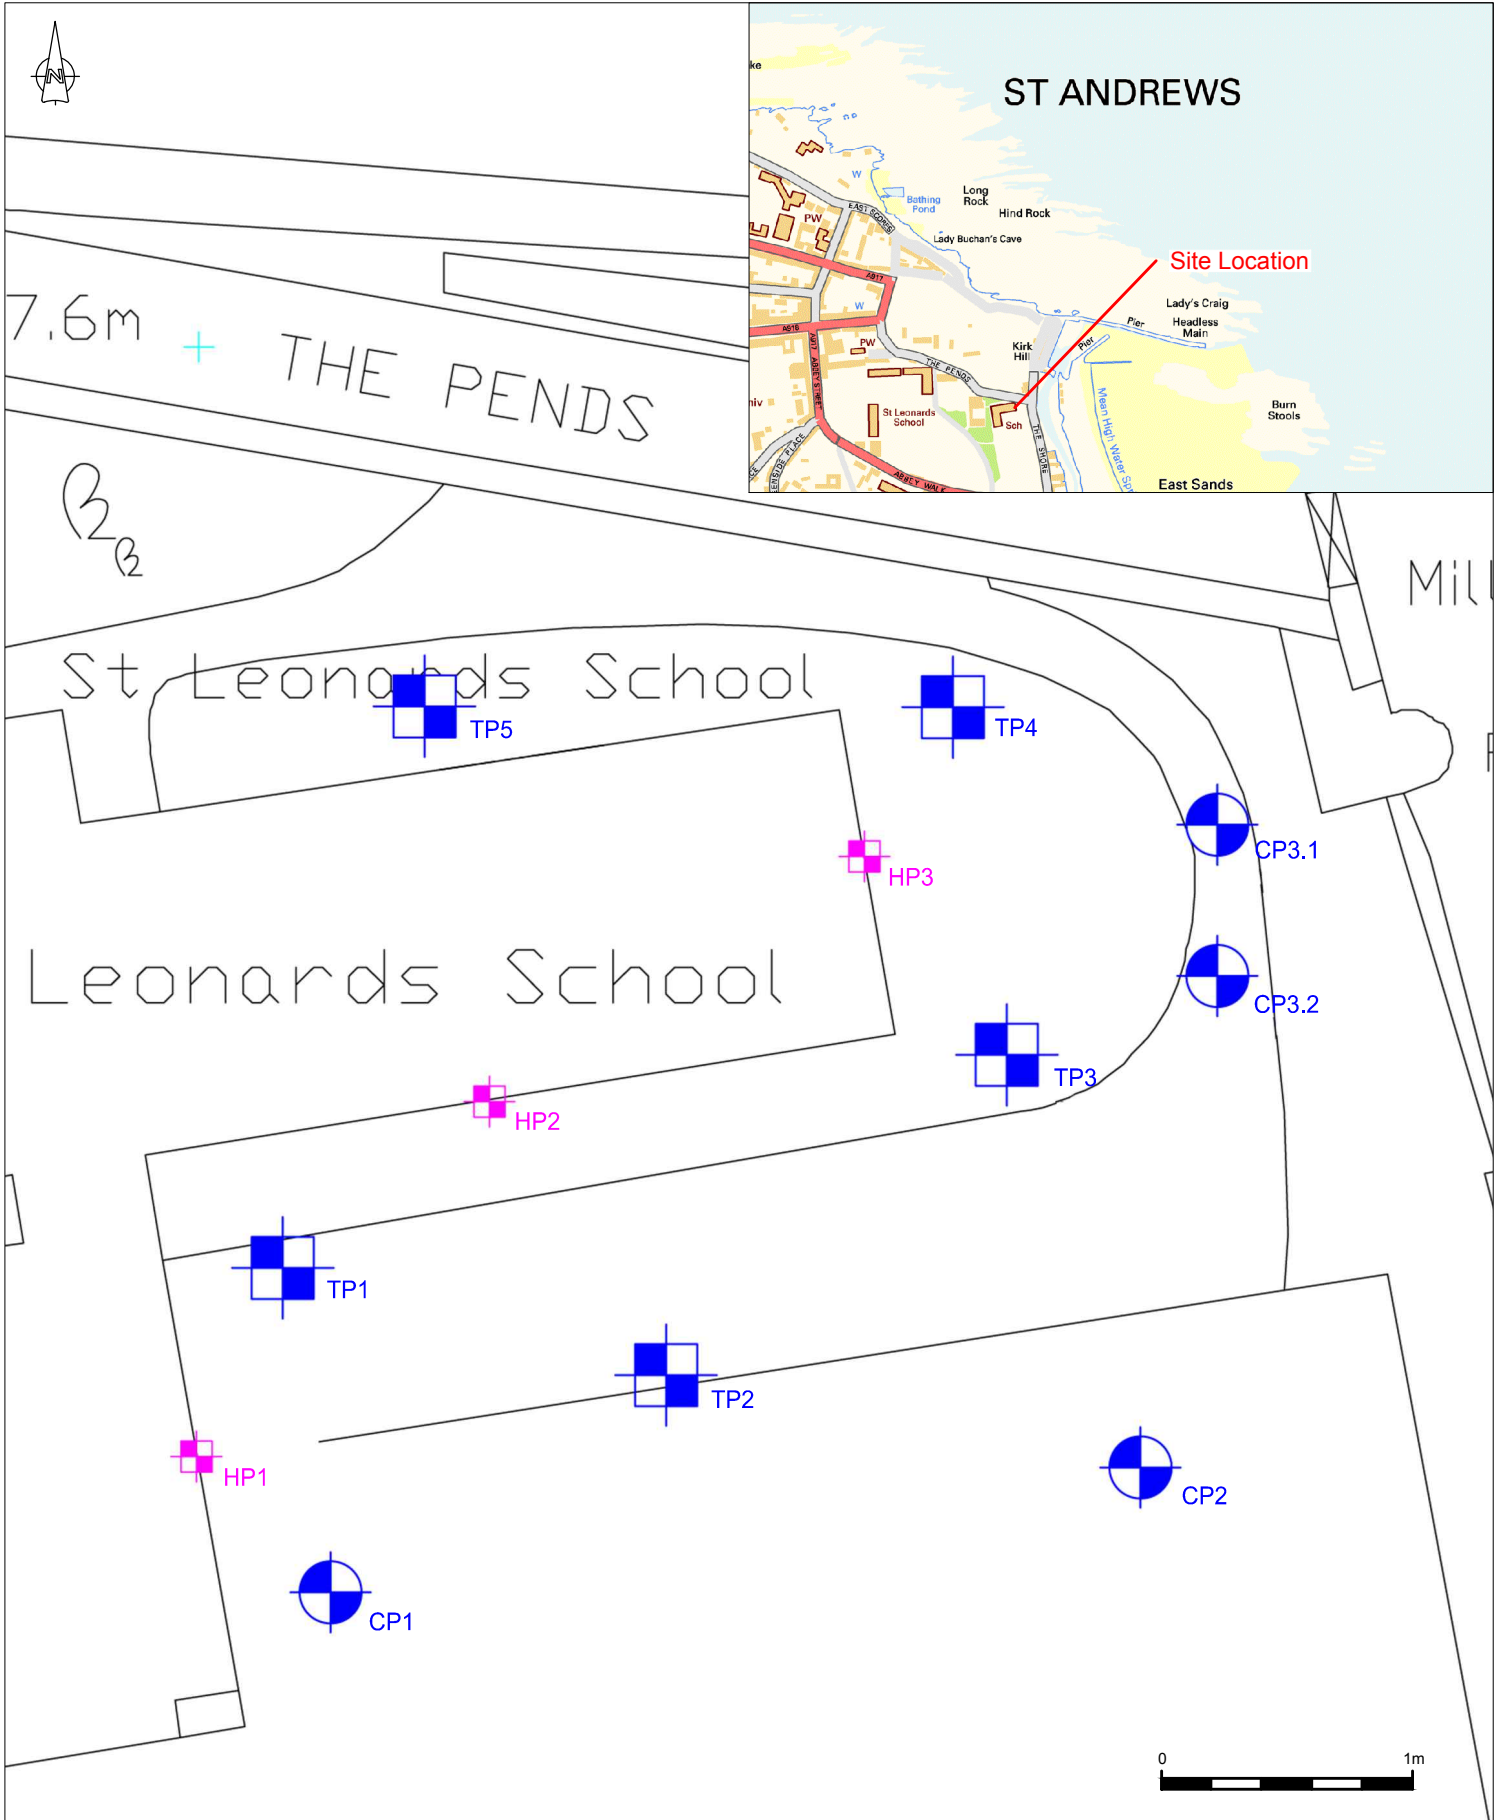
Title:
Site location and plan

Numbers in bold refer to contexts, a full list of which are contained in Appendix 1. The locations of the monitored pits are shown on Fig. 1.

The site is situated to the south and east of St Leonard's School and comprised a levelled car-parking area surfaced with tarmac and hardcore, and a raised grass-covered bank upon which the east wing of the school stands. A compacted gravel access road which runs around the east wing of the school and the grass bank to the car-parking area were also subject to investigation.

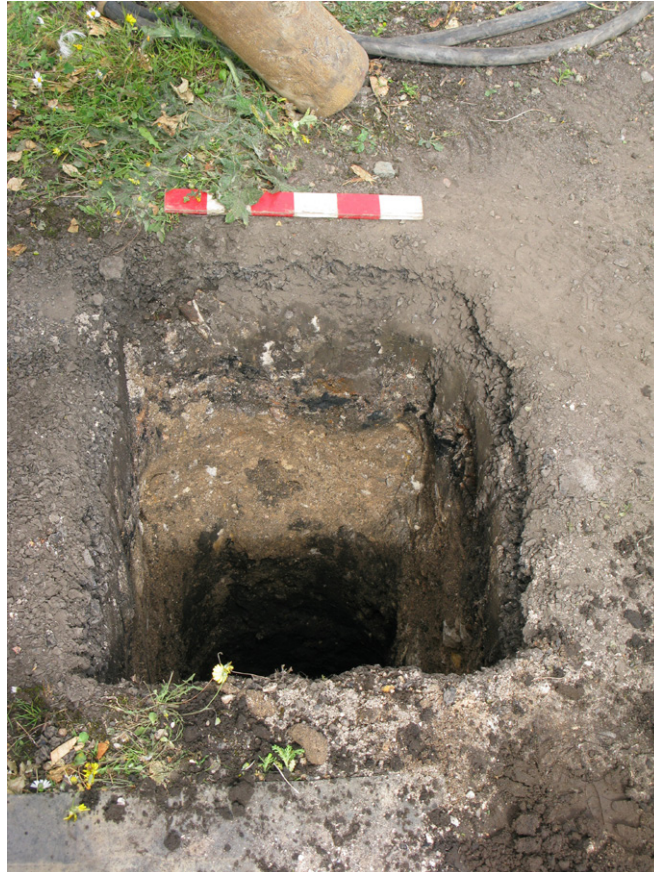
Fig. 2 - Section of CP1

Bore-hole 1 (CP1; Fig. 3) was located on the south-west of the site within the car-parking area. It was excavated to 1.2m deep. The surface comprised a 0.1m thick layer of tarmac (**CP1/01**) overlying a capping layer of redeposited pink clay (**CP1/02**) which was 0.15m thick. The clay sealed a 0.4m thick deposit of crushed sandstone rubble (**CP1/03**) which in turn overlay dark garden soil (**CP1/04**) to a depth of 0.55m, although it extended deeper than the limit of excavation. No archaeological features were identified or impacted upon.

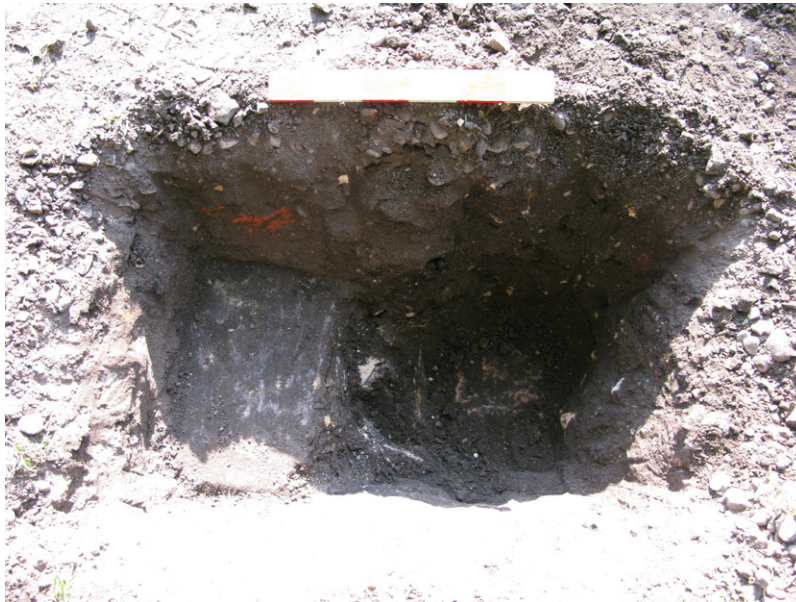
Fig. 3 - Wall CP3.1/003

The original borehole location (CP3.1; Fig. 7) was located to the north-east of the site on the access road. The surface was hard compressed topsoil, gravel and hardcore (**CP3.1/01**) which was 0.05m deep. The surface overlay a compact topsoil and rubble deposit (**CP3.1/02**) which was excavated to a depth of 0.25m. A substantially built sandstone structure (**CP3.1/03**) was identified within the pit. A hewn sandstone block and a single volcanic stone with flat upper surfaces were set parallel and c.0.25m apart with randomly laid sandstone rubble blocks between. This arrangement is strongly indicative of a wall running roughly east to west, although this interpretation should be treated with caution due to the limits of the small area excavated. The wall was cleaned by hand, recorded and backfilled by the archaeologist.

The remains of what are likely to be substantial walls were identified in two of the pits. In accordance with the conditions of the SMC these were recorded and backfilled to be preserved in situ. Without further investigation it not possible to assign a date or function to these structures; however, it is possible that they are associated with the surviving medieval elements of the site. No other archaeological remains were identified during the work.

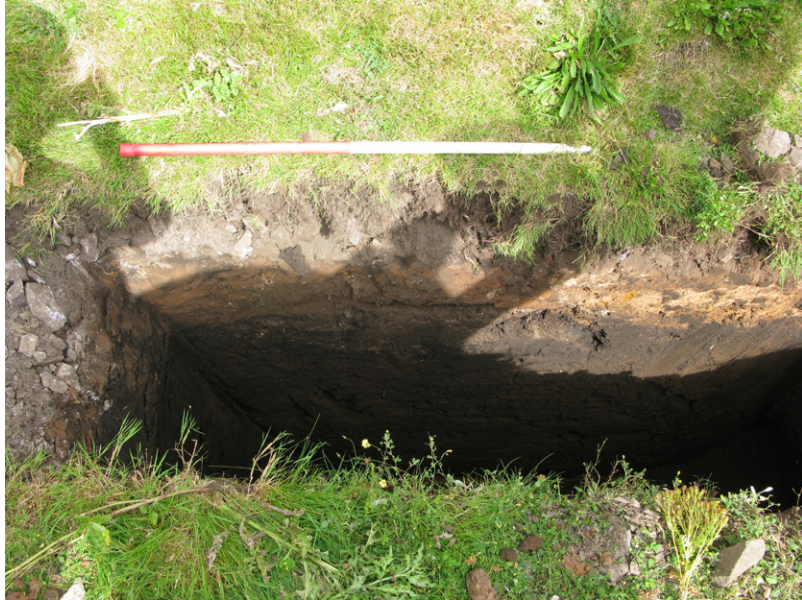
Fig. 4 - Section of TP1

Trial Pit 1 (TP1; Fig. 2) was located at the west of the site within the car-parking area and at the base of the elevated grass bank. It was dug to natural undisturbed subsoil at a depth of 2.2m. The surface comprised hardcore (TP1/01) to a depth of 0.3m which overlay a 0.2m thick layer of redeposited clay (TP1/02). This in turn overlay a 0.9m thick layer of buried topsoil (TP1/03). This soil contained occasional shell fragments. A 0.8m thick deposit of buried mid-brown soil (TP1/04) underlay the topsoil and overlay natural subsoil (000) which comprised coarse sand with occasional stones and boulder clay. No archaeological deposits or features were identified.

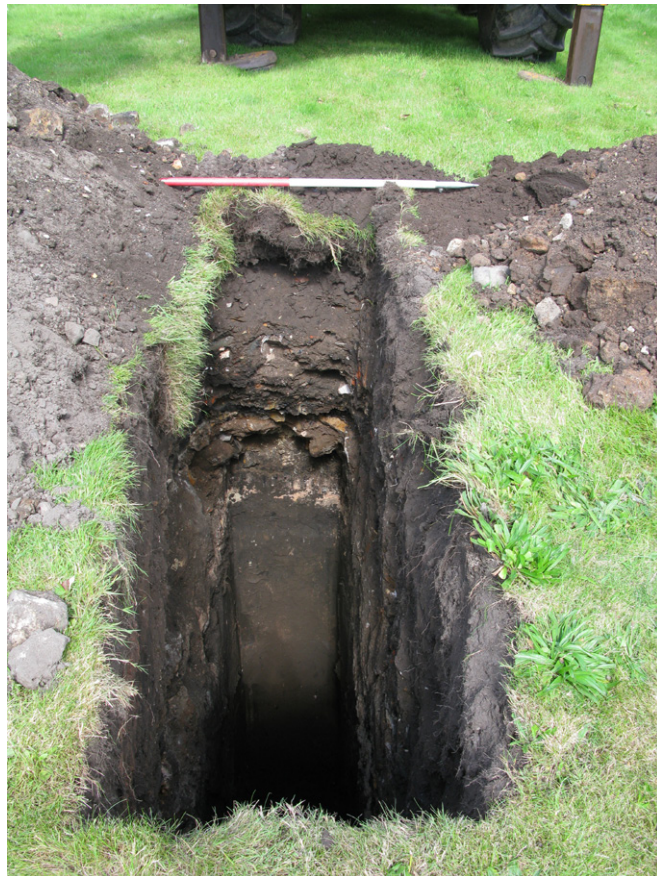
Fig. 5 - Section of TP 3

Trial Pit 3 (TP3; Fig. 6) was located to the south edge of the grass bank. It was dug to natural undisturbed subsoil at a depth of 3.3m. The surface was grass and topsoil (TP3/01) to a depth of 0.25m and overlay 0.7m of made ground (TP3/02) comprising redeposited topsoil and rubble. A 0.7m layer of crushed sandstone rubble (TP3/03) underlay the made ground and overlay buried topsoil (TP3/04) which was 1m deep and contained occasional shell fragments. Underlying the buried topsoil was a 0.7m layer of buried mid-brown midden-rich soil (TP3/05) overlying natural subsoil (000) which was coarse sand and boulder clay. No archaeological deposits or features were identified.

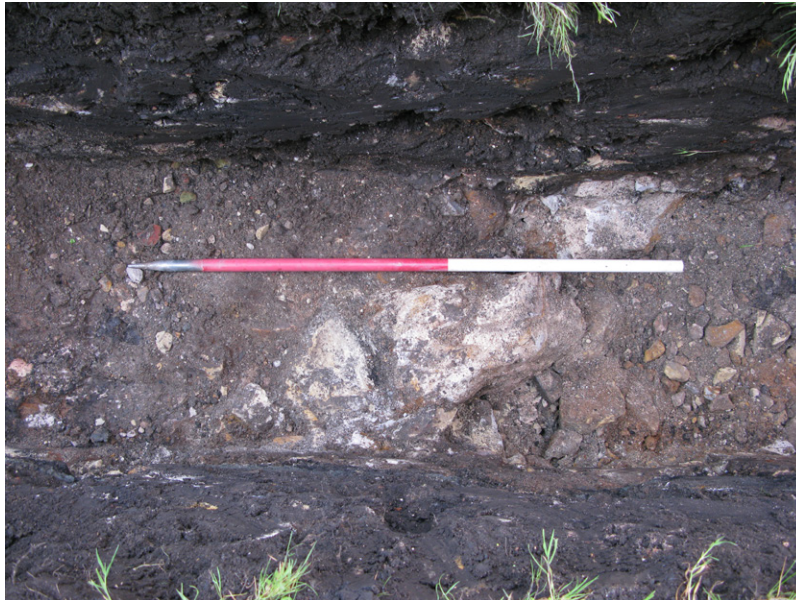
Fig. 6 - Wall TP5/005

Trial Pit 5 (TP5; Fig. 4) was located on the north side of the St Leonard's School building, close to the edge of the grass bank. Excavation of the pit revealed the surviving remains of a sandstone wall so the pit was extended to the east and excavated to its full depth of 2.1m. The surface was grass and topsoil (TP5/01) to a depth of 0.4m which overlay 0.55m of made ground (TP5/02) comprising redeposited topsoil and rubble. This overlay a 0.4m thick layer of crushed sandstone rubble (TP5/03) which in turn overlay a 0.75m deep layer of buried topsoil (TP5/04) which contained occasional shell fragments. Natural subsoil (000) was not reached. The

sandstone wall (**TP5/05**) was aligned roughly SW-NE and was sealed by the made ground deposit (**TP5/02**). The wall was exposed for c.0.5m and measured 0.4m wide. It had two faces with a rubble core and was built of rough hewn sandstone and mortar bonded. It was cleaned by hand, recorded and backfilled. No other archaeological deposits or features were identified.

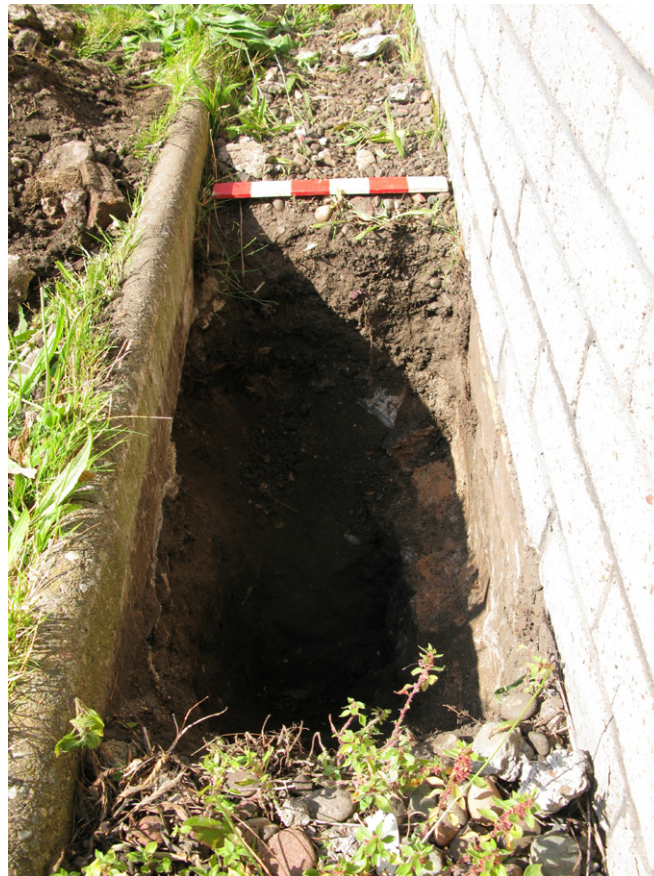
Fig. 7 - Section of HP 2

Hand-pit 2 (HP2; Fig. 5) was set against the south-facing wall of the east wing of St Leonard's School and on the surface of the grass bank. It measured 0.7m by 0.3m and was excavated to a depth of 0.5m. The pit exposed the concrete and sandstone foundation (**HP2/01**) of the building. The surface deposit comprised topsoil (**HP2/02**) to 0.25m deep, which overlay topsoil and rubble infill (**HP2/03**). Natural subsoil was not reached and no archaeological remains or deposits were identified.
