Archaeological Watching Brief on repairs on the foundation of Pylon G037B

**Whitemoss Roman Fort, 175m SW of
Rosarymount (Index No 1652)**

Report No. 3507

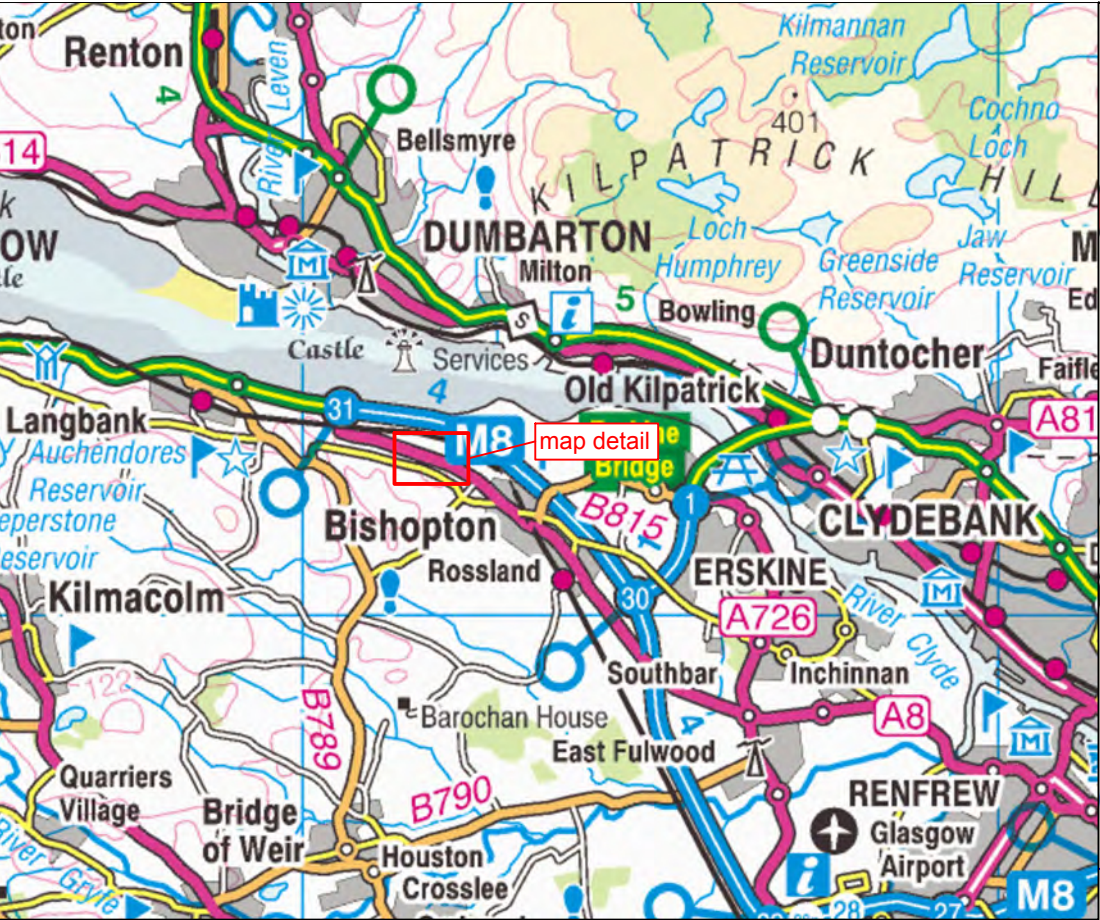
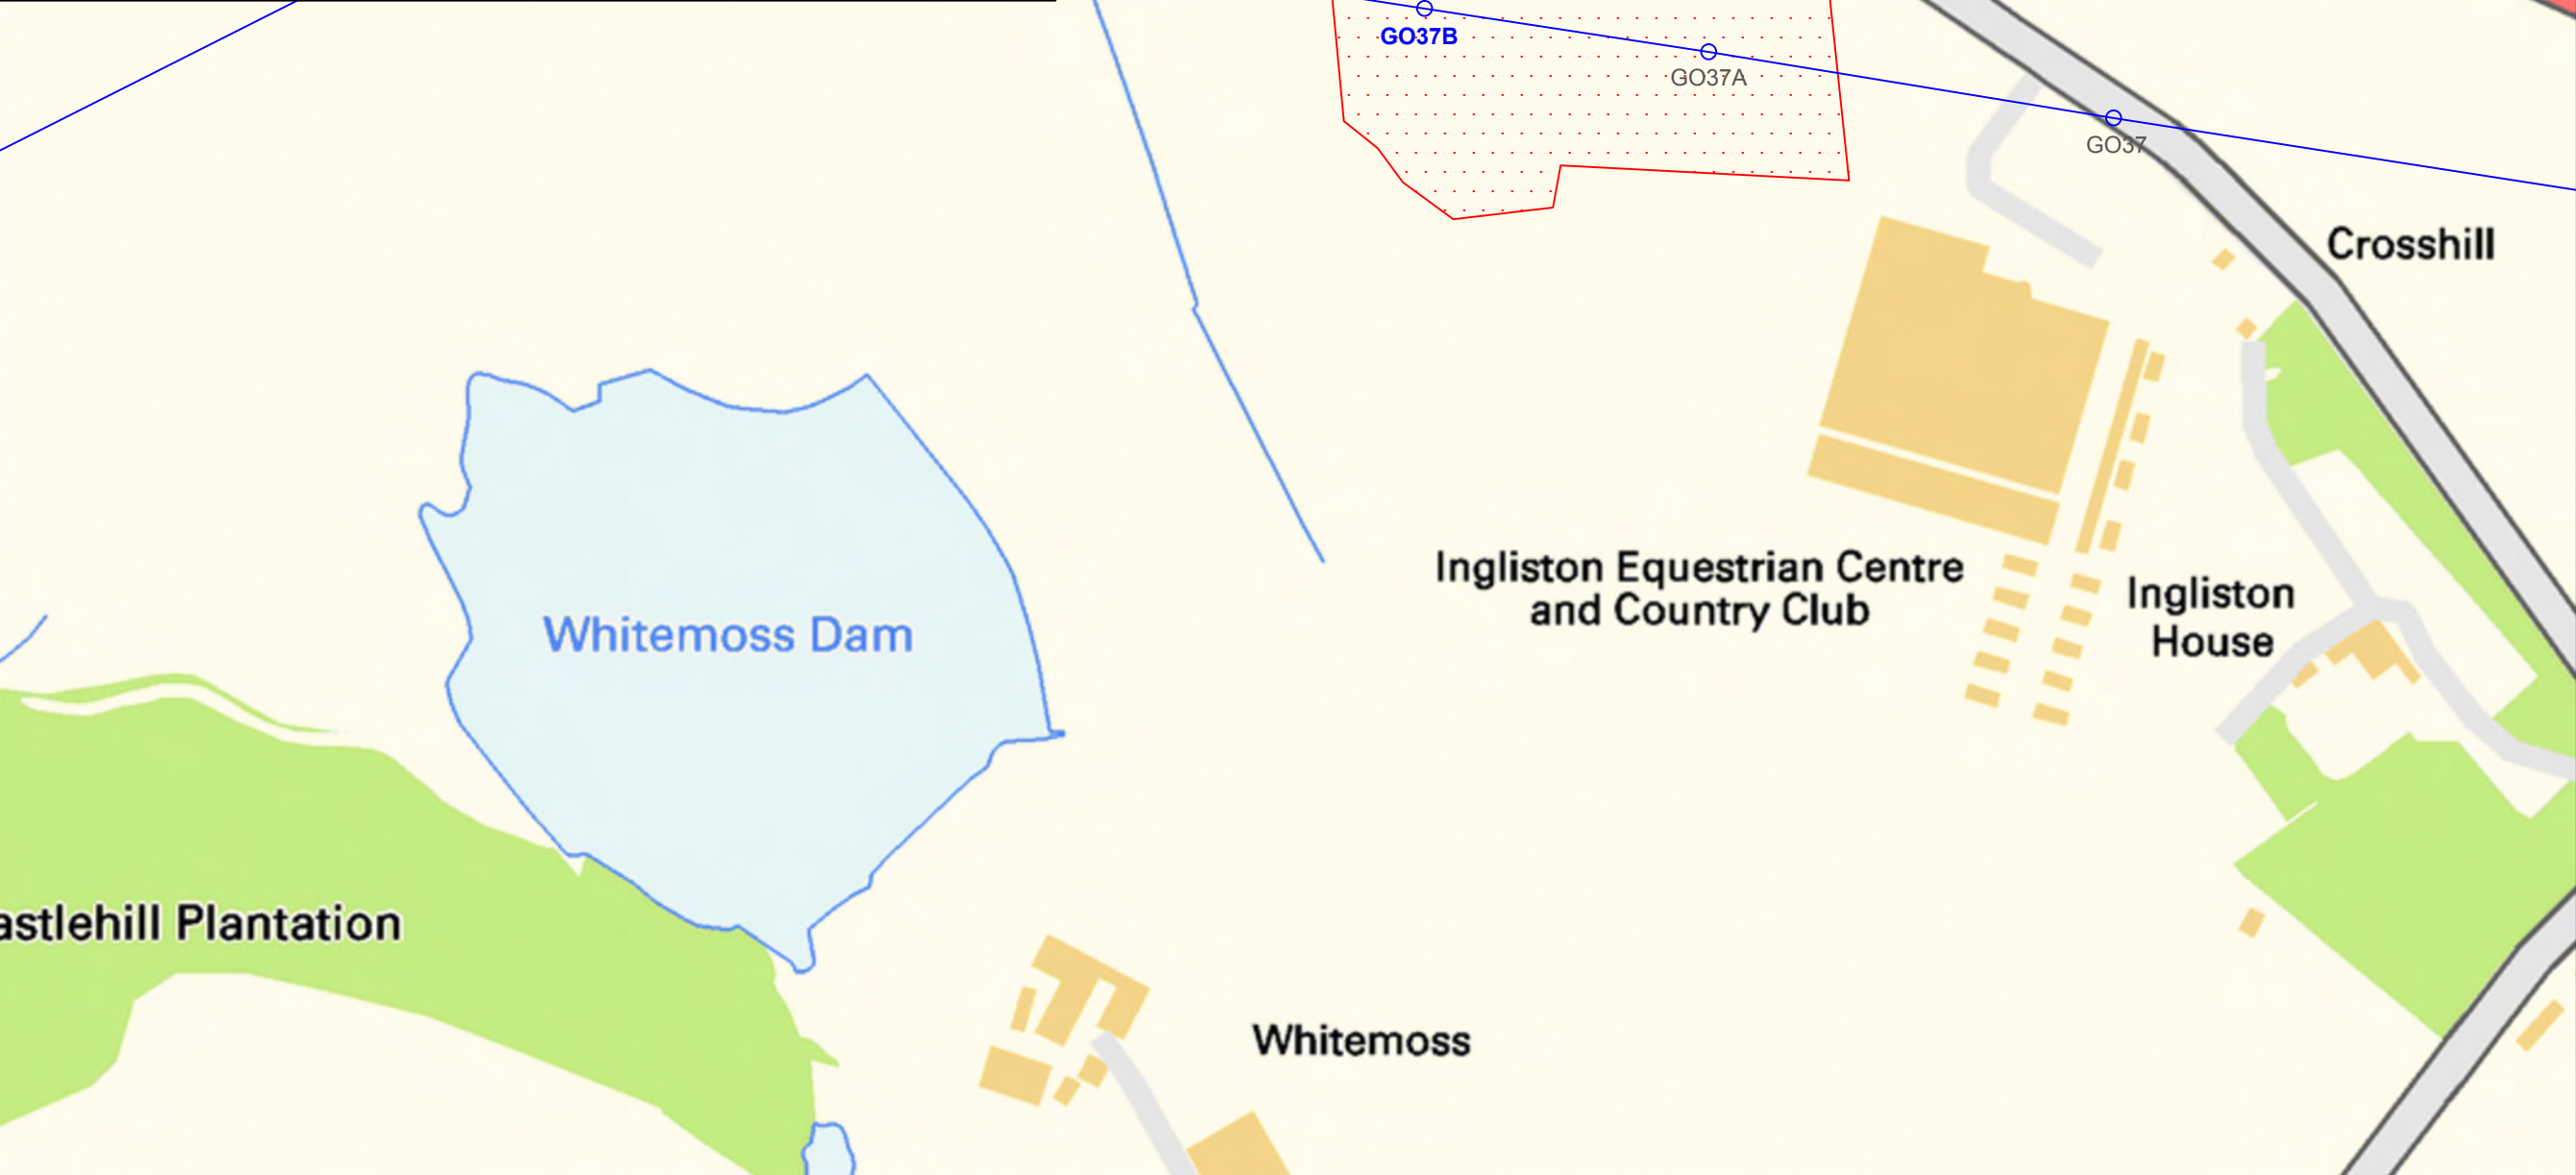
The excavated area at the SE leg was an irregular area measuring no more than 1m by 1m, centred on the existing concrete foundation (Fig. 1), and excavated to a depth of 0.4m. Natural subsoil was not reached. Topsoil was a very stony mid brown silt containing shattered rock. Modern glass bottle fragments were noted but not retained.

The excavated area at the SW leg was a square measuring 1m by 1m, centred on the existing concrete foundation (Fig. 1), and excavated to a depth of 0.2m. Natural subsoil was not reached. Topsoil was a very stony mid brown silt containing shattered rock.

The excavated area at the NW leg was a square measuring 1.2m by 1.2m, centred on the existing concrete foundation (Fig. 1), and excavated to a depth of 0.5m. Natural subsoil was not reached. Topsoil was a very stony mid brown silt containing shattered rock.

The excavated area at the NE leg was a square measuring 1.5m by 1.5m, centred on the existing concrete foundation (Fig. 1), and excavated to a depth of 0.6m. Natural subsoil was not reached. Topsoil was a very stony mid brown silt containing shattered rock.

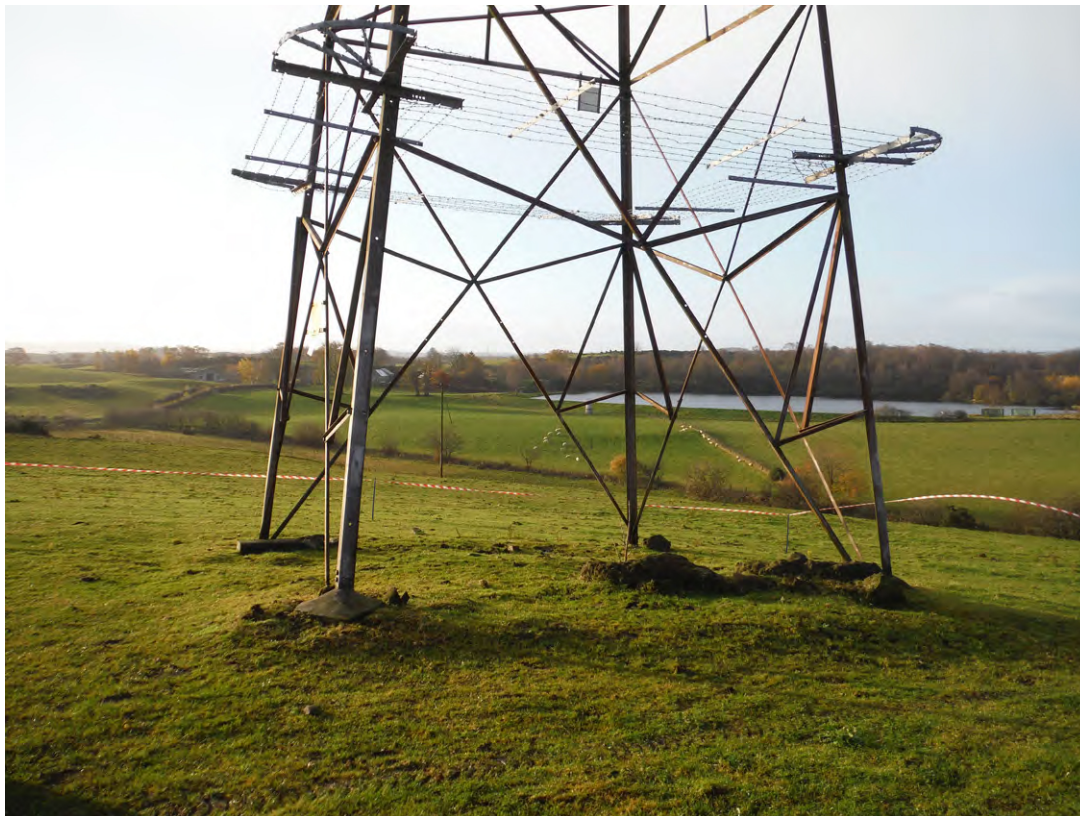
Fig. 2 Photo of Pylon GO37B

The pylon was located in a pasture field (Fig. 2). Access to the pylon was taken by foot and by an All Terrain Vehicle across the surface of the field.
