High Myres Cottage, East Renfrewshire Archaeological Buildings Appraisal

Report No. 3512

Author	Michael Cressey BA MSc PhD MCifA FSA Scot
Illustrator	Greame Carruthers MA MCifA
Approver	Bruce Glendinning BSc Pg Dip MCifA
Commissioned by	ScottishPower Renewables.
Date issued	February 2017
Version	2
Oasis Ref No.	cfaarcha1-271584
Grid Reference No.	NS 58599 47851

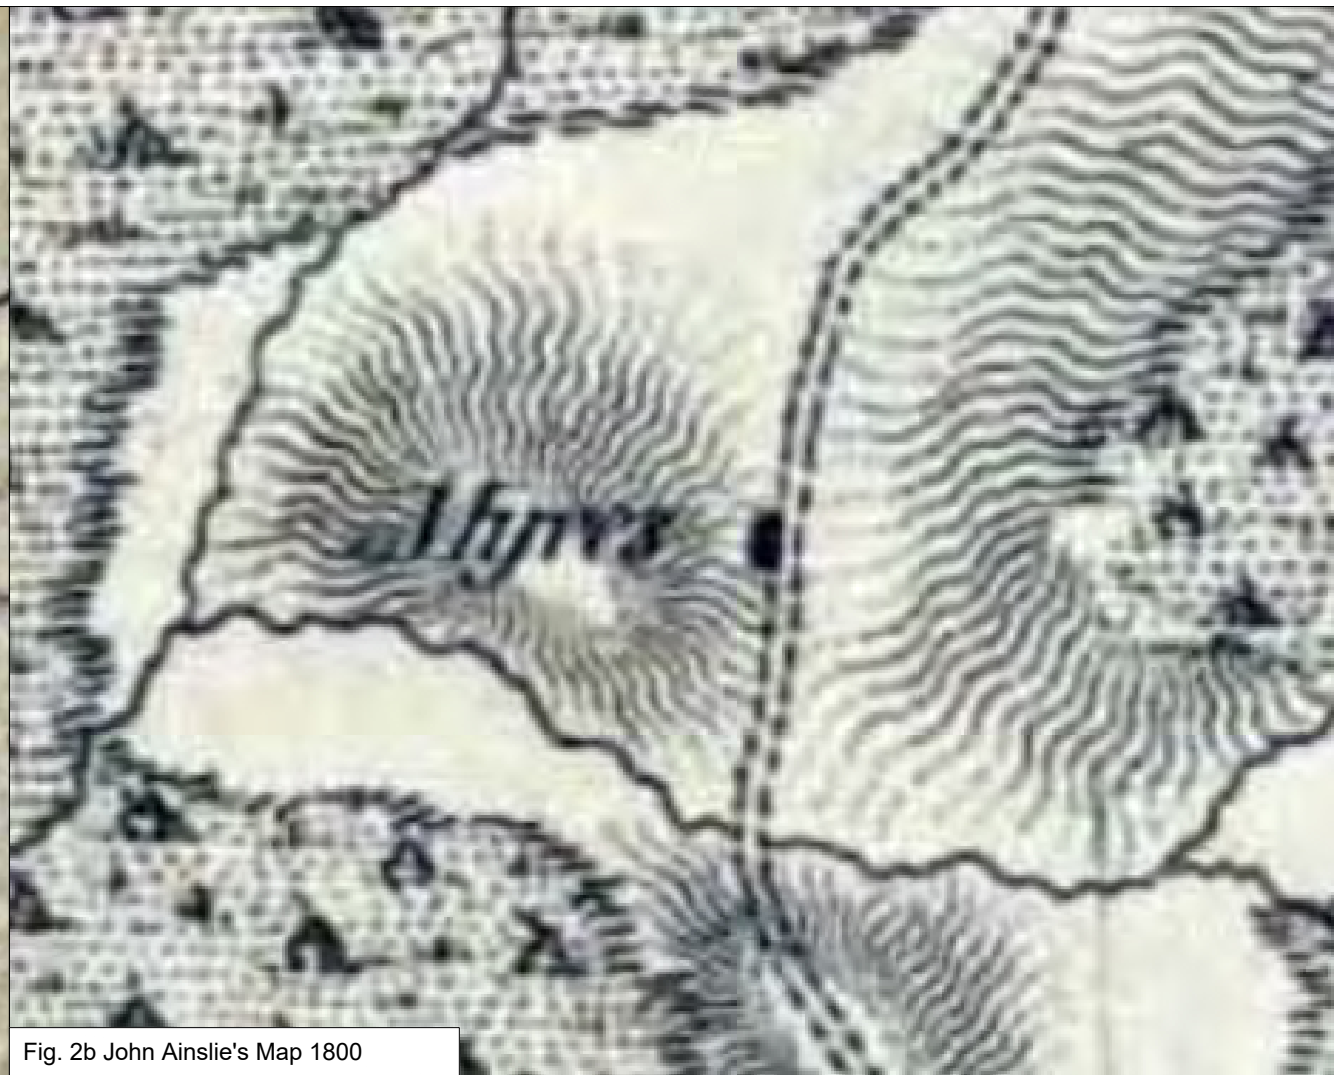
Fig. 2b John Ainslie's Map 1800

John Ainslie's 1800 map (Fig 2b) depicts *Myres* alongside a track surrounded by moorland. John Thompson's atlas of 1832 shows the same detail.

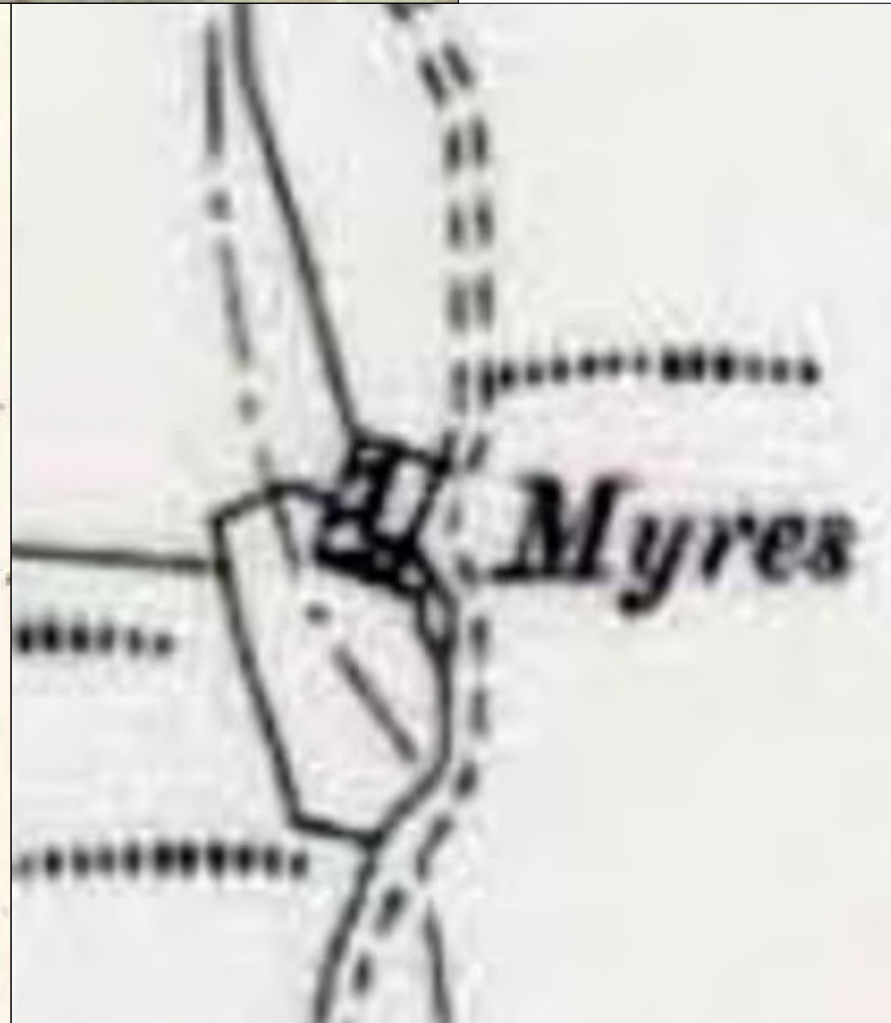
Fig. 2d 1889 Ordnance Survey Map

The 1889 Second Edition Ordnance Survey map (Fig 2d) shows that by this year the cottage had been reconfigured into an L-shaped building. The 1915 Ordnance survey map shows the same cartographic detail.

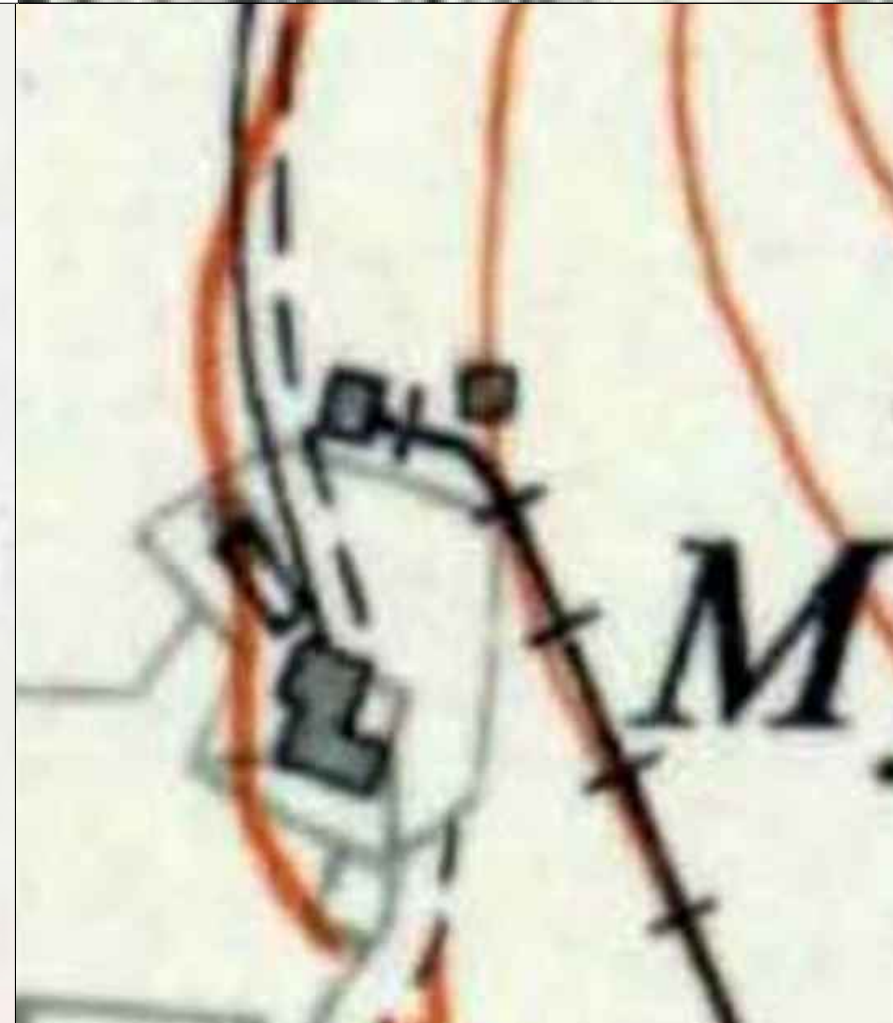
Fig. 2e 1958 Ordnance Survey Map

The 1958 Ordnance Survey map (Fig 2e) shows the cottage with an L-shaped footprint and a slightly wider north end. A mineral railway was in operation on its east side.

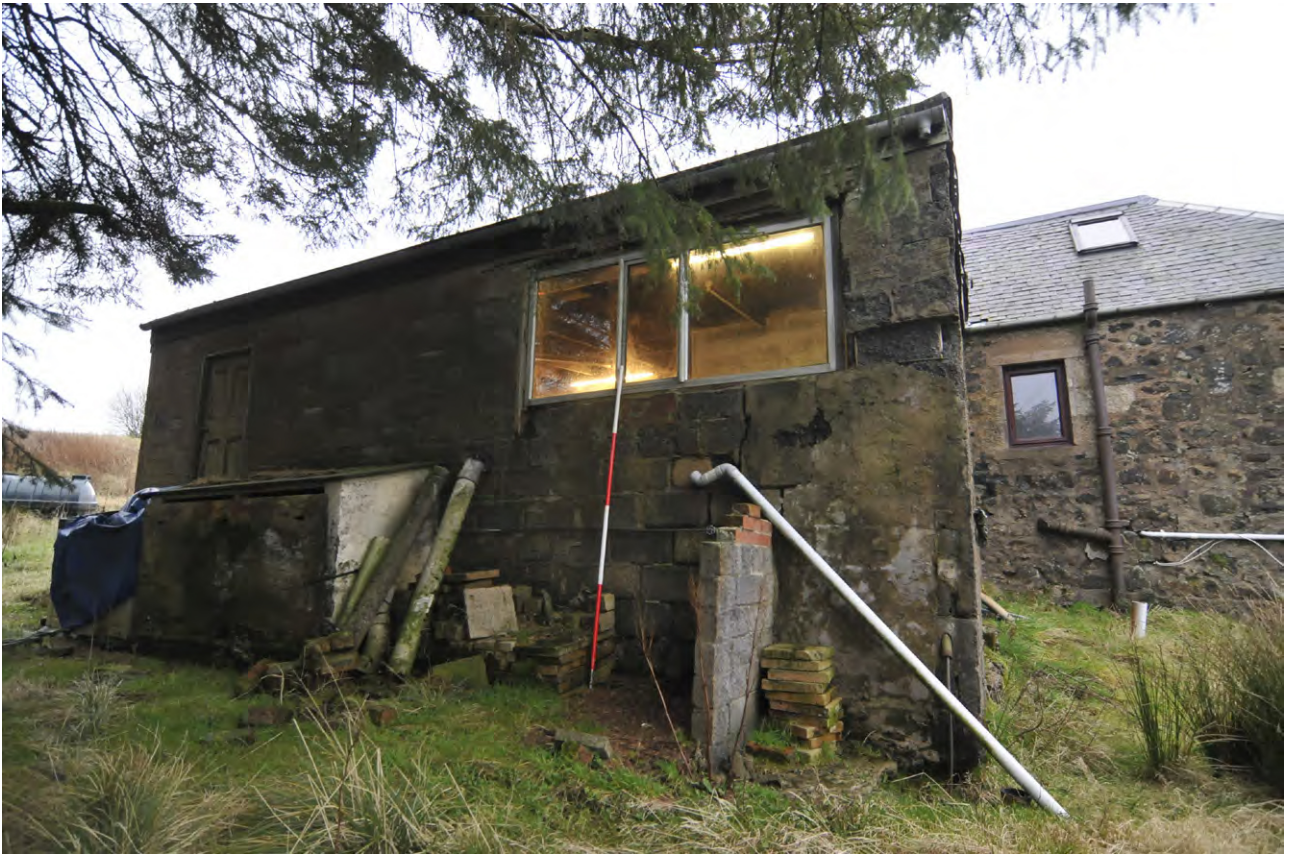
The exterior north-facing elevation had a combined length of 11m and included the outshot garage wall that projected off the cottage gable by 5.4m. The cottage gable was rubble built with mainly basalt whinstone with droved ashlar quoins. Two small rectangular windows were recent inserts. The garage wall was constructed of concrete blocks with a large rectangular window and a door at the east end. The main door was on the east-facing elevation.

Fig. 3 North-facing elevation of the cottage and garage (012)

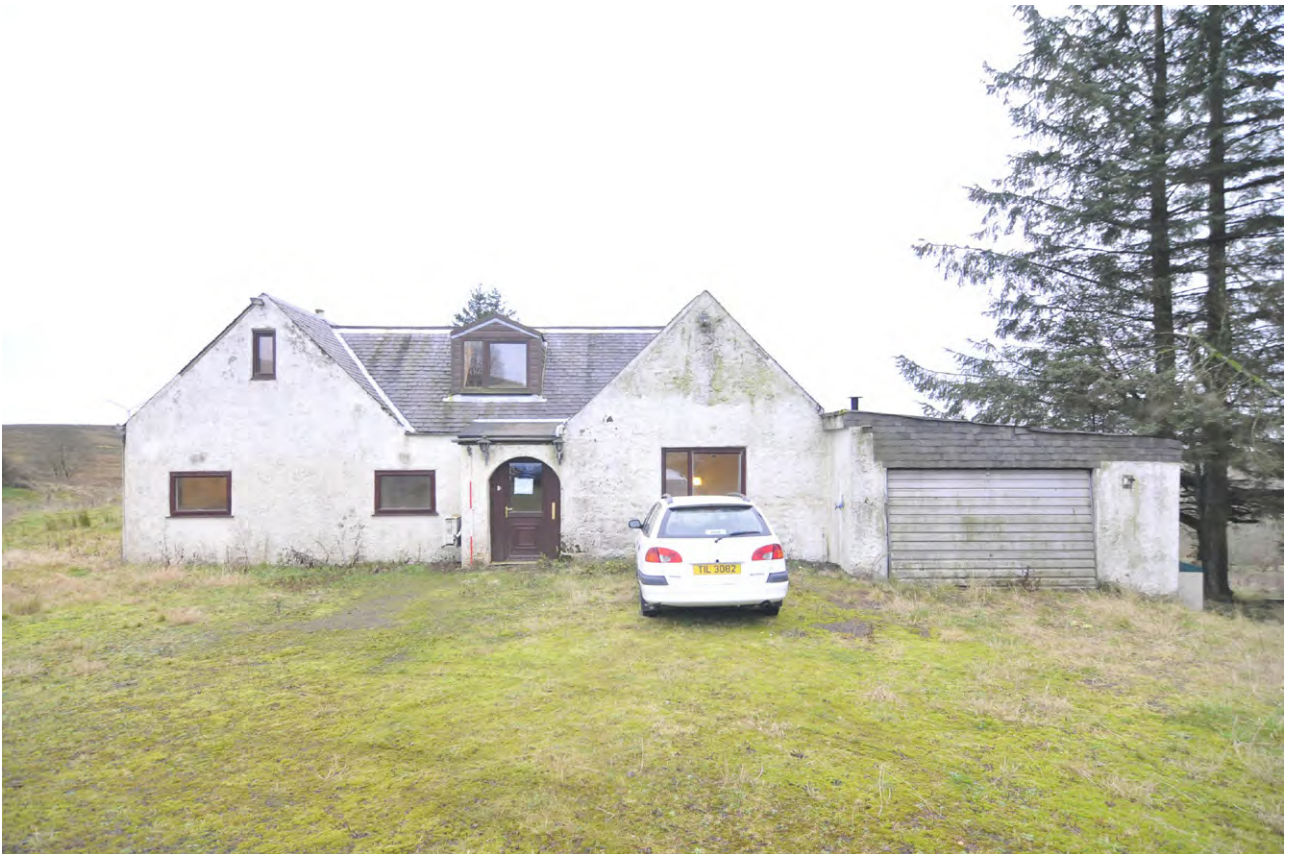
The whitewashed exterior east-facing elevation was 22m long and was built of both ashlar and random rubble. The elevation contained two wings dating to the 20th century, both had pitched gables and a centrally placed modern dormer window in the slate roof. The main entrance door was set below an arched opening that entered into a small porch. Attached to the north end of the cottage was the aforementioned

garage. The fenestration included the aforementioned dormer and a small rectangular window in the south gable and three rectangular windows on the ground floor. All were modern double-glazed uPVC.

Fig. 4 East-facing elevation of the cottage (001)

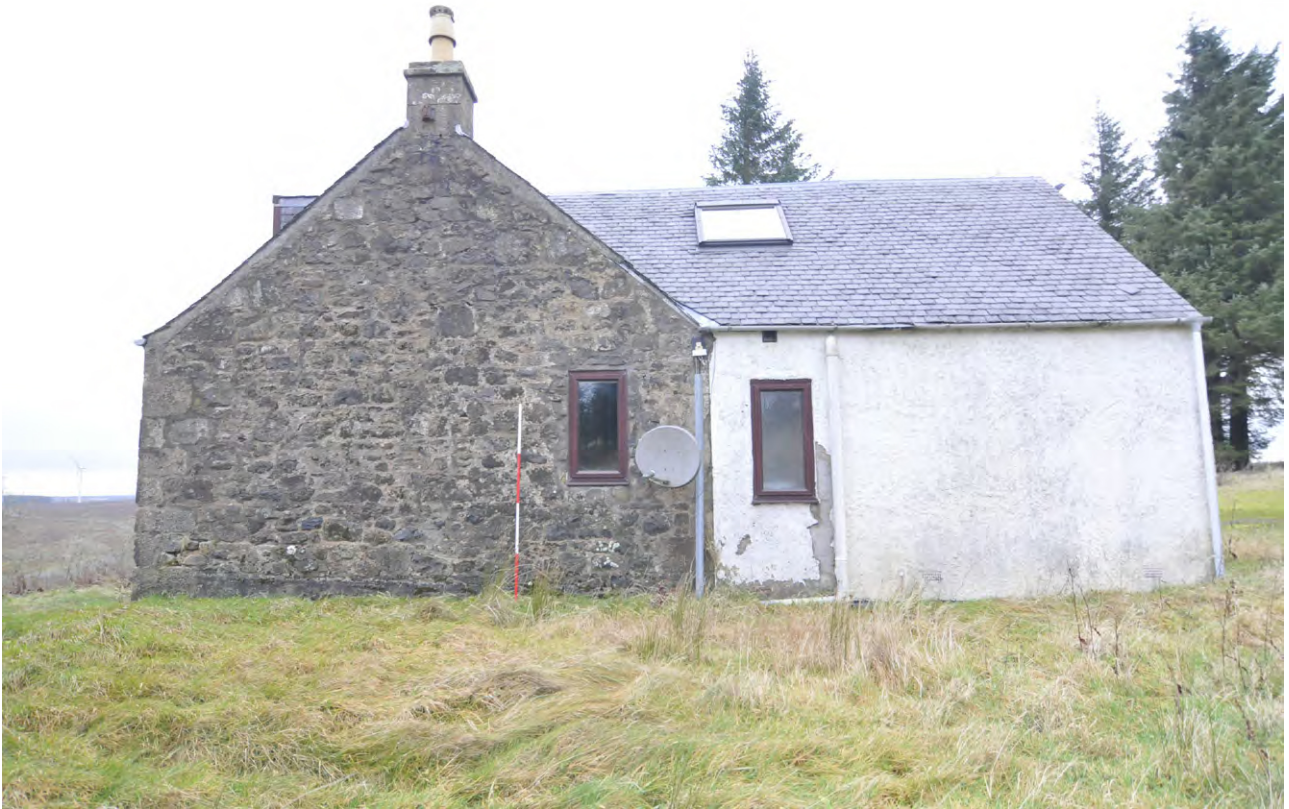
The south-facing elevation included the original 19th century rubble-built gable wall with droved ashlar quoins and chimney stack. The elevation also contained the more recent (20th century) stone-built whitewashed south wing wall. The roof was slate and included a Velux window. On the ground floor were two rectangular inserted windows.

Fig. 5 South-facing elevation of the cottage (005)

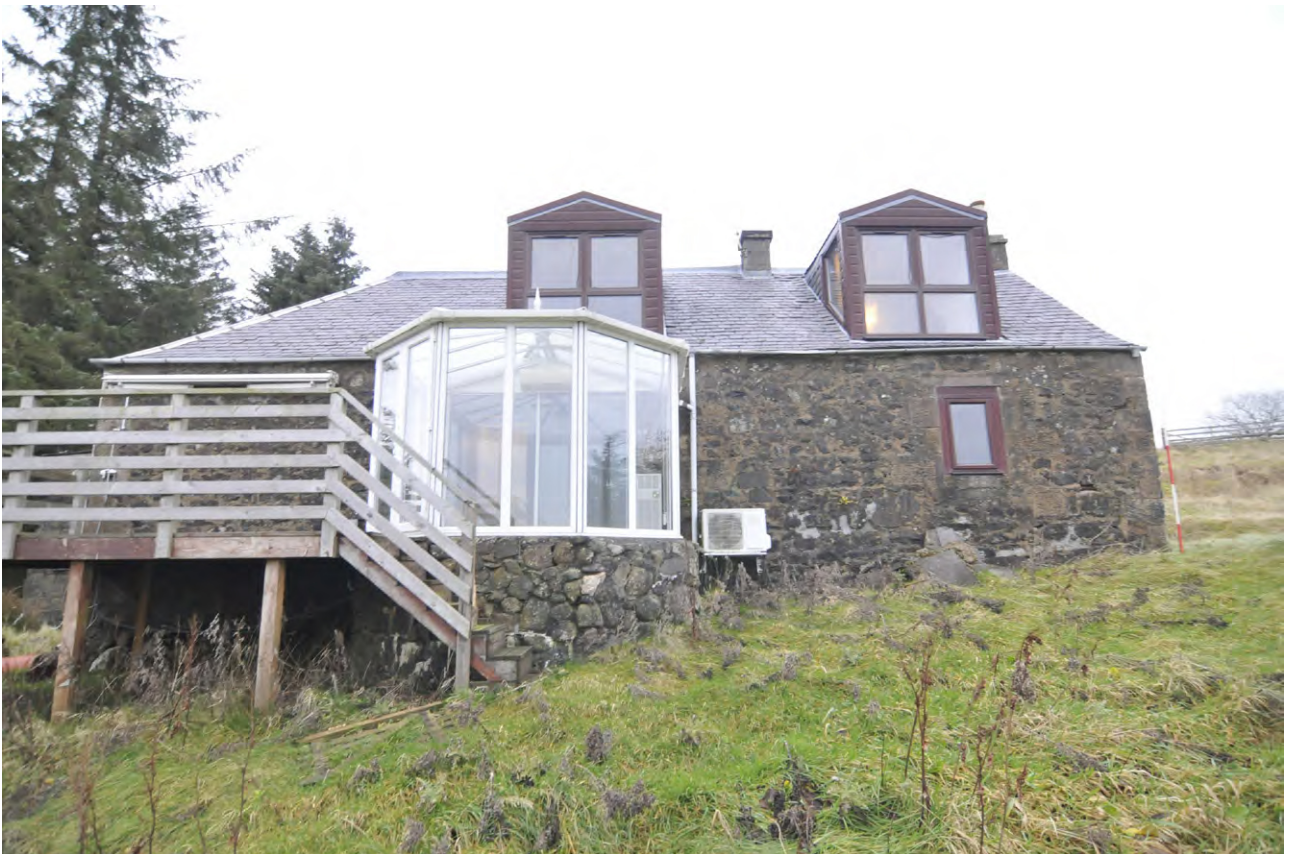
The exterior west-facing elevation comprised the original 19th century core block with off-set dormer windows and a chimney stack in between. The rubble-built wall was framed with droved ashlar quoins. An original window reveal contained droved surrounds with a modern uPVC bedroom window. A timber deck with steps led up to a modern hexagonal uPVC conservatory that was built on a rubble wall.

Fig. 6 West-facing elevation of the cottage (007)

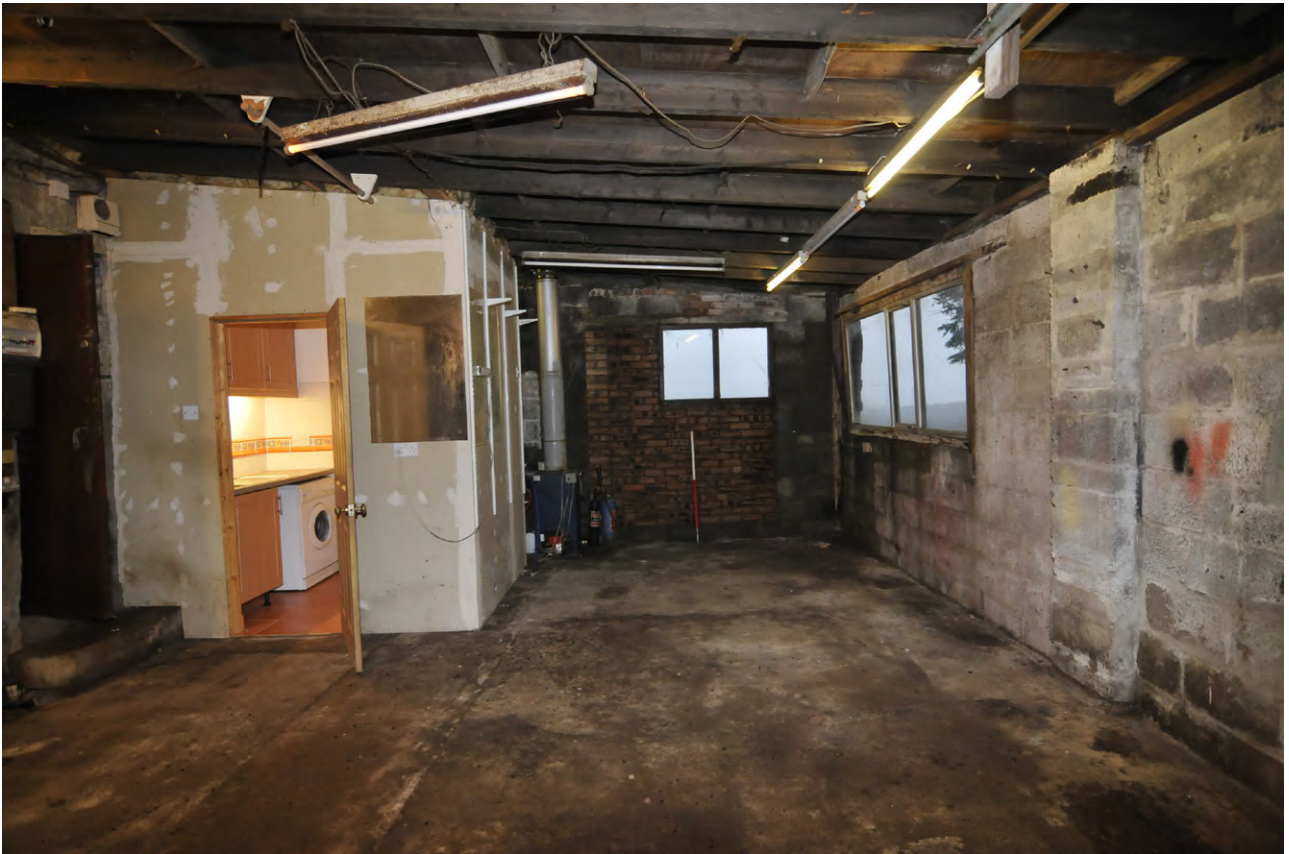
The garage occupied a rectangular footprint and had exposed timber rafters and a concrete floor. The west wall was bare brick and the north wall was bare concrete block. Both walls contained casement windows. The main garage door was on the east wall. Part of the later 20th century wing wall was exposed on the north-facing elevation, which the garage was attached to. The corner of the wing had been built using re-used droved quoins. On the same wall a door led into the kitchen (Room 2).

Fig. 7 Room 1 Garage, interior view (030)

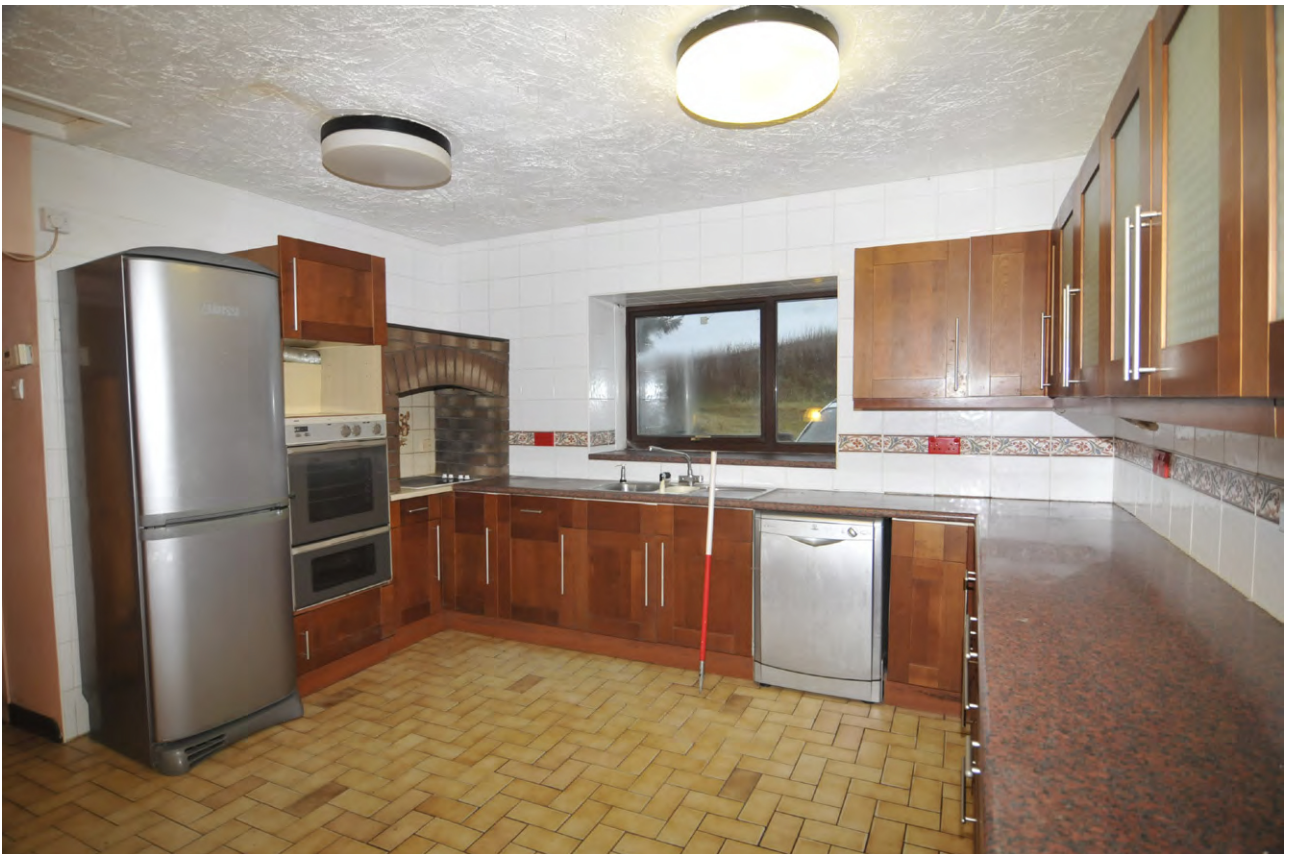
The kitchen was roughly square shaped with modern fixtures and fittings. A window faced eastwards. On the west side of the kitchen contained a dining area with a sunken floor.

Fig. 8 Room 2 Kitchen interior view (026)

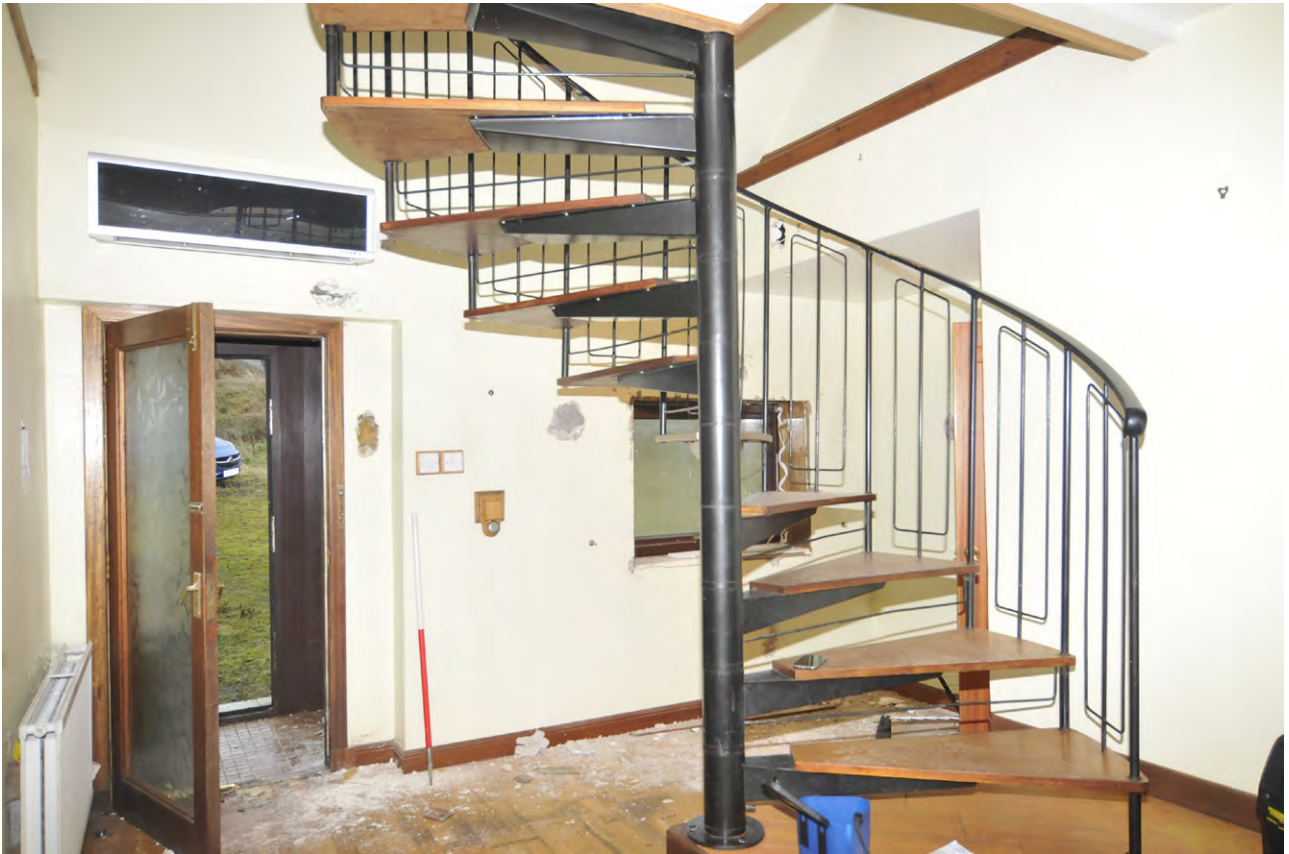
The hall was L-shaped with the main door on the east wall (west-facing elevation). A metal and wooden spiral staircase occupied the middle of the hall. The floor was wood laminate. A narrow passage led off to three bedrooms at the south end of the cottage (Rooms 4-6).

Fig. 9 Room 3 Hall and spiral staircase (014)

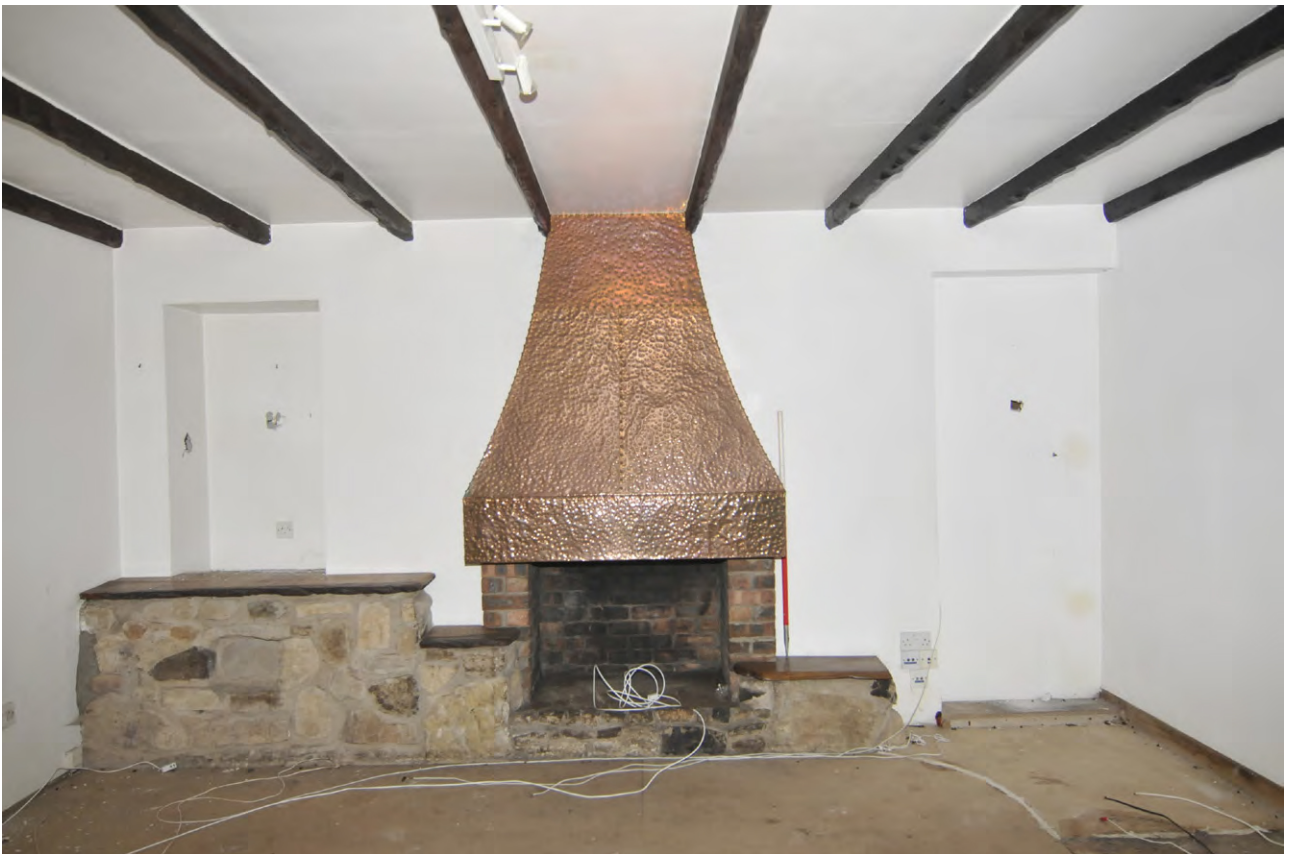
The living room was L-shaped and was lit by a large double-paned sliding door leading out to the conservatory. On the south wall (north-facing elevation) was a large brick-built fireplace with a beaten copper paneled hood above it. A stone-built fire surround occupied most of the wall. A blocked doorway was present on the right hand side (facing) of the fireplace. The walls were whitewashed and the ceiling had mock wooden beams. At the north end of the room was a small ancillary study room lit by a window on the north gable.

Fig. 10 Room 7 Living Room fire place (022)
